Inspection Report

Property Address:
3 Proprietor Lane
Whitehouse Station NJ 08889

New Jersey Property Inspections

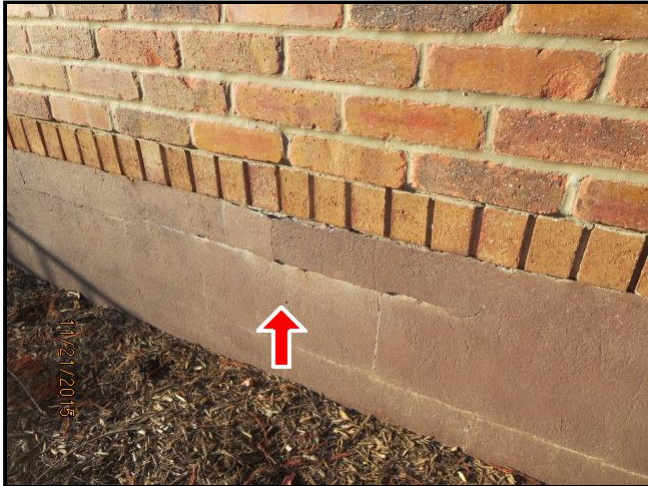
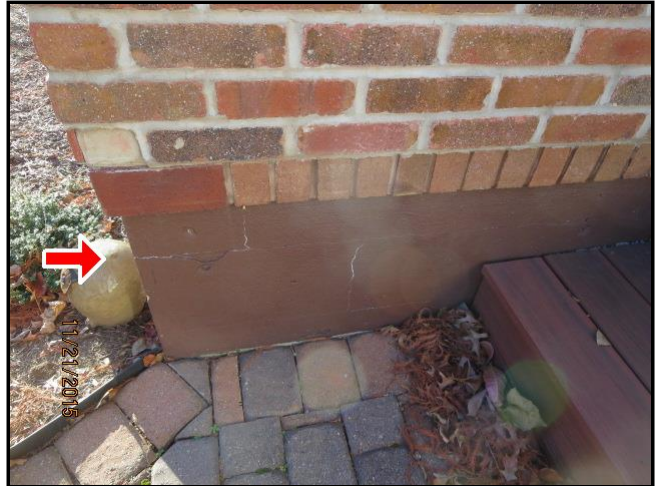
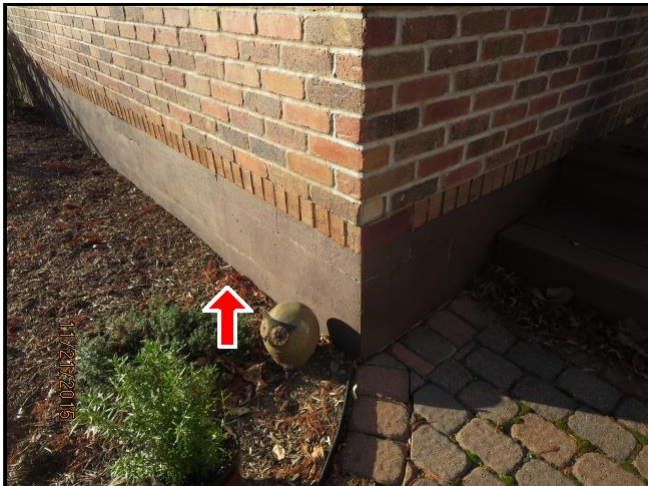
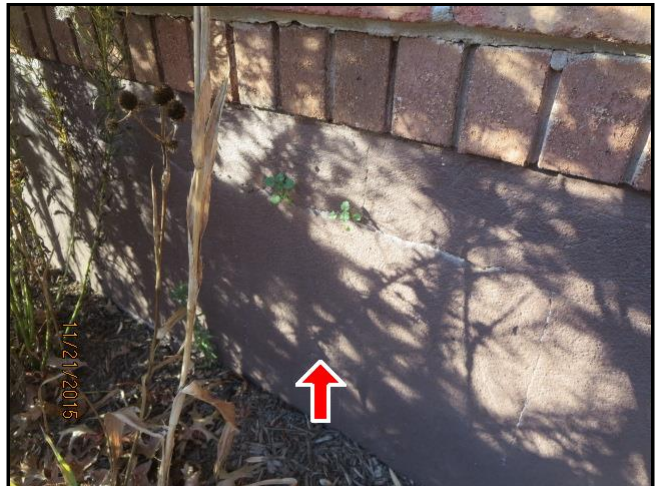
6.0 Item 1(Picture) Wall Cracks

(1) There are structural crack(s) in the foundation wall at the rear of home. The wall(s) may need reinforcement. A qualified structural engineer should inspect and repair or replace as needed.

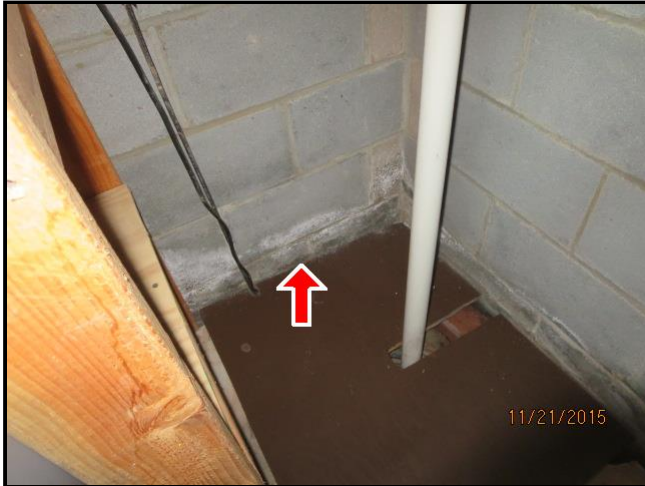
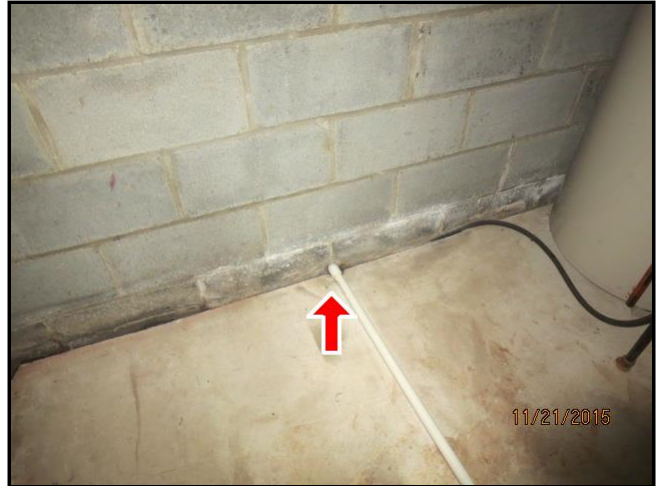
6.0 Item 5(Picture) Efflorescence

(2) White efflorescence (powder substance) on block wall indicates moisture is in contact with the masonry. This does not necessarily indicate that intrusion will occur. I recommend checking the gutters and the downspout drain lines for proper operation. Also, a water proofing paint could be applied to the interior side of the block if necessary. Efflorescence is found on many homes without water intrusion occurring inside the home. But, it should alert you to the possibility that future steps may be needed.

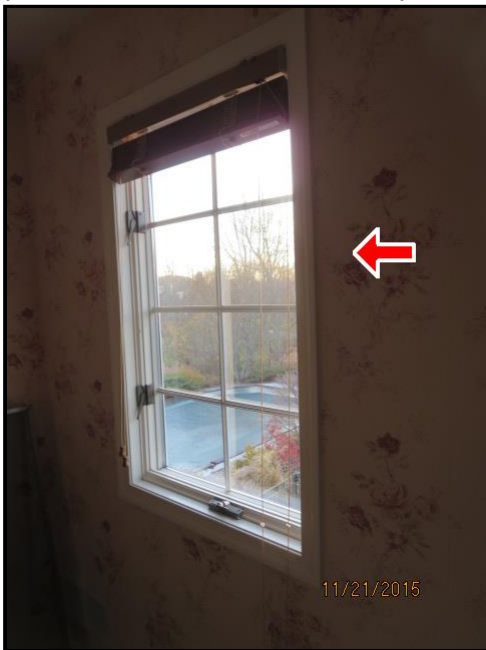
8.6 Item 1(Picture) Bed window

One window difficult to operate at the Bedroom. Further deterioration may occur if not repaired. A qualified contractor should inspect and repair as needed.

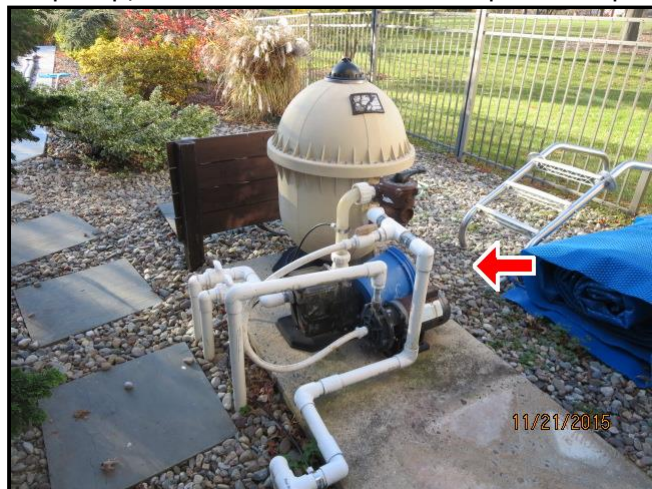
11.0 Item 1(Picture) Pump & Filter

Pool was closed at time of inspection. Pump and filter could not be inspected. Dating on the pump indicates the pump and filter maybe from 1998 this should be verified by the seller. Due to the age of the pump, it is recommend that the pool be opened and a full inspection be completed before closing.
