BUCKEYE HOME INSPECTIONS OF NEO

RESIDENTIAL REPORT

1506 Garrett Rd
Jefferson OH 44047

Dave Hayes
MAY 7, 2020

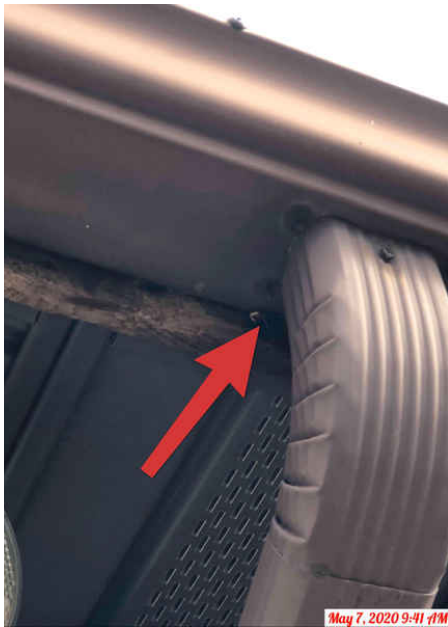
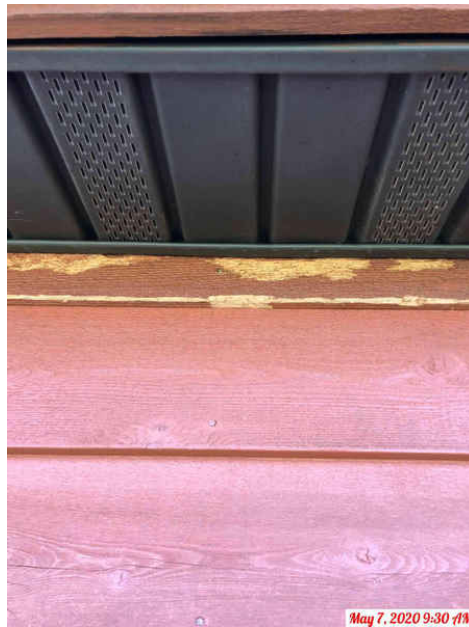
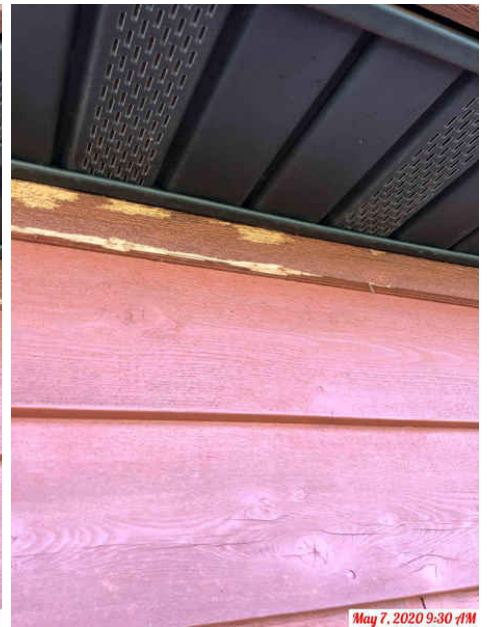
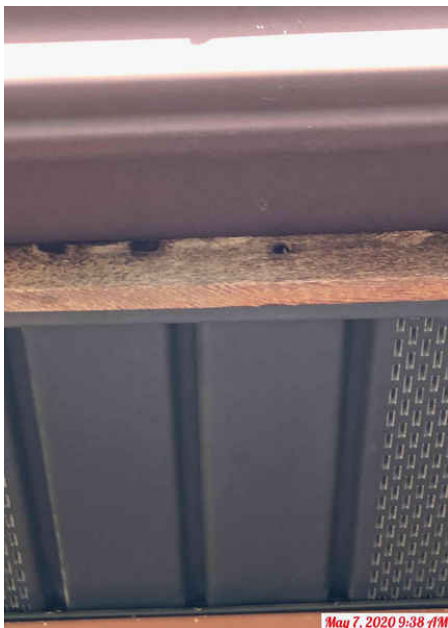
Observations: I observed indications of dead insects, insect parts, mud tubes, holes, or staining (description and location):

Yes

Details / Description: Exterior of home, rear, near gutter.

Observations: Based upon my observations during my home inspection, I recommend that a state licensed pesticide applicator further evaluate the home for possible wood-destroying organism (WDO) infestation and provide control if deemed necessary.

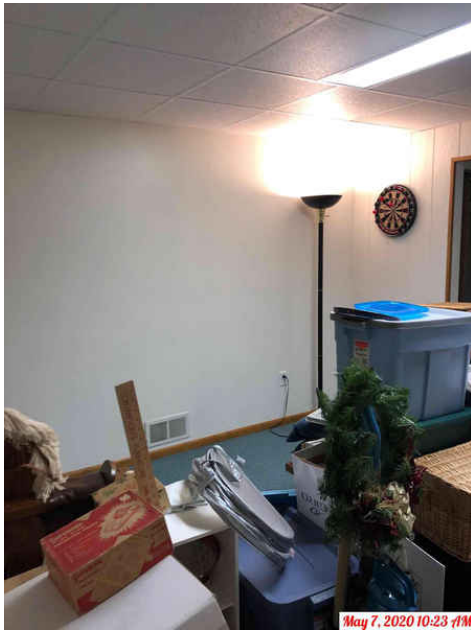
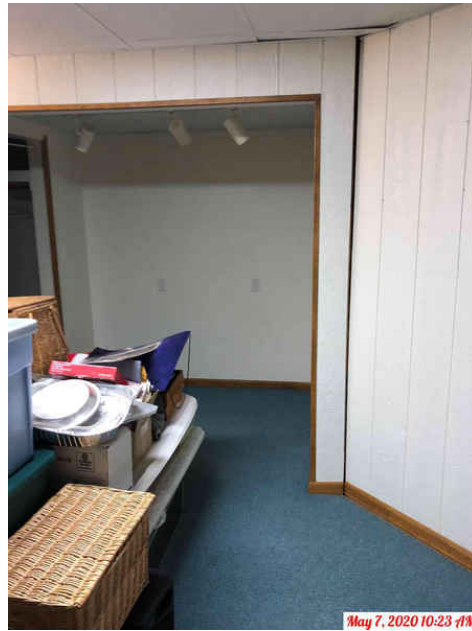
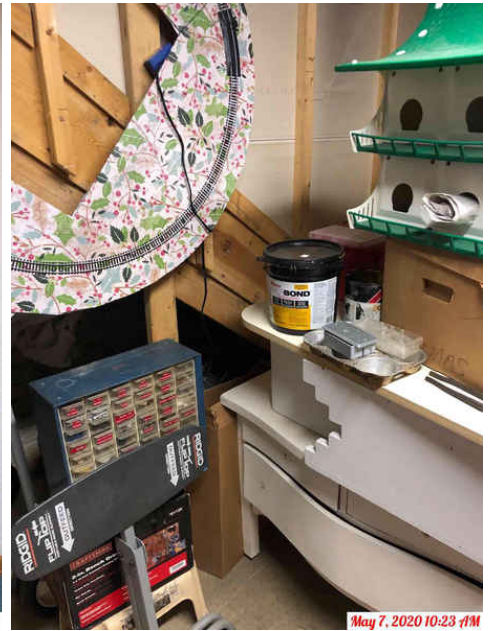
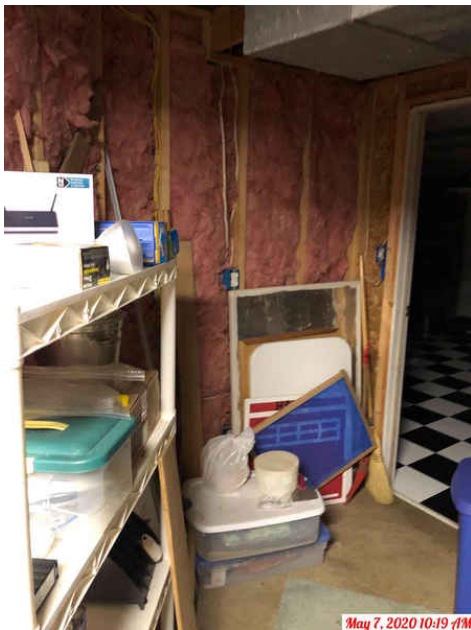
BASEMENT

Stored items or cluttered conditions

Stored items and partially finished basement restricted inspection.

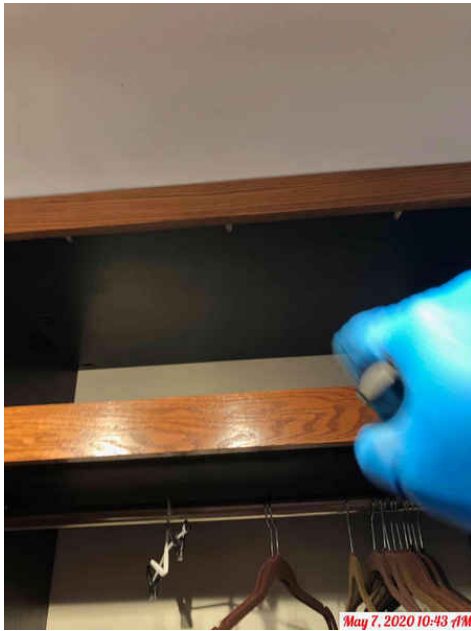
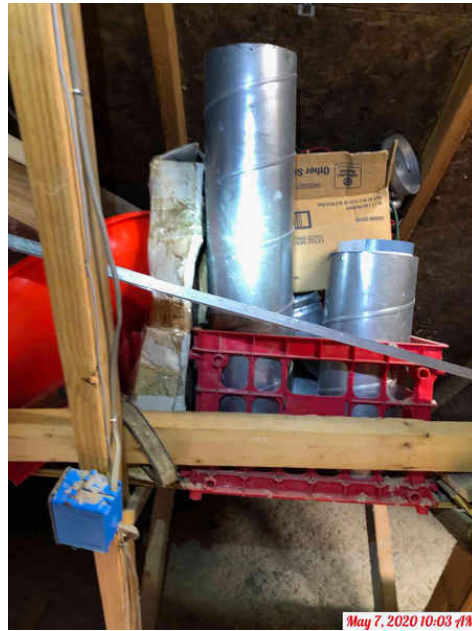
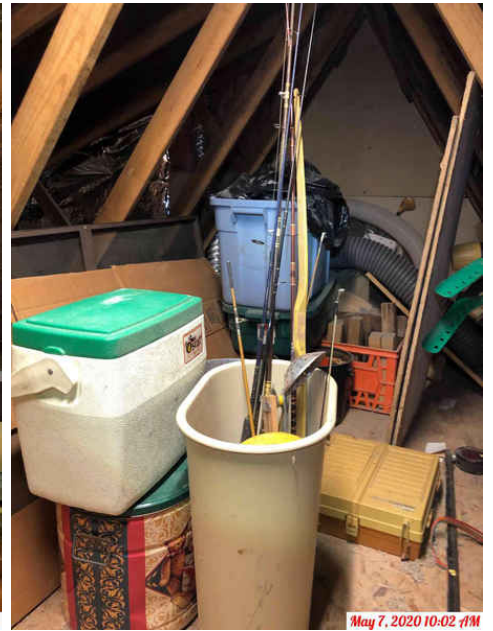
ATTIC

Restricted access

The attic access was fixed to ceiling. Attic above garage held personal items. Restriction.

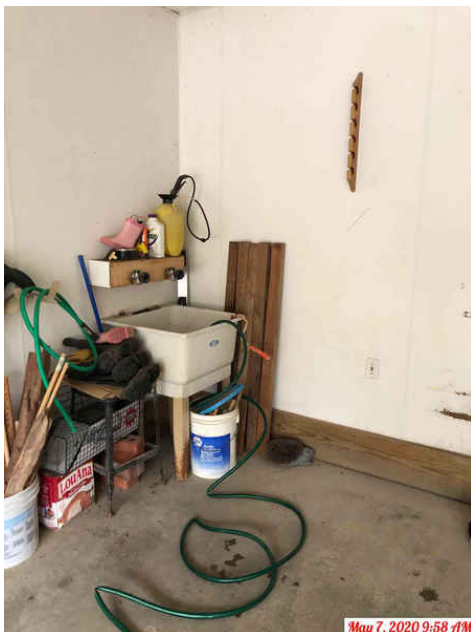
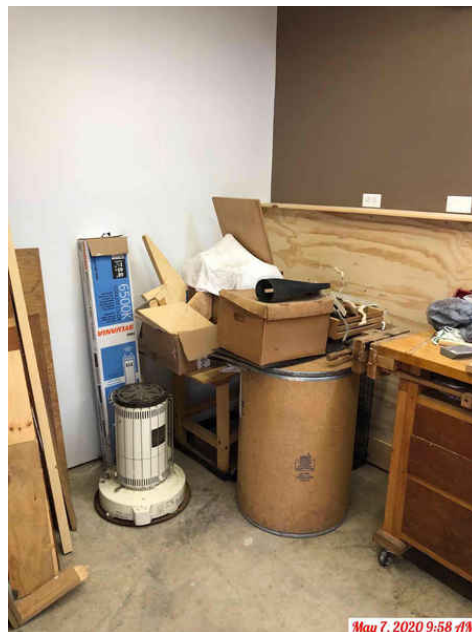
GARAGE

Stored items or cluttered conditions

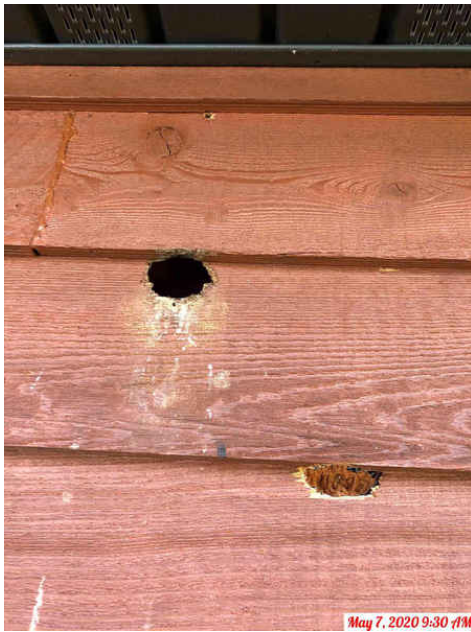
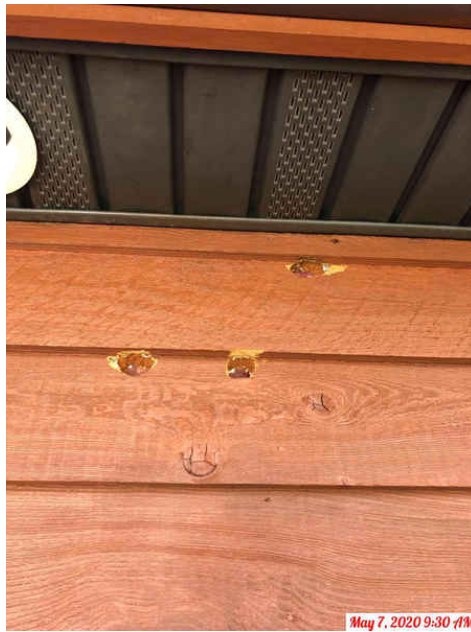
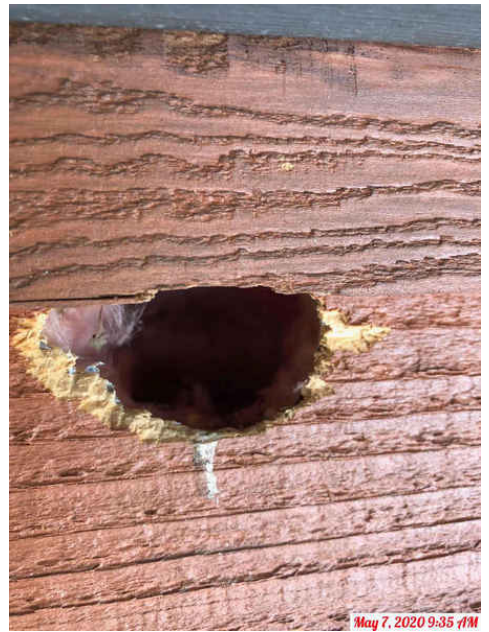
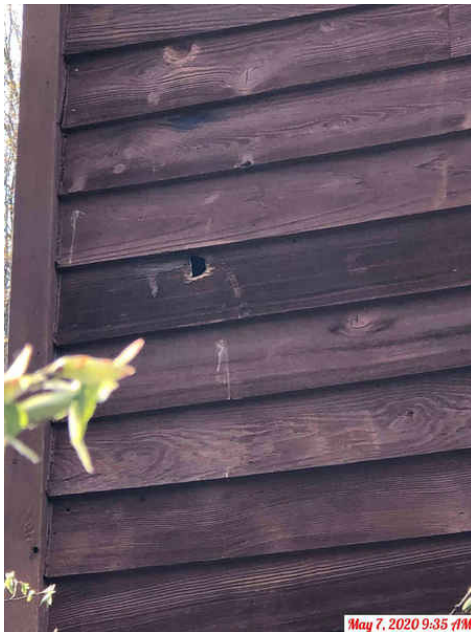
4.1.1 Wall-Covering, Flashing & Trim

DAMAGED WALL-COVERING MATERIAL

Marginal

I observed indications of a defect at the exterior wall-covering material.
Correction and further evaluation is recommended.

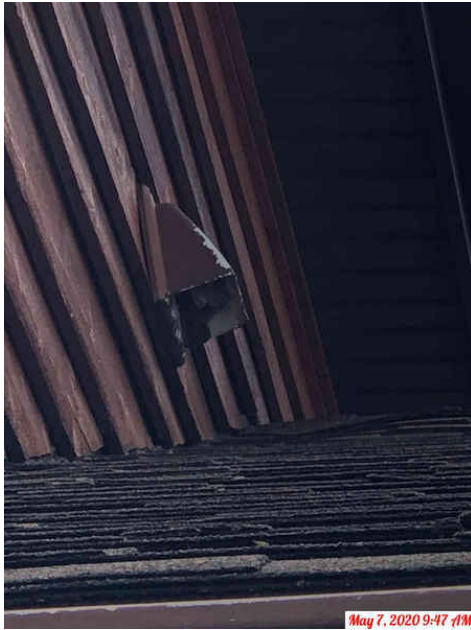
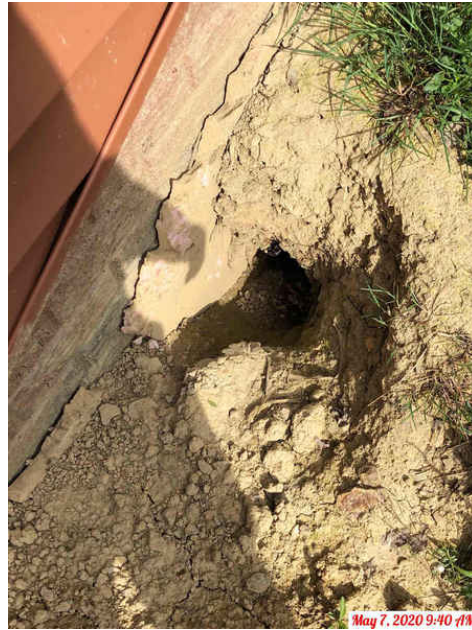
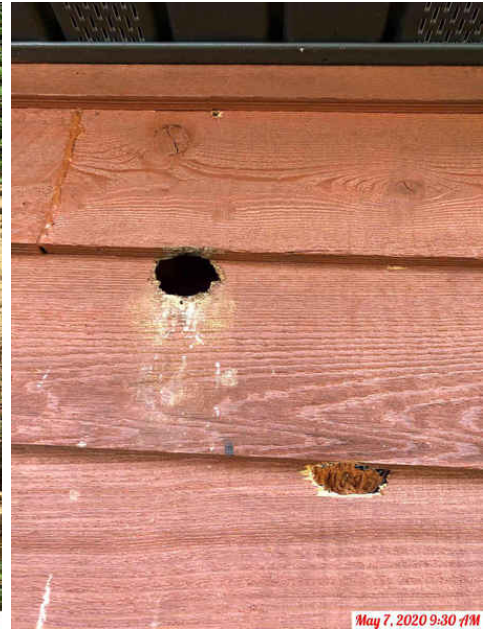
4.1.2 Wall-Covering, Flashing & Trim

PEST OBSERVATIONS

Marginal

There was noise coming from birds from i side the walls near the attached garage, an old bee nest near the upstairs vent, and a groundhog hole near air conditioner. Recommend a pest company evaluate for further treatment.

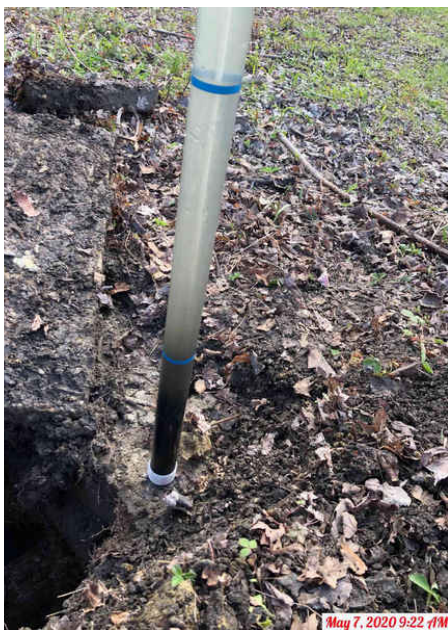
Solids Measurement: Septic tank solids

The solids of a septic tank should not equal more than 1/3 of the total fluids. Your septic fluids were 42" deep. The scum and sludge was less than 12". Pumping is recommended every three to five years, and is not currently recommended.

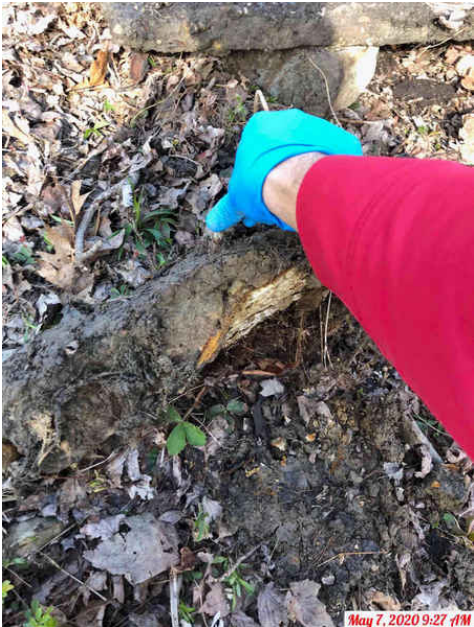
5.2.2 Condition of Septic System

DETERIORATION OF TREATMENT TANK LID.

Deterioration has occurred at the treatment tank lid. The lid will need replaced or repaired.

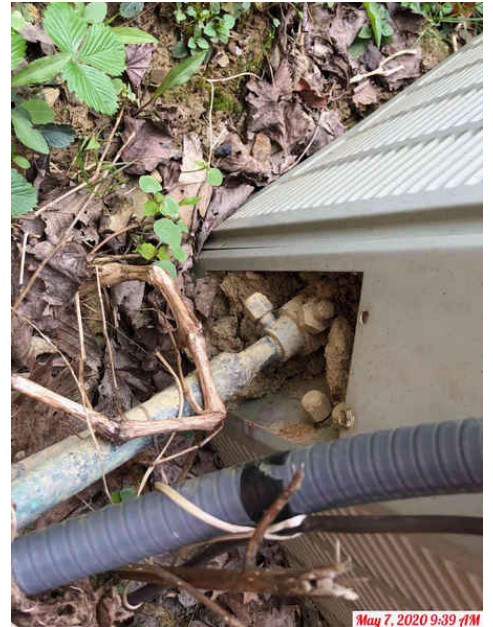
6.1.1 Cooling System Information

DENSE VEGETATION

Minor/Maintenance/FYI

I observed heavy dirt around the exterior cooling unit. Soil was too close to the unit, which can limit heat dissipation and limit effectiveness. Recommend removing to help improve performance.

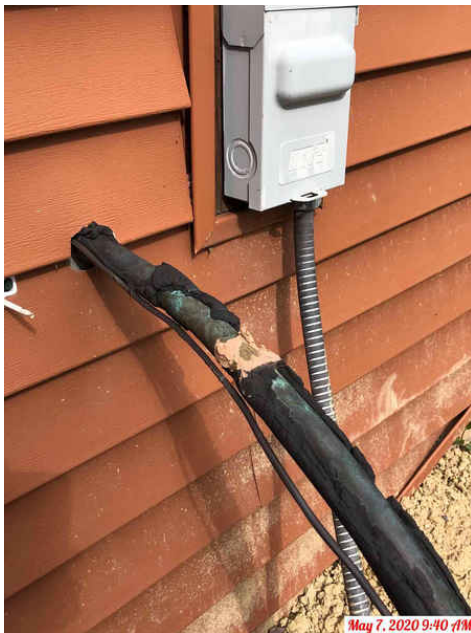
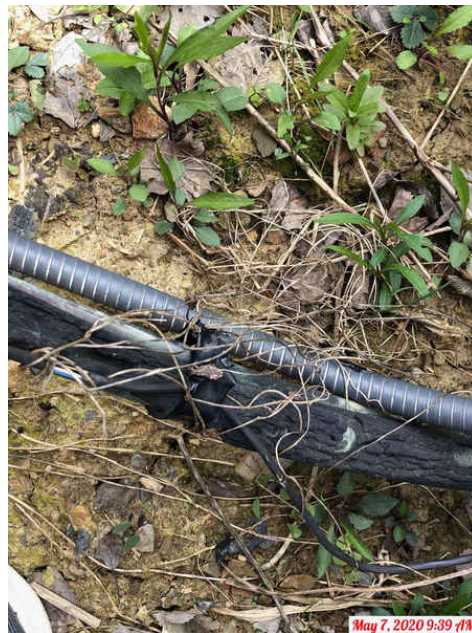
6.1.2 Cooling System Information

REFRIGERANT LINE INSULATION MISSING OR DAMAGED

Minor/Maintenance/FYI

I observed missing or damaged foam insulation at the cooling system's refrigerant line, which can cause energy loss and condensation.

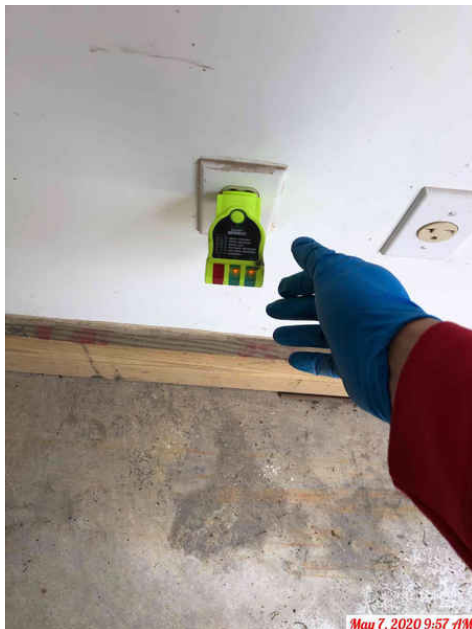
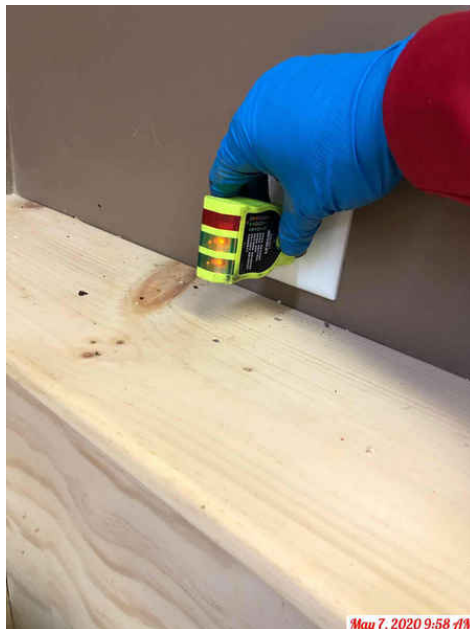
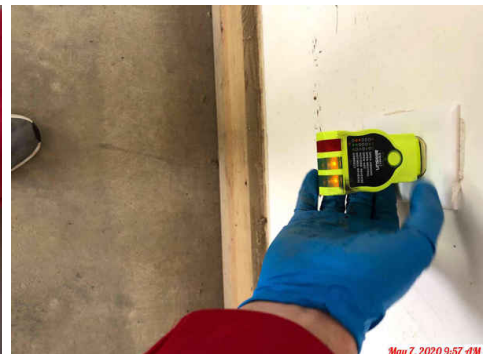
7.4.1 Electric in Garage

Marginal

MISSING GFCI-PROTECTION IN GARAGE

I observed a receptacle in the attached garage without GFCI (or ground fault circuit interrupter) protection.

GFCI protection is required for all 15- and 20-amp receptacles, including outlets for refrigerators, garage door openers, and washing machines.

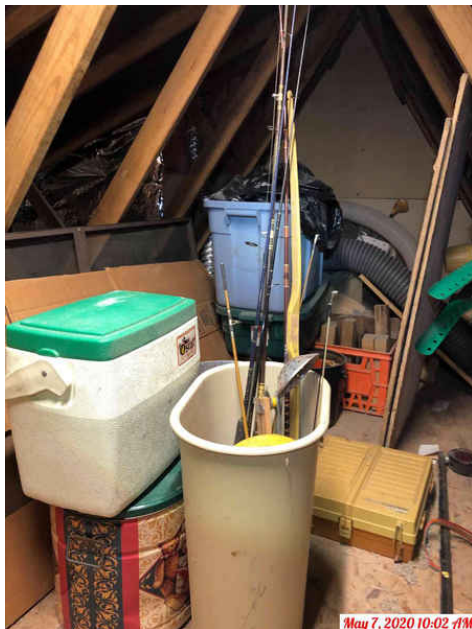
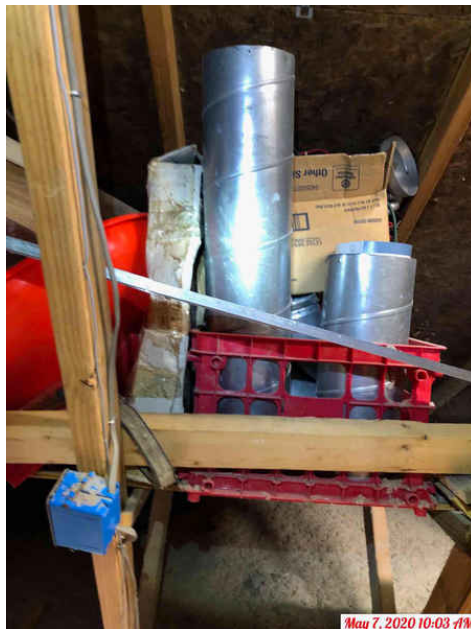
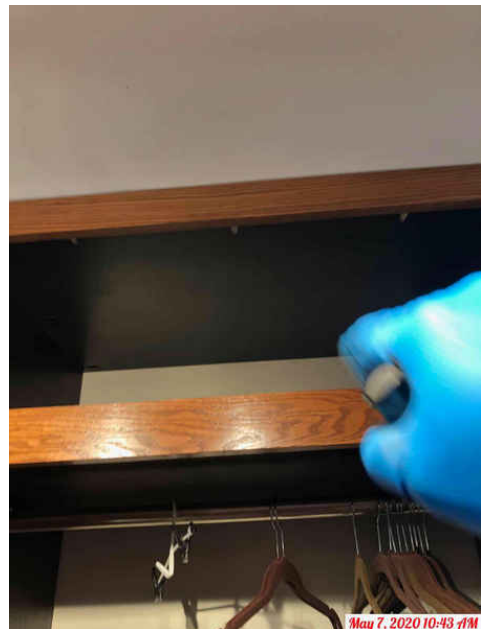
COULD NOT SEE EVERYTHING IN ATTIC

I could not see and inspect everything in the attic space above garage due to personal items. The attic access in the upstairs closet was fixed to the ceiling. The access is restricted and my inspection is limited.

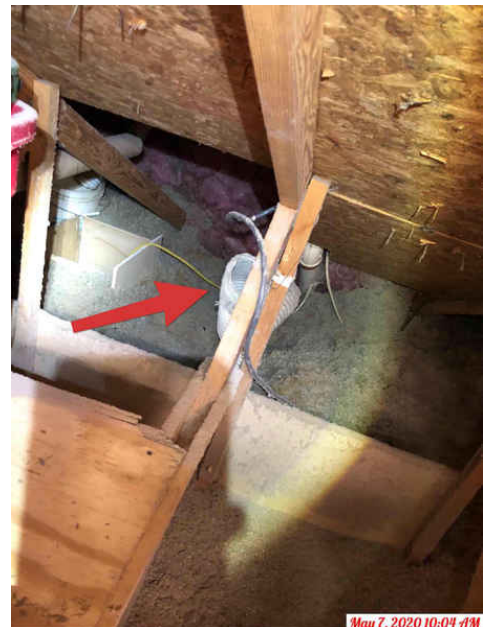
IMPROPERLY EXHAUSTING

I observed that the bathroom fan is improperly exhausting air from the bathroom into the attic above garage. Exhaust air from bathrooms, toilet rooms, water closet compartments, and other similar rooms shall not be:

- exhausted into an attic, soffit, ridge vent, crawlspace, or other areas inside the building; or
- recirculated within a residence or to another dwelling unit.

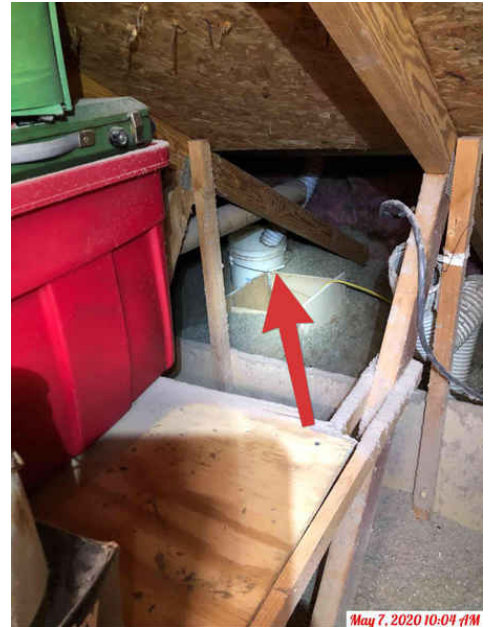
11.3.2 Bathroom Exhaust Fan / Window

UNKNOWN VENTING

Marginal

I observed an unknown venting component terminate in a bucket in the attic. Recommend further evaluation and correction.

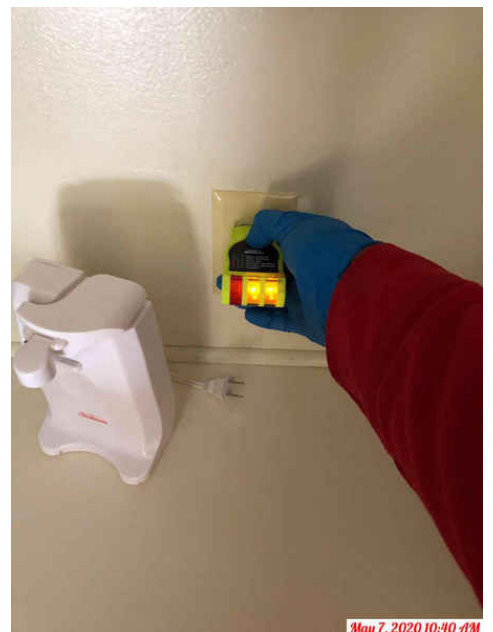
MISSING GFCI PROTECTION

Marginal

I observed indications of missing GFCI protection in the kitchen. All kitchen counter receptacles are required to be GFCI protected.

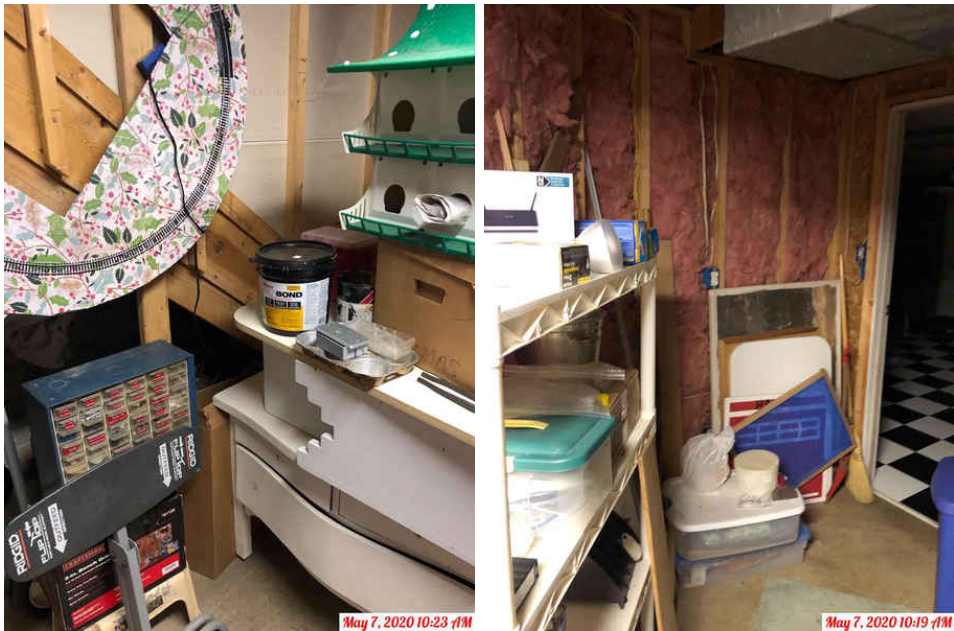
PERSONAL STORAGE RESTRICTION

Personal items limited my visual inspection. Moving personal items and storage is not required by the Standards of Practice. I could not see everything. Many things were blocking my inspection.

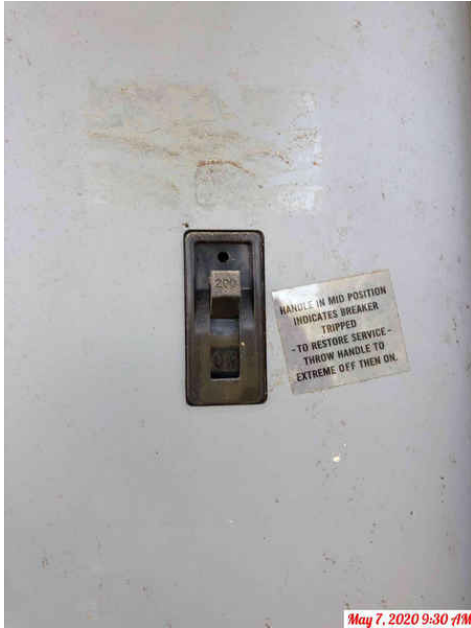
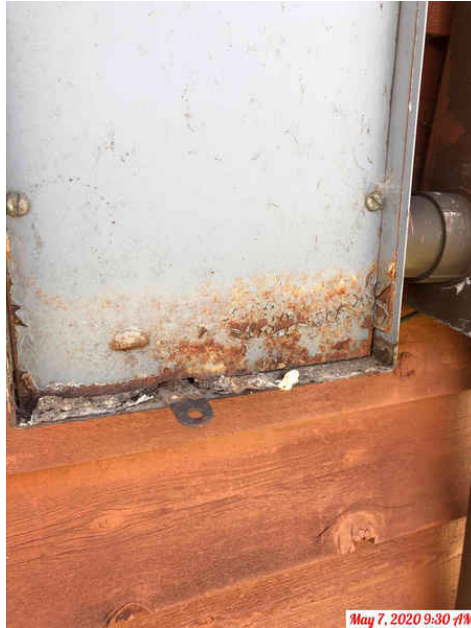
Marginal

I observed the exterior main shut-off. I recommend this be installed in a weather-protective box. It is showing signs of deterioration.

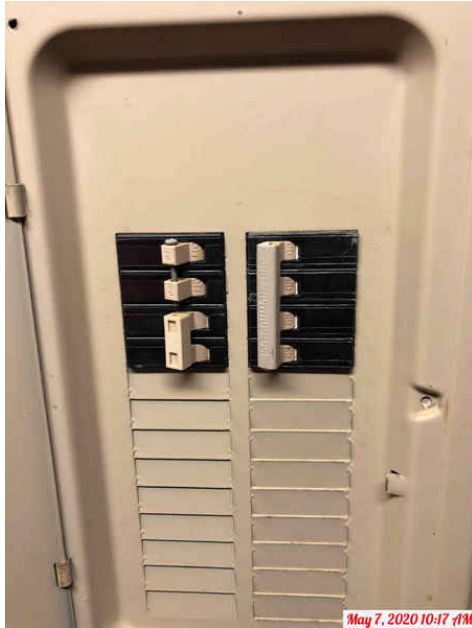
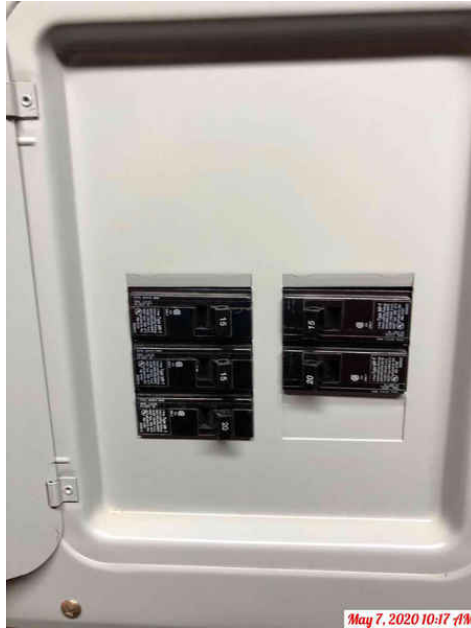
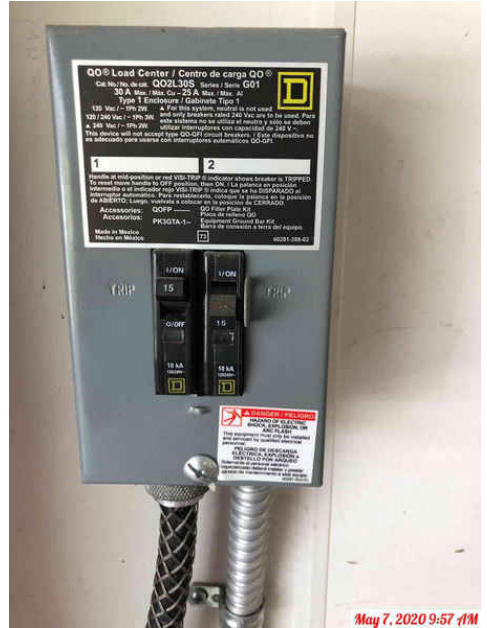
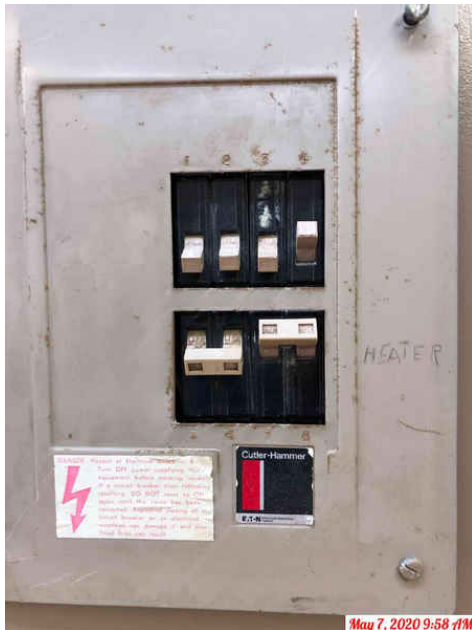
16.5.1 Panelboards & Breakers

MISSING IDENTIFICATION OF DISCONNECTS AT PANEL

Safety

I observed missing/inadequate identification of each circuit in the basement and garage. Each circuit must be clearly identified as to its purpose. No two circuits should be labeled the same.
