**TRIP REPORT – COW MOUNTAIN – THIRD-PARTY TESTING AND INSPECTION**

**COW MOUNTAIN**  
Ukiah Field Office

SECTION 01 45 23 – THIRD-PARTY TESTING AND INSPECTION SERVICES

**ATTACHEMENT A – ON-SITE INSPECTION PUNCH-LIST**

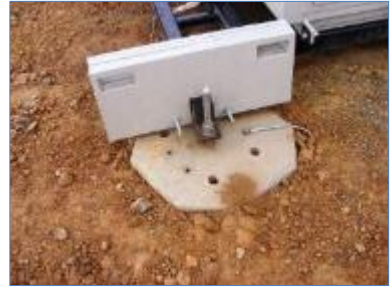
- b. The support frame for the shelter is mounted at each corner to a concrete pedestal providing a footer placed directly on the ground. Each concrete pedestal is designed with a concrete encased electrode (UFER) encased in the concrete. A grounding connection is made between each UFER and the ground ring using one of the bolts used to secure the frame to the pedestal. The top of each pedestal is above grade and mechanical, single-hole connections are used to bond the #2 AWG, bare, tinned, solid grounding conductor to each pedestal. Below ground connections are made using exothermic welds.

Frame Fastened to Concrete Pedestal at each Corner

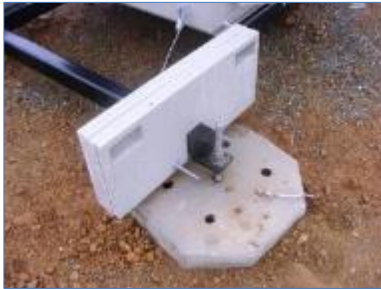
- A. Cabinet Structure Design and Installation – FAIL
  - 1. The cabinet structure meets size and structural requirements detailed in Section 13 34 18.13 and further meets the minimum specifications of the Telecommunications Industries Association's (TIA) standards, National Electric Code (NEC), applicable building, and mechanical codes, and Motorola R56 requirements.
  - 2. The cabinet was properly installed and level.
  - 3. The support frame for the shelter is mounted at each corner to a concrete pedestal providing a footer placed directly on the ground. Four 100-pound steel plates are placed on each corner of the frame to provide ballast. The four plates are fastened together using all-thread and placed directly on the steel frame. The following deficiency is noted:

- a. The ballast plates are not fastened to the frame to prevent movement.

Steel Ballast Plates Installed at Each Corner

- A. PEPRO shall fasten the plates to the support frame at each corner by providing a U-Bolt or other fastening mechanism to ensure the ballast plates are secured in place to the support frame.

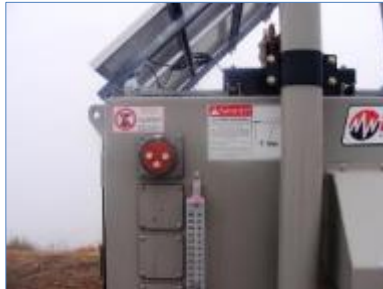
2. The tower ground bus bar is fastened to the cabinet near the RF cable entrance. The tower ground bus bar is properly grounded to the ground ring with a #2 AWG, bare, tinned, solid conductor. The conductor is bonded to the bus bar using a two-hole, irreversible crimp connector and stainless steel hardware. The connection to the ground ring is made using an exothermic weld.

Tower Ground Bus Bar Installed Near RF Cable Entrance

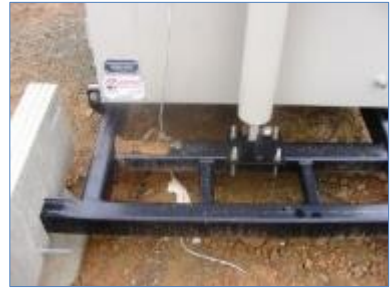
Tower Ground Bus Bar Grounded to Ground Ring

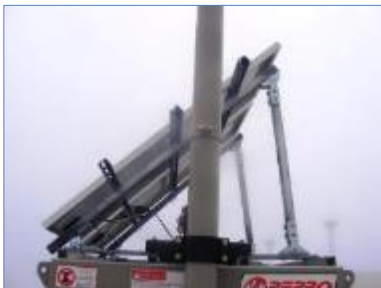
3. The cabinet is equipped with two roof-mounted solar panels. The solar panels are mounted on framework constructed of channel brackets (Unistrut). The following deficiencies are noted:

Solar Panels Installed on Roof

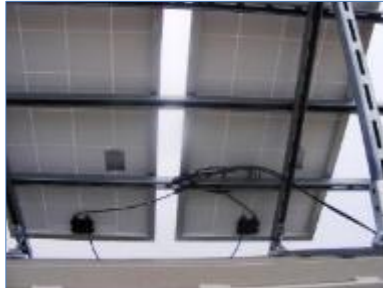
1. The cabinet is equipped with two roof-mounted solar panels. The solar panels are mounted on framework constructed of channel brackets (Unistrut).
2. Wiring between the solar panels and the electrical entrance is fastened to the side of the cabinet. The following deficiencies are noted:
  - a. Wiring between the solar panels and the electrical entrance is not fastened to the support frame is 24-inch increments.

Solar Panel Wiring Not Properly Fastened to Framework

- A. PEPRO shall fasten the DC power wiring in 24-inch increments to the solar panel support frame using cable anchors with through-bolted stainless steel hardware.

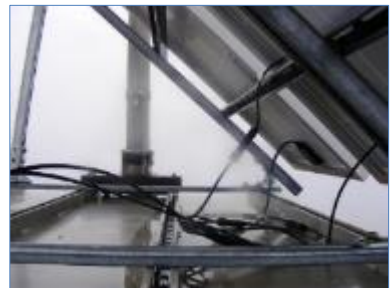
- a. The solar panels and the framework are not grounded.

Solar Panels and Framework Not Grounded

- A. PEPRO shall complete the following: 1) Ground the solar panel support frame to the tower ground bus bar with a #2 AWG, bare, solid, tinned copper conductor using UL 467 listed, single-hole, irreversible crimp connectors and through-bolted stainless steel hardware; and 2) Bond each solar panel to the support frame with a #2 AWG, bare, solid, tinned copper conductor using UL 467 listed, single-hole, irreversible crimp connectors and through-bolted stainless steel hardware including star or lock washers.

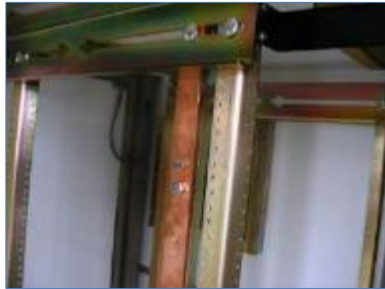
1. Observations of the internal grounding and bonding of ancillary devices meets the minimum requirements. PEPRO shelters are designed with an aluminum unibody structure and all surface mounted ancillary devices are properly bonded to the structure. In addition, the following grounding observations were made:
  - a. Each door is bonded internally internal door is bonded to the unibody shelter frame.
  - b. Rack ground bus bars are installed vertically on each rack assembly and properly grounded to the pass-through bus bar installed below the electrical entrance to the cabinet.

Rack Ground Bus Bar #1

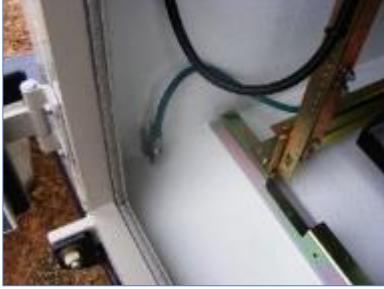
Rack Ground Bus Bar #2  
Grounded to Pass-Through Bar

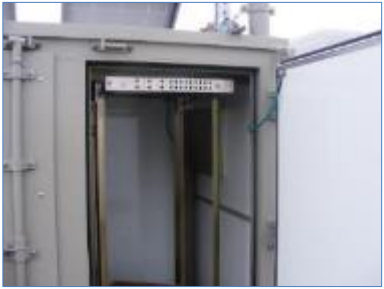
Door Grounded to Cabinet  
Unibody Structure

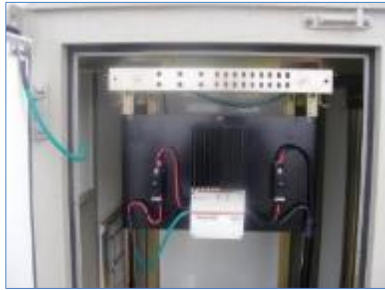
Solar Charger/Controller

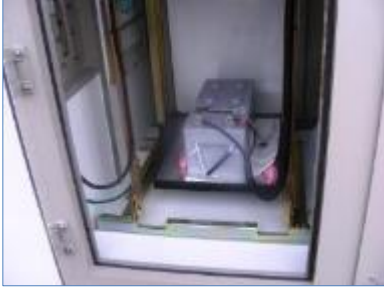
Battery Installed and Connected  
to Solar Charger/Controller

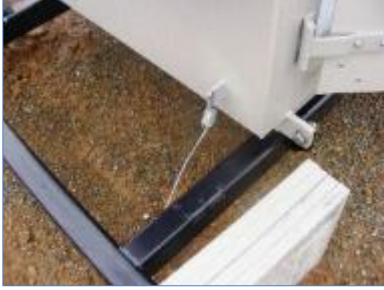
Pass-Through Bar Grounded to  
Ground Ring

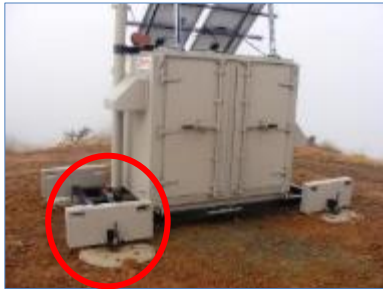
- A. The support frame for the shelter is mounted at each corner to a concrete pedestal providing a footer placed directly on the ground. Four 100-pound steel plates are placed on each corner of the frame to provide ballast. The four plates are fastened together using all-thread and placed directly on the steel frame. The following deficiency is noted:
  - a. The ballast plates are not fastened to the frame to prevent movement.

Ballast Plates Installed on Each Corner of the Frame

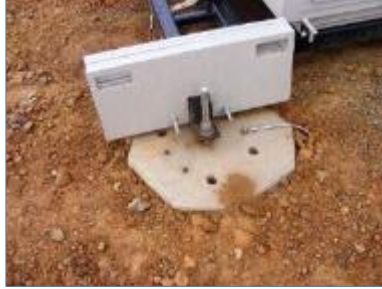
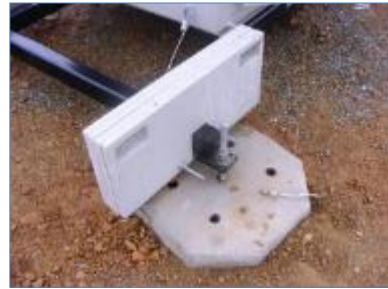
Plates Fastened Together But Not to the Frame

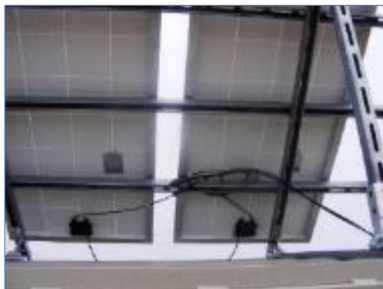
- A. The cabinet is equipped with two roof-mounted solar panels. The solar panels are mounted on framework constructed of channel brackets (Unistrut). The following deficiencies are noted:
  - a. The solar panels and the framework are not grounded. The mechanical connection between the solar panel support frame and the welded Unistrut is not a compliant grounding bond.

Two Solar Panels Not Grounded

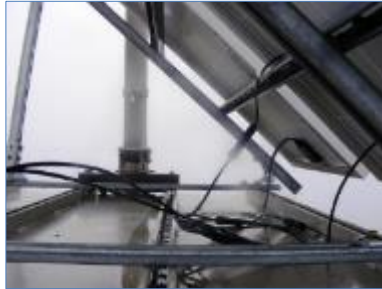
Solar Panel Support Frame Fastened to Top of Cabinet

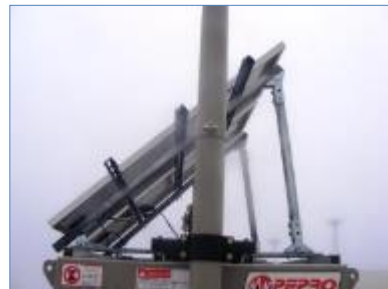
Support Frame Not Grounded

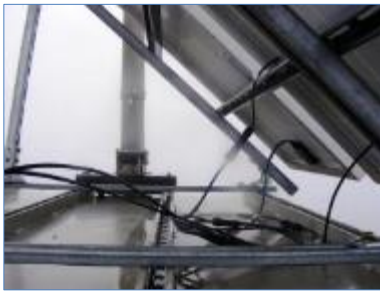
- A. The cabinet is equipped with two roof-mounted solar panels. The solar panels are mounted on framework constructed of channel brackets (Unistrut). Wiring between the solar panels and the electrical entrance is fastened to the side of the cabinet. The following deficiencies are noted:
  - 1. Wiring between the solar panels and the electrical entrance is not fastened to the support frame in 24-inch increments. Excess DC power wiring is coiled and laying on top of the equipment cabinet.

Excess DC Power Wiring Coiled

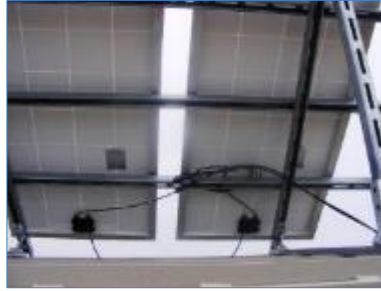
DC Wiring Not Adequately  
Fastened to Framework

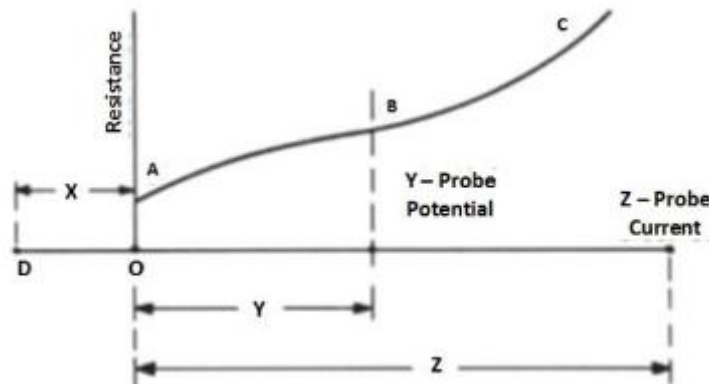
IMAGE 4.4 A

3. Suppose that all measurements are made from an arbitrary starting point O, the distance Z to the current probe and the variable distance Y to the potential probe being measured from this point. Then a curve such as *ABC* (See Figure Below), giving the measured resistance against the value of Z, can be obtained.

4. Now suppose the electrical center of the earth-electrode system is actually at D, distance X from O. Then the true distance from the center to the current probe is Z + X, and the true resistance is obtained when the potential probe is at a distance 0.618 (Z + X) from D. This means that the value of Y, measured from O, is 0.618 (Z + X) - X.

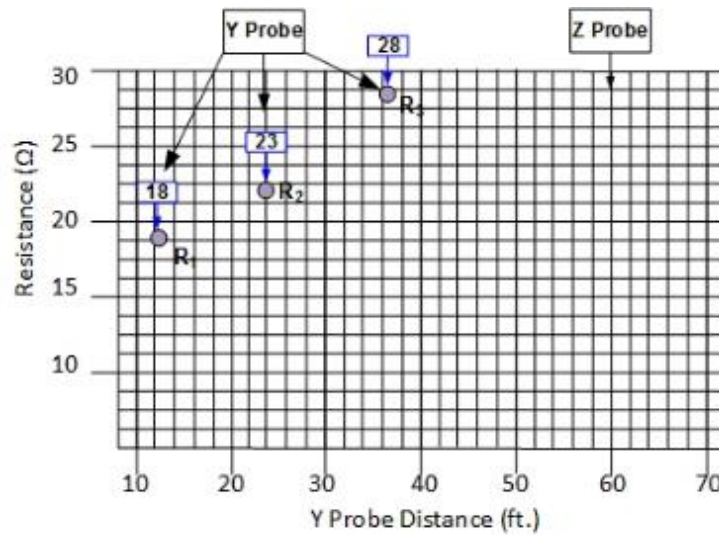
IMAGE 4.4 B

5. If X is now given a number of values, the corresponding values of P can be calculated and the resistance read off the curve. These resistances can be plotted against the values of X in another curve. When this process is repeated for a different value of C, and another curve of resistance against X obtained, the two curves should cross at the required resistance. The process can be repeated for a third value of C as a check. These curves are called intersection curves. It has been assumed that D, O and C are in the same straight line.
