De-culverting Gilwiskaw Brook, Bath Grounds Feasibility Assessment

Report to Trent Rivers Trust
September 2022

PR120/R1.1/F

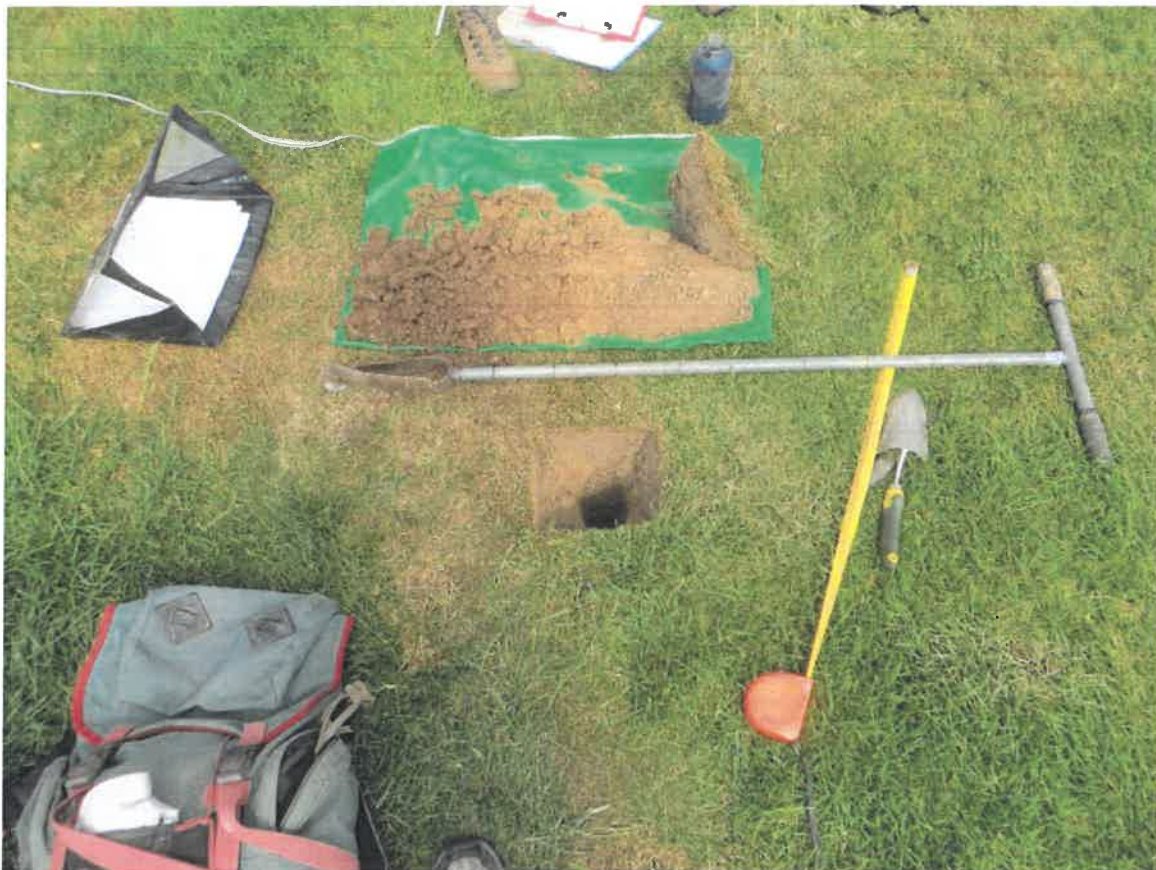
Soil profile (SC2) from Bath Grounds.

- 2.2.4. A walkover soil survey was conducted across Bath Grounds. Soils were investigated using a 70mm Dutch auger at several locations. Four summary descriptions were produced (Appendix 1).
- 2.2.5. The soils were predominantly silty clays, silty clay loams and sandy clays. No water was intercepted in any of the soil survey locations. Some mottling was observed suggesting that in the lower lying areas of Bath Grounds the water table may fluctuate to within 0.3 to 0.5m of the ground surface. Evidence of human disturbance and indications of made or disturbed ground were common with gravel, rubble and bricks common in some areas in the upper 0.4m of the soil profile.

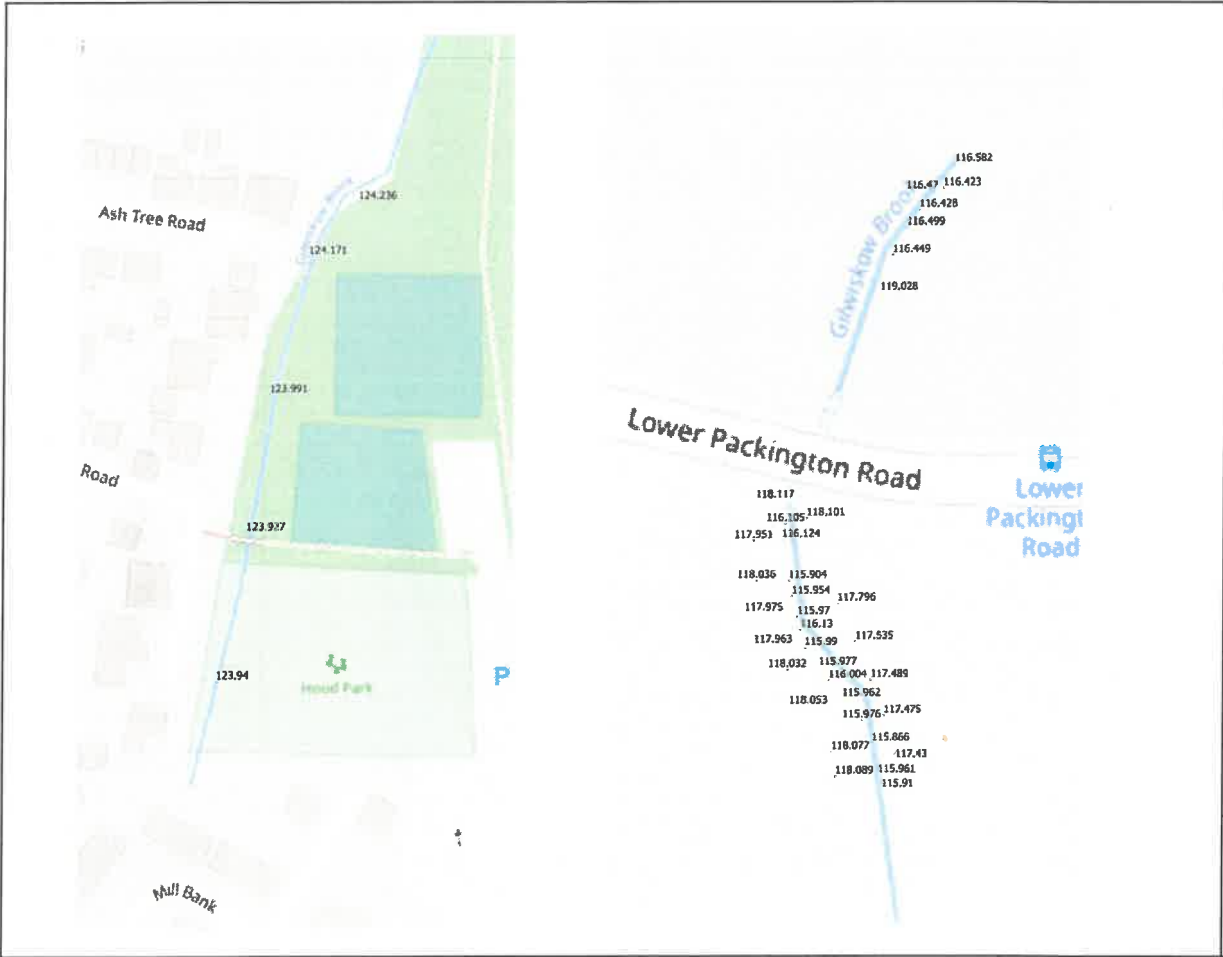
Bath Grounds
121.965 Surveyed spot heights (mAO)

- 2.2.2. A field reconnaissance topographic survey was conducted to verify and ground truth the LiDAR data. A global positioning system (GPS) receiver was used to survey the site. The entire area of Bath Grounds was covered with a grid at a minimum of 10m intervals. More targeted readings were taken in areas of pronounced ground level change or to record specific features such as inspection chambers or trees (Figure 8). The topographic survey also extended along Gilwiskaw Brook both upstream and downstream of its entry and exit from the culvert (Figure 9). Stream bed levels were recorded so that the overall gradient of the stream could be understood in order to inform flood risk modelling and restoration design development.

- 2.2.3. The results of the field survey were compared with the LiDAR data. Within the open areas of Bath Grounds there was a strong correlation among values suggesting that the LiDAR data is relatively accurate in this area with a similar range in values between c.121 and 119mAOD observed. However, the LiDAR data was considered less accurate in the upstream and downstream reaches of Gilwiskaw Brook where the stream was in an open channel.

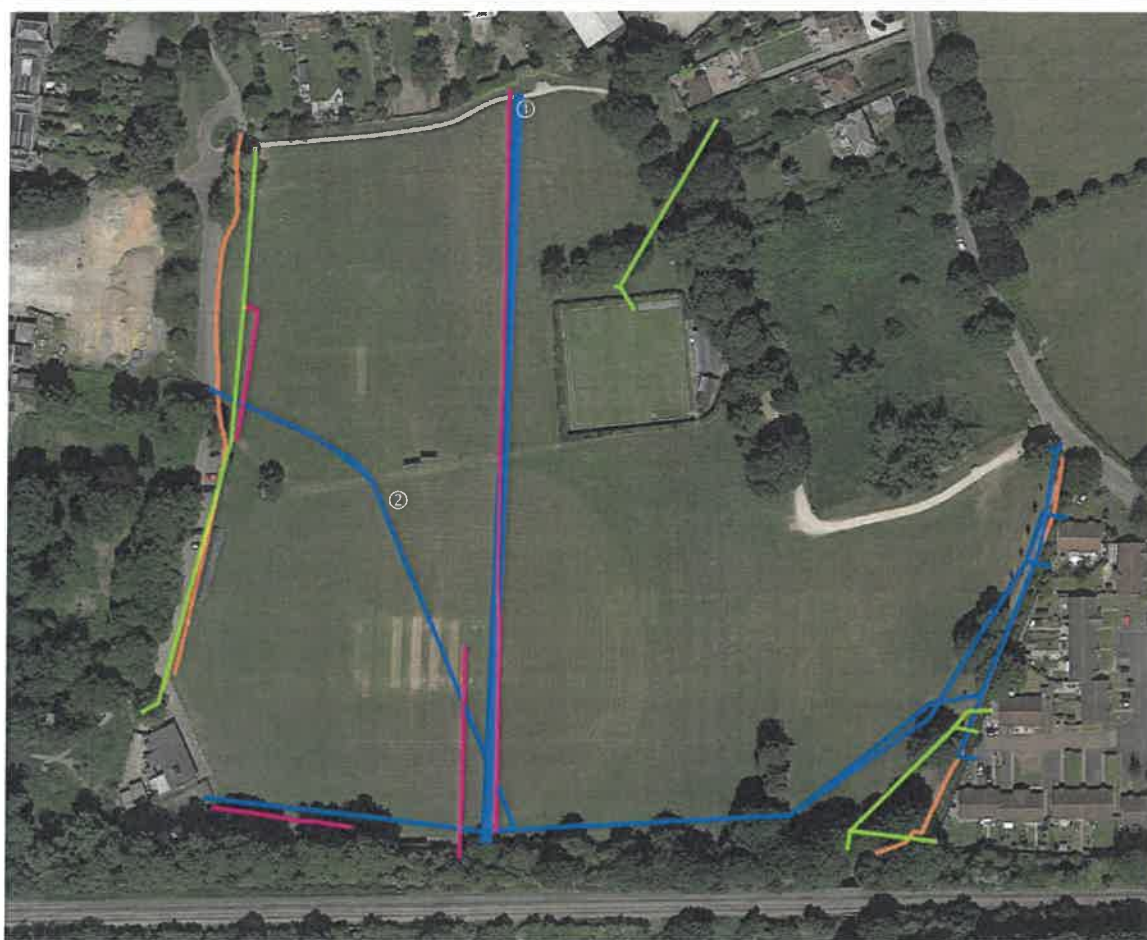
- Bath Grounds
- Surface water sewer
- Foul water sewer
- Electric
- Unidentified

- Voids / cavities
 - Foundations
 - Underground Utilities
 - Storage tanks
 - Culverts
 - Pipe routes (metallic and non-metallic)
 - Duct and cable routes
- 2.2.13. The survey company provided results as a DWG file. Features were mapped as lines only and no information was provided on the depth of features. Some descriptive information was provided for a few of the features. The features have been imported to a geographic information system (GIS) to integrate them with other information on the site (Figure 11).

- 2.2.14. The survey identified the following features:
- Surface water sewer
 - Foul water sewer
 - Electric services
 - Unidentified features
- 2.2.15. The survey confirmed some of the previous information, particularly the Severn Trent Water assets map (Figure 6) and the historic sewer map from 1967 (Figure 7). For instance, the courses of the southern surface water sewers reflect the information on the 1967 map and the Severn Trent Water assets maps. It also concurred with some of the findings in the 2017 archaeological survey report. The line of the culvert also reflects the depiction in the 1967 map. However, it differs slightly to the lines indicated on the Severn Trent Water asset map.

- 2.2.16. The survey also shed new light on certain features. Electric services were identified on both the western and eastern margins of Bath Grounds. A, presumed to be, foul water sewer was observed to the north of the bowling green. A 600mm diameter surface water sewer was identified traversing the cricket ground from the centre of the western margin of Bath Grounds to the point where the culvert passes under the railway embankment. The most northern section of this sewer appears to partially follow the line of a path indicated on the 1967 map (Figure 7). However, this feature does not appear on any other sources.

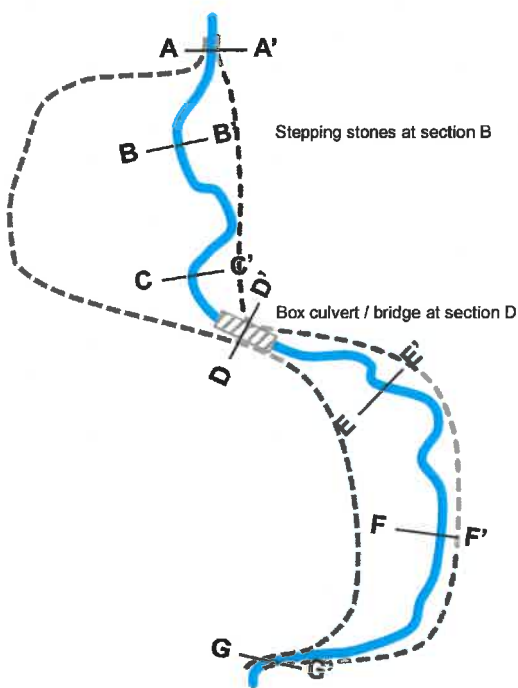
Section A

Current ground level c. 121.25m AOD
Bed level in chamber 118.55m AOD
Depth to channel bed 2.70m

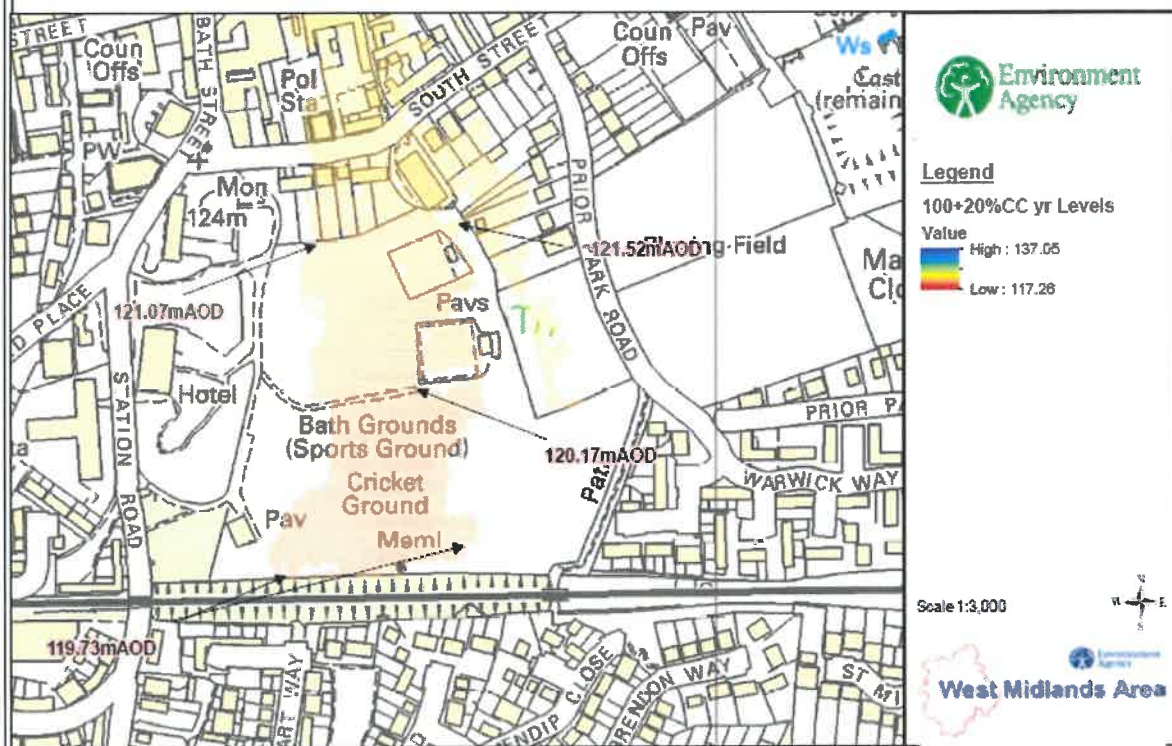
Flood Heights map for 1%+20%Climate Change AEP, centred on SK 35700 16300 created 11 August 2020.

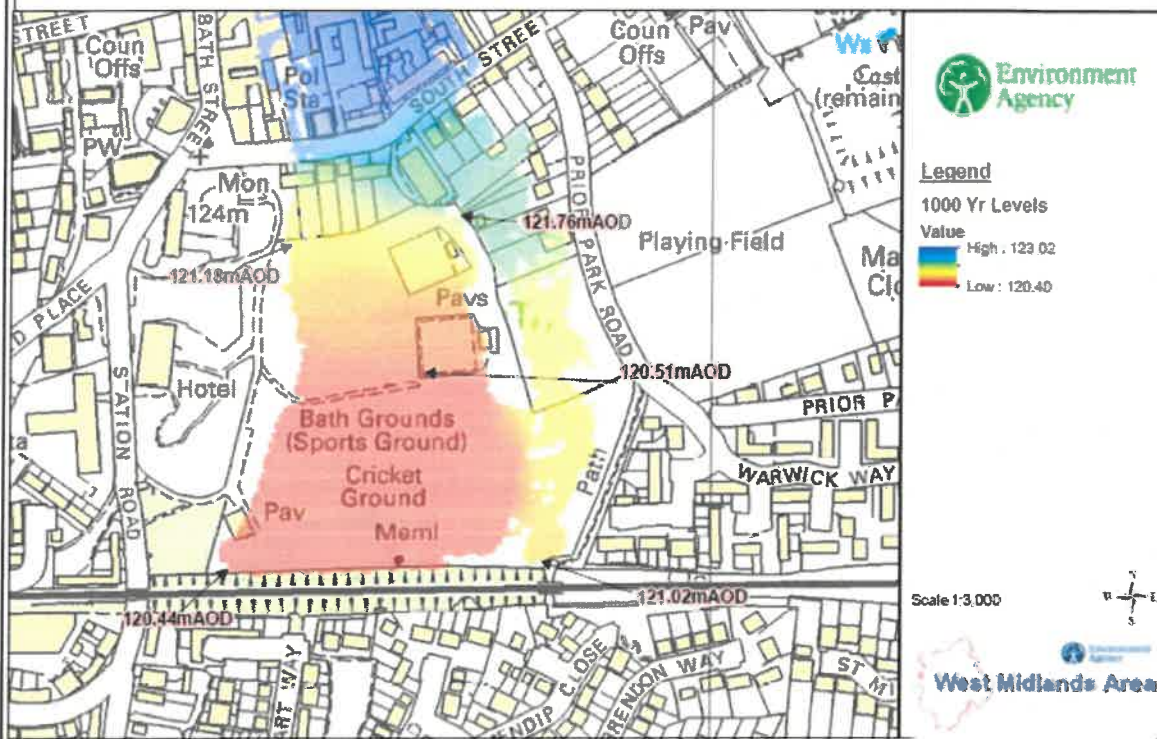
Flood Heights map for 0.1% AEP, centred on SK 35700 16300 created 11 August 2020.

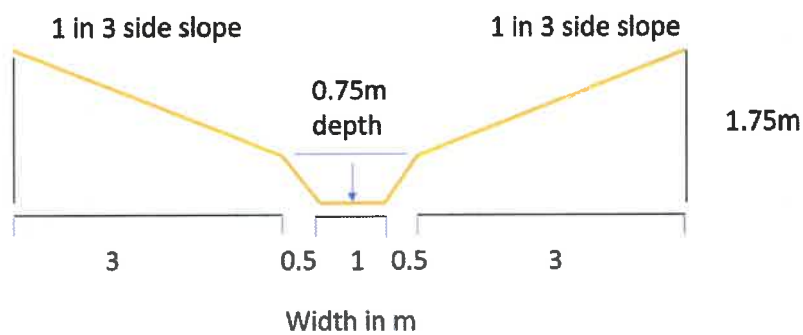
Project: Bath Grounds
Client: Trent Rivers Trust
Title: Figure 20. Illustrative channel cross-section.
Drawn: RJM Checked: RAW

Approximate channel profile for sections A, B, C, E, F, G

Assume grassed channel sides
