# **Pembroke Watershed Association**

## **2007 Water Quality Testing Report Presented to the Town of Pembroke, Ma**

Submitted by Charles Banks and Patricia McCabe,  
Co-Chairs, Water Quality Committee, PWA, May 2008

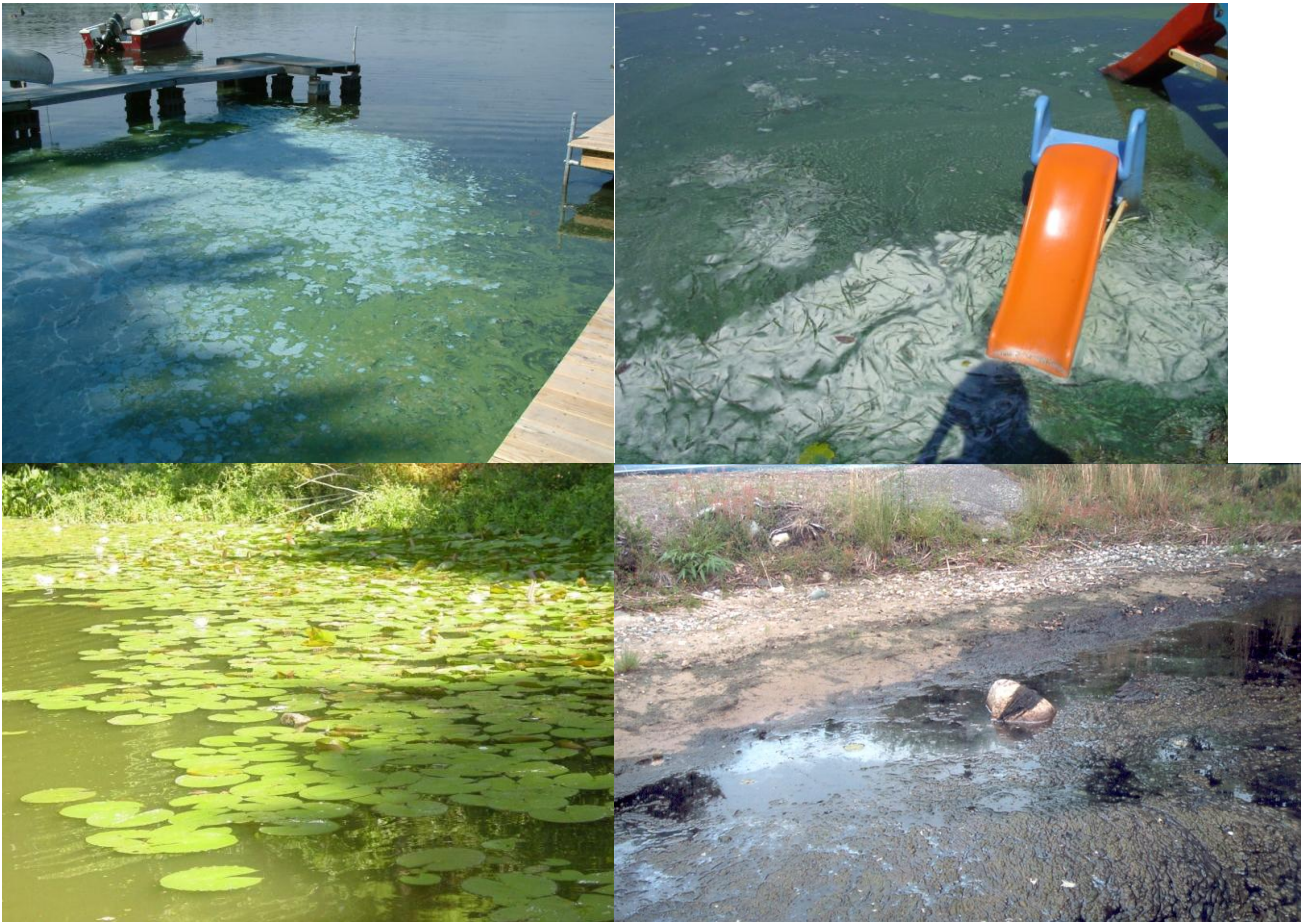
What was the problem in 2007?

### Eutrophication:

- 90% of Massachusetts ponds have symptoms of Eutrophication.
- Phosphorus and Nitrogen loads stimulate the growth of algae, which cloud the water and limit light diffusion. This halts the growth of native grasses and plants in the water, and permits growth of noxious weeds. The habitat for fish and native insects is altered, and algae growth has been identified as a major threat to the diversity and health of native fish populations in the northeast. Both nighttime plant respiration and algae decomposition reduce the available oxygen in the water, threatening the supply for fish- resulting in fish kills in early AM. Furnace and Oldham have intermittently experienced fish kills of this type in the last few years.

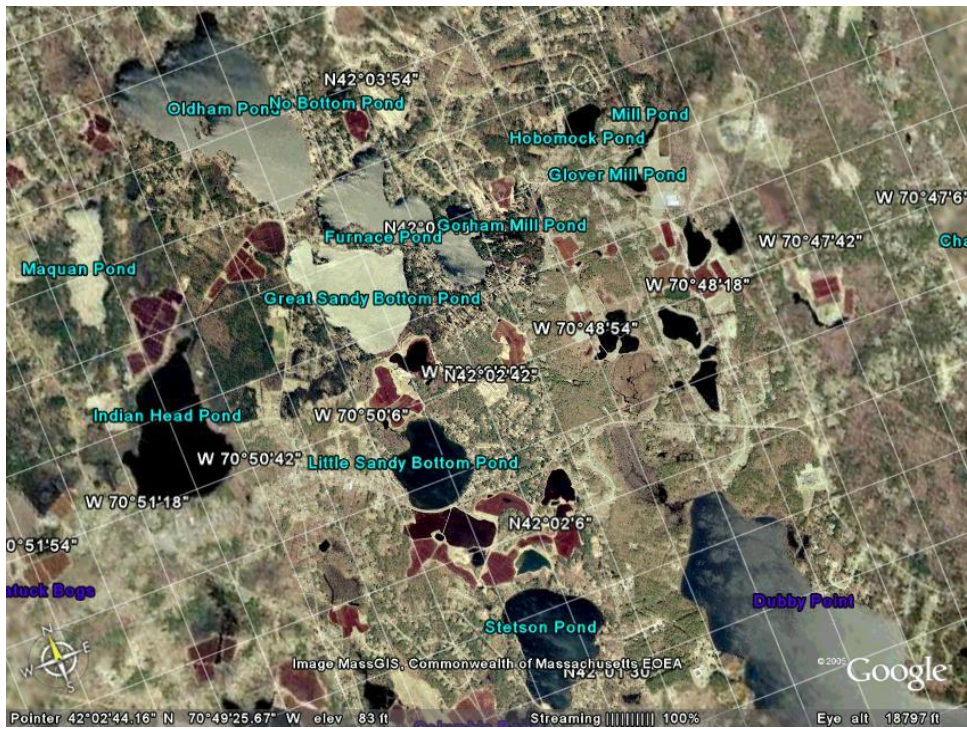
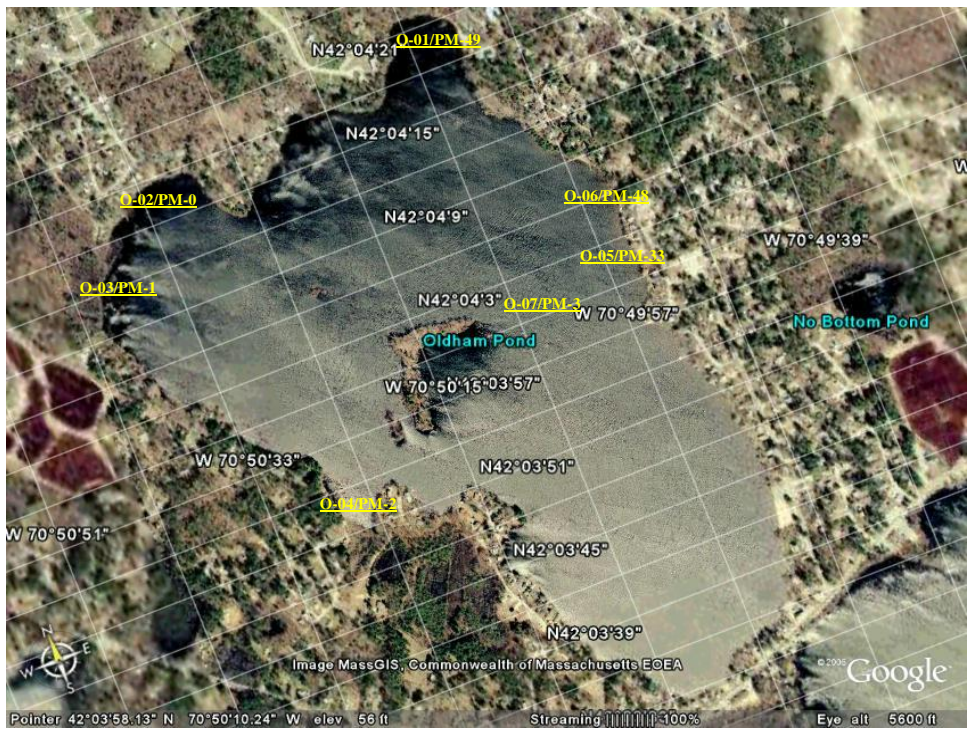
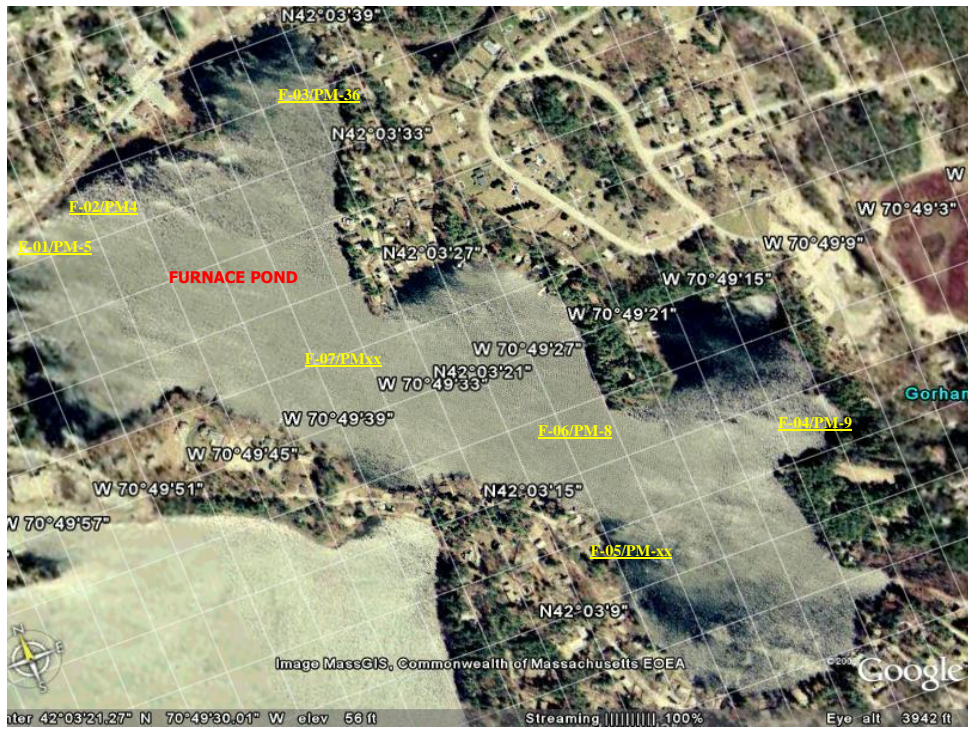
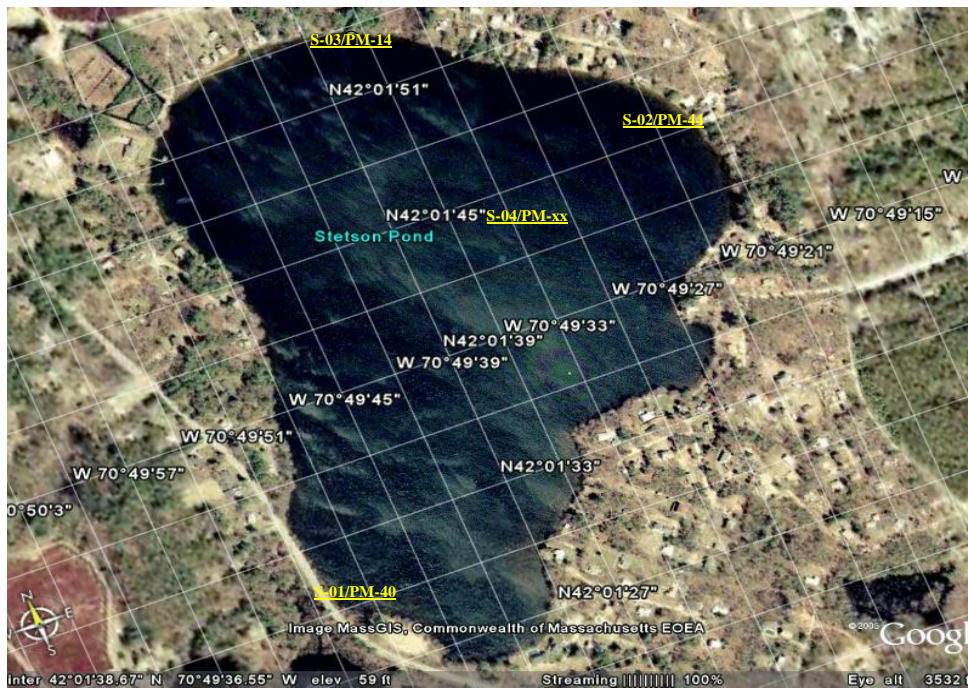
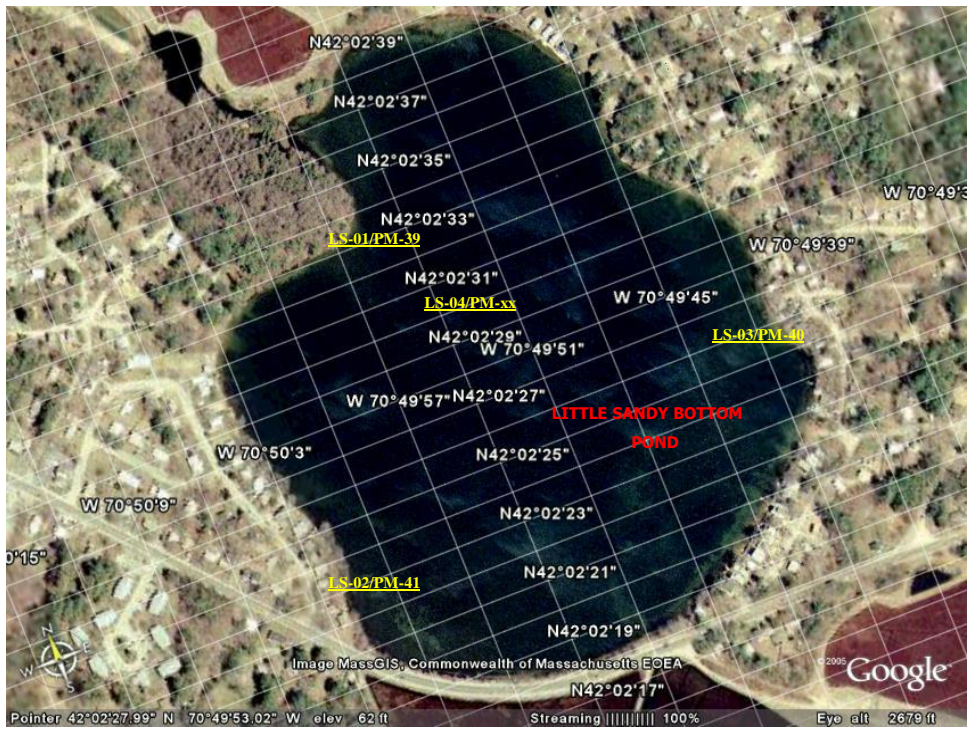
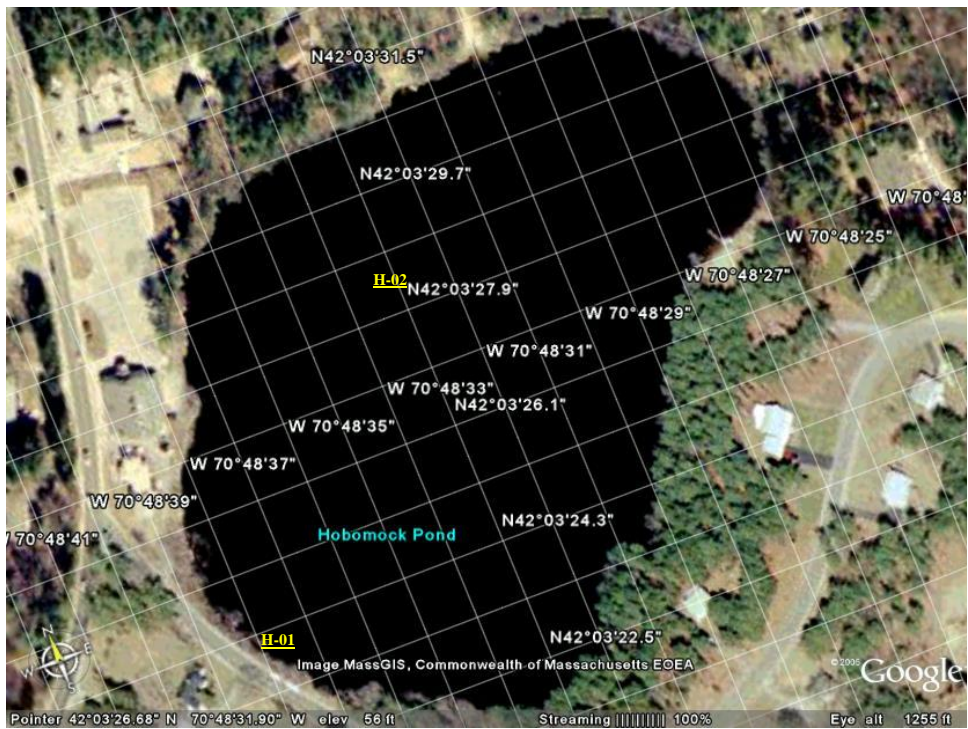
We identified our test sites in yellow on the Google Earth Maps

This year we utilized input received from MassDEP and our own experience and moved our sites to deeper water in the same general vicinity, so that our results would be more indicative of overall pond health. We also removed several sites that were too close to other sites and produced possible redundant results.

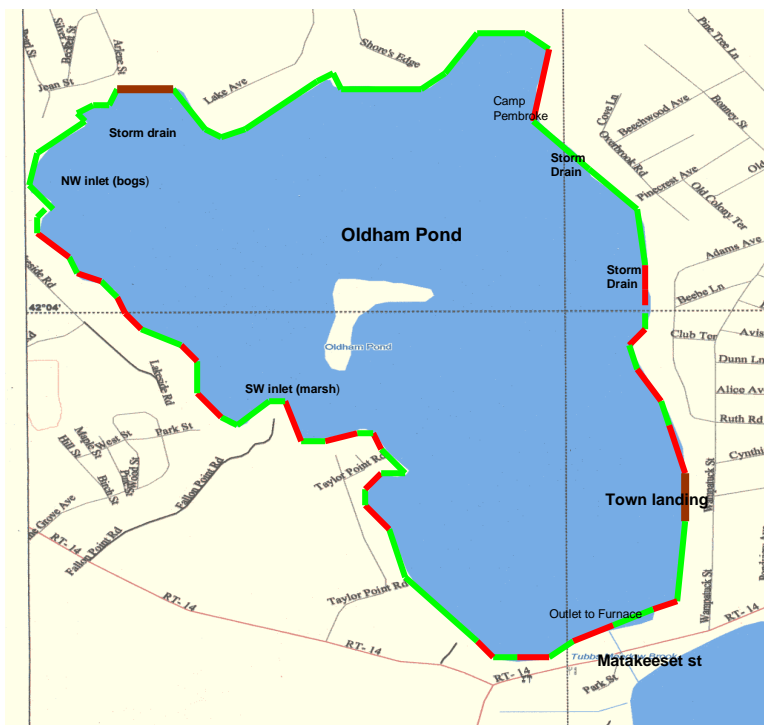
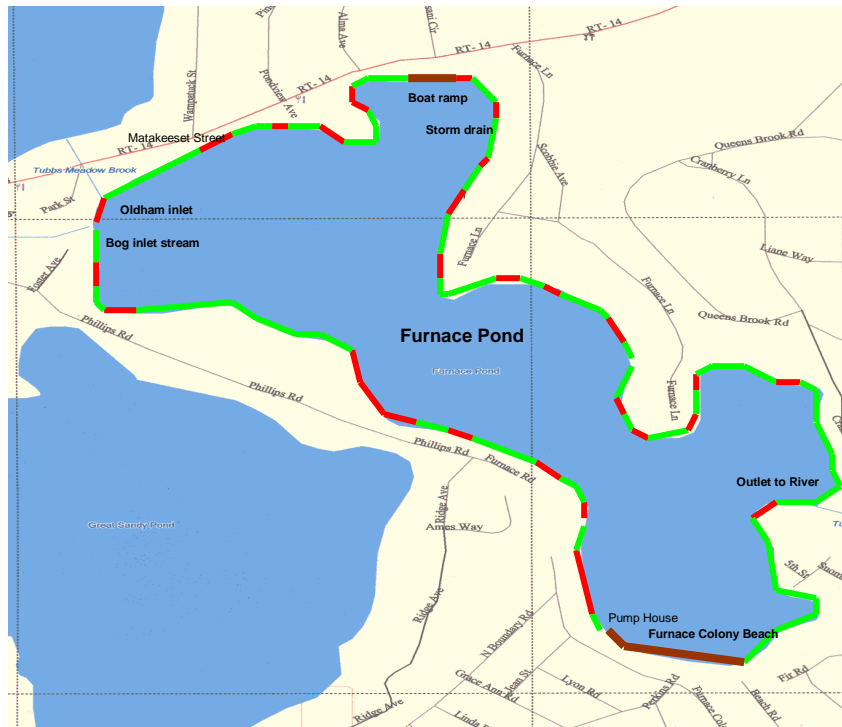
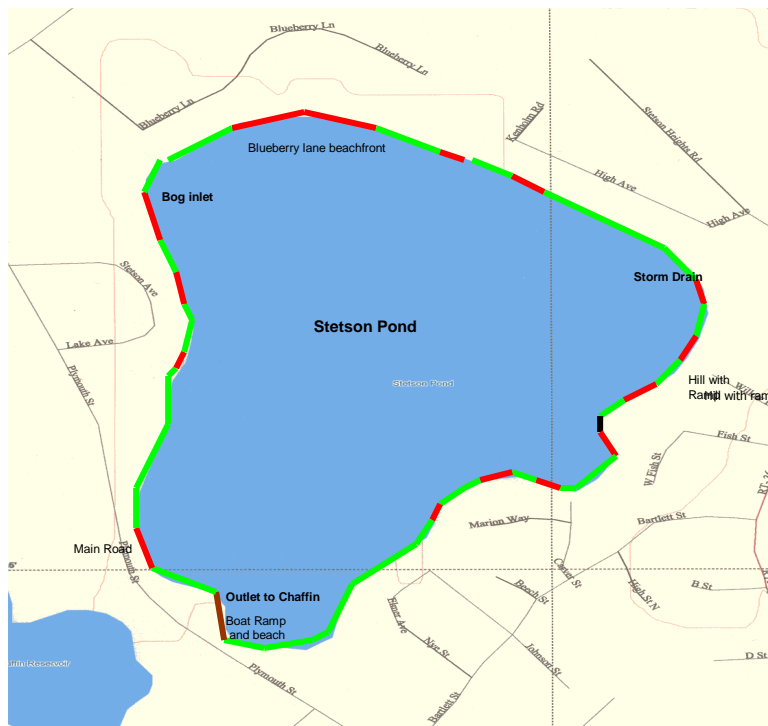
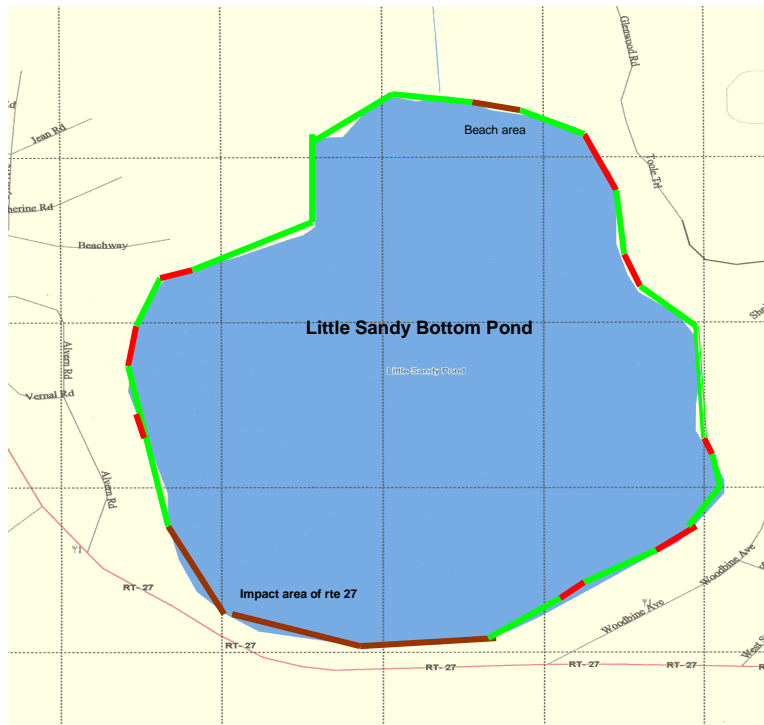
- The following slides indicate the approximate degree of suburban development at each of the ponds, including buffer zones, impervious public ramps, and impact of roads.
- \_\_\_\_: buffered areas
- \_\_\_\_: no buffer zone
- \_\_\_\_: public unbuffered areas

Pond	Public Unbuffered	Private Unbuffered	Buffered
Oldham	7%	38%	55%
Furnace	10%	35%	55%
Stetson	5%	30%	65%
LSB	17%	18%	65%
