St Mary's in the Marketplace

PHASE 6 (Week 7)

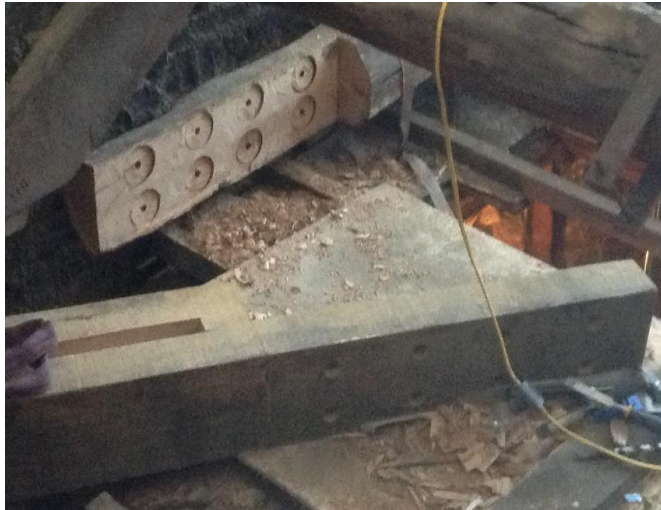
Robinsons ,the timber experts, are already hard at work rectifying the rotten beams, splicing new onto the old, as they have done so impressively in the Tower in Phase 5.

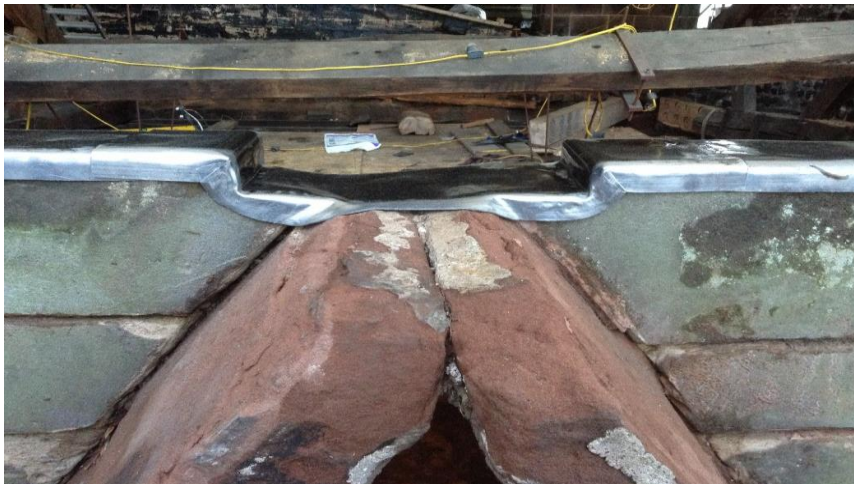
The great medieval walls of the clergy vestry need sealing, and lead is the only and best solution to the problem of damp in this situation. Now that the lead seal is in place, the heavy coping stones can be put back in place.

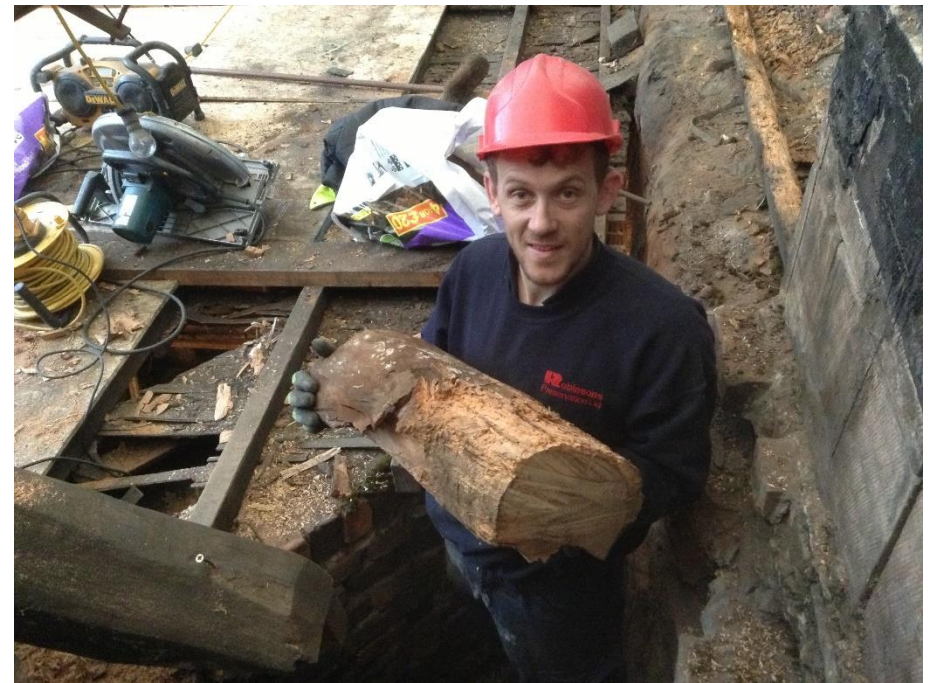
Matt the joiner of Robinson's Preservation is working on the roof timbers above the clergy vestry. The need for this urgent work is quite obvious when you see the rotten state of some of the timbers.

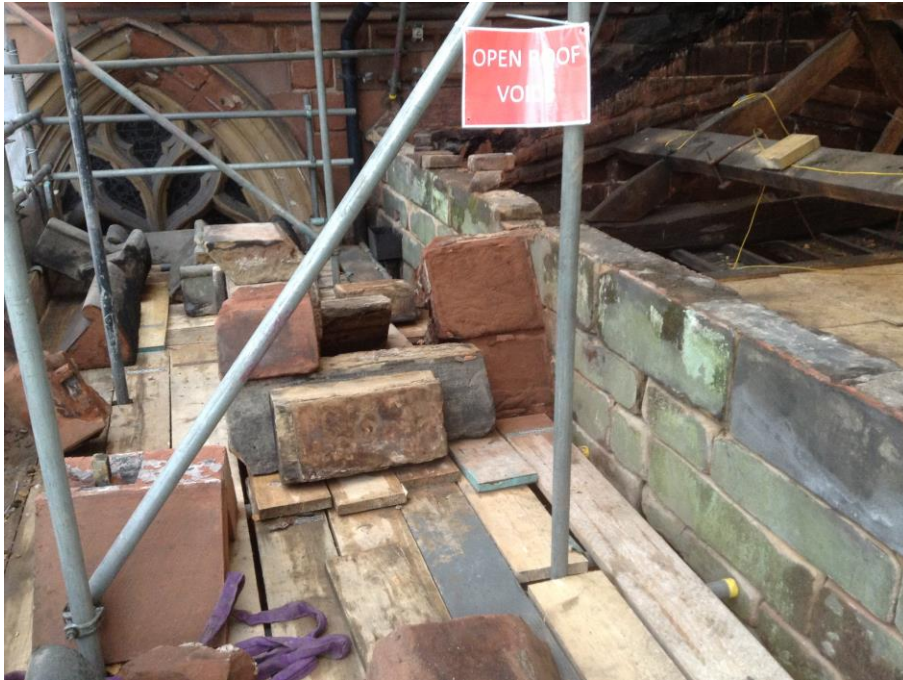
The reason for this major phase of conservation work on the church vestries is that water has been coming into the building for many years, running down the walls, creating damp and rotting timbers. The massive sandstone walls are having to be partially rebuilt, repaired and finally given weather proof coverings to ensure the long term future of this historic building, which is at least 700 years old in parts. At present it is a series of open roof voids! Everyone working on site has to take care!

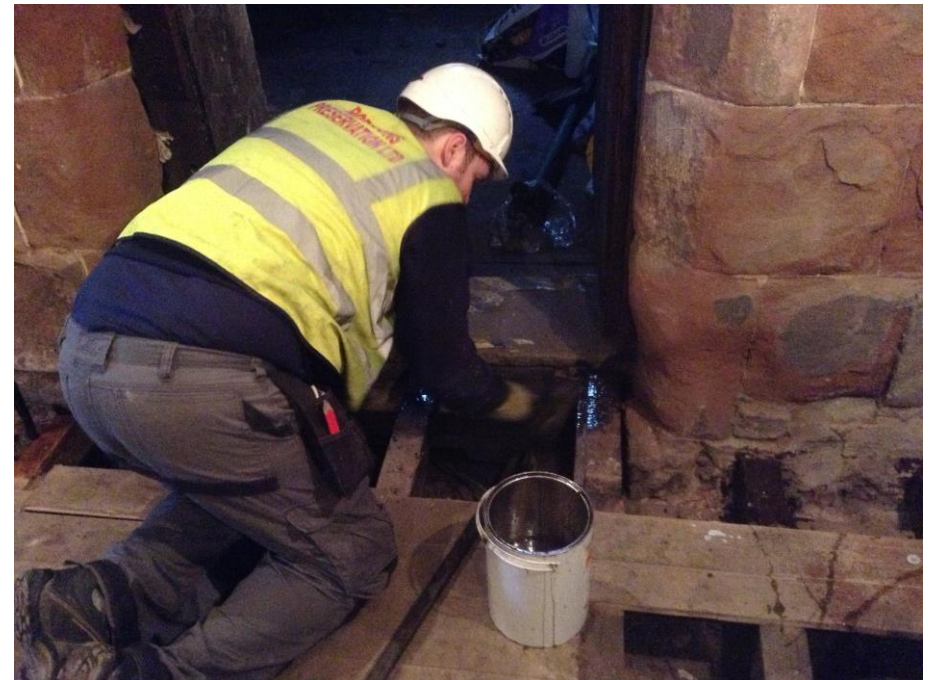
Stuart the joiner, working inside the vestries, has been renewing rotten floor timbers; and then covering new and old timbers with a preservative gel, to prevent dry and wet rot, some of which has already been eradicated. In some places a plastic sheeting has been put in place, to create a further barrier to any damp coming through the brickwork.
