# TYPICAL COMMUNICATION CABLE IN MOST NEWMARK RVS

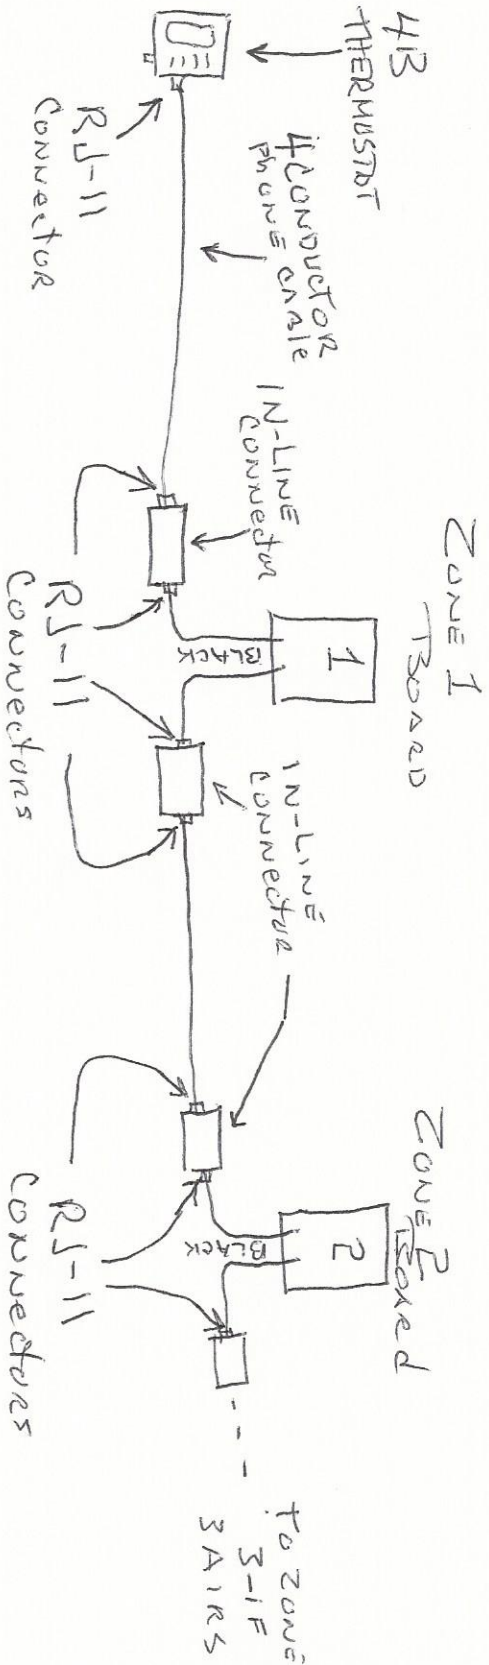
REMOVE SHROUDS AND LOOK FOR THE  
TELEPHONE STYLE CONNECTIONS

LOOK FOR MOISTURE AND CORROSION  
AT ALL THE RJ-11 CONNECTORS

REMOVE FUSE MARKED "AIR COND" IN MAIN  
RV INVERT FUSE PANEL BEFORE CLEANING THE  
CONNECTIONS AS SHORTING WILL BLOW THE  
ZONE I 3AMP FUSE - REPLACE IN-LINE  
CONNECTIONS IF CORROSION IS PRESENT.  
IF YOU MUST REPLACE THE RJ-11 CONNECTORS  
THE COLOR PATTERN MUST BE MAINTAINED ON THE  
REPLACEMENT
