# Home Inspection Report

Property address: 1000 Suburban Dr.  
Charleston SC 29414

Inspected by: Stephen Houmard  
Solid Ground Home Inspections  
South Carolina License #2046  
*Certified ASHI® Home Inspector*  
*Infrared-Certified® Home Inspector*

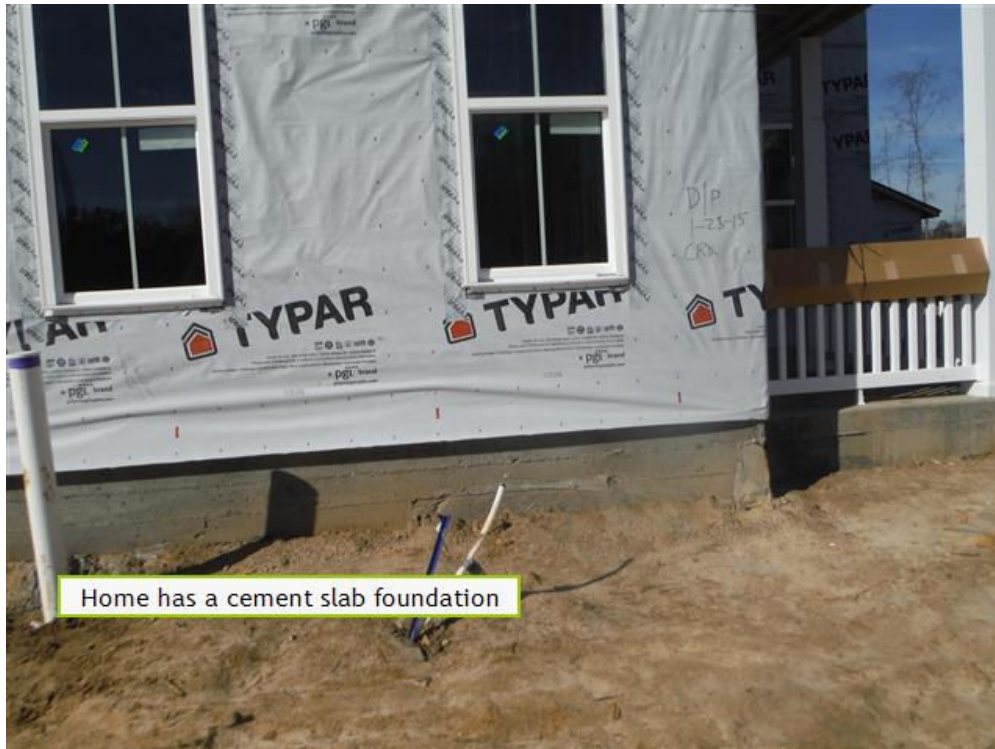
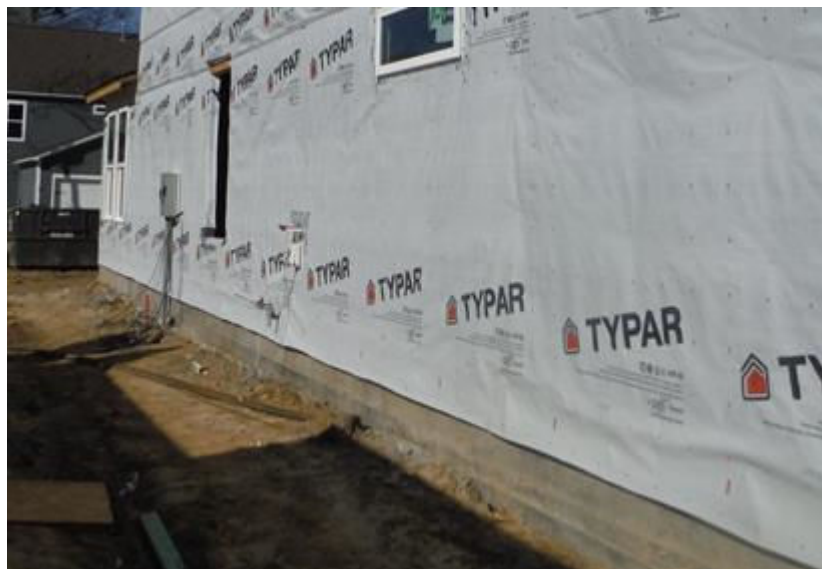
#### 2.0 DESCRIBE THE STAGE OF COMPLETION

Observed that this home has a cement slab foundation which has already been poured and the interior walls are roughed-in and bolted to the slab. The roof is installed and tie downs have been used to secure the home in case of high wind or earthquakes. The house wrap, windows, doors and roofing shingles have been roughed-in. Additionally, the rough plumbing, rough electrical and rough HVAC have been installed. Permits for everyone who will be working on the house are posted.

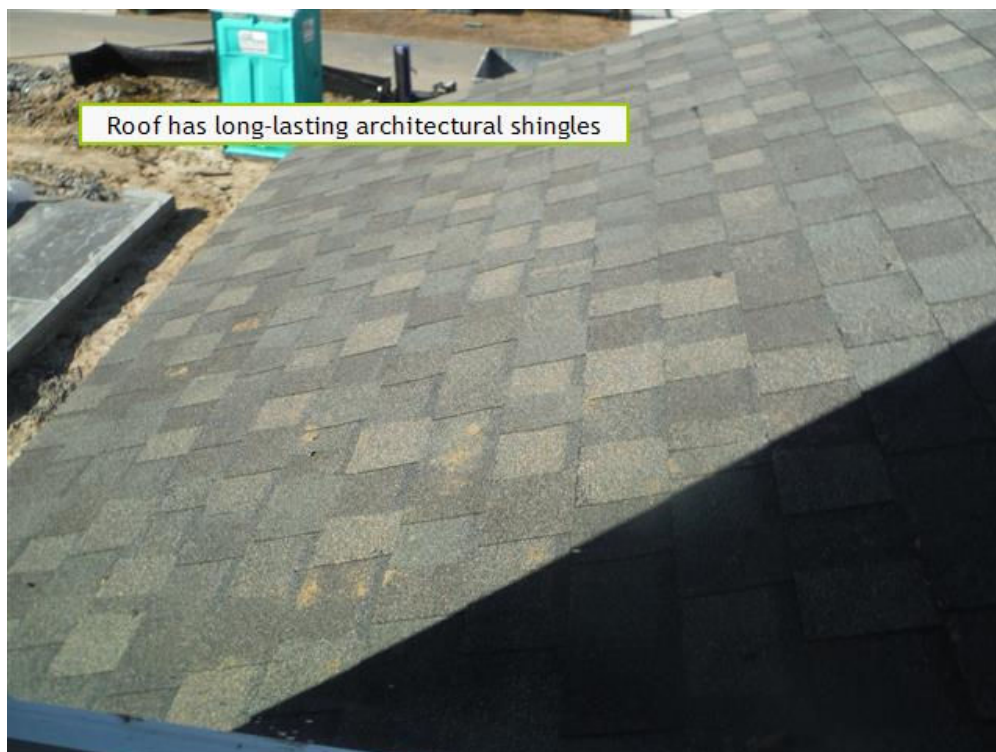
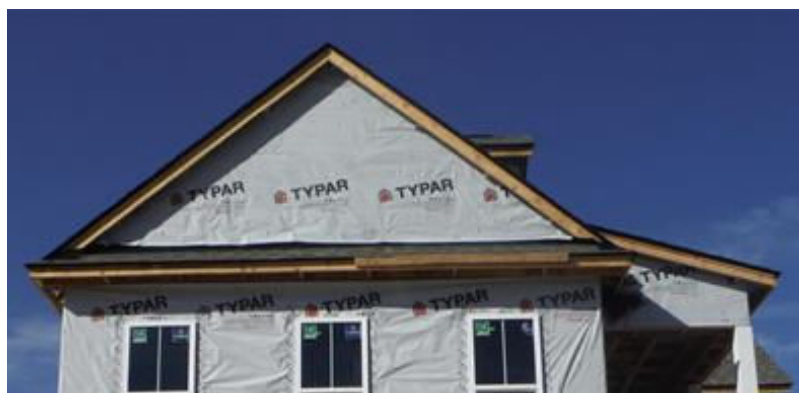
##### 3.0 ROOF COVERING

Observed that the roof has long-lasting architectural shingles. Please note the roof will be inspected fully when the house is complete. For your reference, this type of shingle lasts an average of 30-35 years.

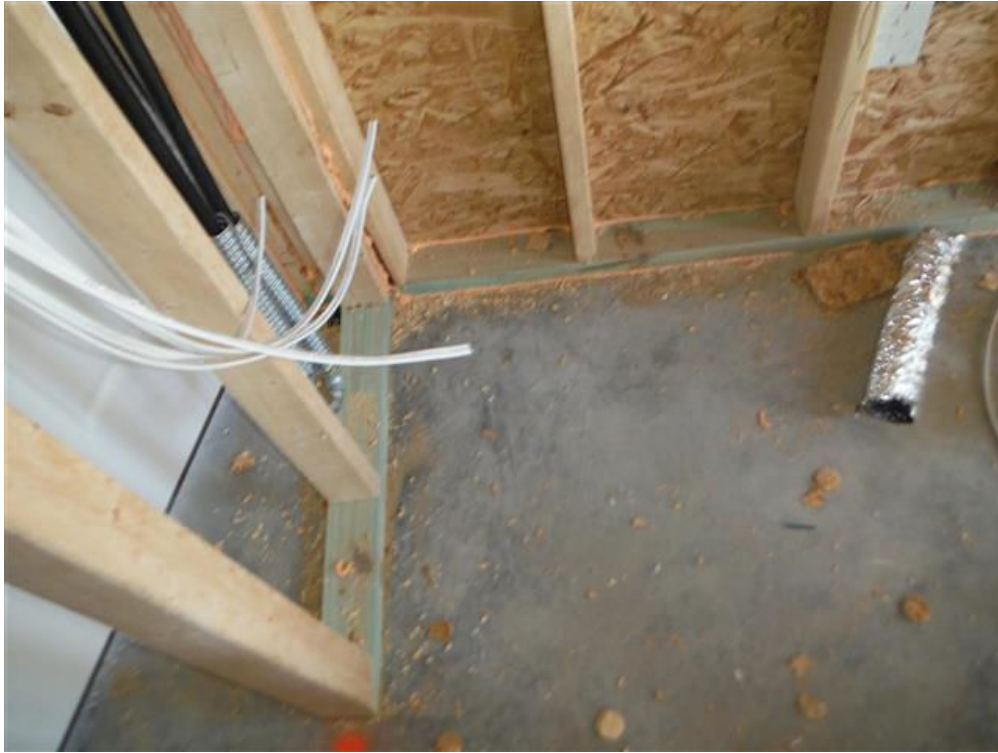
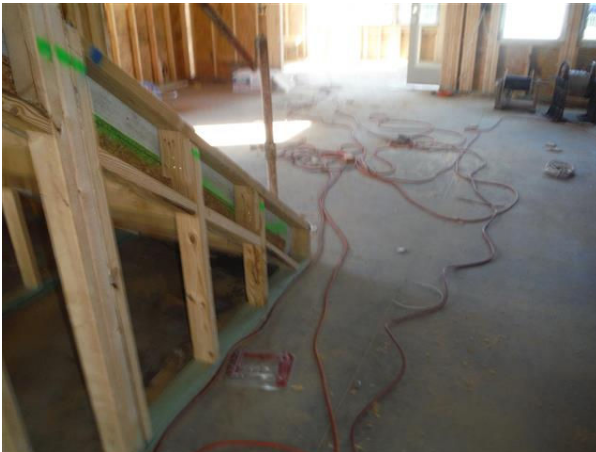
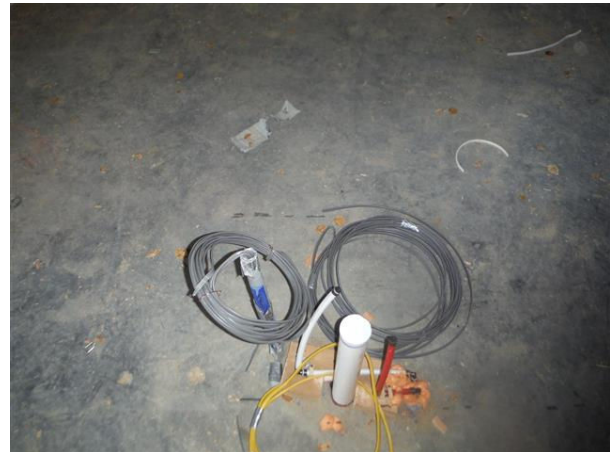
**FLOORS (Structural)****Comments:** Inspected

A view of the downstairs and upstairs floor structures. Courtesy photos:

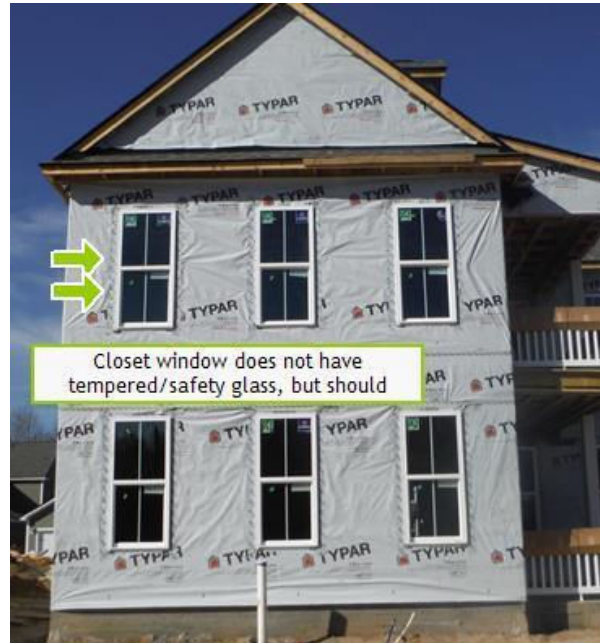
(1) Observed that the window in the upstairs front bedroom closet is not tempered/safety glass, but should be due to its location near the closet door. Please note the builder has been notified so repairs can be made.

(2) For your reference, tempered glass is a strong, break-resistant type of safety glass that, if broken, shatters into small granular pieces or pebbles instead of shards. In a home, windows and glass in certain locations are tempered to help prevent or lessen injuries in the event the glass is broken -- shower and tub window/glass enclosures, doors with glass, window panels in the door or near the door, sliding glass doors, storm doors, very large windows that someone could accidentally walk into and so on.

(1) Observed that the window in the upstairs front bedroom closet is not tempered/safety glass, but should be due to its location near the closet door. Please note the builder has been notified so repairs can be made.

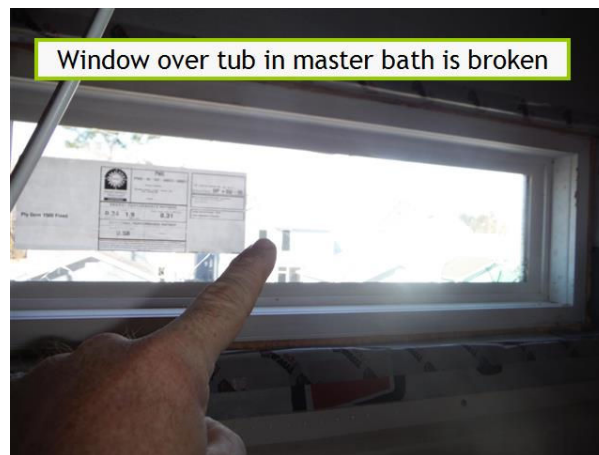
(3) Observed that the window over the tub in the master bath is broken. Please note the builder has been notified so repairs can be made.

(3) Observed that the window over the tub in the master bath is broken. Please note the builder has been notified so repairs can be made.

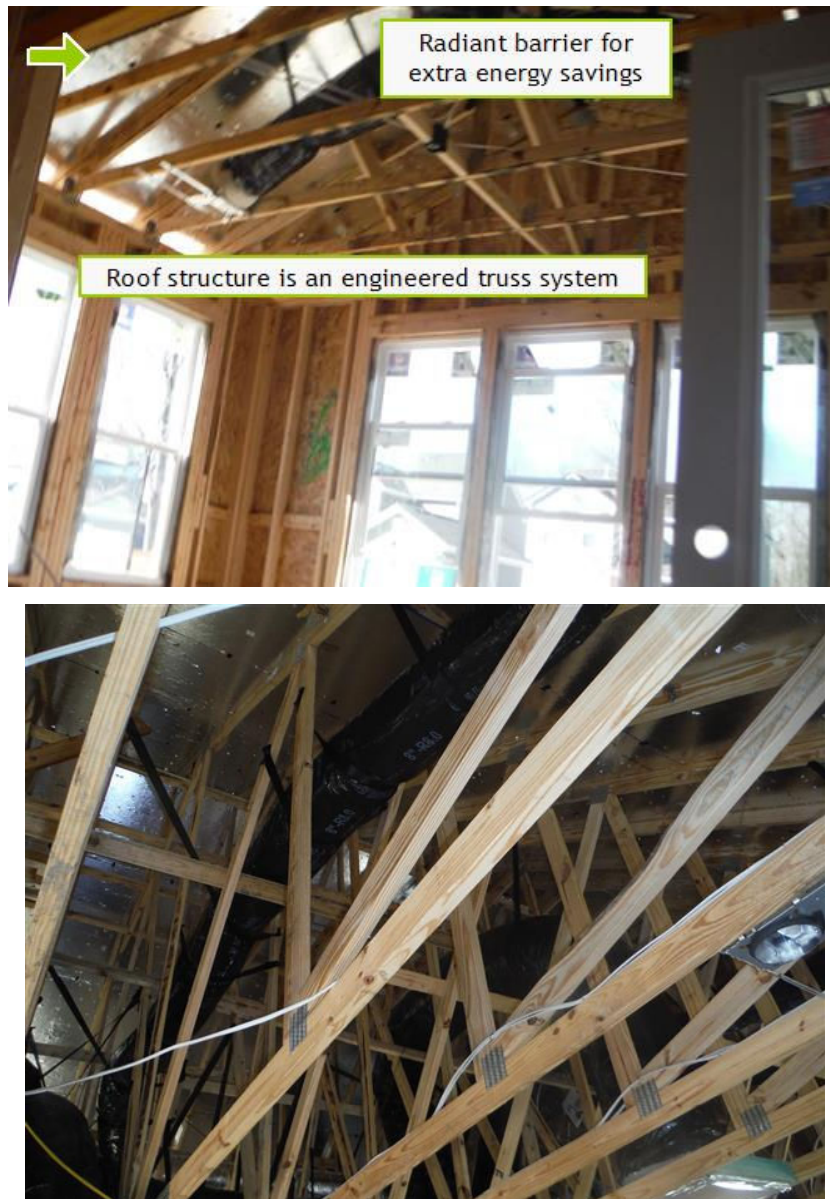
## ROOF STRUCTURE AND ATTIC

Observed that the roof has an engineered truss system. For your reference, these trusses were designed by an engineer, built in a factory for this home, then shipped to the job site and lifted into place.
