## St Mary's in the Marketplace

## Phase 6 (Week 10)

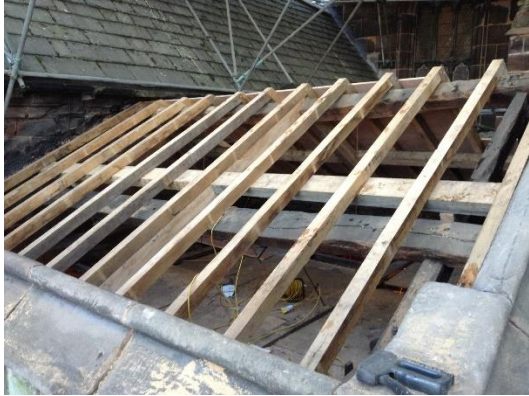
New roof spars made and fitted by the timber specialists Robinson's, begin to create the new roof over the Rectors Vestry, supported by the 17th century trusses and purlins

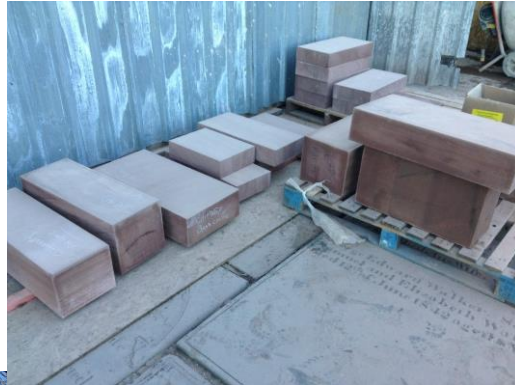
New stone waiting to be worked, comes from St. Bee's Quarry

Worn stones have been removed around the Vestry walls, in preparation for new insets to be skilfully fitted in and repointed by the stonemasons

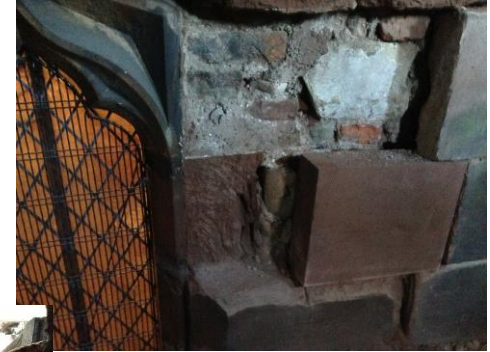
There is a strange hole above the window opening, where the stone cover seems to have worm away. Mystery will continue to surround the look and shape of the Rector's Vestry long after this phase of work is complete

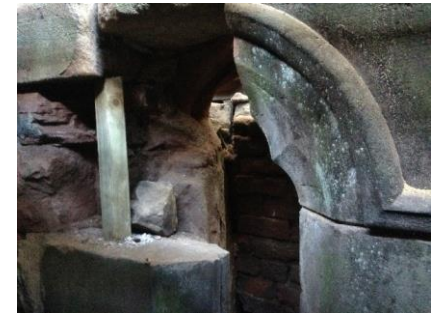
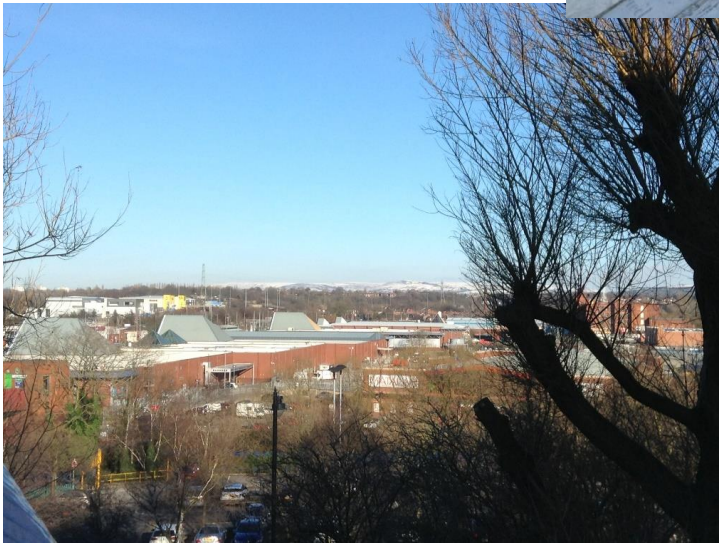
The little window high up in the east wall of the Rector's vestry has remained bricked up, but internally has been cleared of decades of dust and rubbish. It will be glazed in and protected on the outside in due course.

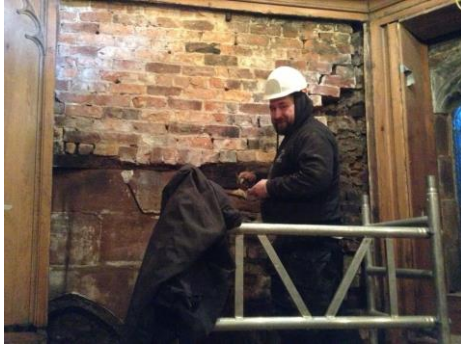
Gary is painting the brick wall above the fireplace. It will shortly be hidden obey panelling once more, for future generations to find and admire!

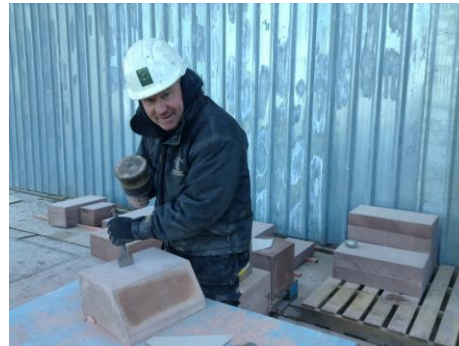
Paul, the stonemason is seen here working the stones , in the traditional way. Each will be set into the outside walls

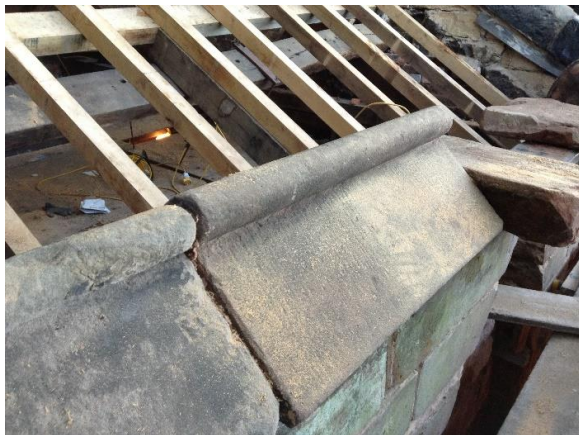
The restored roof is taking shape, soon to be covered with plywood. The pitch of previous roofs can be clearly seen

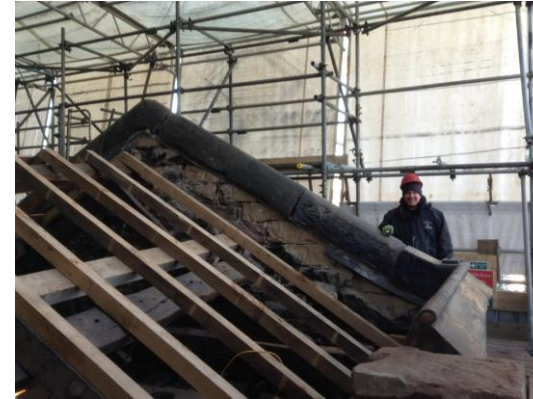
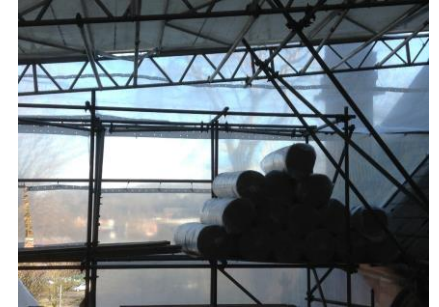
Rolls of insulation (made from the wool of sheep) are ready to be put in between the ceiling spars.

Coping stones around the Rector's Vestry appear to be remarkable similar to those high up on the Tower.

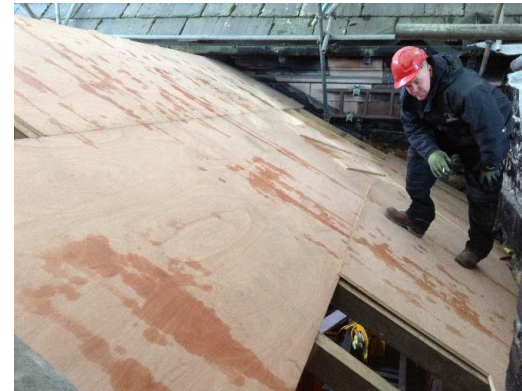
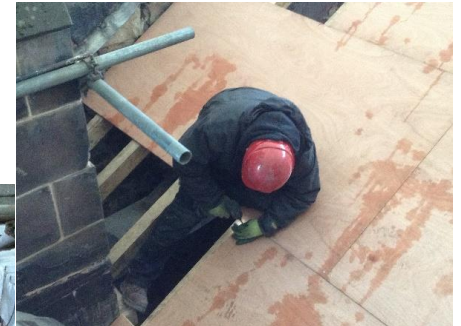
Simon the joiner fixing the plywood onto the roof spars ready for the stainless sheets to go on.

Simon admiring his work on the newly covered roof over the Rector's Vestry
