# THE GOLD KING MINE

## CHALLENGING COLORADO MINING LEGACY

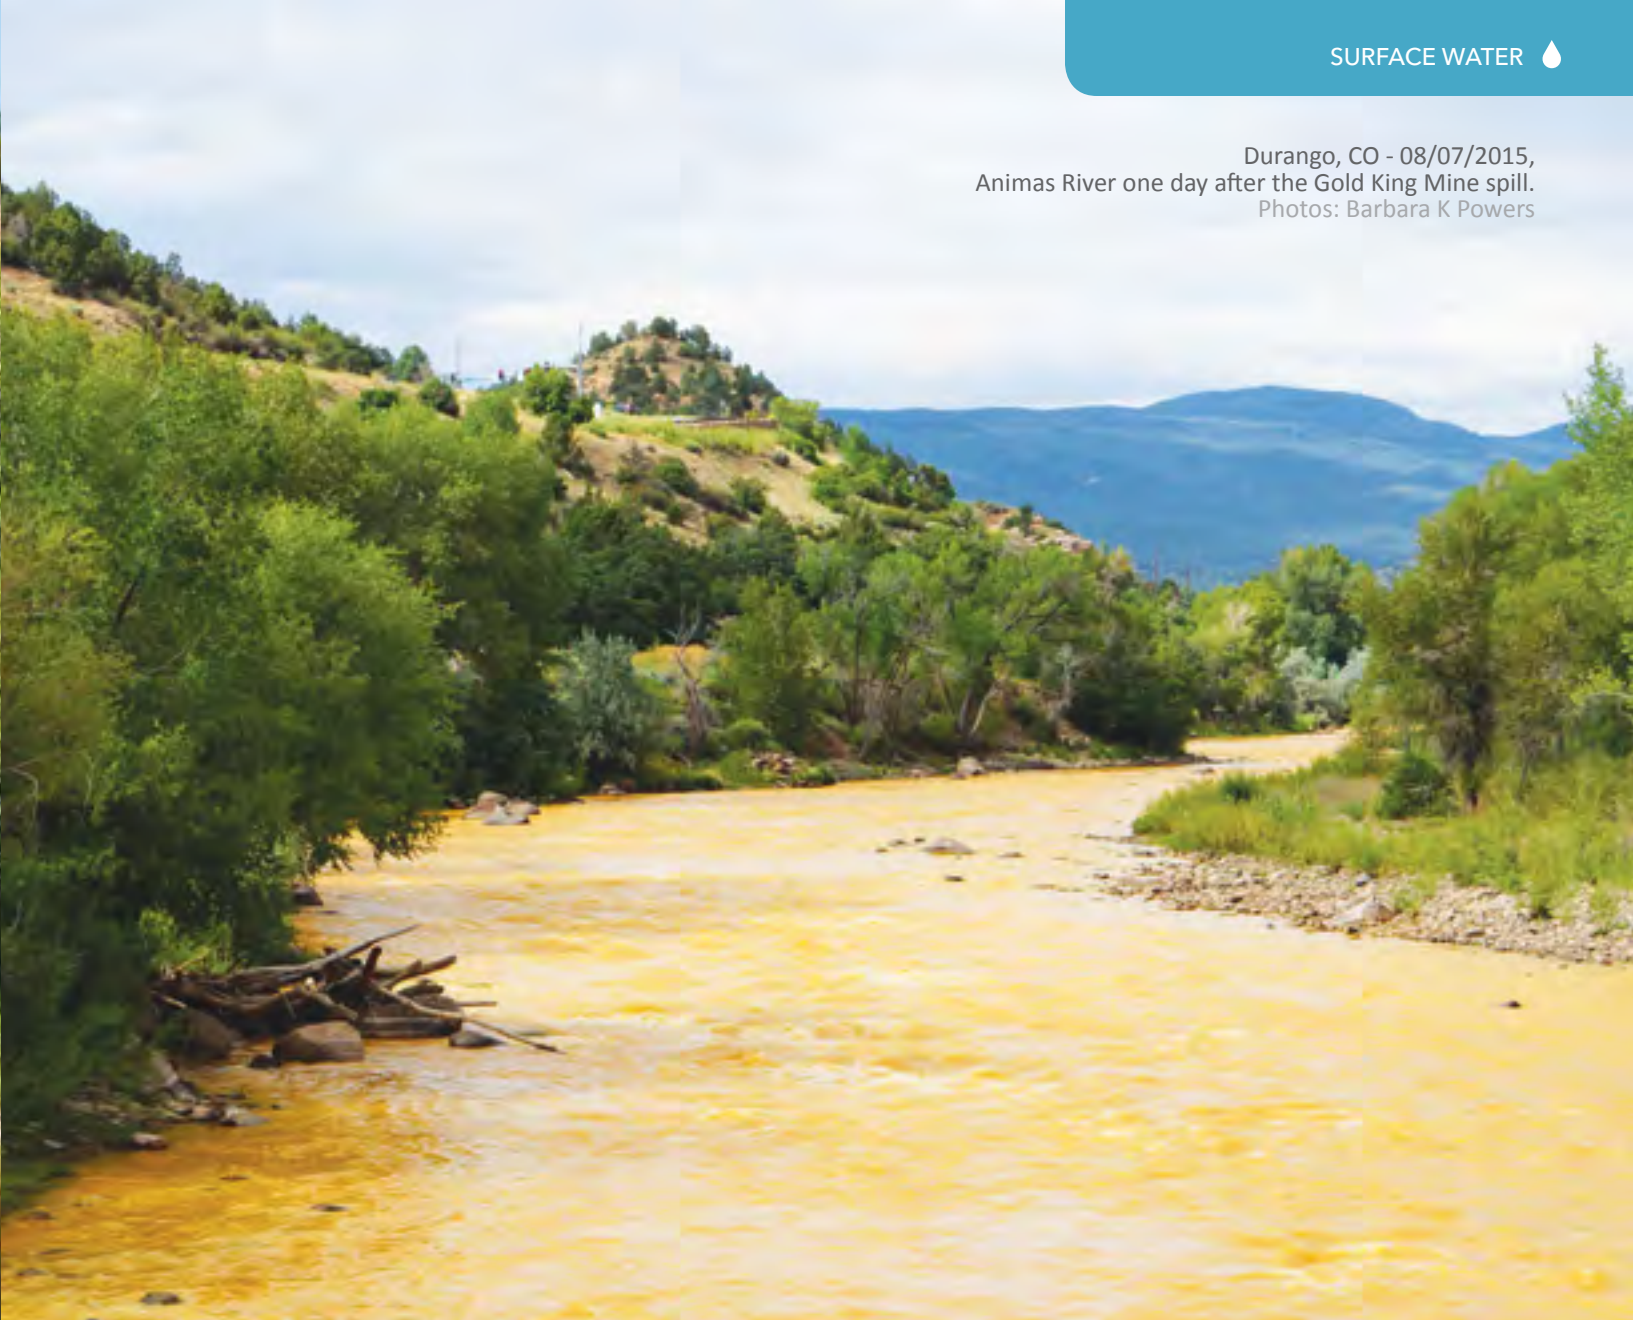
Durango, CO - 08/07/2015,  
Animas River one day after the Gold King Mine spill.  
Photos: Barbara K Powers

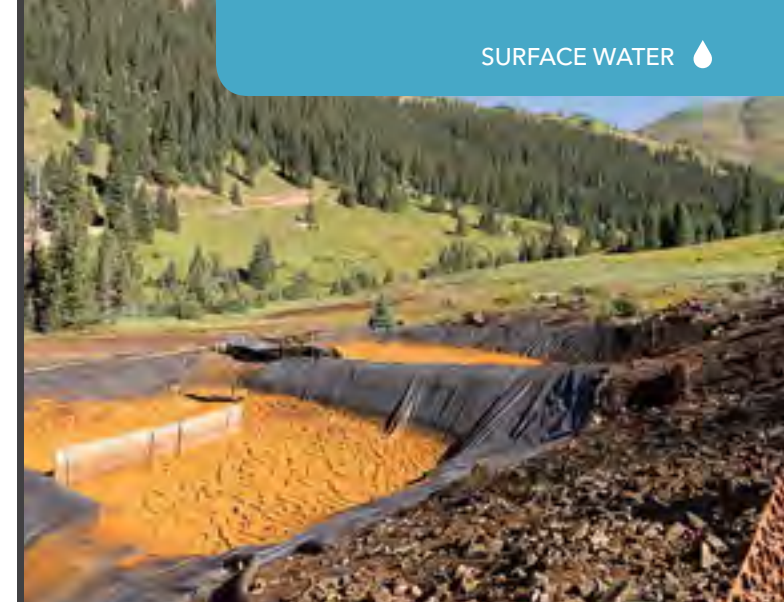
**Above:** Treatment ponds close to the Gold King Mine  
**Below:** Water Monitoring in the Animas River with a YSI handheld multiparameter meter.

EPA staff also quickly established numerous filtering and treatment ponds just below the adit rupture site to reduce toxic overflow from continuing downstream. Unfortunately, the construction of these ponds happened after the initial plume of contaminated water pushed through. But once they were put in place, officials were able to effectively control and treat whatever water was still flowing before it entered the Animas River and beyond. The pond treatment included lime to reduce acidity and raise pH, and sodium hydroxide solution, which aided metals sedimentation within the ponds.

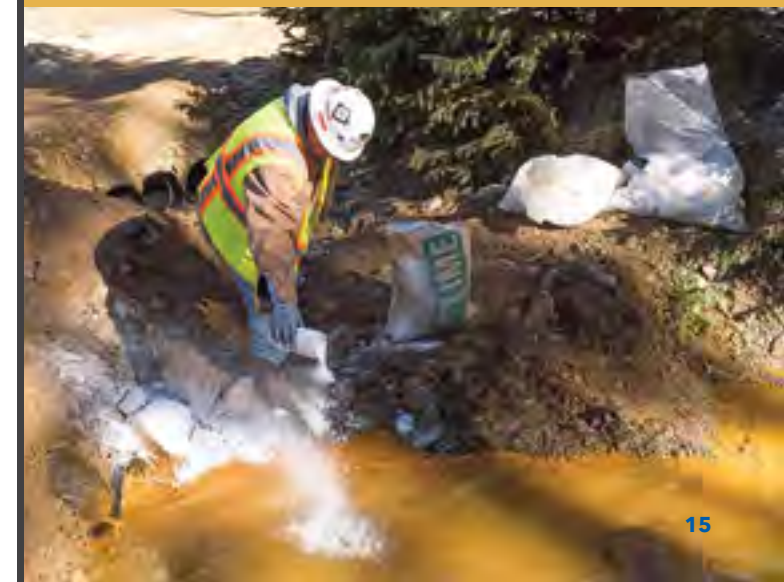
**Below:** Lime is added to a settling pond to assist in the pH adjustment of the water prior to discharge to Cement Creek on August 14th, 2015.  
Photos: Eric Vance / EPA
