SALMON RIVER WATERSHED RAPID BIOASSESSMENT SUMMARY REPORT 2008

The Salmon River Watershed Partnership

Salmon River Watershed Rapid Bioassessment Summary Report 2008

October 2009

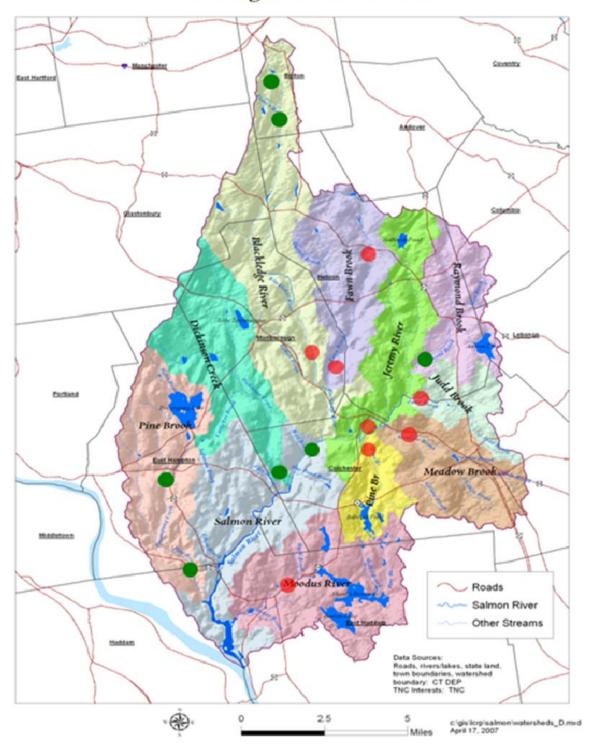
SALMON RIVER WATERSHED Sub-regional & Small Basins

Key:

Red = new site, included in 2008 bioassessment Green = ongoing DEP/other site, not included in 2008 bioassessment
