Home Inspection Report

Property address: 4500 Beachcomber Lane
Charleston SC 29412

Inspected by: Stephen Houmar
South Carolina License #2046
Solid Ground Home Inspections, LLC
Professional Member:
-American Society of Home Inspectors
(ASHI)

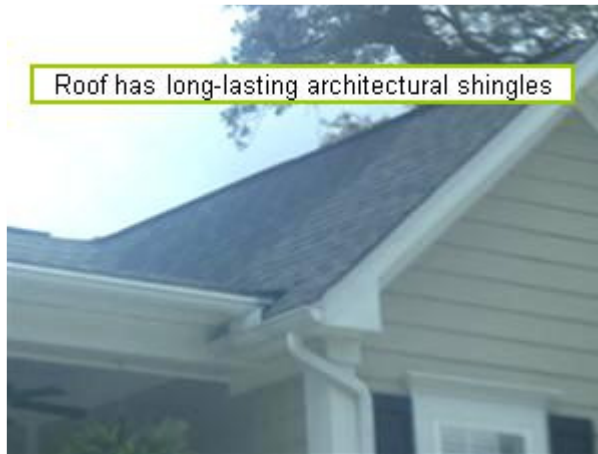
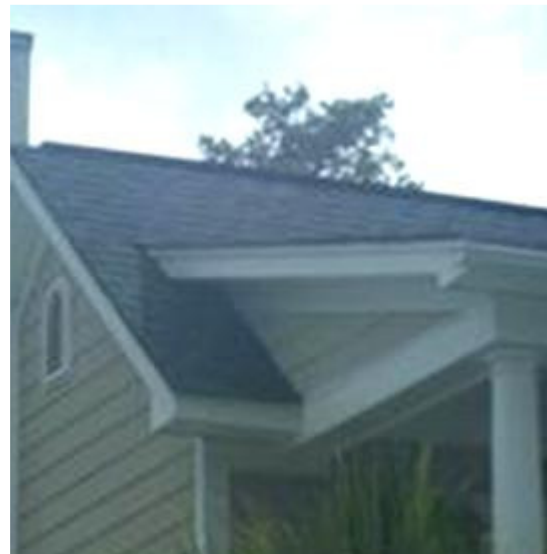
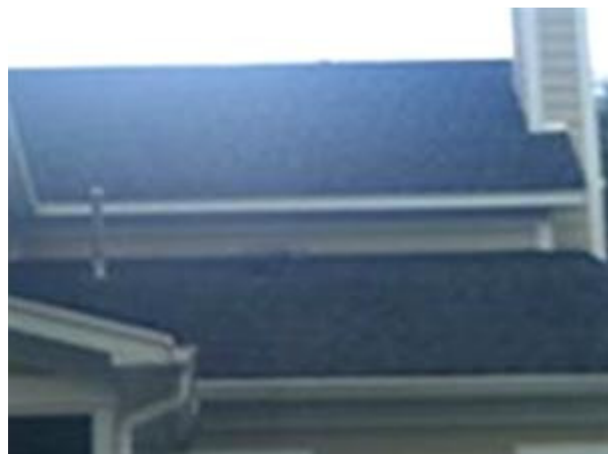
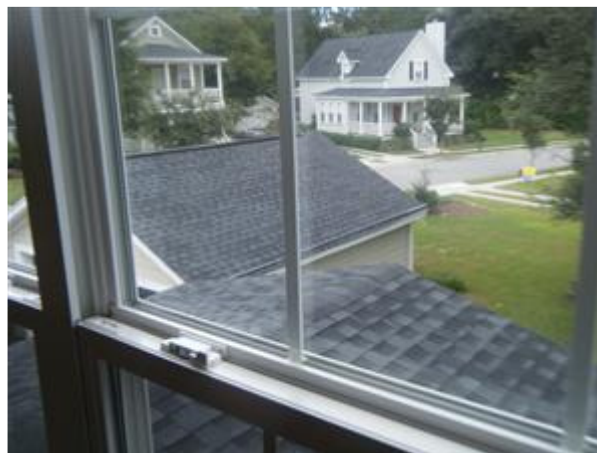
Observed that this home has architectural shingles which are estimated to be 5 years old. For your reference, the average roof with this type of shingles can last up to 35 years and possibly longer depending on the local climate and roof ventilation.

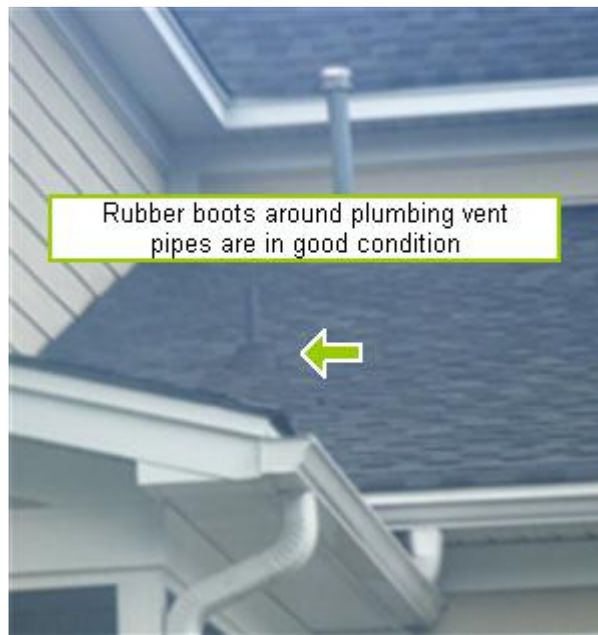
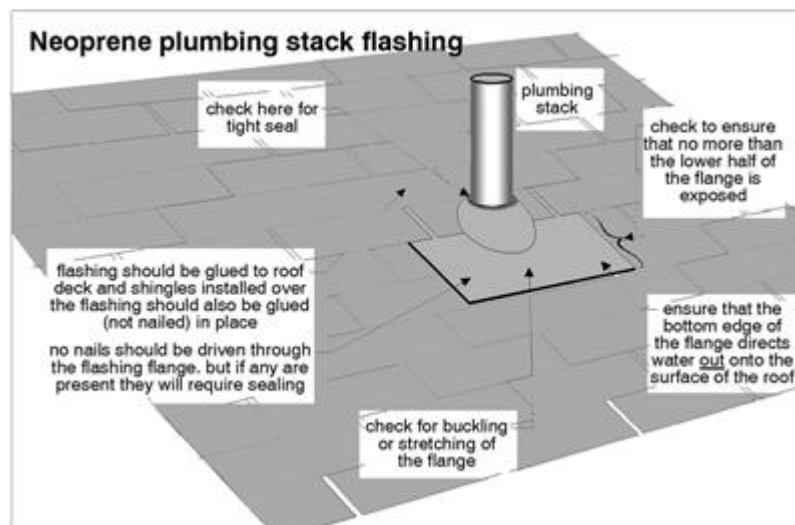
1.1 FLASHINGS

Observed that the flashings are in good condition. For your reference, flashing is a sheet of metal or Neoprene which is installed around pipes and chimneys traveling through the roof to ensure these areas are water tight. Also, flashing is applied along the sidewalls where different parts of the roof come together as well.

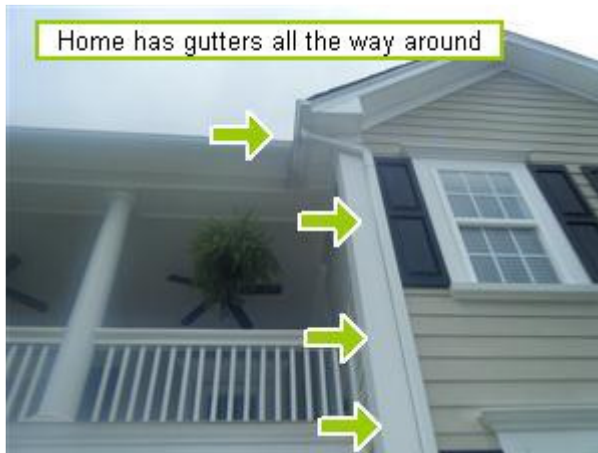
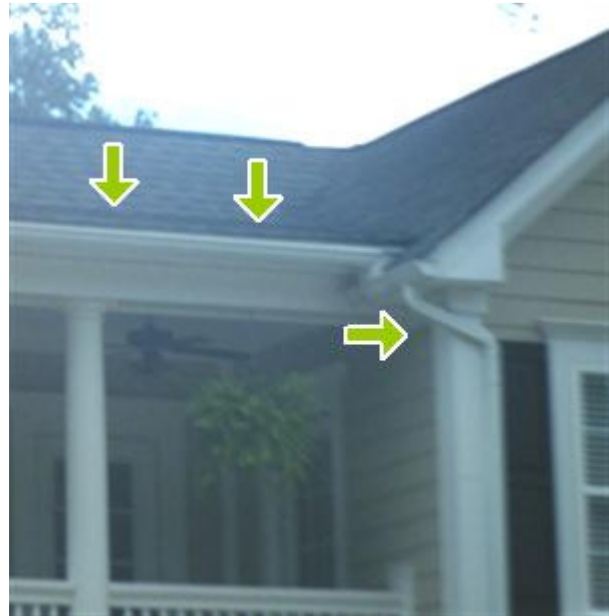
1.2 GUTTERS

Observed that there are gutters all the way around this house. For your reference, gutters carry rain water from the roof and drain it away from the home and the foundation which prevents water damage to the soffits or foundation, discoloring of the siding materials and soil erosion. Recommend cleaning your gutters twice year -- ideally in the spring and in the fall.

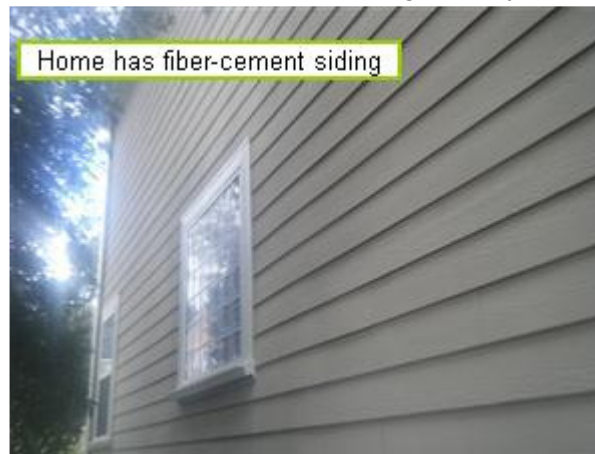
(1) Observed that this home has fiber-cement siding. For your reference, fiber cement siding is a low-maintenance, impact-resistant and durable alternative to wood siding. In essence, it combines the look of natural wood with the durability of cement. For example, HardiPlank, a name you may be familiar with, is a brand name fiber cement product. Also, it is non-combustible and designed to resist wind and hail damage and is naturally resistant to fungus, mildew, termites and deterioration from salt and uv rays. Although fiber cement siding is available in a wide array of colors, it can also be painted any color you choose, should you ever feel in the mood for change and it will hold the paint color. Most cement fiber siding comes with incredible warranties—some run as long as 50 years.

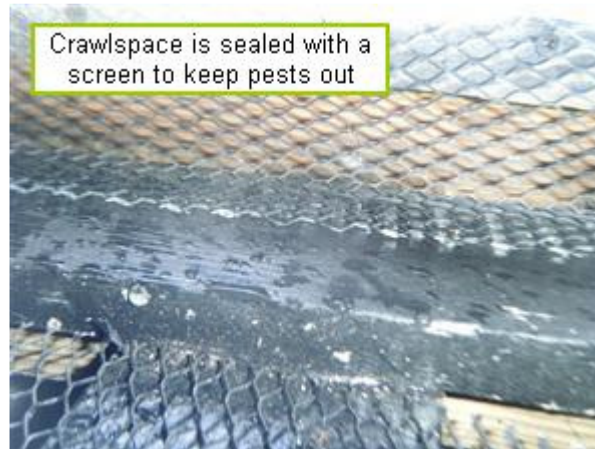
(2) Please note the entire crawlspace has been sealed with a steel screen to keep out pests. This was done buy the home seller, very nice.

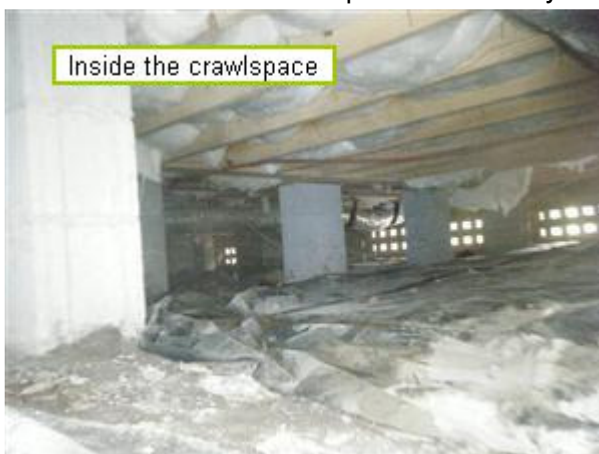
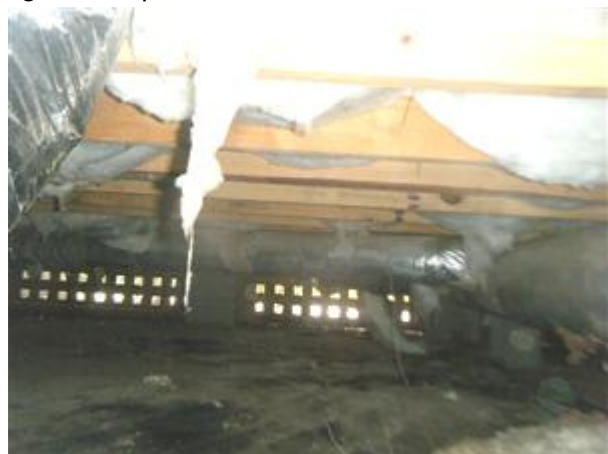
Observed that this home's foundation is a system of cement block piers and has a lattice skirting (wall) which encloses the crawlspace. For your reference, the goal is to keep the crawlspace as dry as possible to protect/preserve the structural integrity of the wood and masonry which comprise the foundation. For your reference, wood which has a moisture content of 20% or more (from direct contact with moisture or from a very humid environment) conditions are ripe for the growth of mold/mildew, the decay fungi which leads to wood rot and termites. When rot sets, the wood loses its structural integrity and the rot can spread if not corrected. In most cases, installation of gutters to divert rain water away from the foundation, a vapor barrier on the ground to reduce moisture vapor along with good ventilation in the crawlspace are usually enough to keep moisture content below 20%.

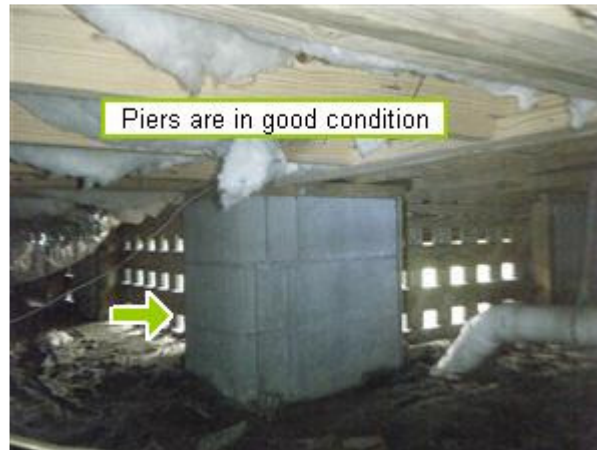
Observed that the piers are in good condition. For your reference, columns/piers are an

important structural component of the foundation. Their purpose is to transfer loads from beams down through the footings to the soil.

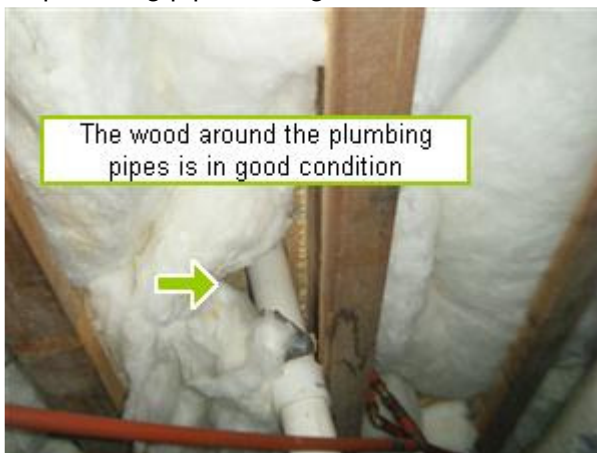
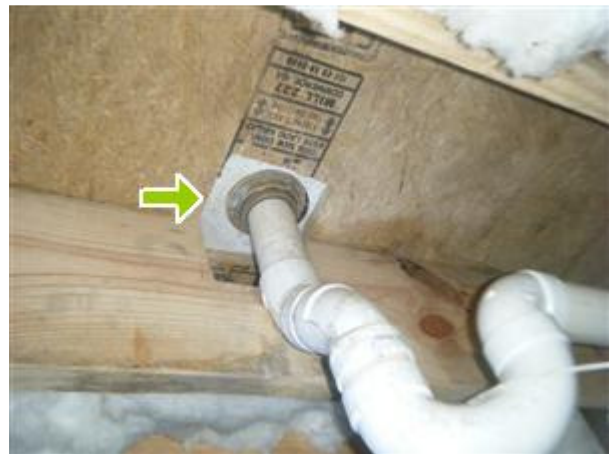
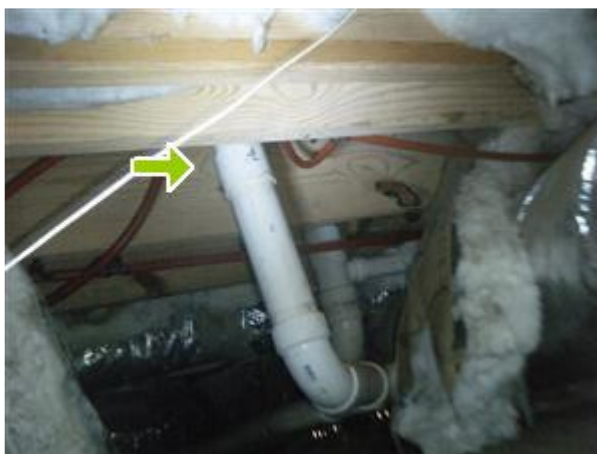
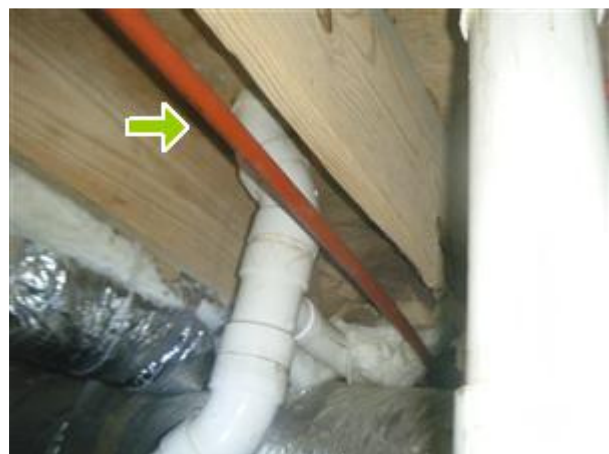
As viewed from inside the crawlspace, the wood (sub-floor and floor joists) around the plumbing pipes is in good condition.

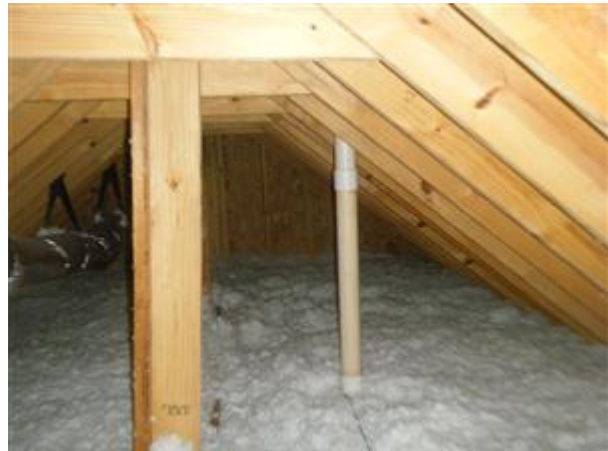
Observed that the roof has a traditional stick built structure with a common board.

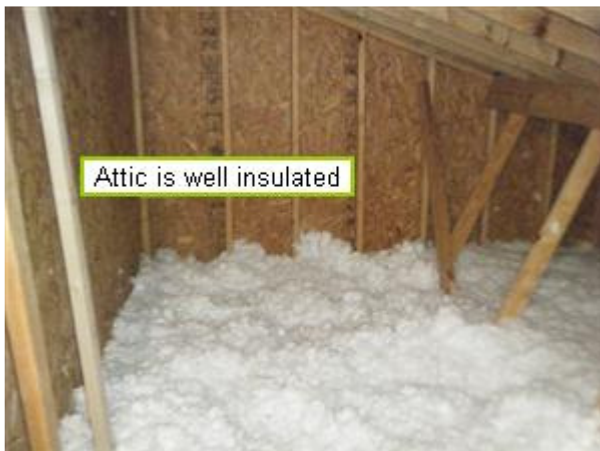
Observed that this home has an amount insulation on the attic floor which equates to R-38 or better. For your reference, the effectiveness of insulation is measured by its R-number which is its ability to resist the flow of heat. The higher the R-number, the greater the resistance to winter heat loss or summer heat gain. Today's standard for insulation in newer homes is R-30 or better.

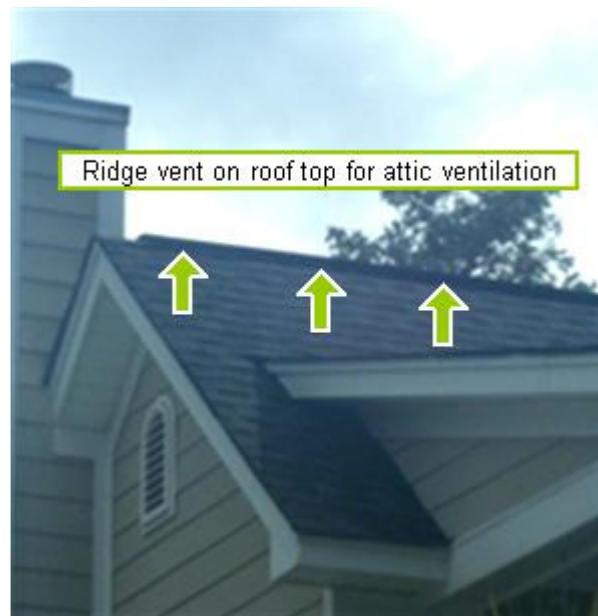
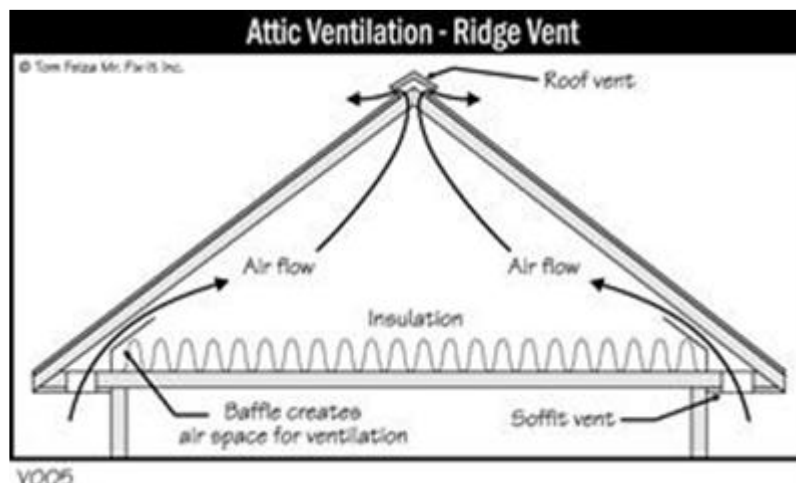
Observed that this home has good ventilation in the attic -- the included illustration describes how the attic is ventilated in your home.

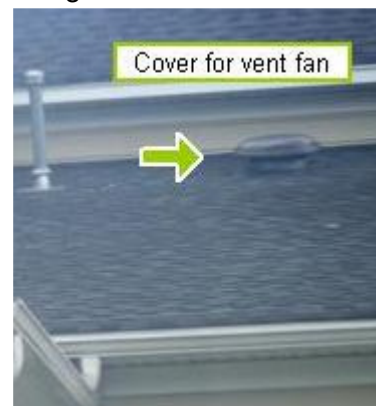
Observed that there is also a thermostatically-controlled vent fan to help with attic ventilation. For your reference, this type of fan helps to increase the overall comfort of your home while reducing the cost of air conditioning and wear on your system. Additionally, it helps to minimize heat and moisture in this space and fights the growth of mold and mildew.

There is also a thermostatically-controlled vent fan to help with attic ventilation

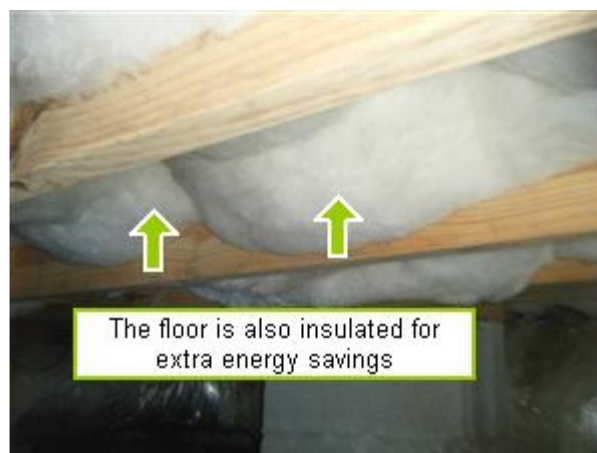
(1) Observed that the floor system is insulated -- a positive. Up to 25% of energy can be lost through a non-insulated floor.

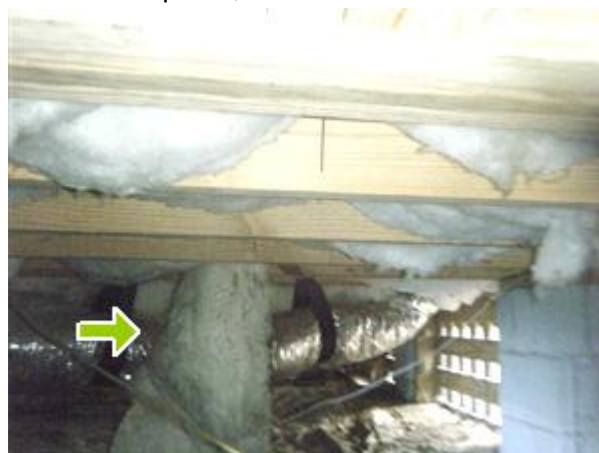
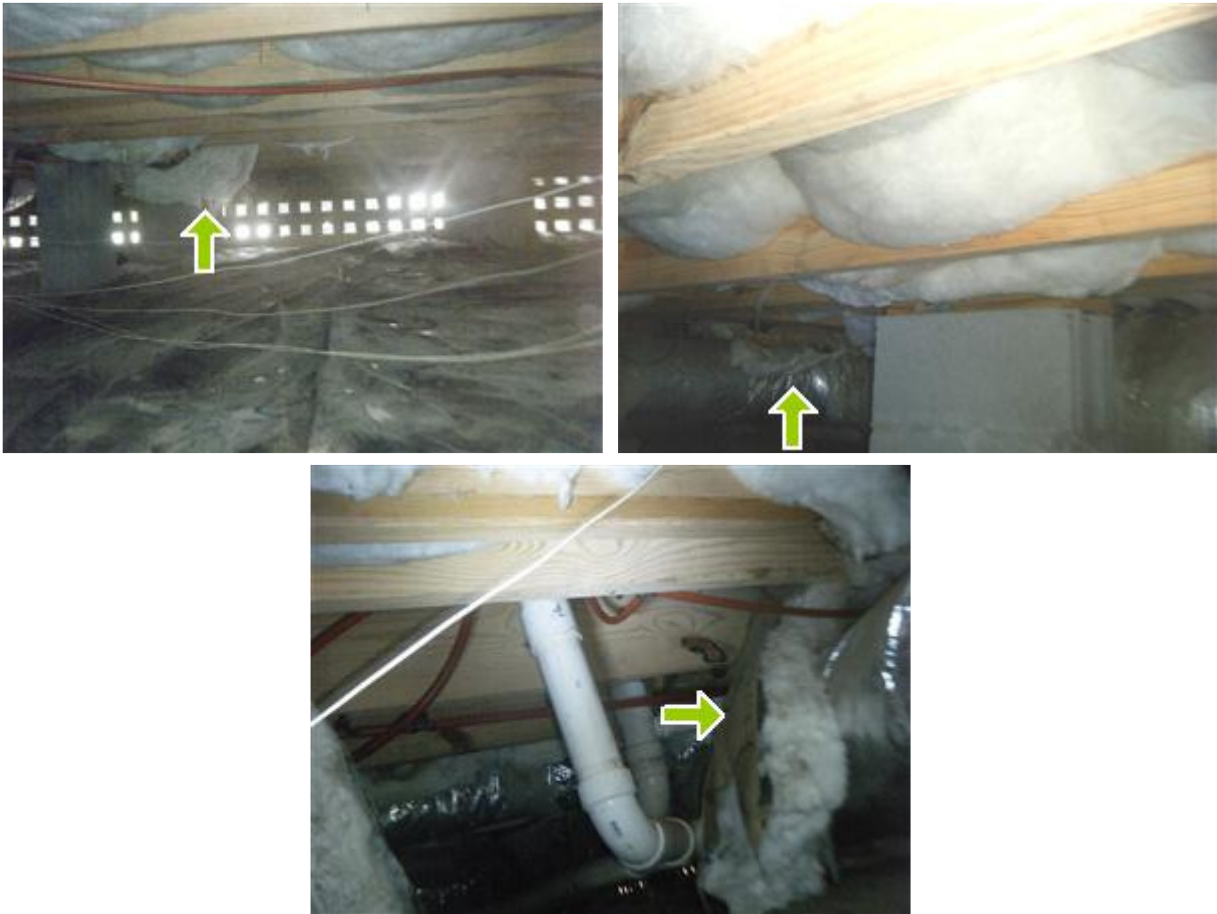
(2) Observed that one or more sections of the insulation under the floor in the crawlspace has fallen (due to humidity). For your reference, insulation which is hanging down acts as a curtain and blocks the flow of air through the crawlspace, thus reducing ventilation. Again, ventilation is important to help keep the crawlspace as dry as possible to preserve the structural integrity of the wood and masonry components which comprise the foundation. Recommend having an insulation contractor or handyman remove the moist insulation to promote good air flow and installing new insulation in its place, as desired.

(2) Observed that one or more sections of the insulation under the floor in the crawlspace has fallen (due to humidity). For your reference, insulation which is hanging down acts as a curtain and blocks the flow of air through the crawlspace, thus reducing ventilation. Again, ventilation is important to help keep the crawlspace as dry as possible to preserve the structural integrity of the wood and masonry components which comprise the foundation. Recommend having an insulation contractor or handyman remove the moist insulation to promote good air flow and installing new insulation in its place, as desired.

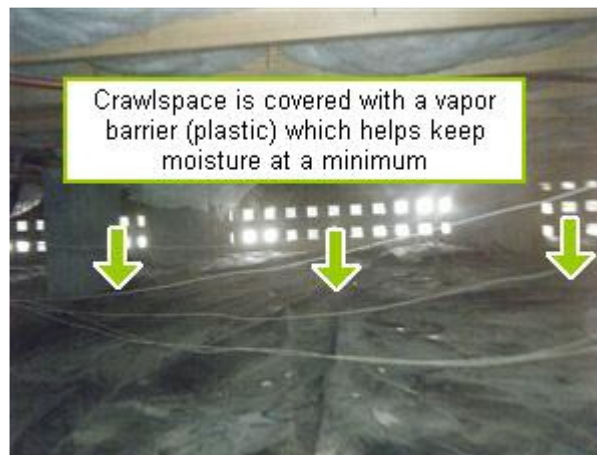
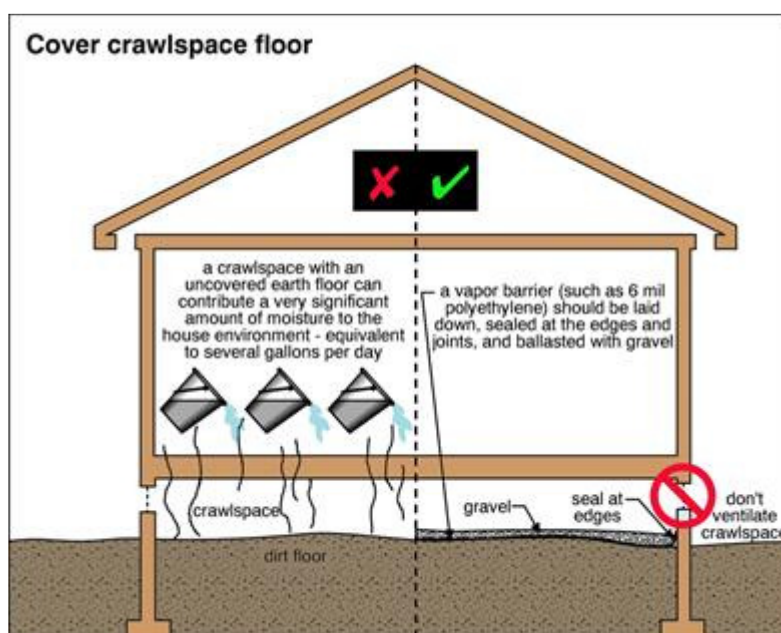
4.5 VAPOR BARRIER (on the crawlspace ground)

Observed that this home has a vapor barrier (plastic) on the ground in the crawlspace and it is in good condition. For your reference, a vapor barrier helps to keep moisture and dampness in the crawlspace at a minimum to preserve the condition of the wood and masonry components that comprise the foundation. Additionally, it helps prevent the house from smelling musty. When there is excess moisture in the crawlspace, conditions are ripe for the growth of mold and mildew, the decay fungi which leads to wood rot and wood-eating insects.

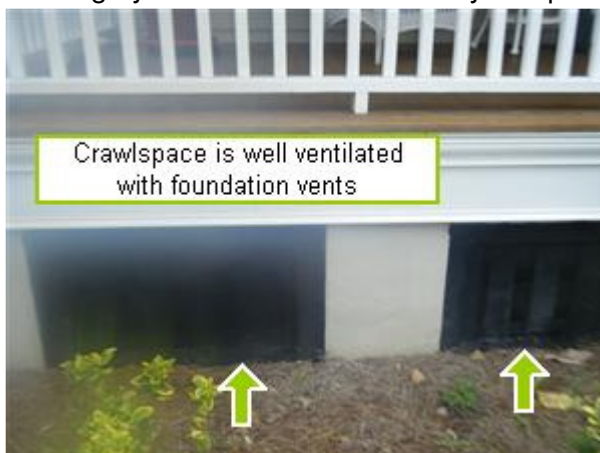
4.6 FOUNDATION VENTILATION

Observed that the crawlspace is partially enclosed with lattice screen and the rest has foundation vents -- this helps keep the crawlspace as dry as possible to protect the structural integrity of the wood and masonry components which comprise the foundation.

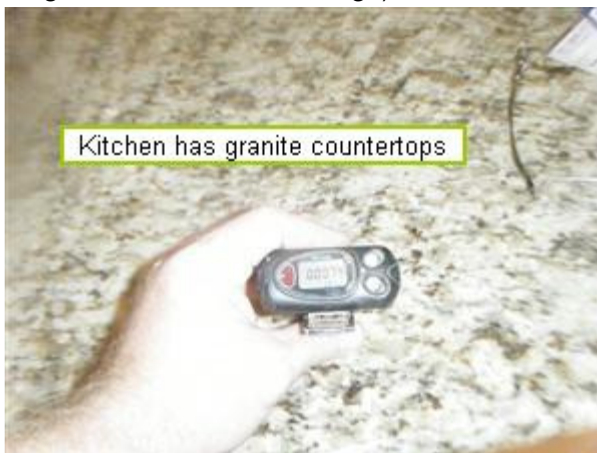
(1) Observed that this home has granite countertops which did not have any 'hot spots' (high gamma radiation readings) when tested for the possible presence/emission of radon gas.

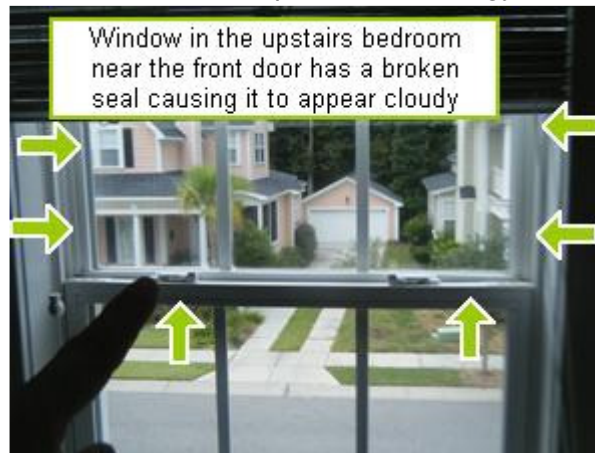
Observed that there is a thermal-insulated window in the second floor bedroom at the front of the home near the door to the balcony which has a broken seal causing it to have a cloudy appearance. When the seal is broken, moisture seeps in between the panes of glass and causes condensation. Additionally, the insulating properties of the window are significantly reduced so that it acts just like a regular piece of glass. Unfortunately, this cannot be repaired. Recommend having a contractor replace the window so that it again has a clear view to the outside and is insulated to help conserve energy.

Observed that there is a thermal-insulated window in the second floor bedroom at the front of the home near the door to the balcony which has a broken seal causing it to have a cloudy appearance. When the seal is broken, moisture seeps in between the panes of glass and causes condensation. Additionally, the insulating properties of the window are significantly reduced so that it acts just like a regular piece of glass. Unfortunately, this cannot be repaired. Recommend having a contractor replace the window so that it again has a clear view to the outside and is insulated to help conserve energy.

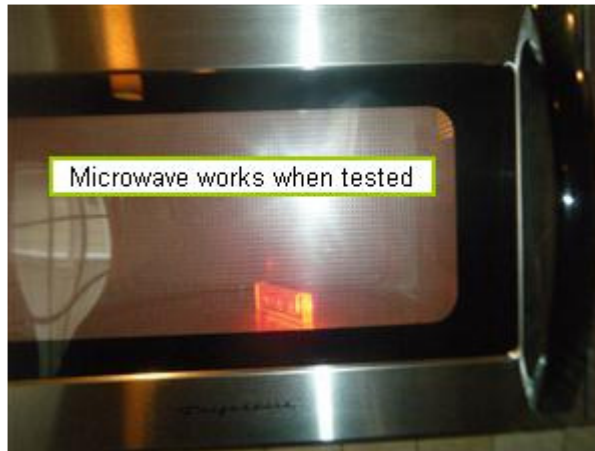
Observed that the microwave appears to be working well -- it was tested with a microwave tester to ensure it is operating properly and that there are no door leaks. For your reference, the average microwave lasts 10 years.

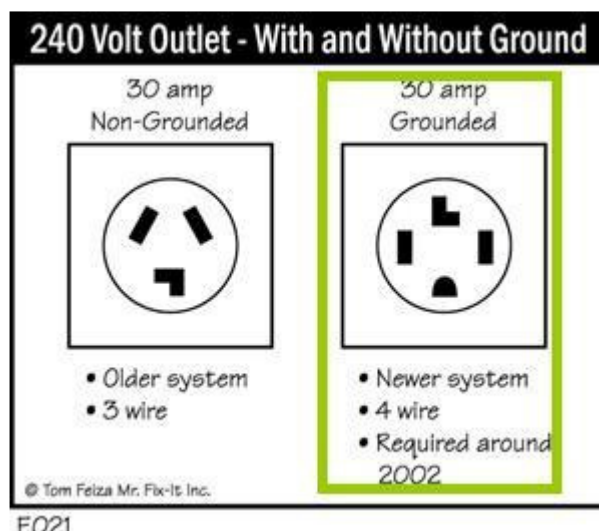
6.6 DRYER OUTLET

If the plug for your dryer doesn't fit into the dryer outlet, then take this photo to your local home or hardware store and ask for a four prong dryer "pig tail" so that the dryer can be plugged in.

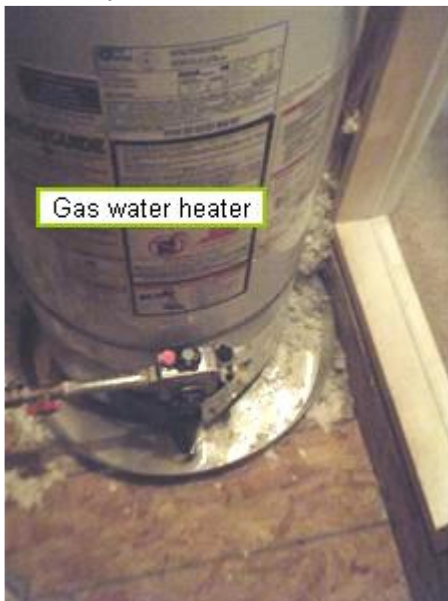
Observed that the gas water heater, located in the attic, is estimated to be 5 years old. For your reference, the average hot water heater can generally last up to 12 years and possibly longer. Please note there are two drain lines for the hot water heater on the back of the house -- one is for the drain pan, the other is for the TPR valve. If you notice either of these lines dripping, suggest having a plumber evaluate to determine the cause of the drainage -- repairs may be needed.

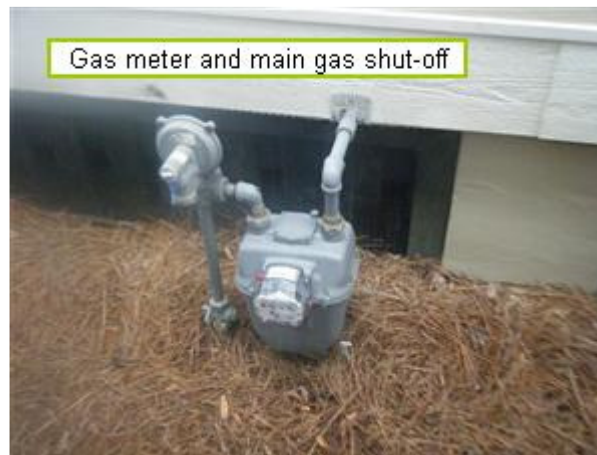
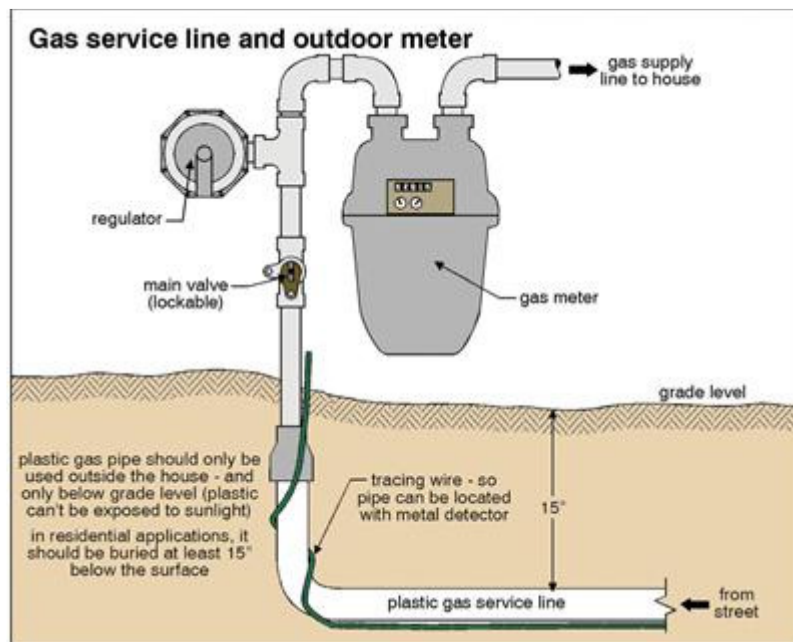
(1) The main fuel/gas shut-off is located at the gas meter outside. In the event that repairs need to be made to the gas line, you'll need to know where the gas shut-off is located.

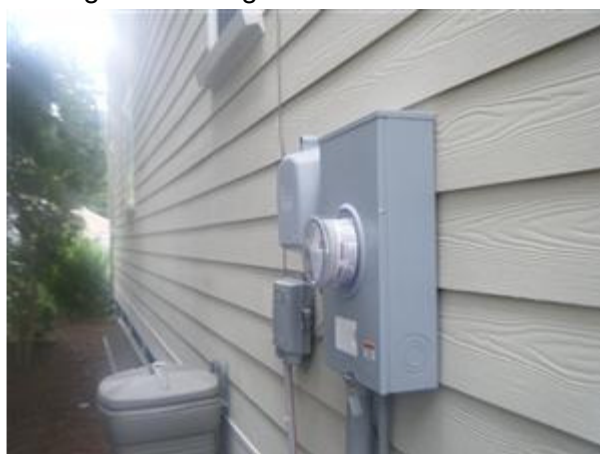
Observed that the underground service entrance conductor (where the power enters the home from the street), electrical meter and grounding rod are located on the side of the home and are in good working condition

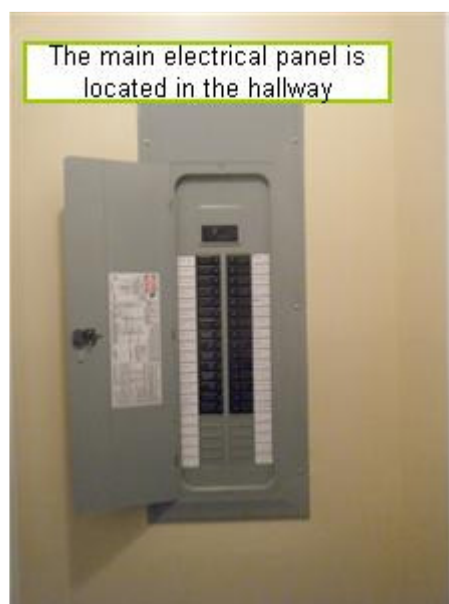
8.1 LOCATION OF MAIN ELECTRICAL PANEL(S) & SUB-PANEL(S)

The main electrical panel is located in the hallway.

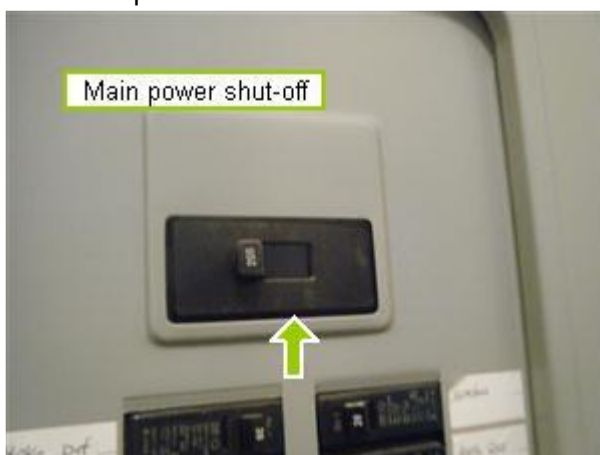
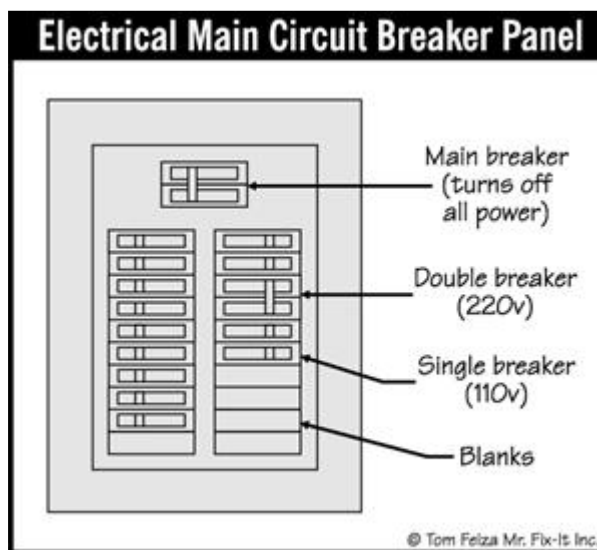
8.2 MAIN POWER SHUT-OFF

Observed the main electrical disconnect (also called a main breaker) is on located on the main electrical panel. It is helpful to know where the main breaker is in case you need to turn off the power for the whole home.

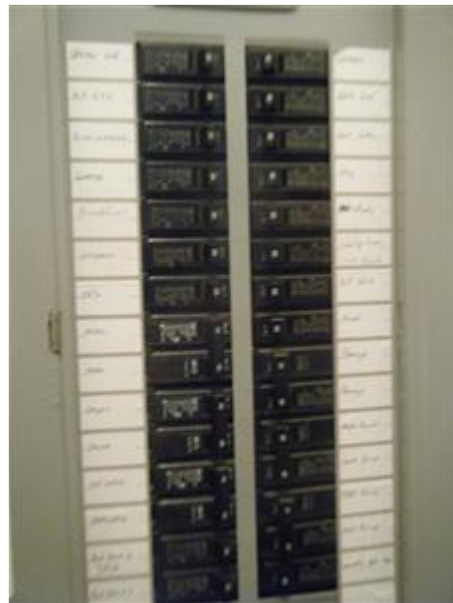
Observed that the inside of the electrical panel is in good condition.

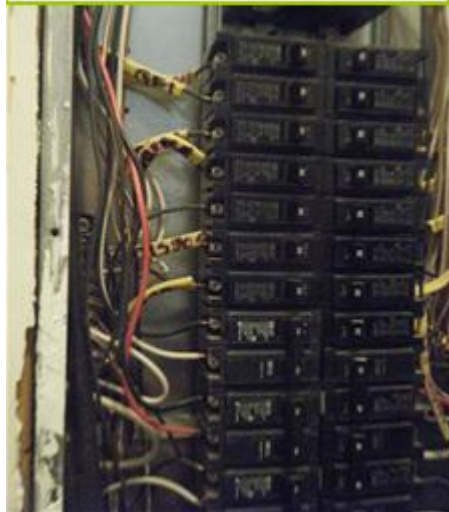
The inside of the electrical panel appears to be in good condition

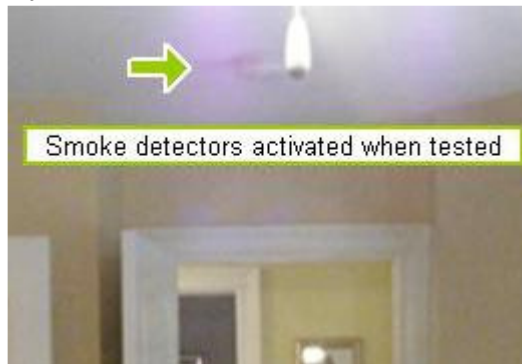
Observed that this home has smoke detectors which activated when tested. Recommend replacing the batteries in your smoke detectors every six months. Also, suggest testing the detectors every 30 days by pushing the test button. Smoke detectors should be replaced every 10 years.

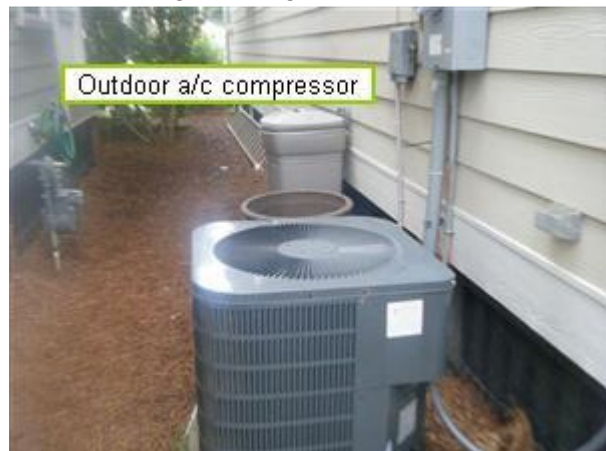
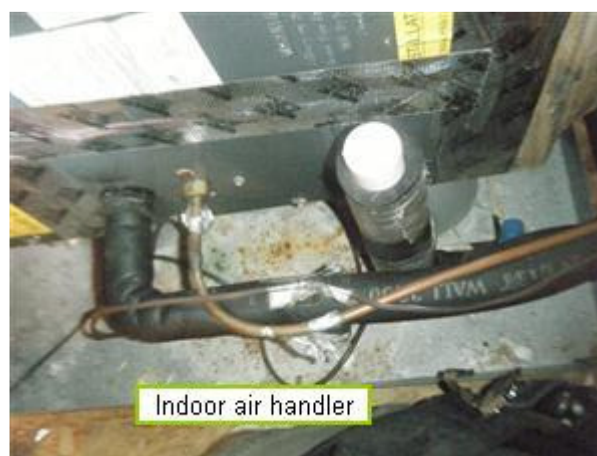
(1) Observed that this home has a heat pump which consists of an outdoor compressor and an indoor air handler to heat and cool the upstairs. Also, there is a forced air gas furnace and an outdoor a/c compressor in an all-in-one unit outside called a 'gas pack' to heat and cool the downstairs. All equipment is estimated to be 5 years old and in good condition. For your reference, gas furnaces generally last between 15 and 20 years, outdoor compressors up to 15 years and air handlers up to 20 years and all often longer with good maintenance.

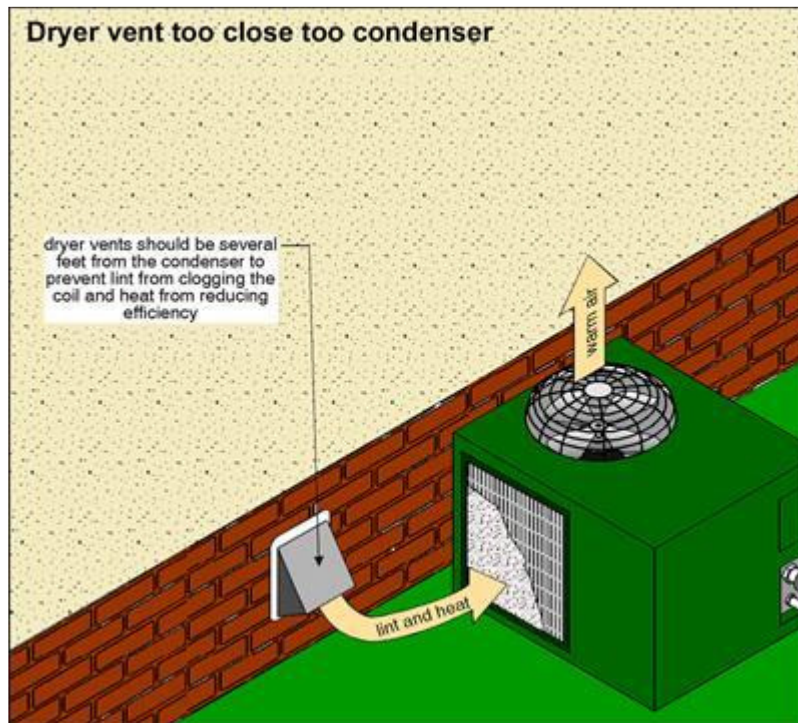
(4) Observed that the dryer vent is located very close to the outdoor a/c unit -- this can clog the HVAC unit with lint and the extra heat (from the dryer vent) can reduce the a/c unit's efficiency and hinder performance. Recommend having a contractor relocate the dryer vent so that it is at least 3 feet away from the a/c unit.

(4) Observed that the dryer vent is located very close to the outdoor a/c unit -- this can clog the HVAC unit with lint and the extra heat (from the dryer vent) can reduce the a/c unit's efficiency and hinder performance. Recommend having a contractor relocate the dryer vent so that it is at least 3 feet away from the a/c unit.

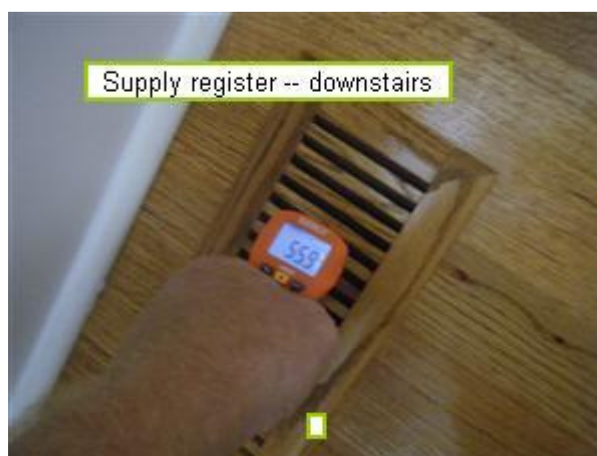
(1) When tested, it appears that the air conditioning for the downstairs is working well. For your reference, there should be at least a 14 degree difference between the air at the return air register and where the cooled air enters the home from the supply air register to indicate normal functioning. In this case, there was a 18 degree difference.

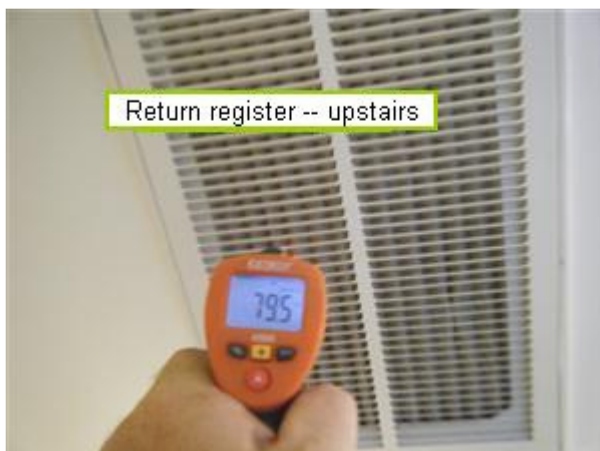
(2) When tested, it appears that the air conditioning for the for the upstairs is working well. In this case, there was a 21 degree difference.

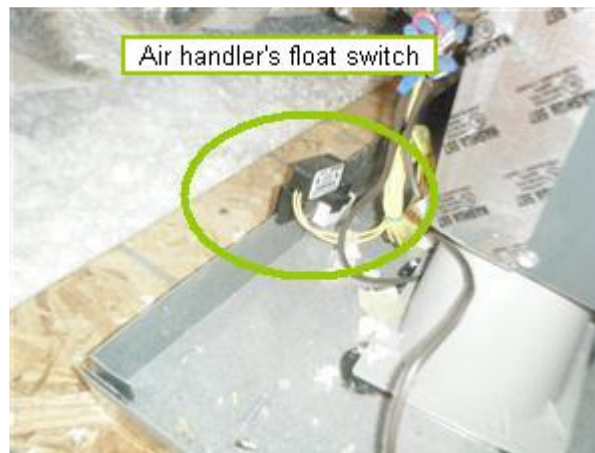
Please note the air handler has a 'float switch' which will turn off the outdoor compressor when the condensation pan (for the air handler) fills up to prevent the water from spilling over onto the floor below.

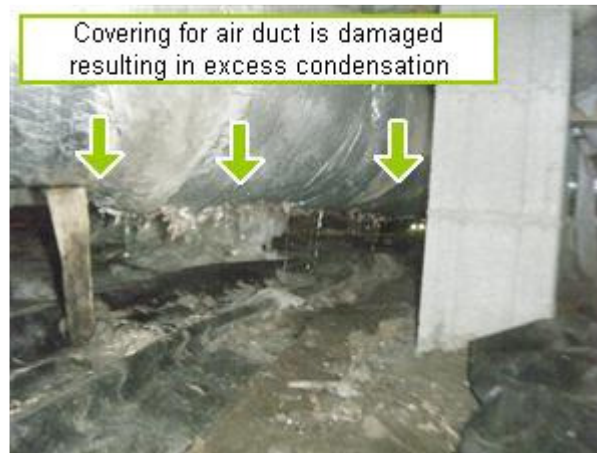
(1) As viewed from inside the crawlspace, observed that a section of the covering for the main air duct from the outdoor gas pack is damaged and has resulted in excess condensation in this area. Please note there was no air leak noted at the time of the inspection. Recommend having an HVAC repairman properly seal the outer covering of this duct for energy savings and to help stop excess condensation.

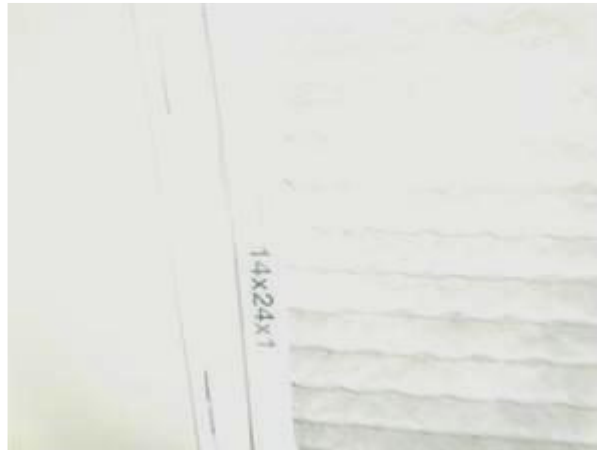
(2) Observed that the size of the air filters are 14 x 24. Recommend using an inexpensive air filter and changing it frequently - ideally once a month. An easy way to remember to change the air filter is to change it when you pay the power bill each month. For your reference, the purpose of the air filter is to keep your furnace/air handler clean. A dirty, clogged filter blocks air flow and reduces the system's efficiency. If dirty air filters aren't changed regularly, the system can produce excess condensation which you may then see as a moisture stain on your ceiling. Please note the higher end filters make it more difficult for your furnace/air handler to draw and push air throughout your home, putting strain on your furnace/air handler and your energy bills.

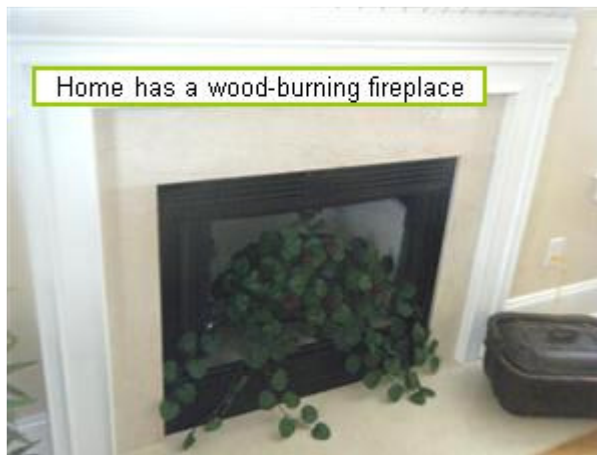
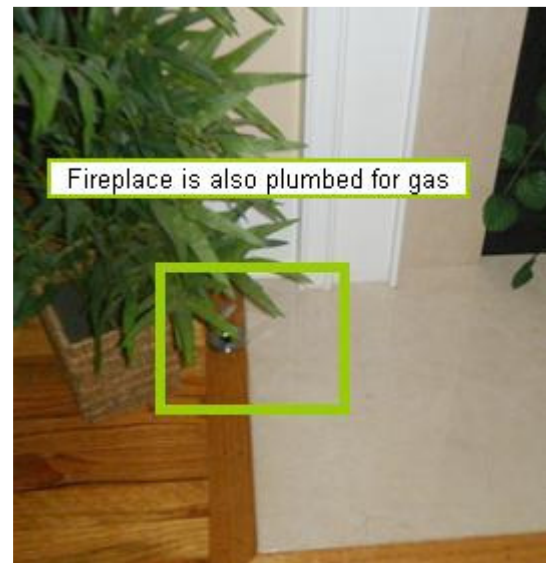
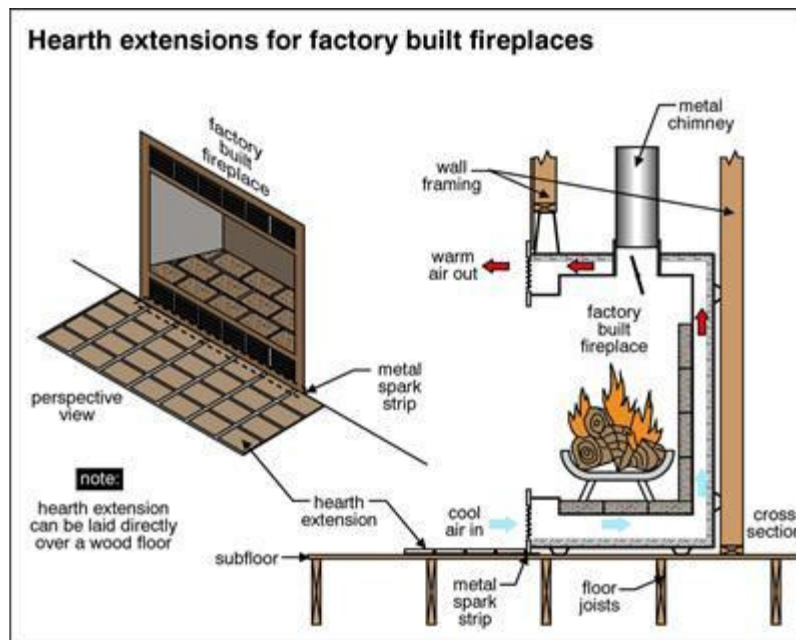
Observed that this home has a metal insert, wood-burning fireplace. Please note the fireplace is also plumbed for gas, but it does not have gas firelogs.

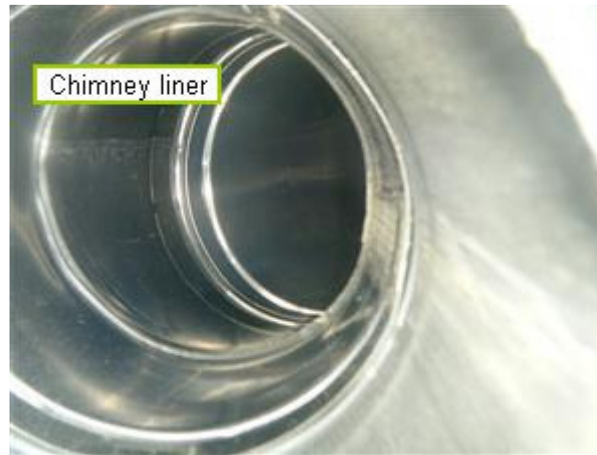
9.7 CHIMNEYS, FLUES & VENTS (for Gas Fireplaces, Gas Water Heaters & Gas Furnaces)

Observed that the chimney liner appears to be in good condition.

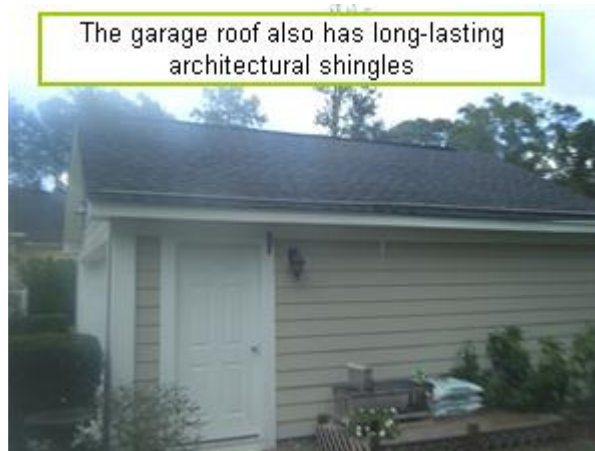
Observed that the garage roof has architectural shingles which are estimated to be 5 years old.

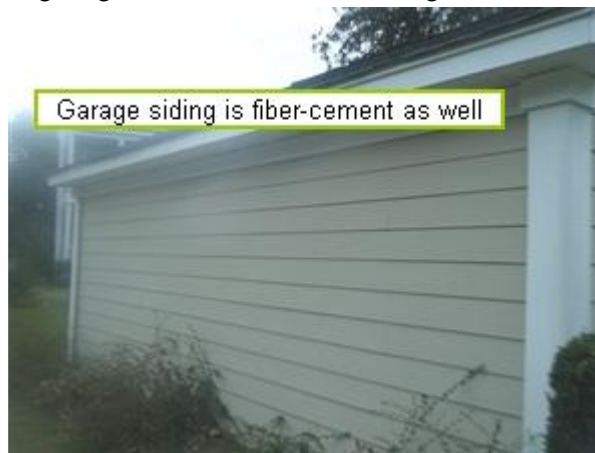
(2) Observed that this garage has fiber-cement siding.

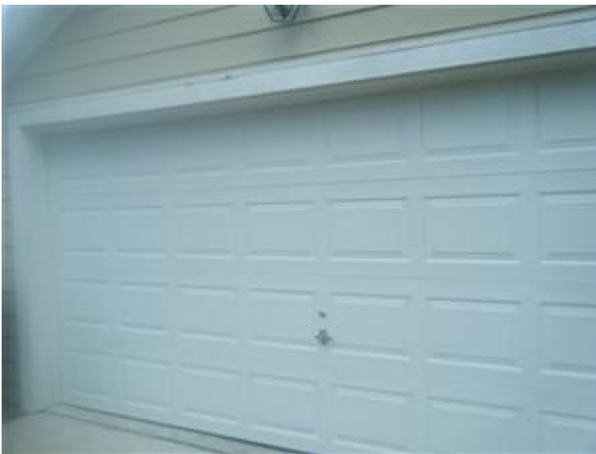
Observed that this home has an automatic garage door opener in good working order. For your reference, there are three basic safety features on your garage door that should periodically be tested, ideally once a month:
