CRACKING THE CODE ON FOUNDATION CRACKS

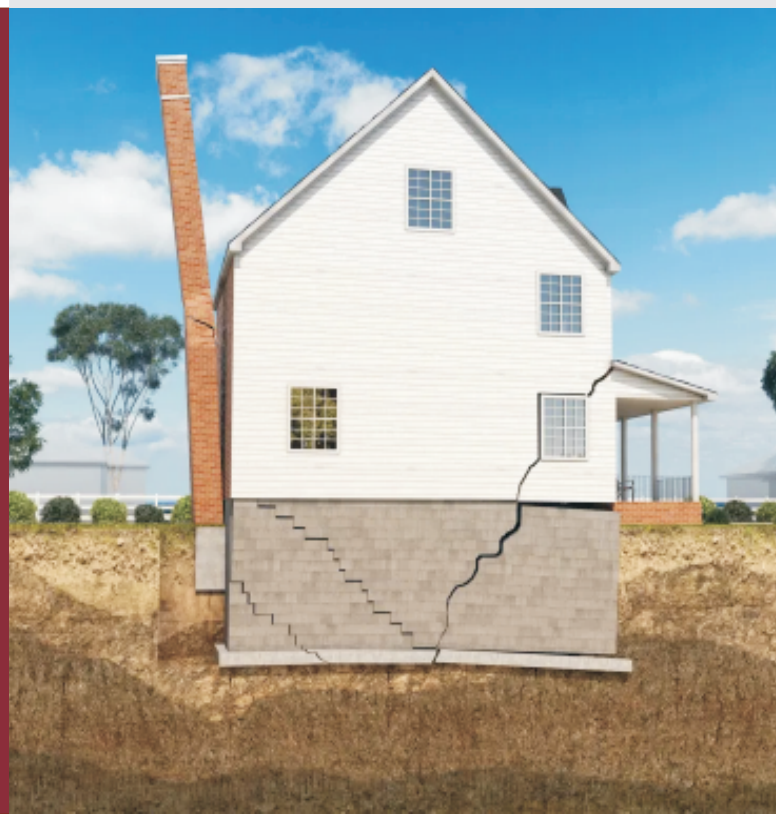
Horizontal Cracks

Horizontal cracks in a foundation can be serious. This type of crack is often due to unbalanced soil and hydrostatic water pressuring/pressing against your foundation wall.

You may notice the foundation bowing inwards and water leaking into the basement. Both block and poured foundations can develop horizontal cracks.

Horizontal cracks are common, they are found below grade where the frost line is located and often caused by the freezing and thawing cycle.

Over time this can create unbalanced pressure on the foundation wall creating a horizontal crack.

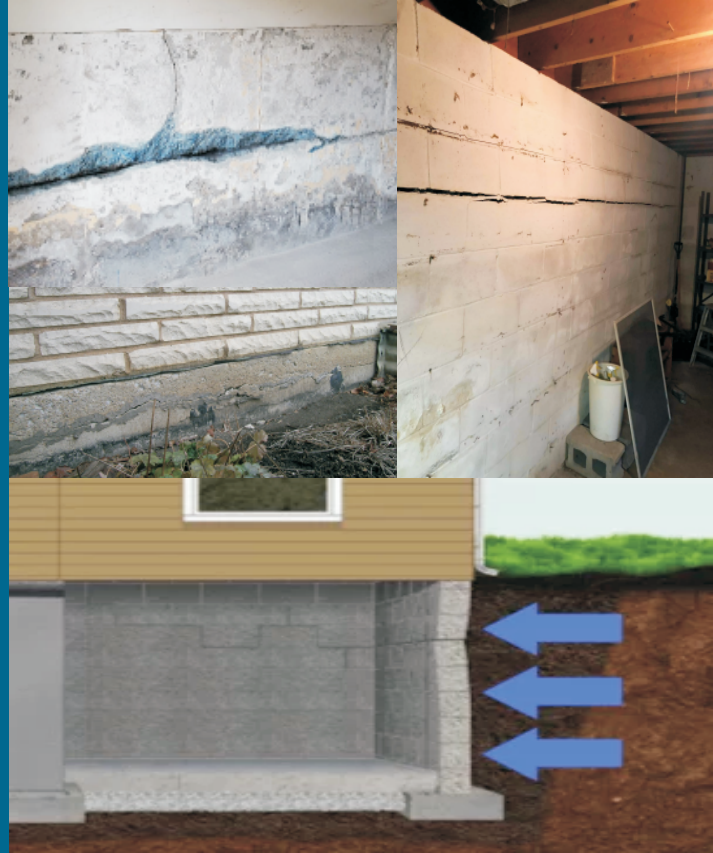
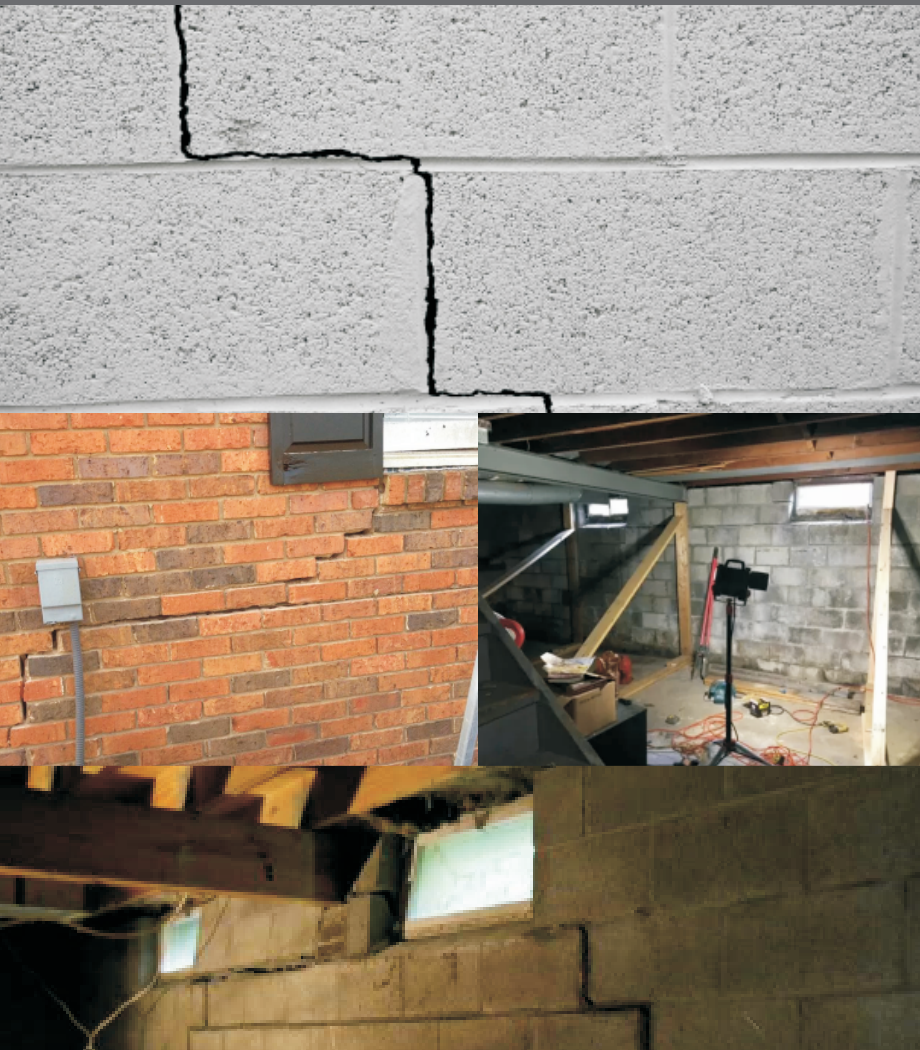
Stair Step Cracks.

Block foundations are prone to “stair-step” cracks. These types of cracks happen along mortar joints and can pose a serious threat to the integrity of your basement foundation.

There are two common causes of stair-step cracks:

1. Foundation settlement or localized sinking in one area
2. Moisture related problems outside your foundation

TOK Tip: If you can put more than a quarter in the foundation crack call a trusted source for inspection and repair options. While some mortar-based hairline cracks are common, anything larger may pose a significant threat.

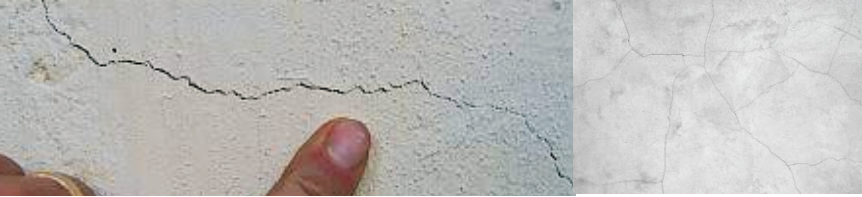
Hairline Cracks

Hairline cracks are commonly found in new construction foundations across the country.

They usually appear within the first year and are caused by the settling and drying of the new foundation.

The good news is these cracks are usually cosmetic in nature and can be repaired.

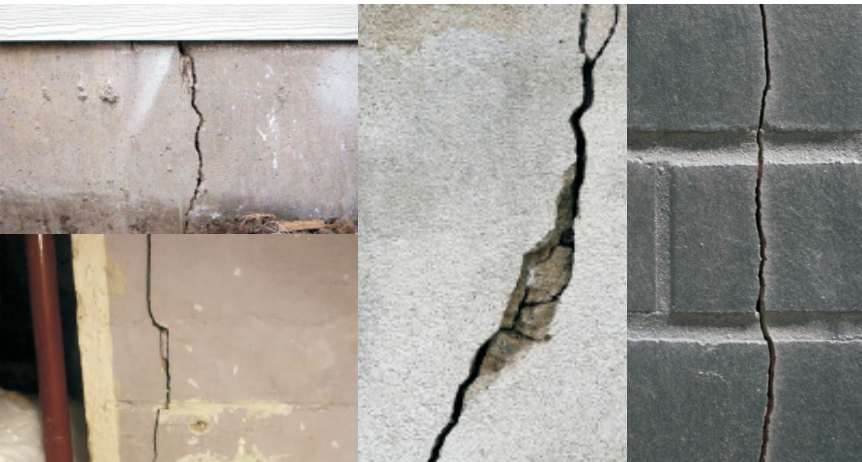
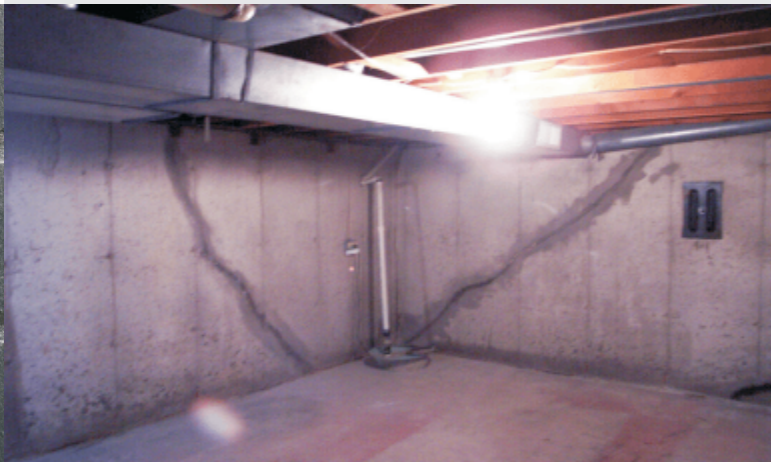
Vertical Cracks

Vertical cracks in a foundation wall are less serious than horizontal cracks and usually do not pose a structural threat.

They are commonly found in poured foundations running straight up and down your wall. Vertical cracks are one of the most common crack types found in basements.

They are due to the foundation settling over time or the natural concrete curing process

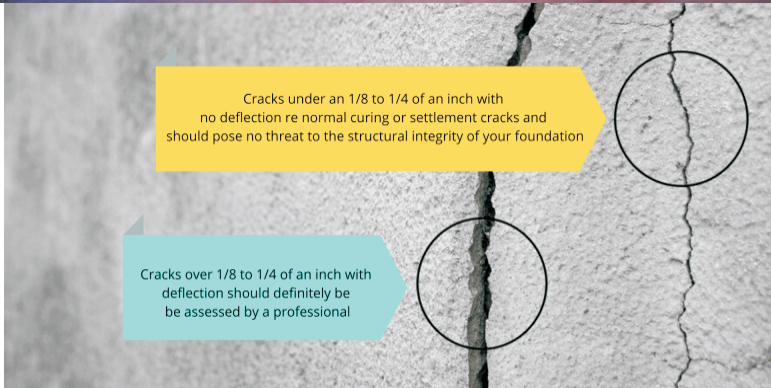
Shrinkage Cracks

Like hairline cracks, shrinkage foundation cracks happen when poured concrete foundations begin to dry out and lose moisture.

New builds are prone to shrinkage cracks within the first year. These cracks are often vertical and pose little structural threat to your foundation.

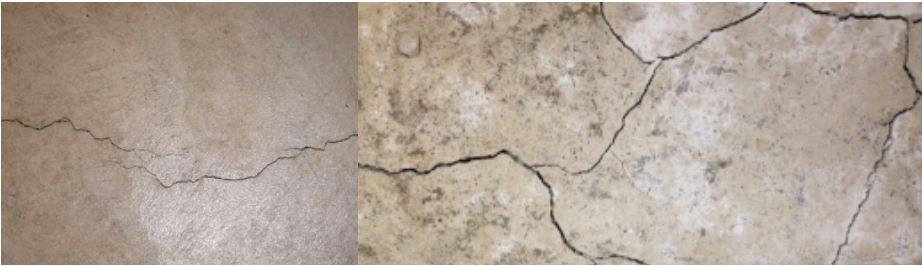
Structural Foundation Cracks

These types of cracks are extremely serious as they pose a risk to the integrity of any structure. A sure sign of a structural deficiency are horizontal cracks, and cracks wider than a 1/4 inch.

Structural foundation cracks are normally the result of movement, whether it's caused by temperature changes, soil pressure or soil shrinkage.

Because the crack was initially caused by stress resulting from movement which may continue, temporary solutions (epoxy) alone are not generally enough to ensure the repair of the crack.

Further reinforcement, in the form of carbon fiber countersunk staples or straps, are often necessary to ensure that the crack does not expand.

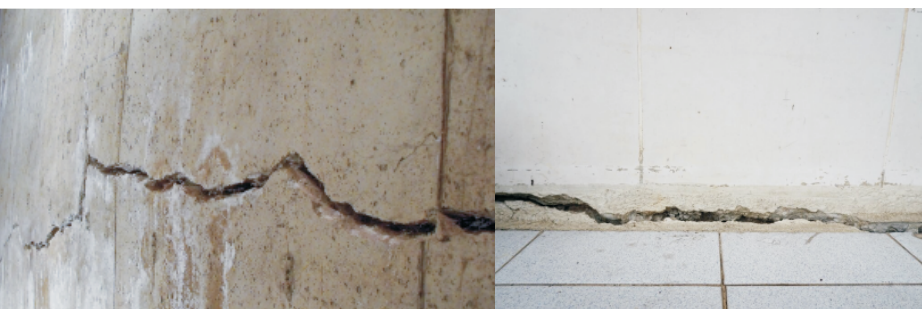
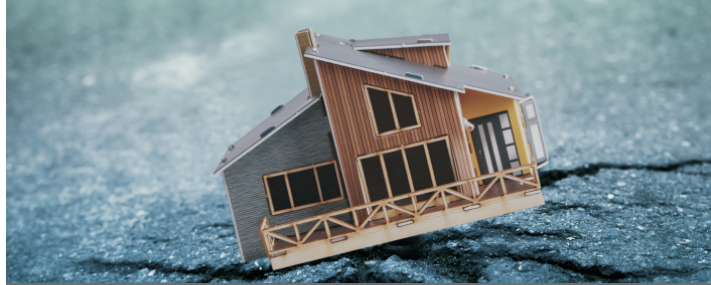
Foundation Slab Cracks

Poured concrete slabs are prone to developing cracks over time. The challenge is understanding why the foundation slab crack has occurred.

Concrete Curing: The most common reason is the natural drying, settling, and curing of the concrete slab. This poses no structural threat and is mostly cosmetic.

Slab Settlement: If a new foundation slab develops cracks due to settlement issues; this is significant.

This may be caused by poor, initial workmanship where the supporting ground was not sufficiently compacted or by poor soil conditions. Call a professional for an inspection right away.

Frost Heave: Crawl space slab foundations that sit at or above grade are at risk of frost heave. During freezing, moisture underneath the slab can freeze, expand, and cause the concrete to buckle.

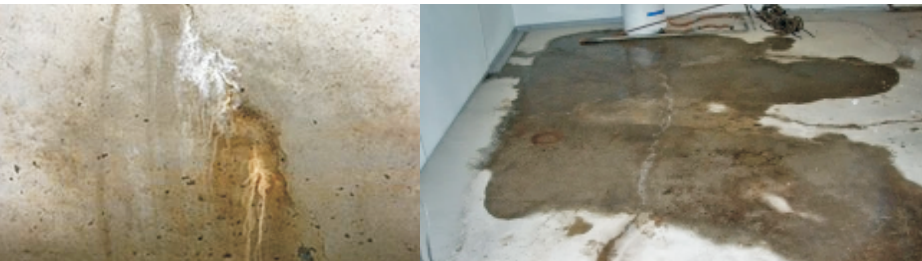
Wet Non-Structural Foundation Cracks

This type of crack is the result of foundation shrinkage due to water evaporating from the concrete. It would typically happen within the first month after a foundation is poured.

The wetter the concrete mix was initially, the more shrinkage will happen, increasing the likelihood of cracks forming. The natural setting of the concrete can also lead to cracks.
