## Hobomock Pond Hydrilla (*Hydrilla verticillata*) Management Program

### Project Completion Report for 2010 Hydrilla Management Performed at Hobomock Pond – Pembroke, MA

December 2010

**AQUATIC CONTROL TECHNOLOGY, INC.**  
POND AND LAKE MANAGEMENT SPECIALISTS

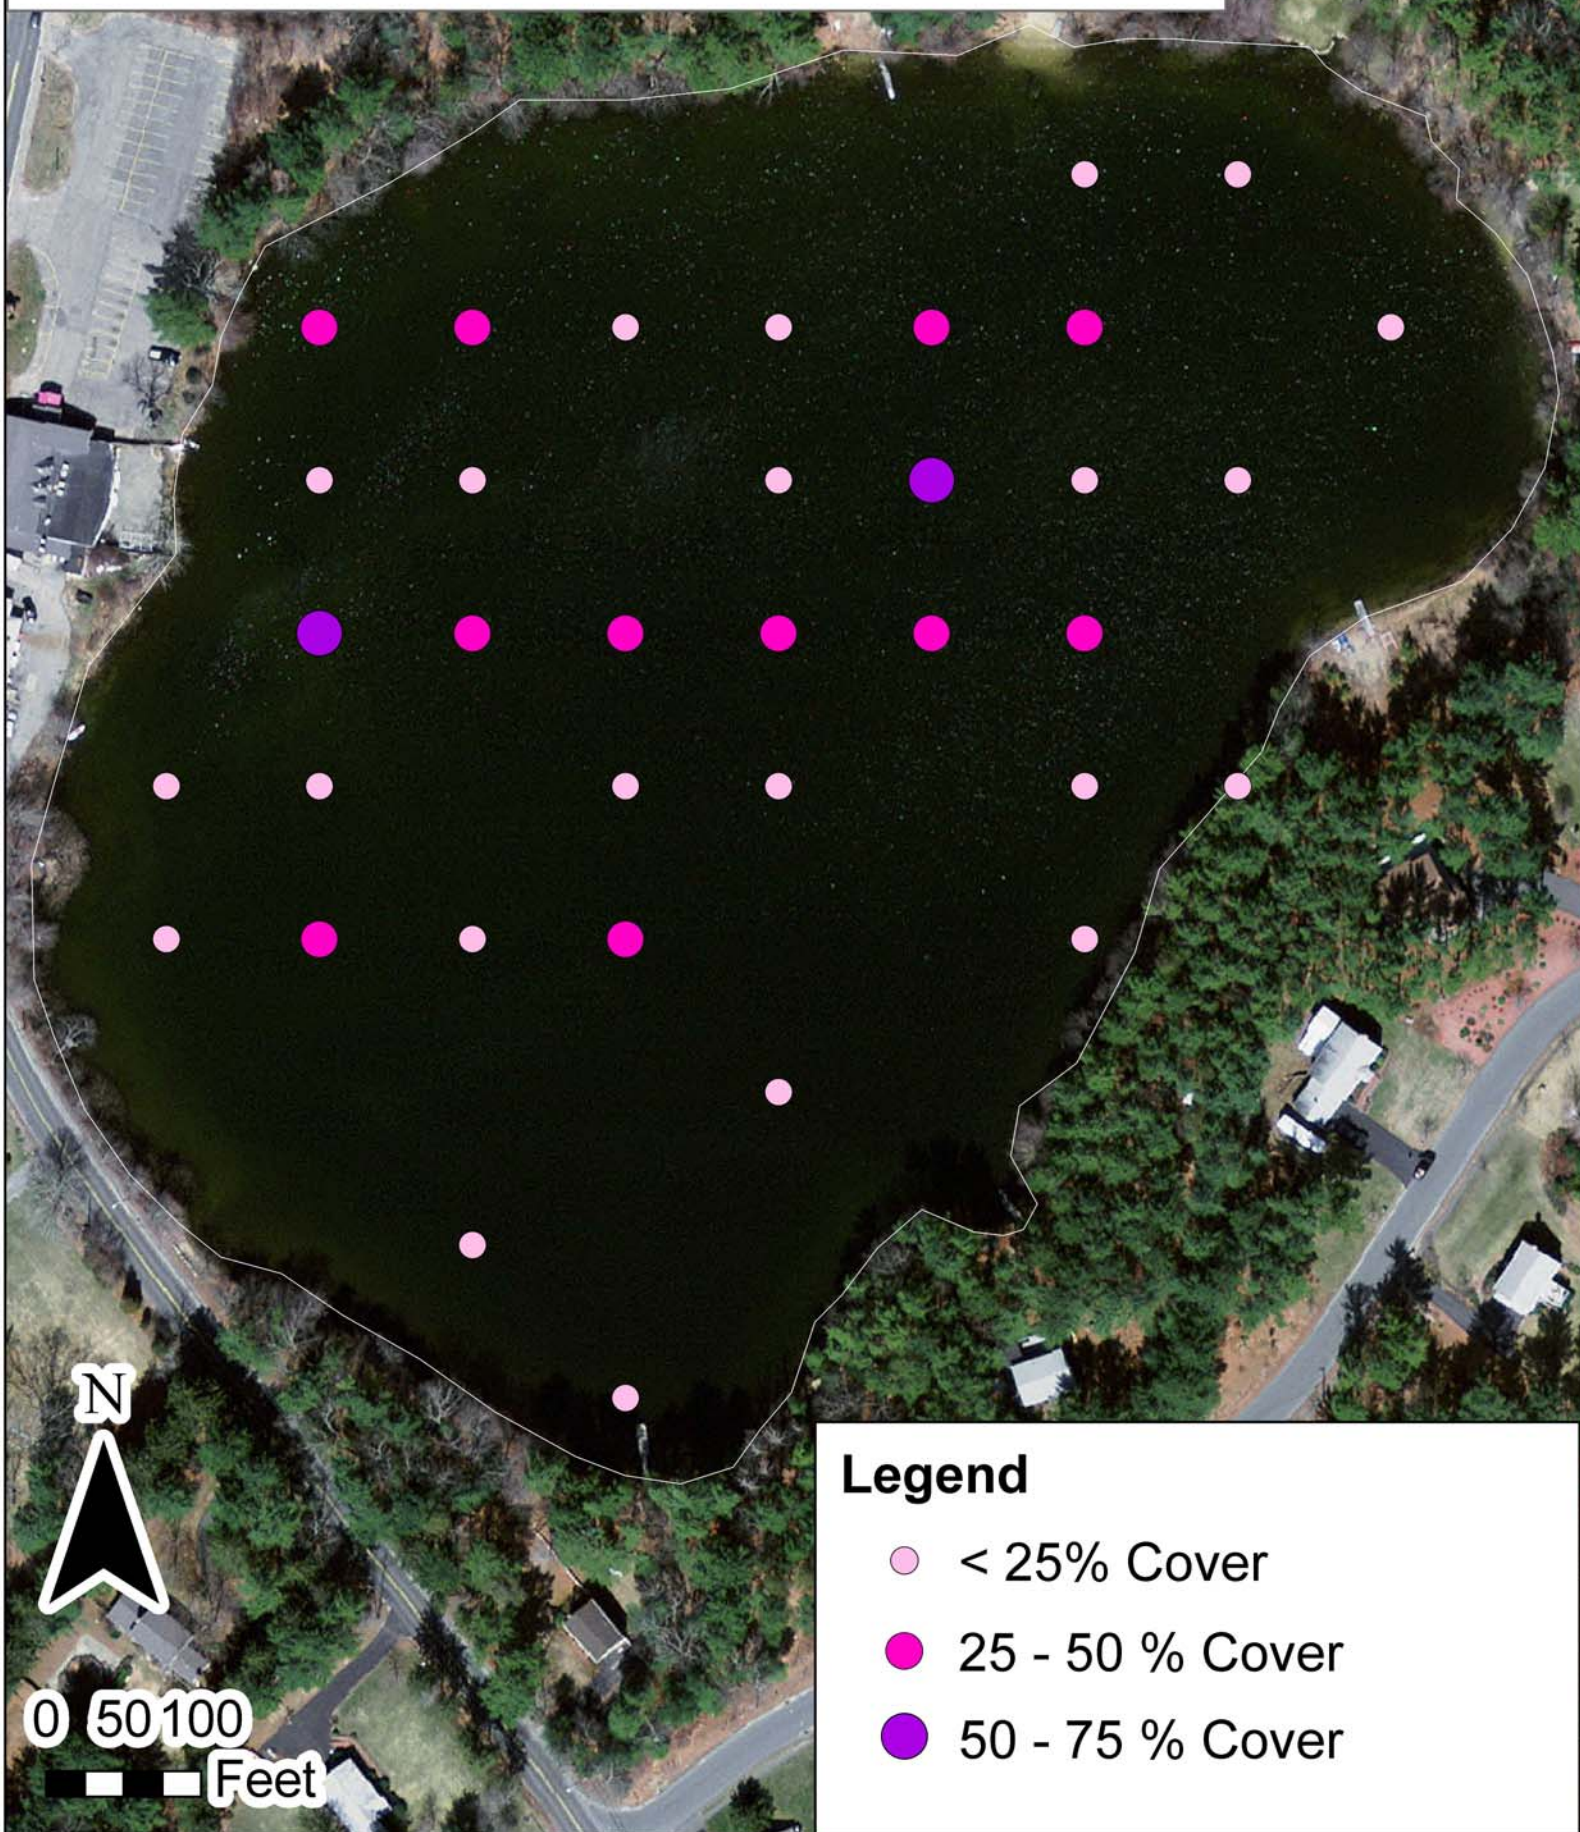
## Vegetation Density Post-Treatment
