INSPECTION REPORT  
586 Mountain Fancy Drive  
Big Lake NC 28715

INSPECTED BY  
Russell Buchanan  
HomeGauge  
Software

INSPECTION DATE  
📅 12/15/2020  
🕒 1:00 PM

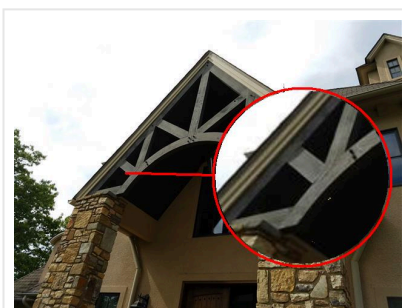
2.0 Item 1 (Picture)

(2) The gable wood work on at least two locations shows signs of some damage from carpenter bees etc. and need repair and prep and paint.

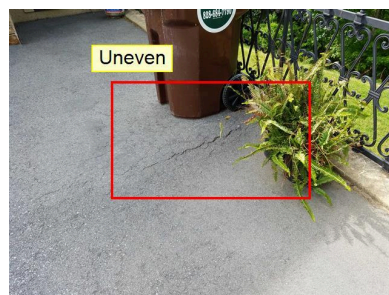
(1) Driveway does not drain water and an attempt to correct with trench drains is not par with the expectations of this home and does not appear to work. Uneven or sag in areas. A proper repair is to remove pavement, slope correctly and apply new pavement.

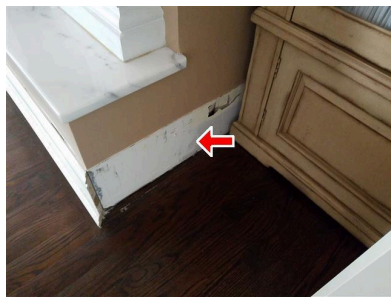
8.1 Item 1 (Picture)

Baseboard and trim missing from both sides of fireplace in Master bedroom.

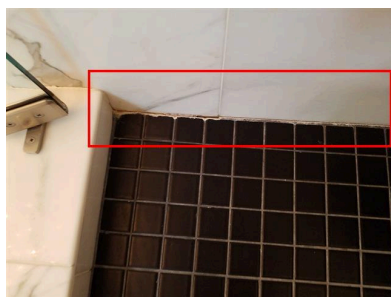
8.2 Item 1 (Picture)

Tile floor in Master needs grout where missing and reseal.

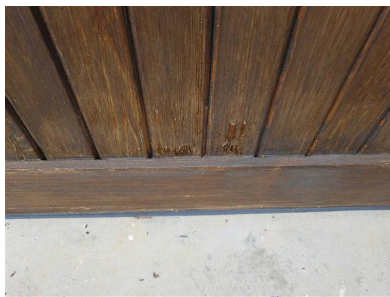
9.3 Item 1 (Picture)

All three garage doors are no longer protected by the stain or sealant and are starting to peel, fade and eventually deteriorate.
