St Mary's in the Marketplace

PHASE 6 (Week 6)

Week 6 (on site) – the team having been away for Christmas and New Year but back now to continue the work(s).

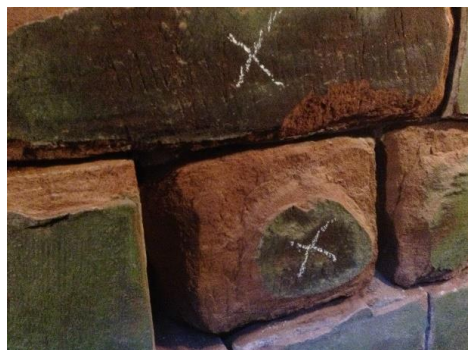
St. Mary's is built of sandstone which weathers and wears away quite dramatically in places. This week Architect made an inspection of the work so far. He made decisions, based on his own experience and listening to the stonemason's advice, about which stones should be

replaced. They were then marked with a chalk cross. Fortunately not too many stones need to be replaced, which will hopefully maintain the overall look of great age and beauty of the Vestries currently being worked on.

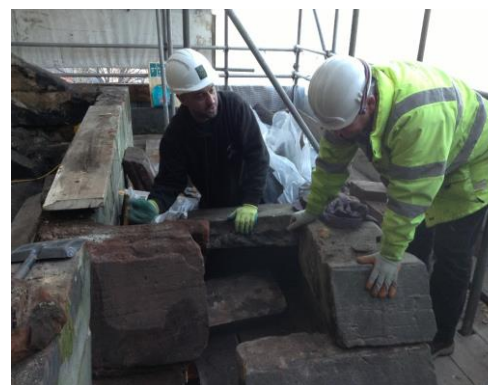
Marcus is now in charge of the site and he is seen here advising the Architect, John Prichard , who is asking how the old chapel roof had been made, and how the stones were set, and most important of all, how were they going to stop water getting into the

building ever again!
And so the work goes on!

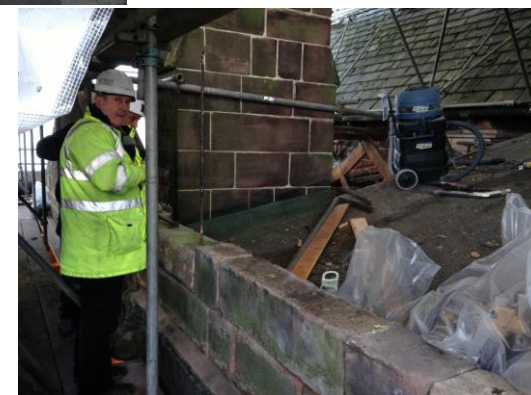
The Victorian boiler house chimney is a huge structure imposed on this venerable old building in the early 1880s, when the Choir Vestry was created. The choir must have been very pleased with their new accommodation, right above the boiler house. The contractors have a machine on site for hovering up all the dust, which has accumulated over the centuries. It will all be clean and tidy again one day!

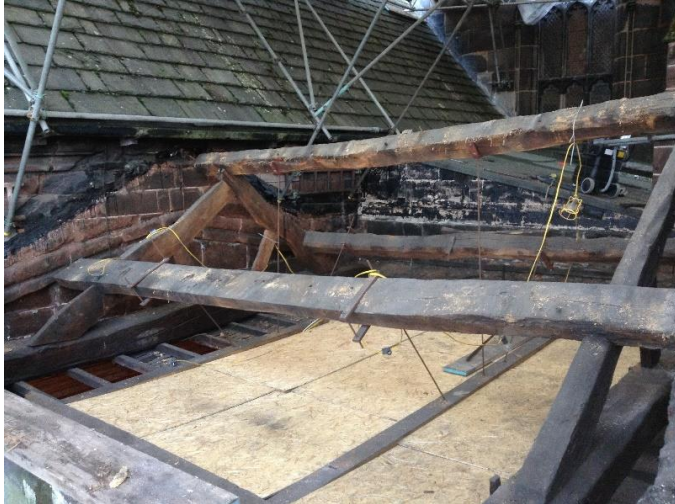
The roof over the Rector's Vestry was held up by the timbers seen here, which have been ring dated as having been cut down in 1623, implying that the building was re-roofed in

that century. However there are stone channels and holes for a Main beam and roof timbers in the north wall, clearly indicating the pitch of the original roof. It is hoped that those with the skill to do so will one day create an artist's impression of what this building may have looked like centuries ago, and how it was used.

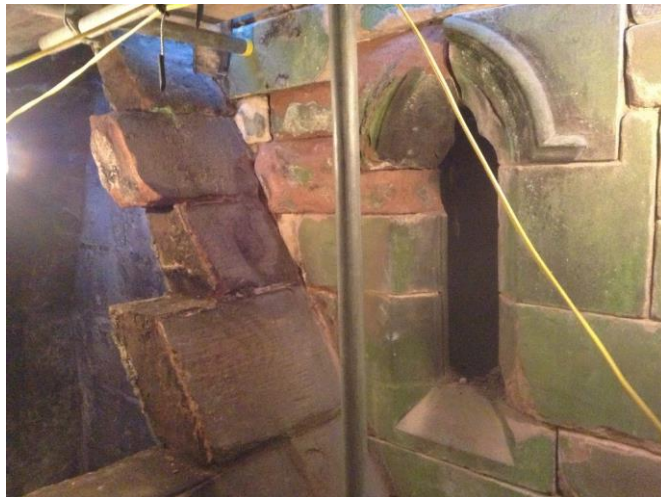
The little medieval looking window high up on the east wall of the Rector's Vestry is all that it seems and more. Inside it is deeply splayed and had a

domed, gently curved roof. It is bricked up on the inside, and there is a groove around the window, suggesting that it once had glass in it. We think it lit an upper room.

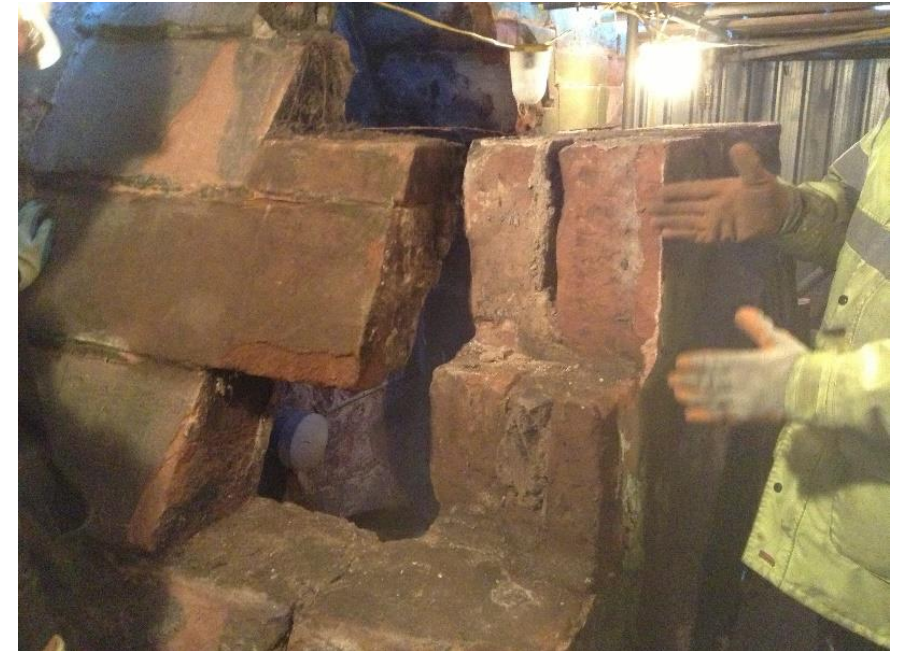
The little chapel attached to the Rector's Vestry has a stone roof, seen in the photo, which has now been dismantled, and which be rebuilt in a way that will allow water to escape more satisfactorily than before. It is interesting to see it at close quarters, and to admire the craftsmanship of bygone years. Having said that, this part of the building has been rebuilt a number of times, most recently in the Victorian era.
