Public Scoping Meeting for Hunter's Run Conservancy District Structures 4 and 9 Fairfield County, Ohio

DECEMBER 2, 2021

Statistics for Structure No. 4

Statistics for Structure No. 9

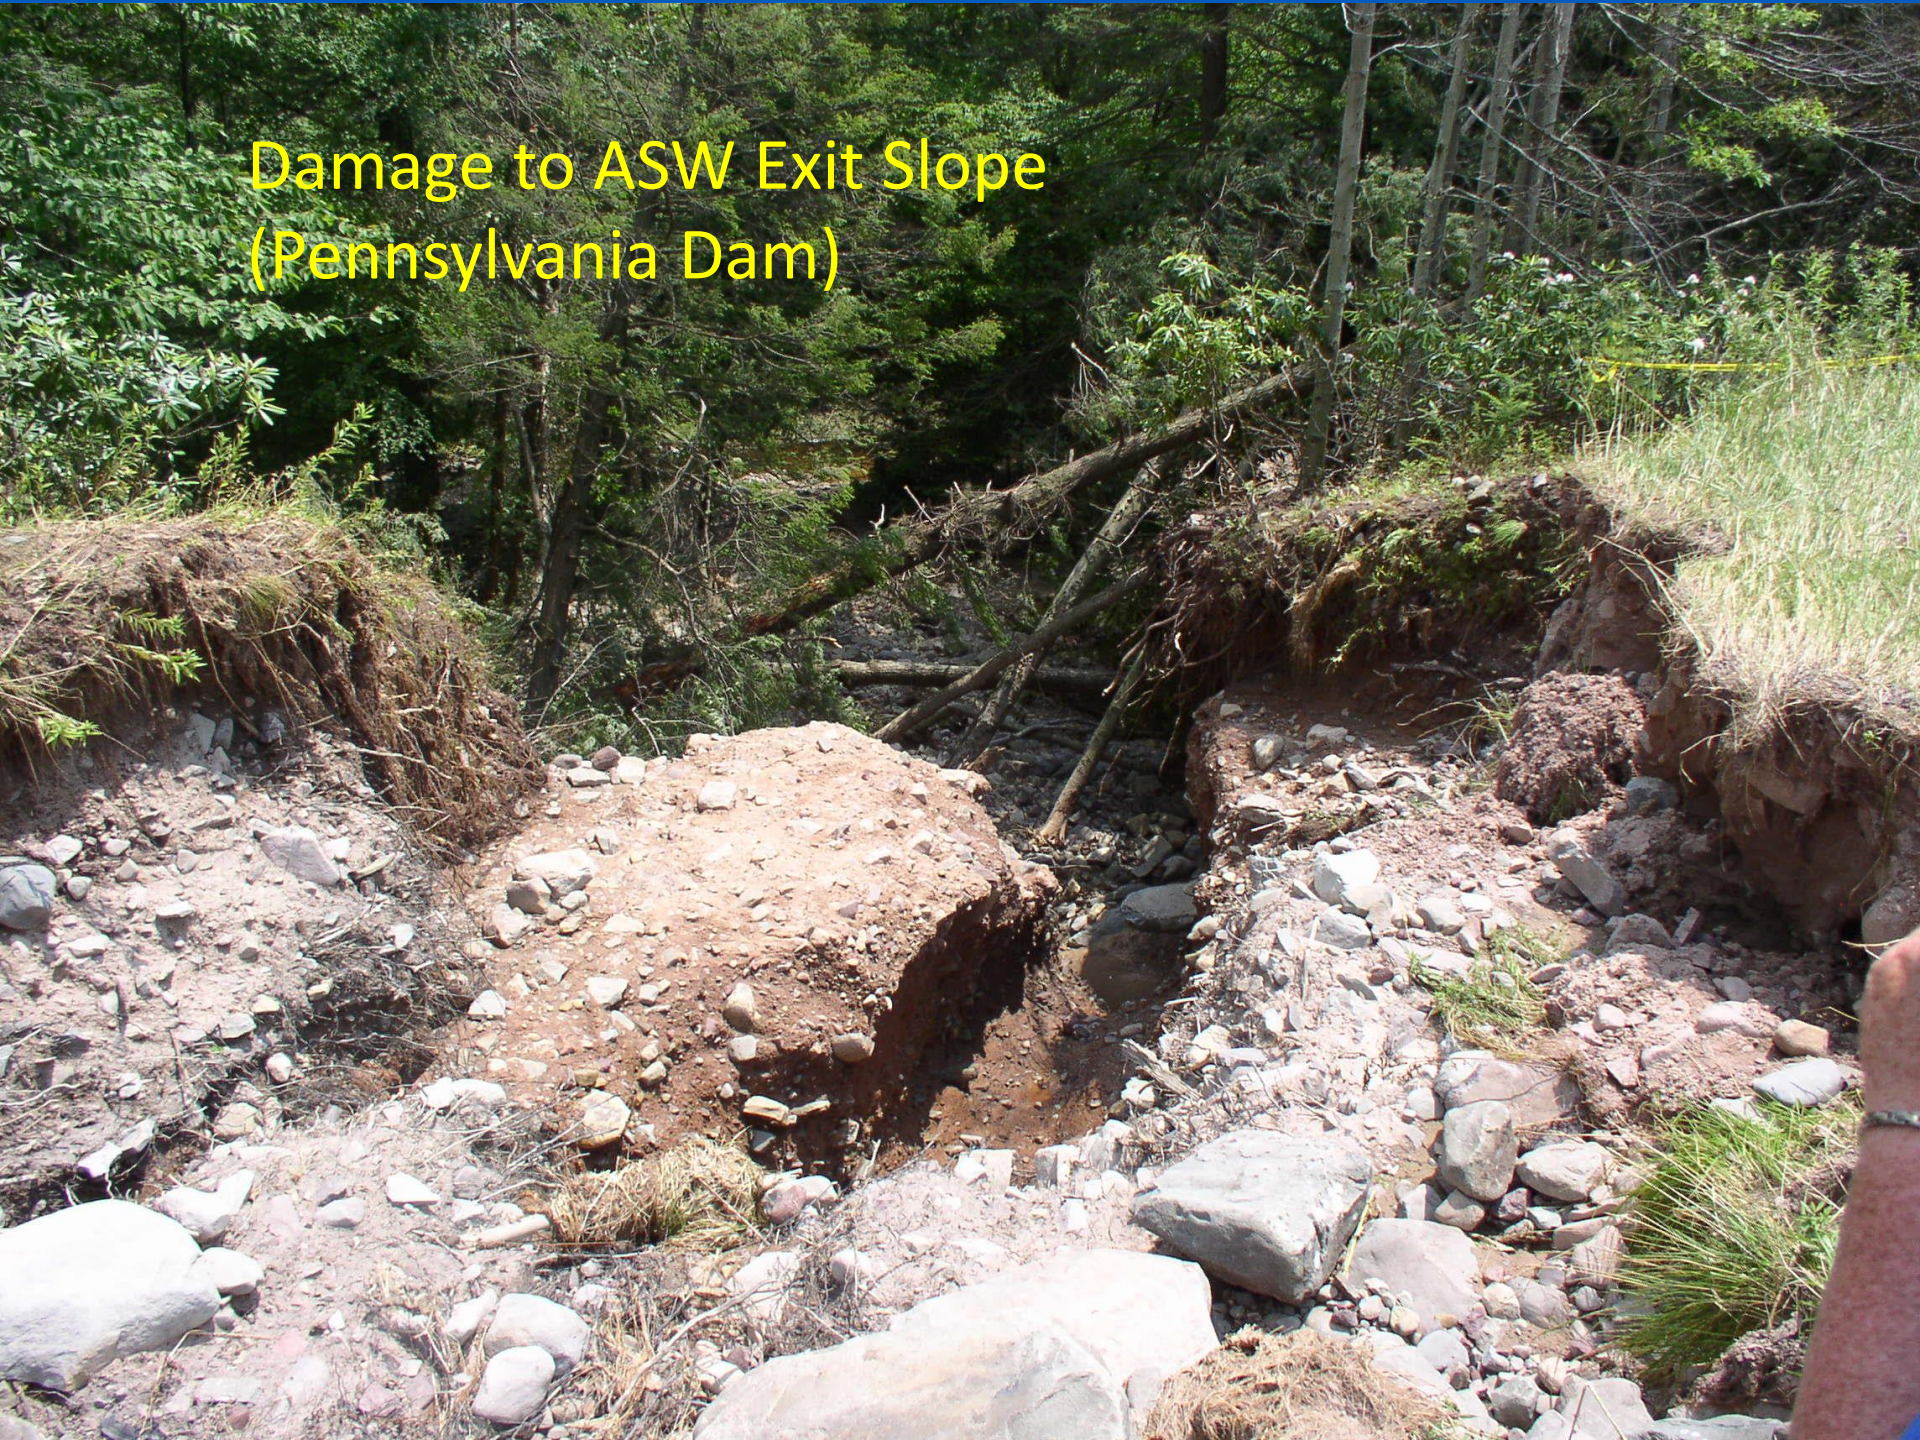
Damage to ASW Exit Slope (Pennsylvania Dam)

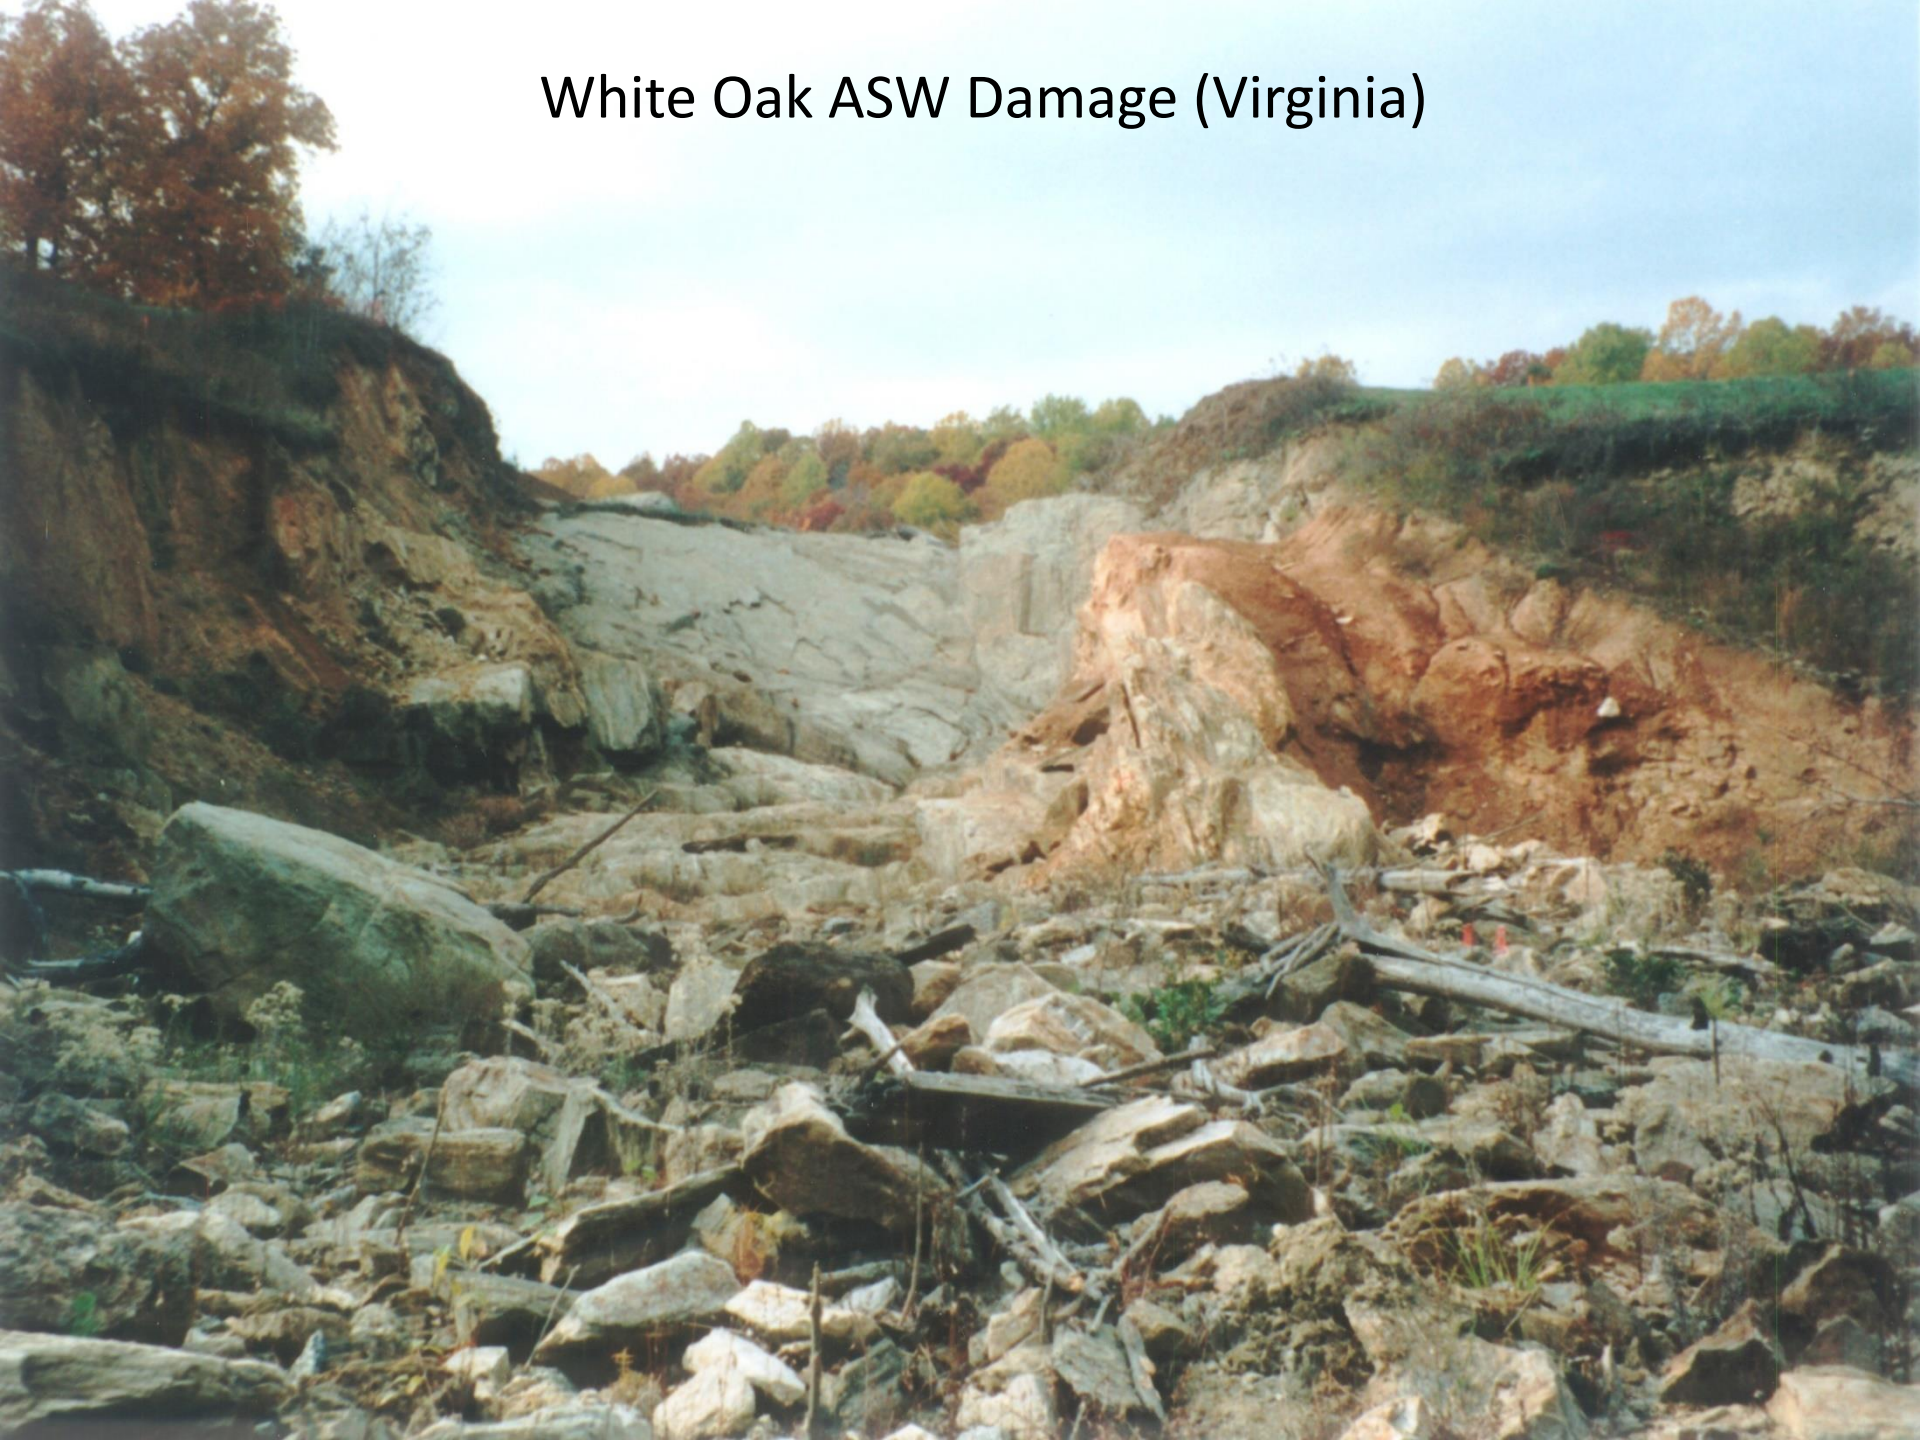
White Oak ASW Damage (Virginia)

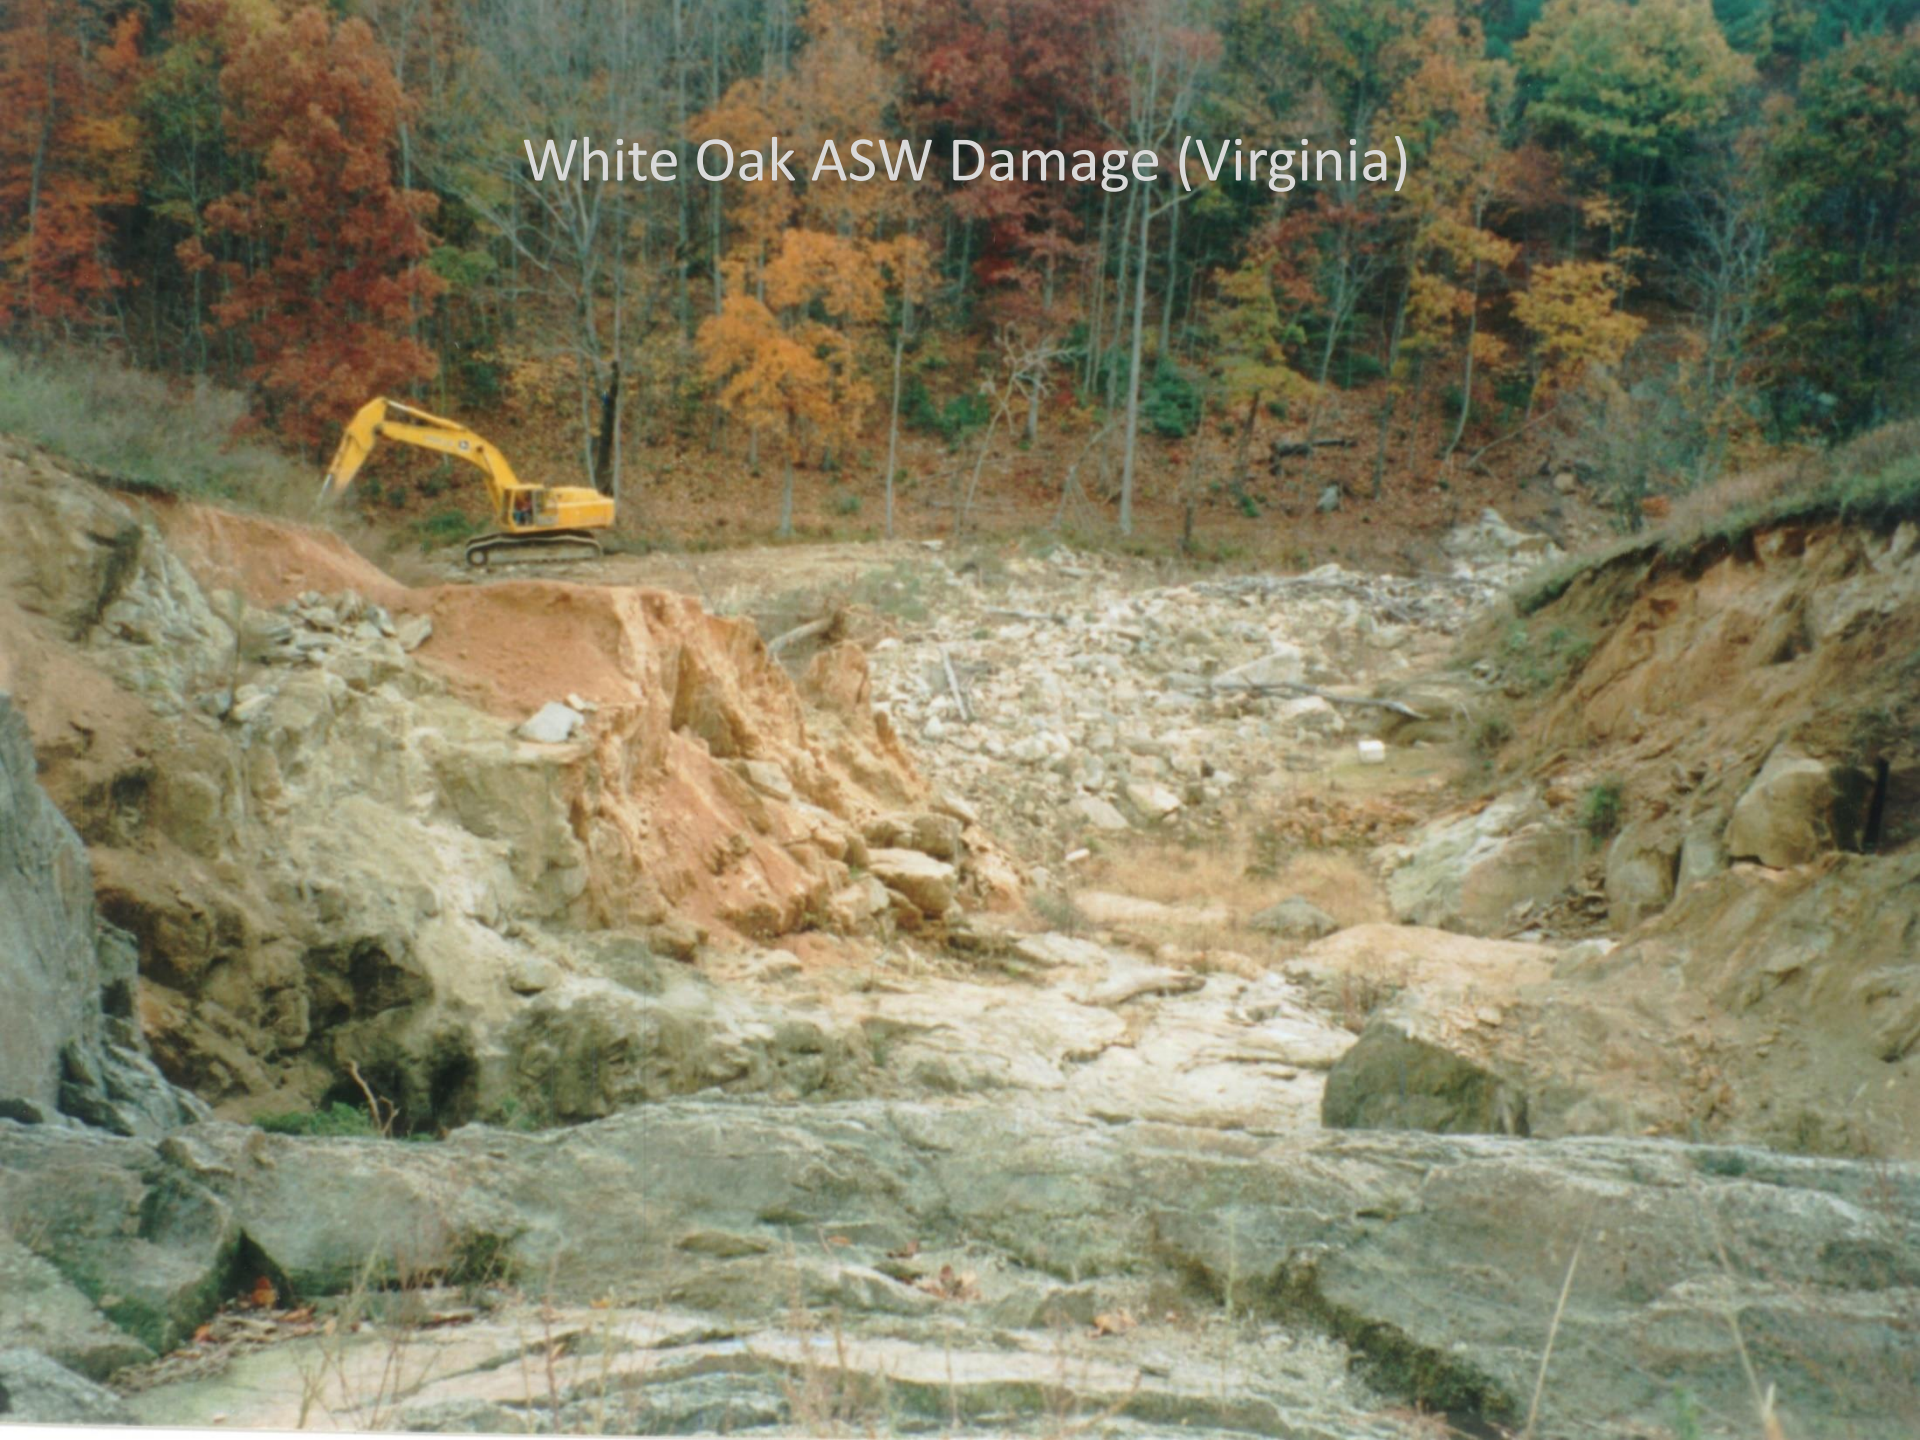
White Oak ASW Damage (Virginia)

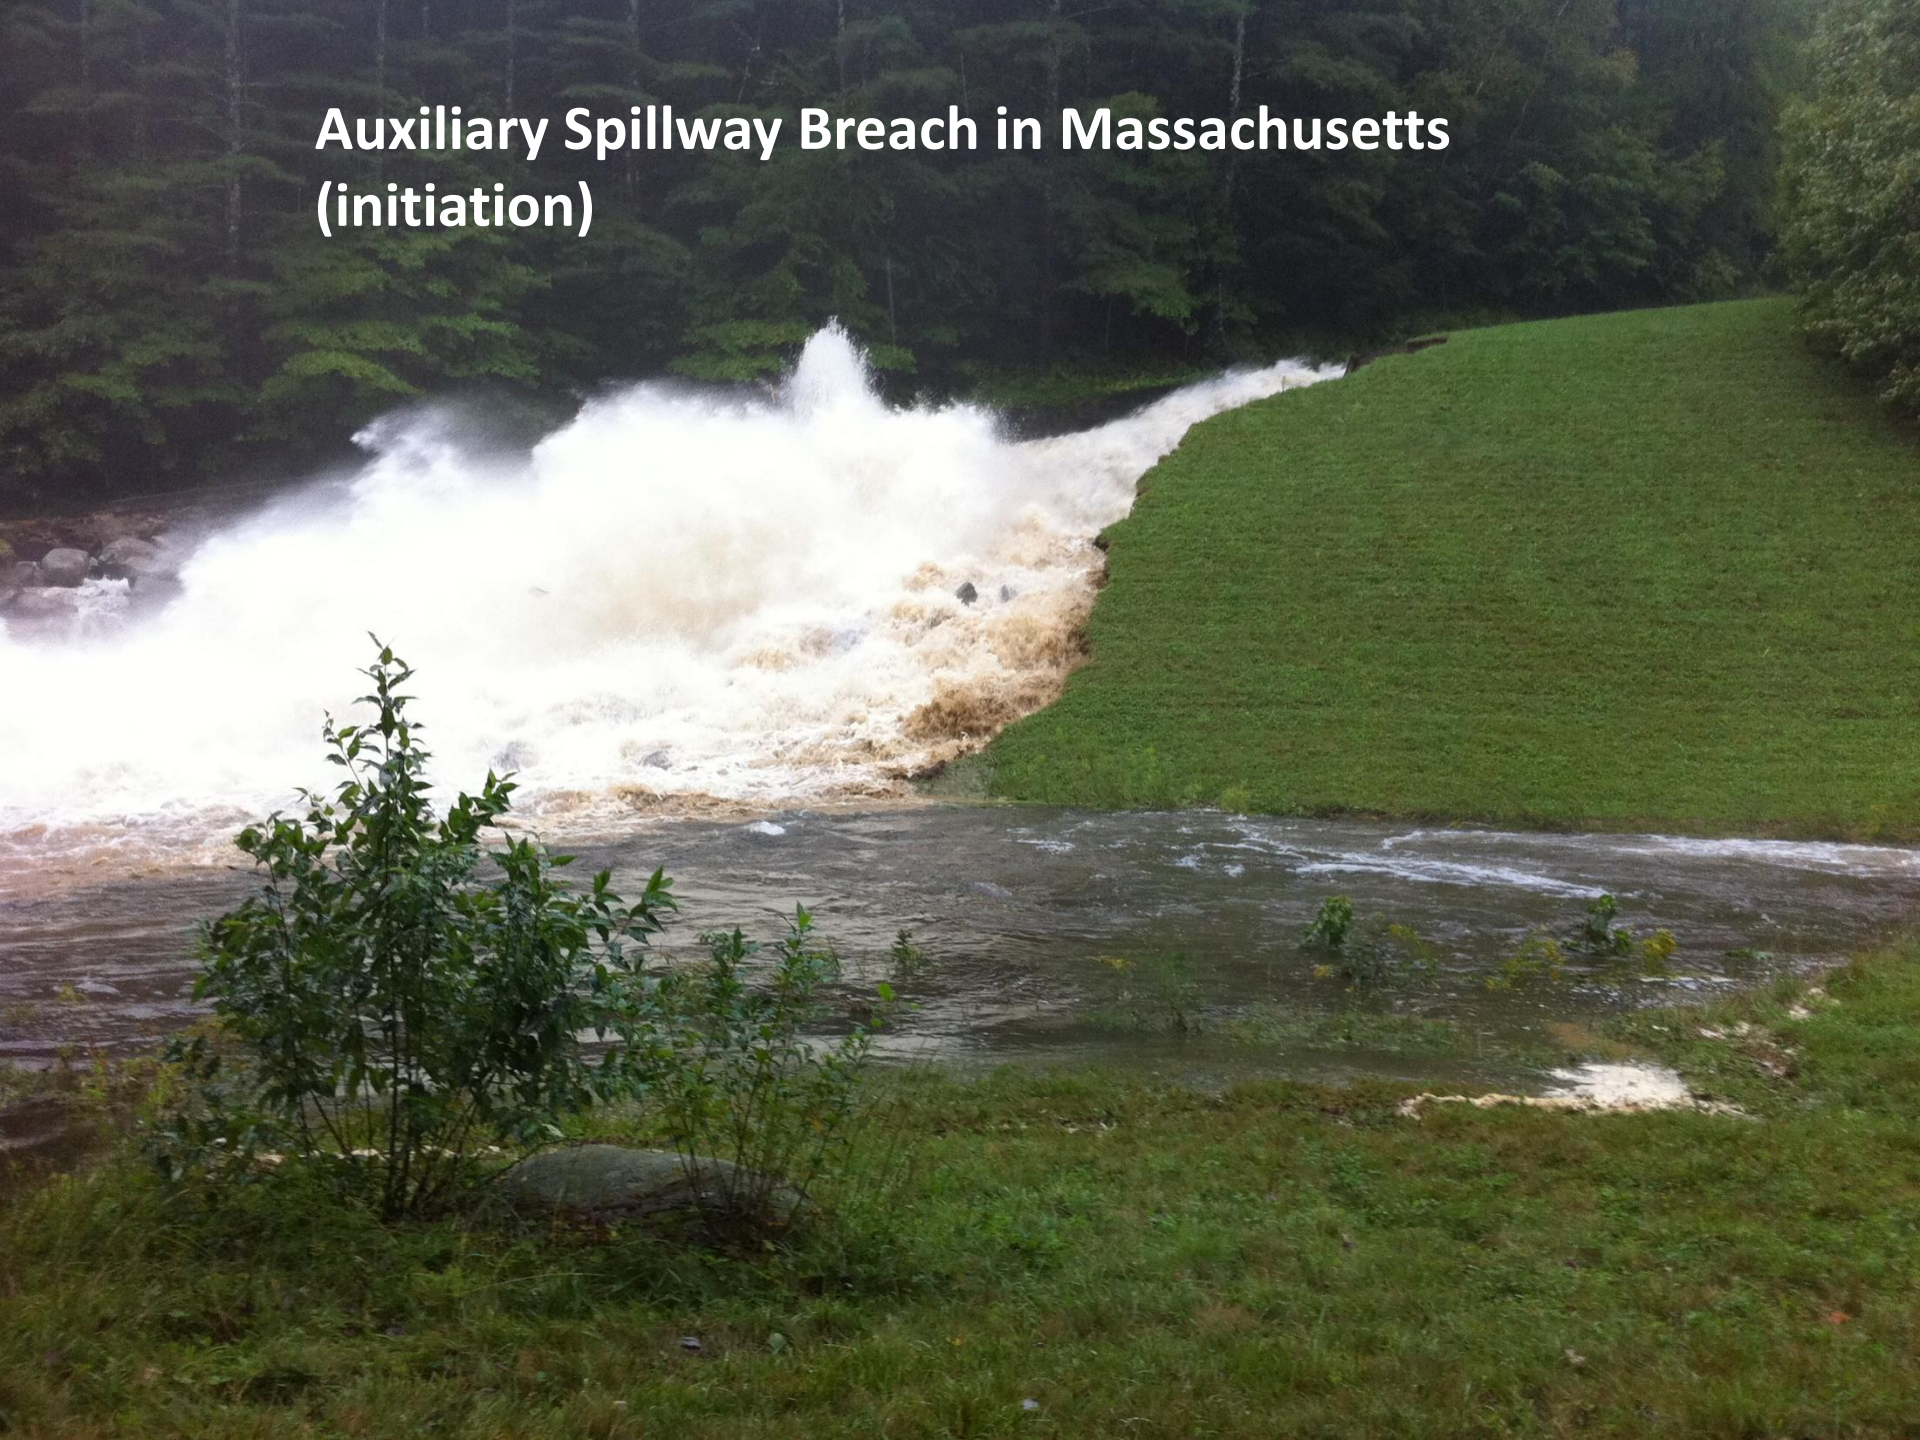
Auxiliary Spillway Breach in Massachusetts (initiation)

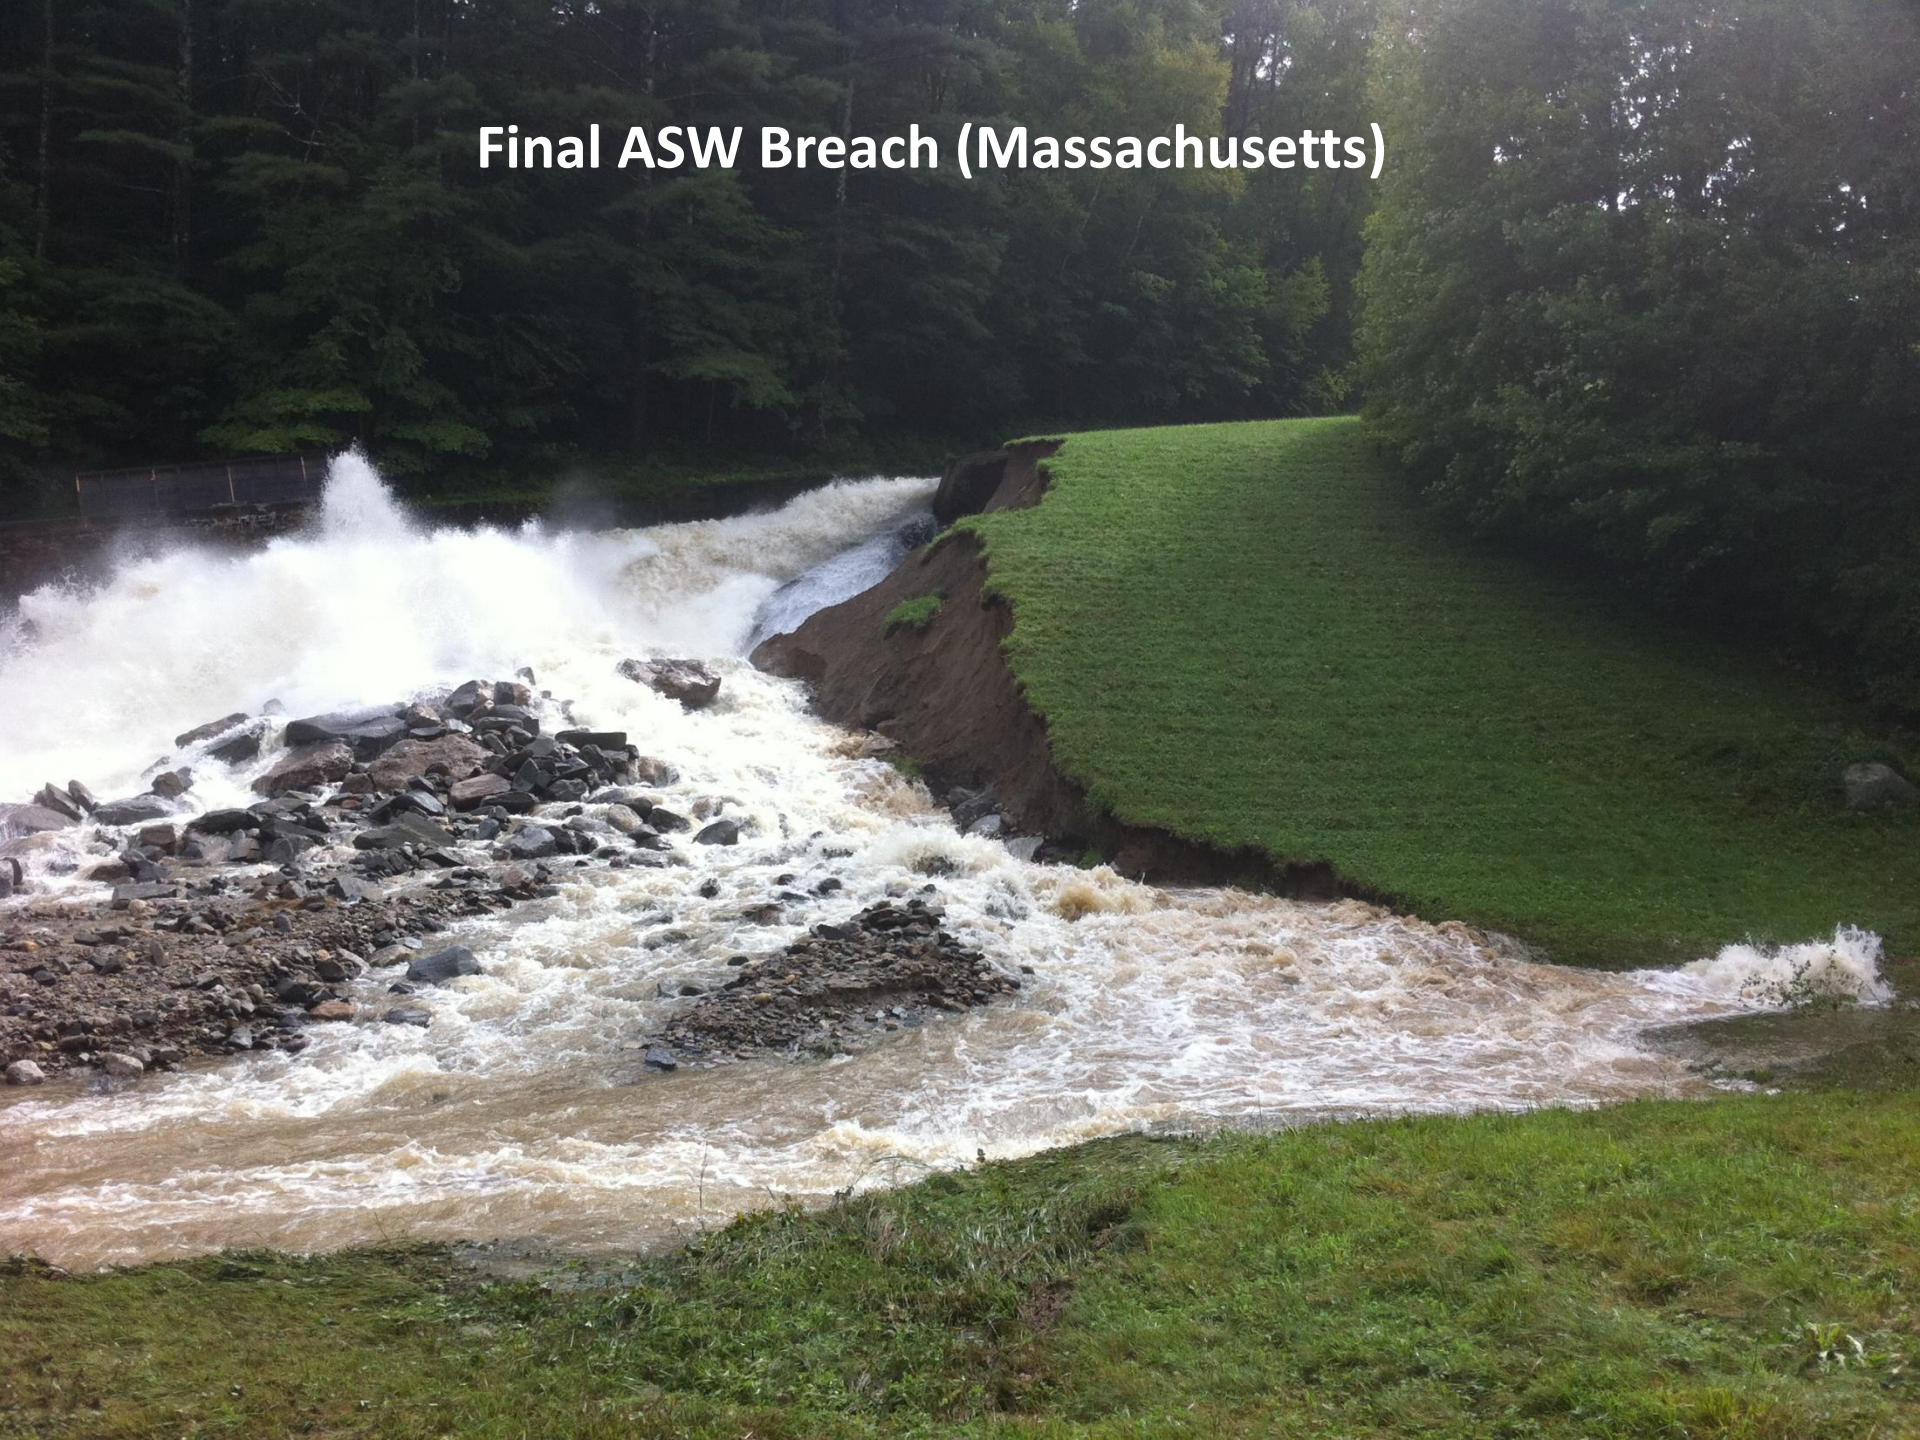
Final ASW Breach (Massachusetts)

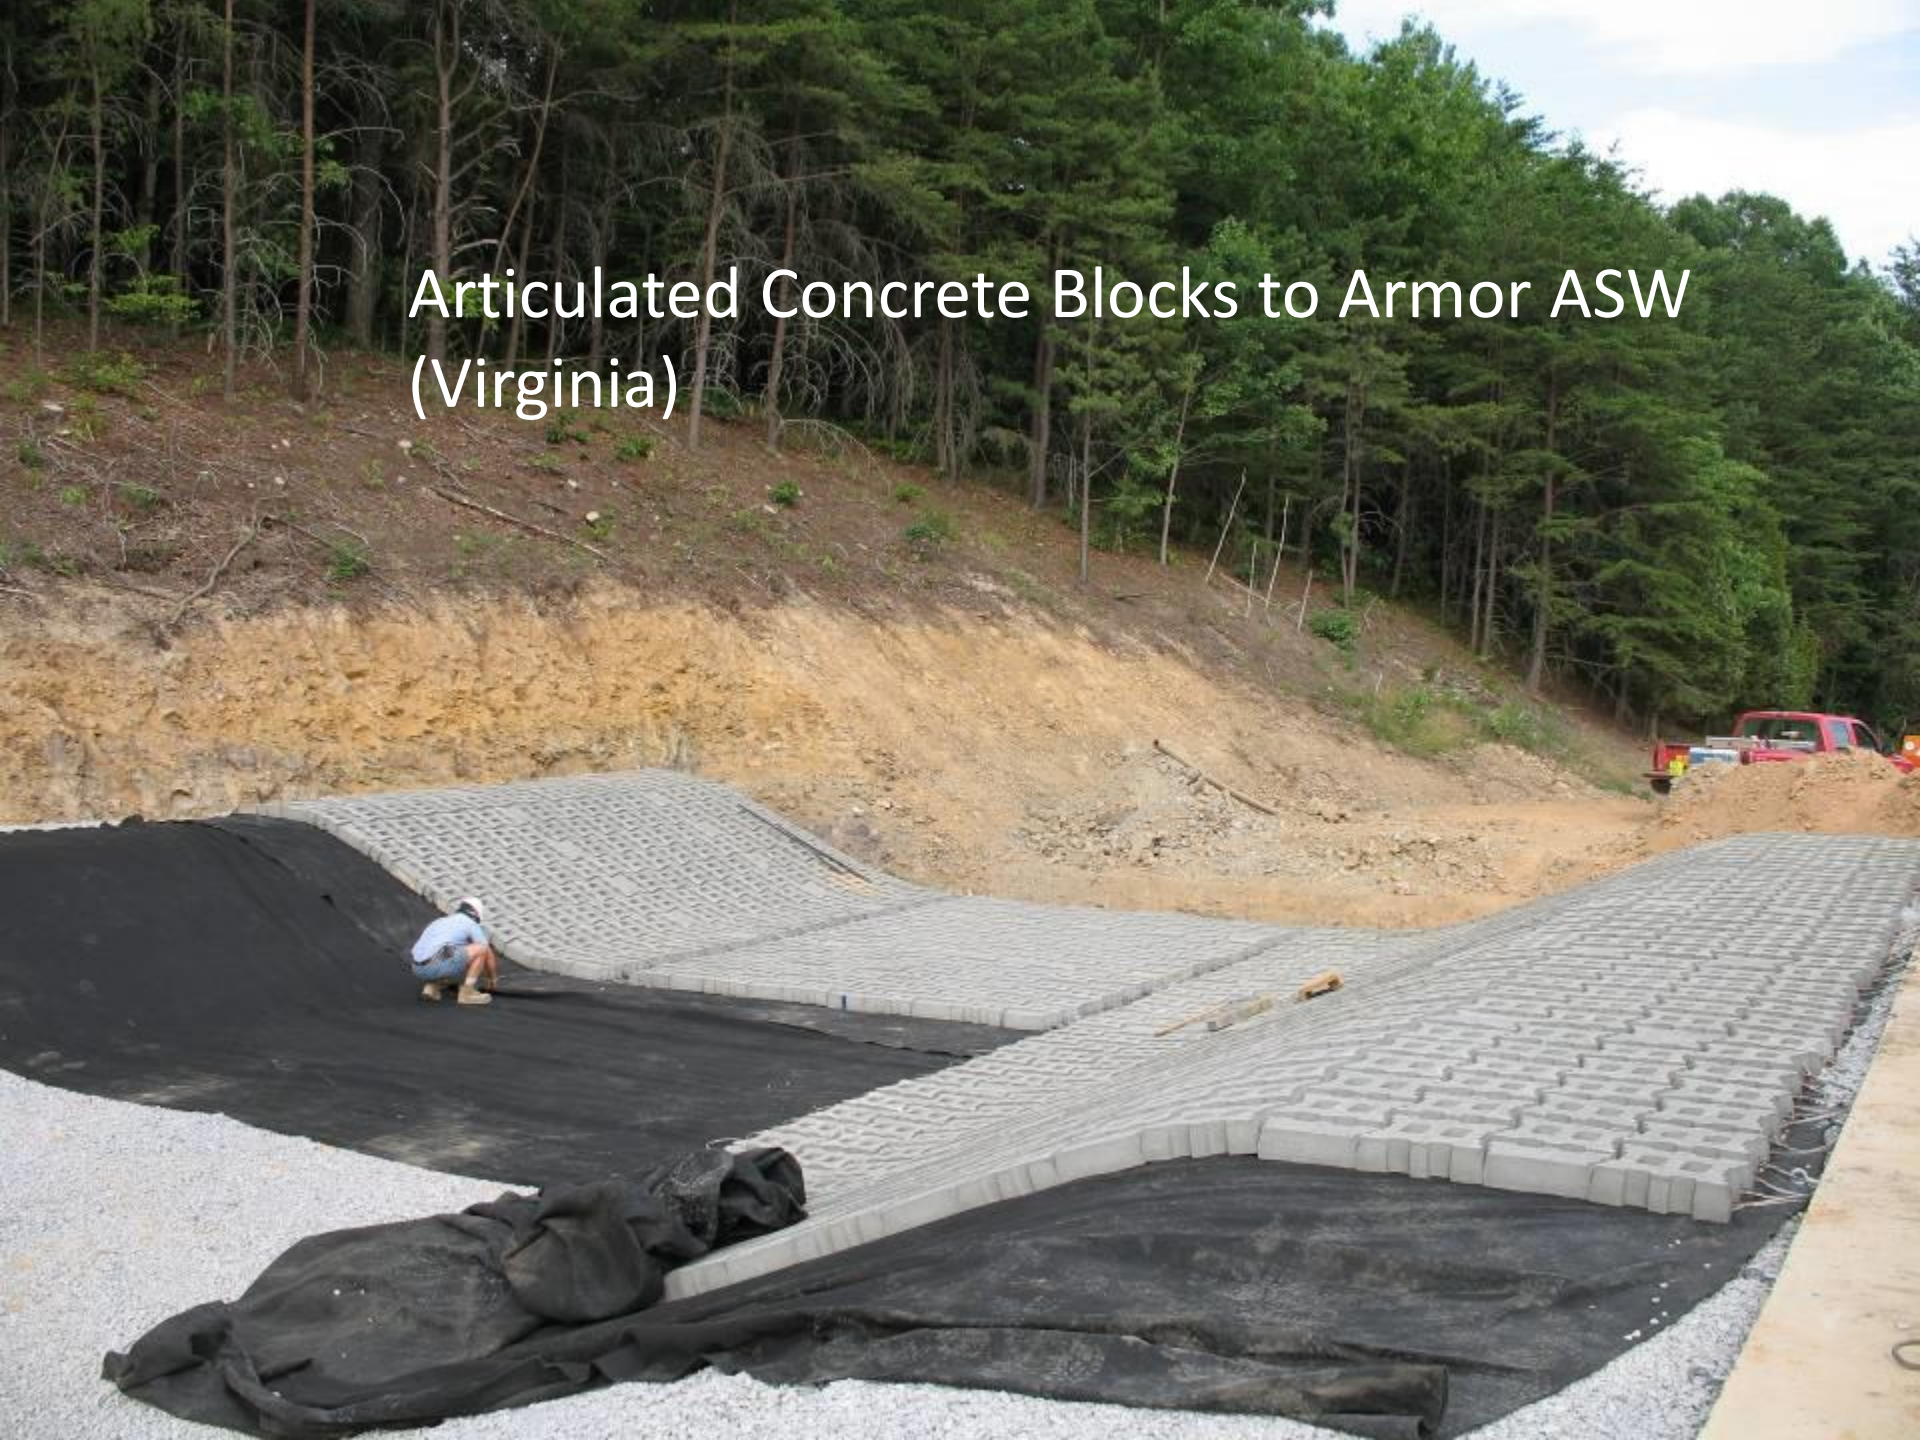
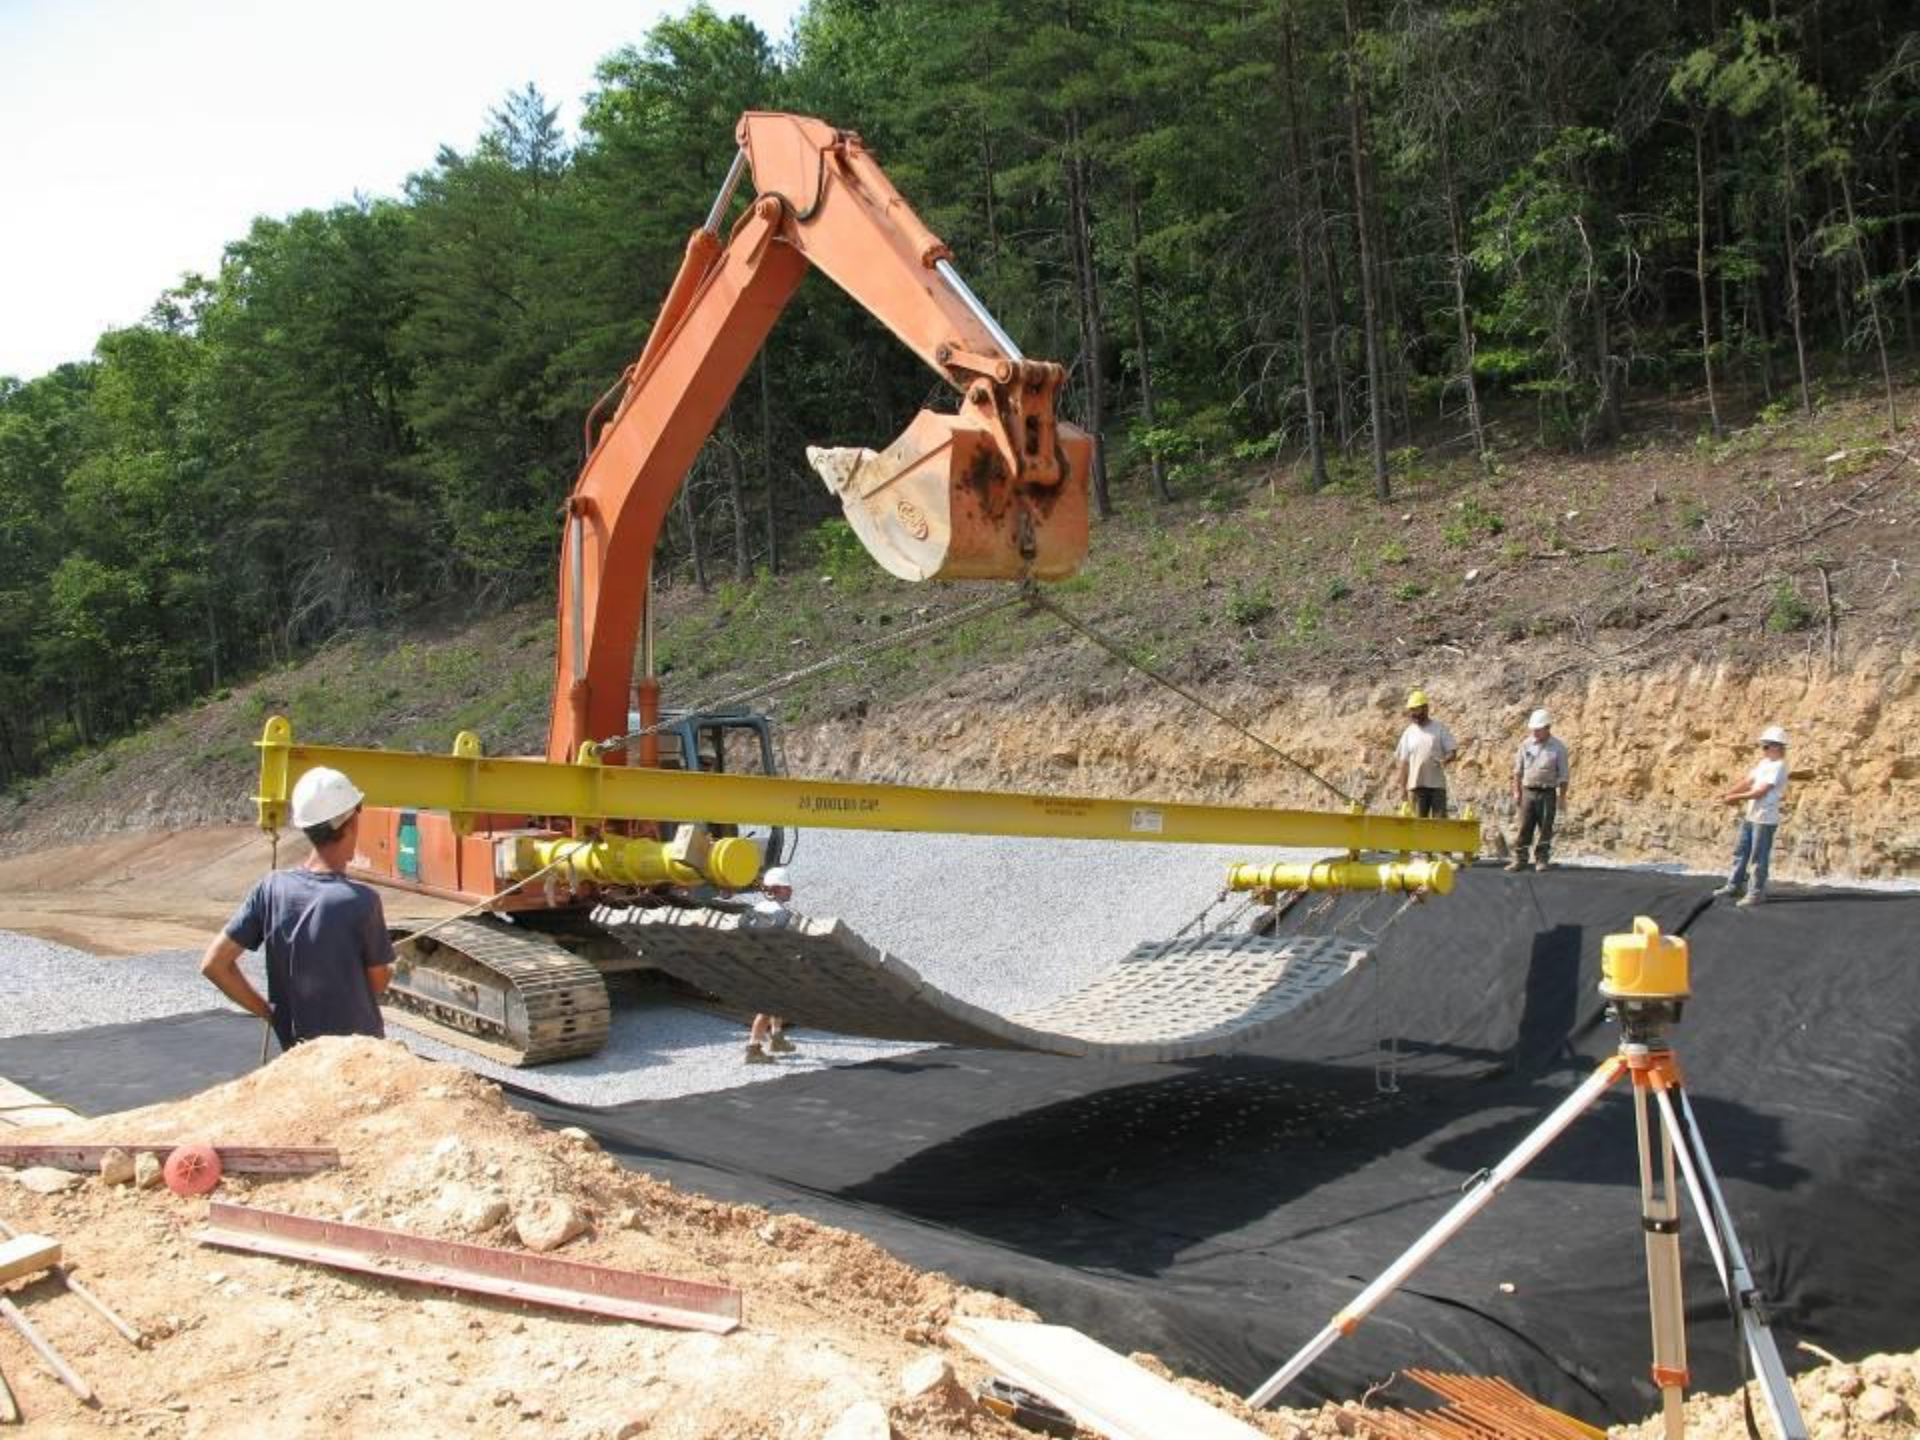
Articulated Concrete Blocks to Armor ASW (Virginia)

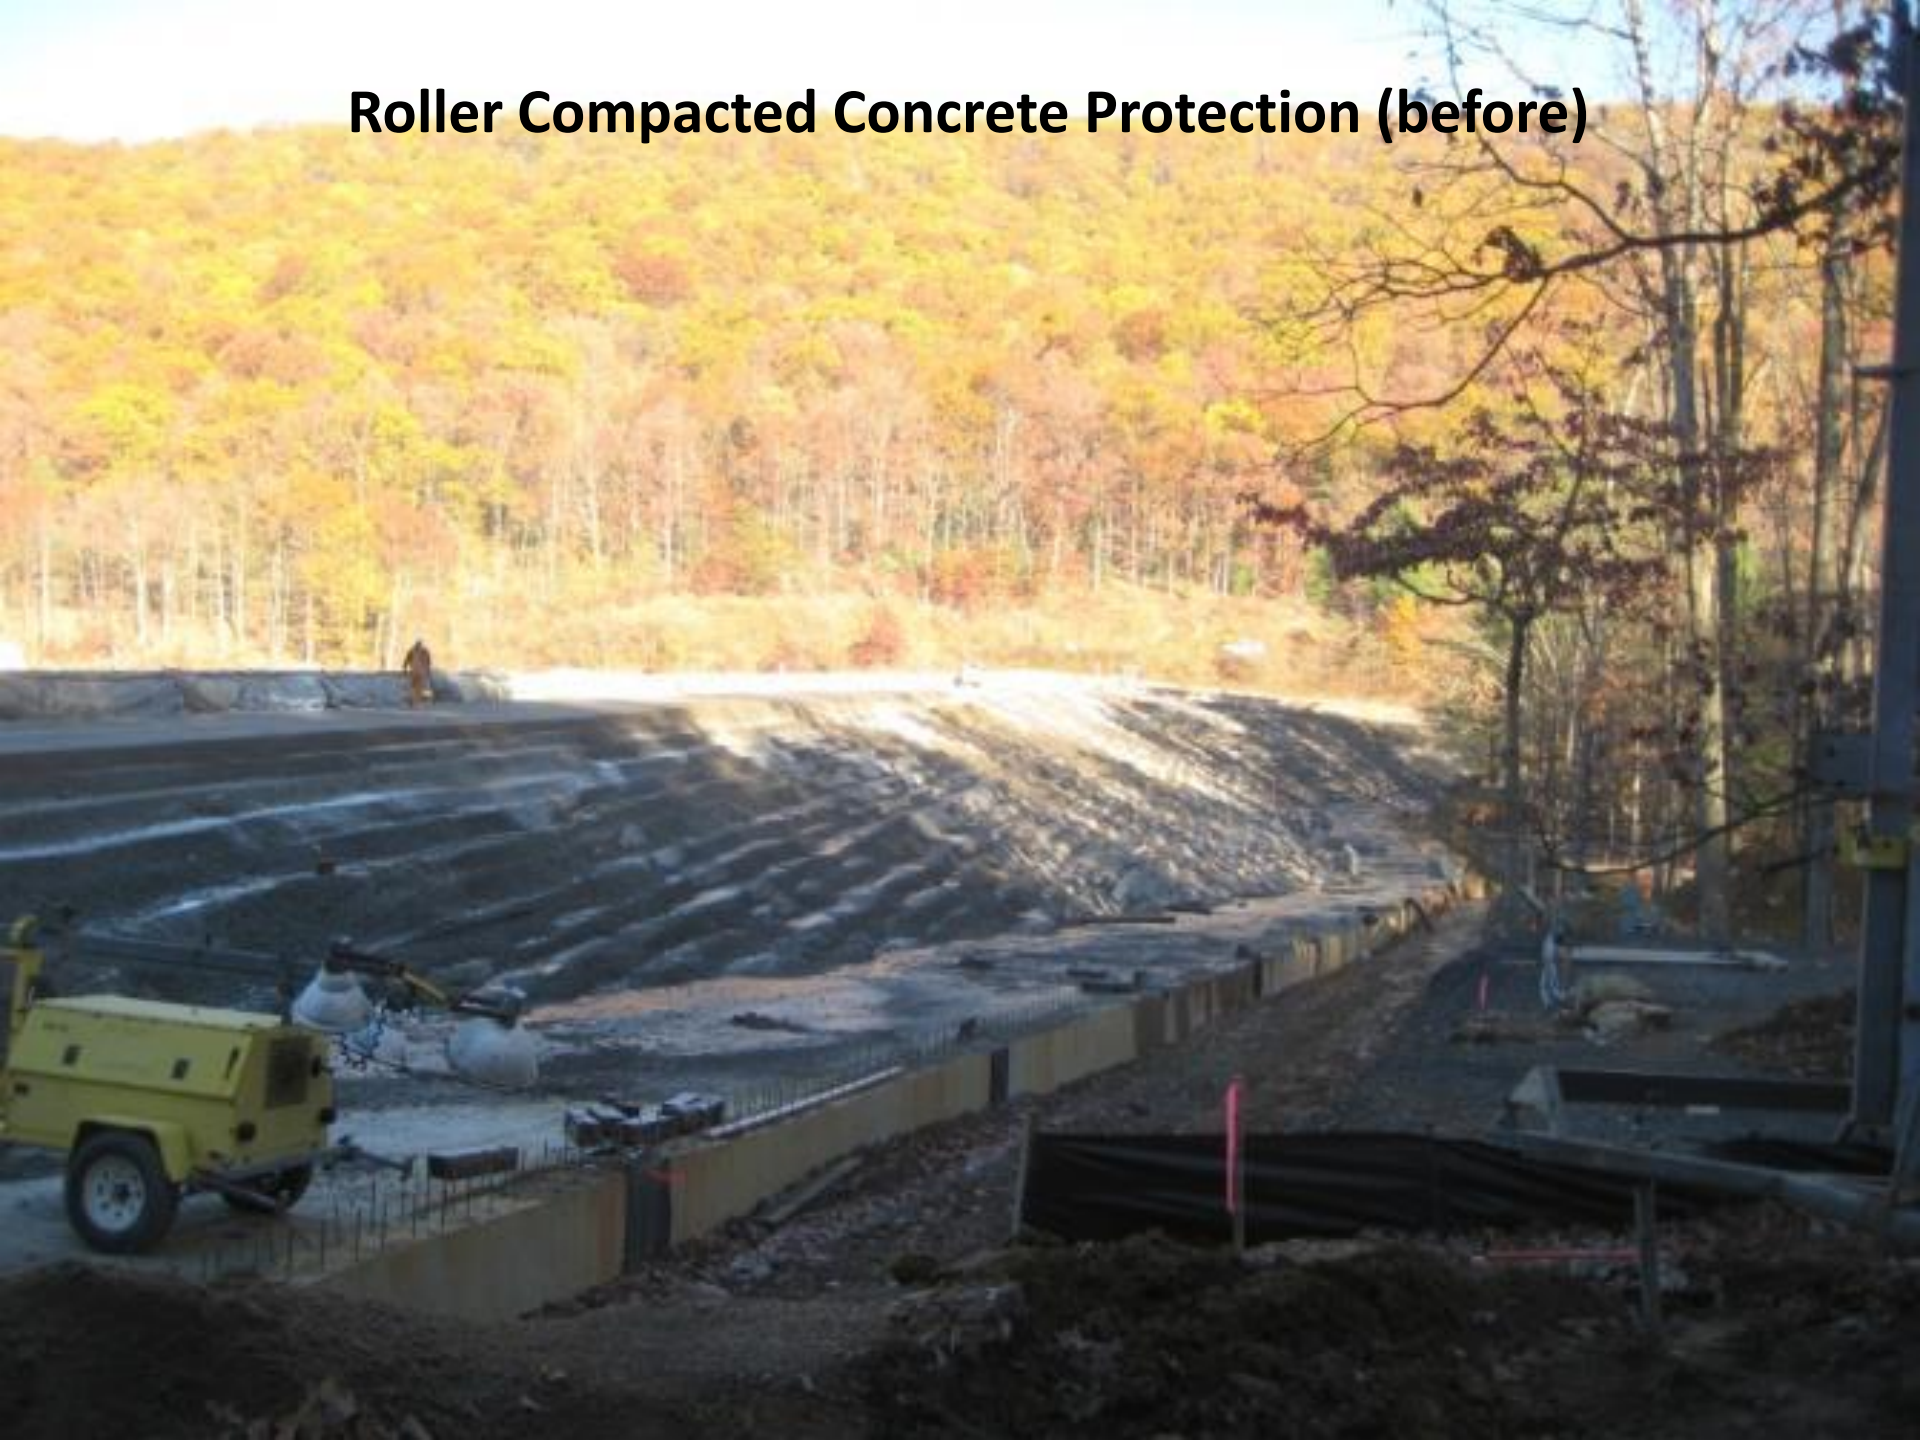
Roller Compacted Concrete Protection (before)
