Public Scoping Meeting for Hunter's Run Conservancy District Structures 4 and 9 Fairfield County, Ohio

DECEMBER 2, 2021

Statistics for Structure No. 4

Statistics for Structure No. 9

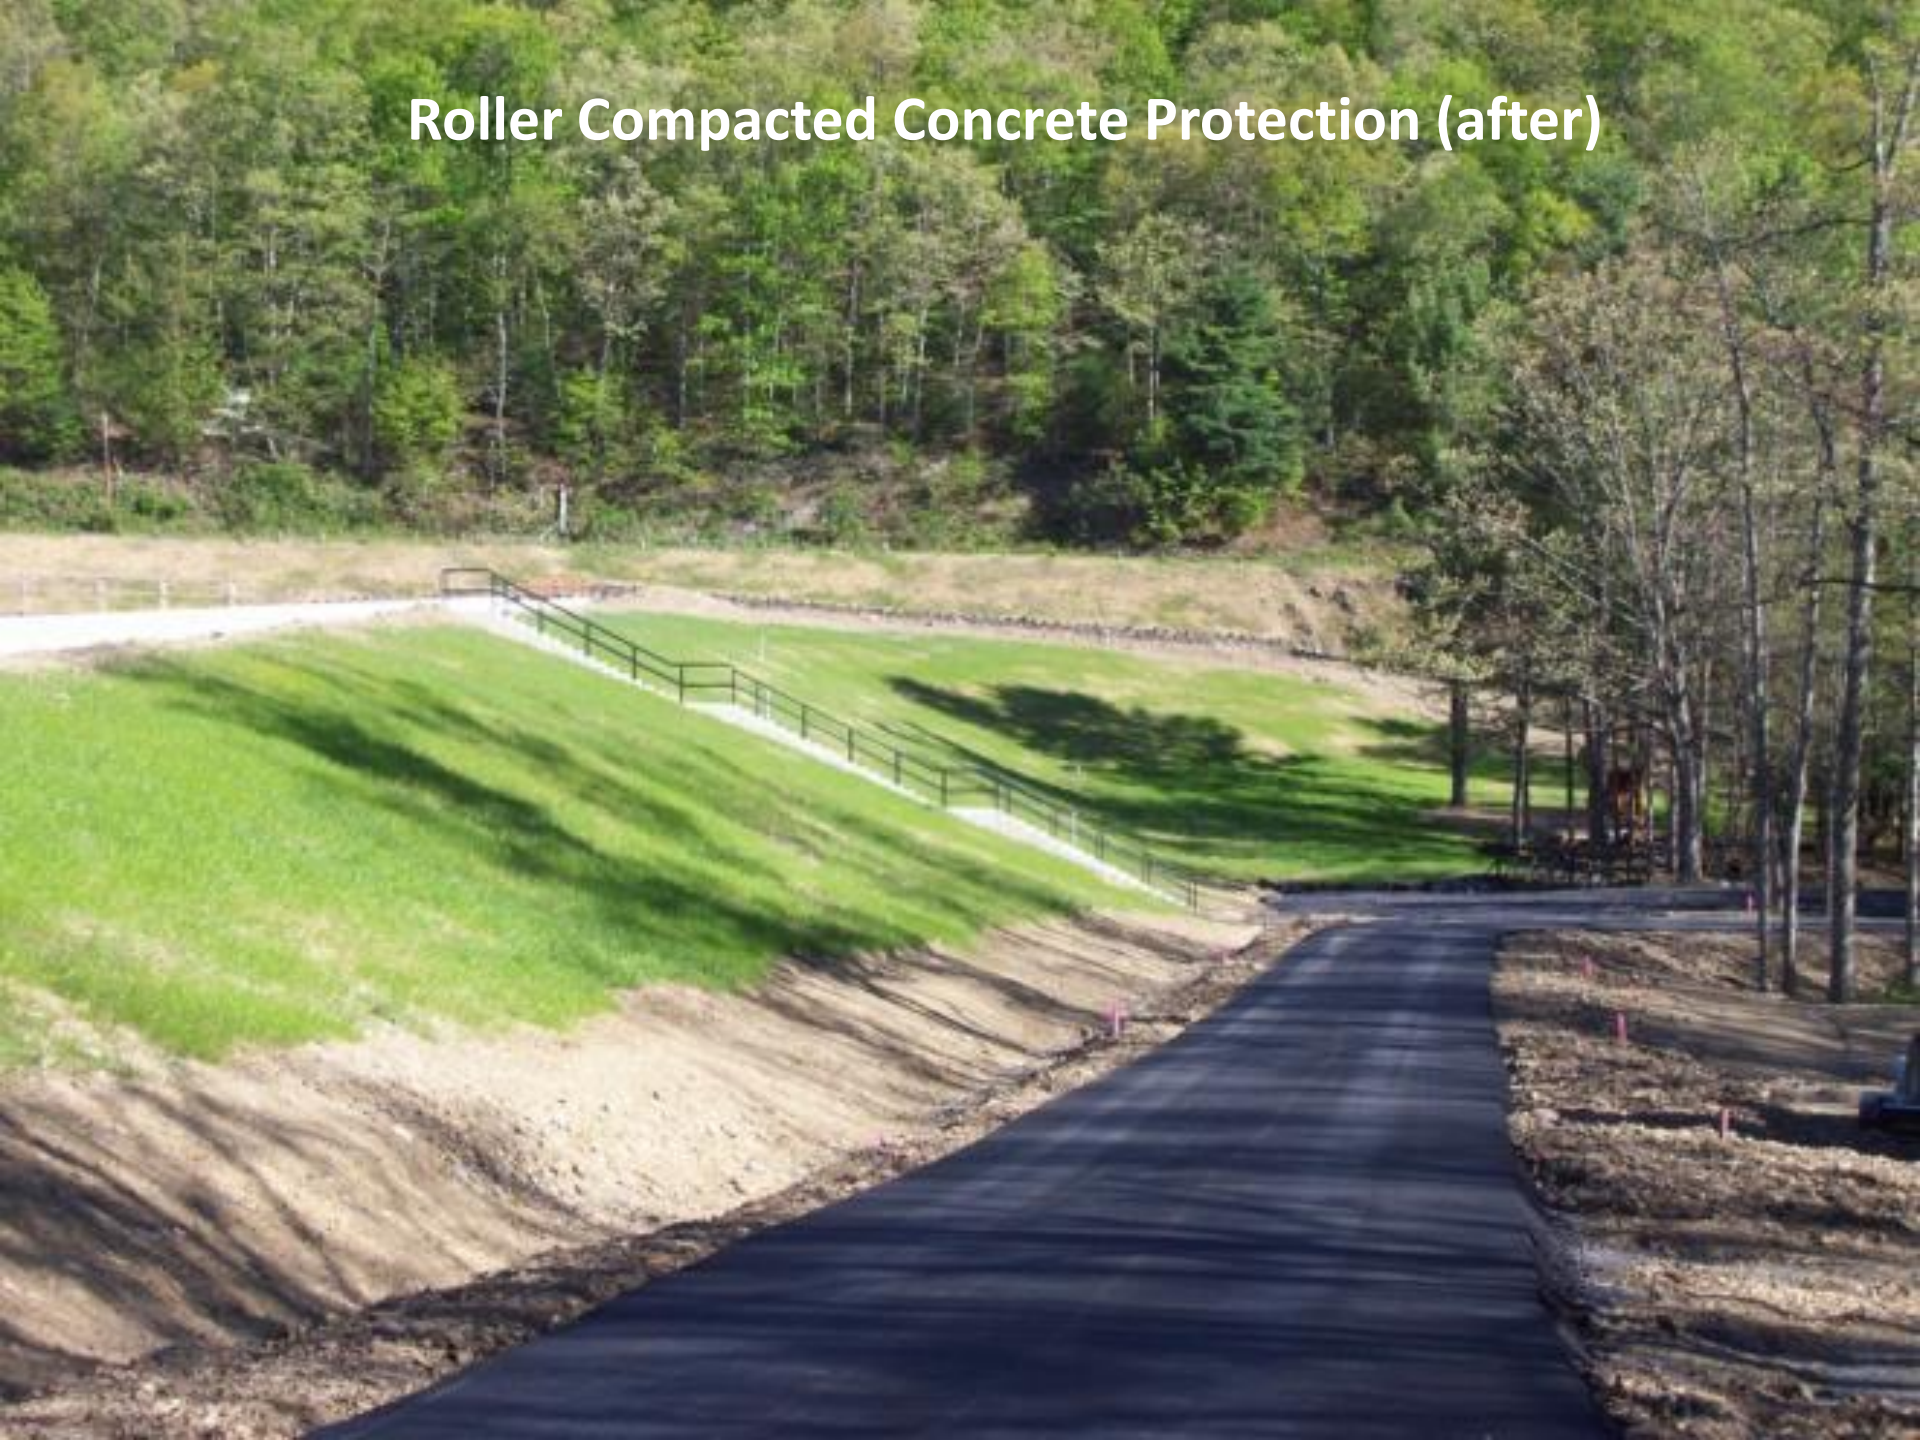
Roller Compacted Concrete Protection (after)

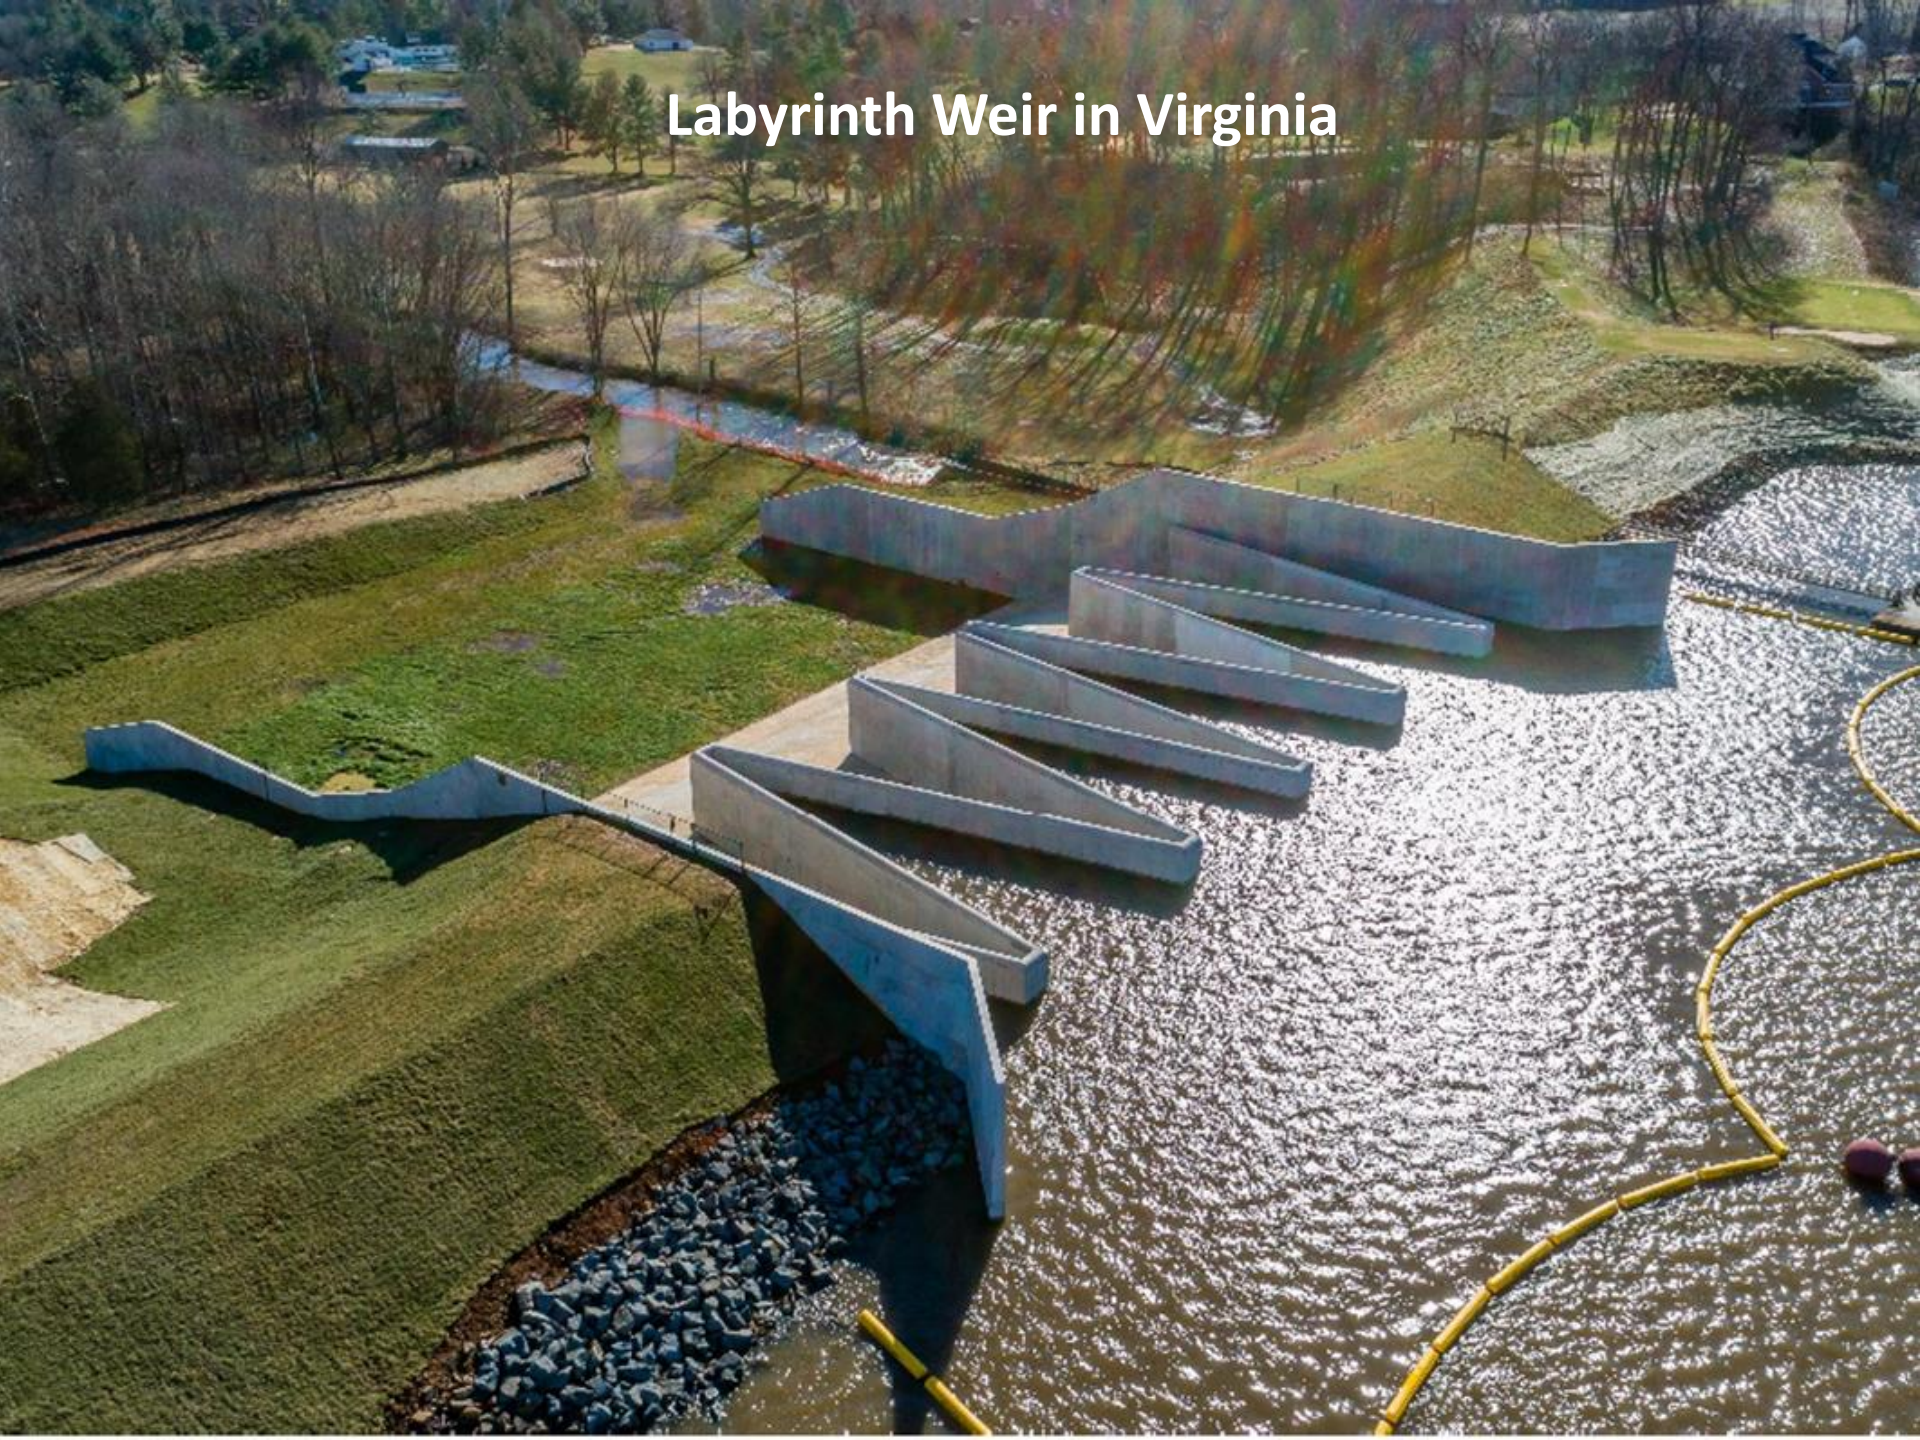
Labyrinth Weir in Virginia

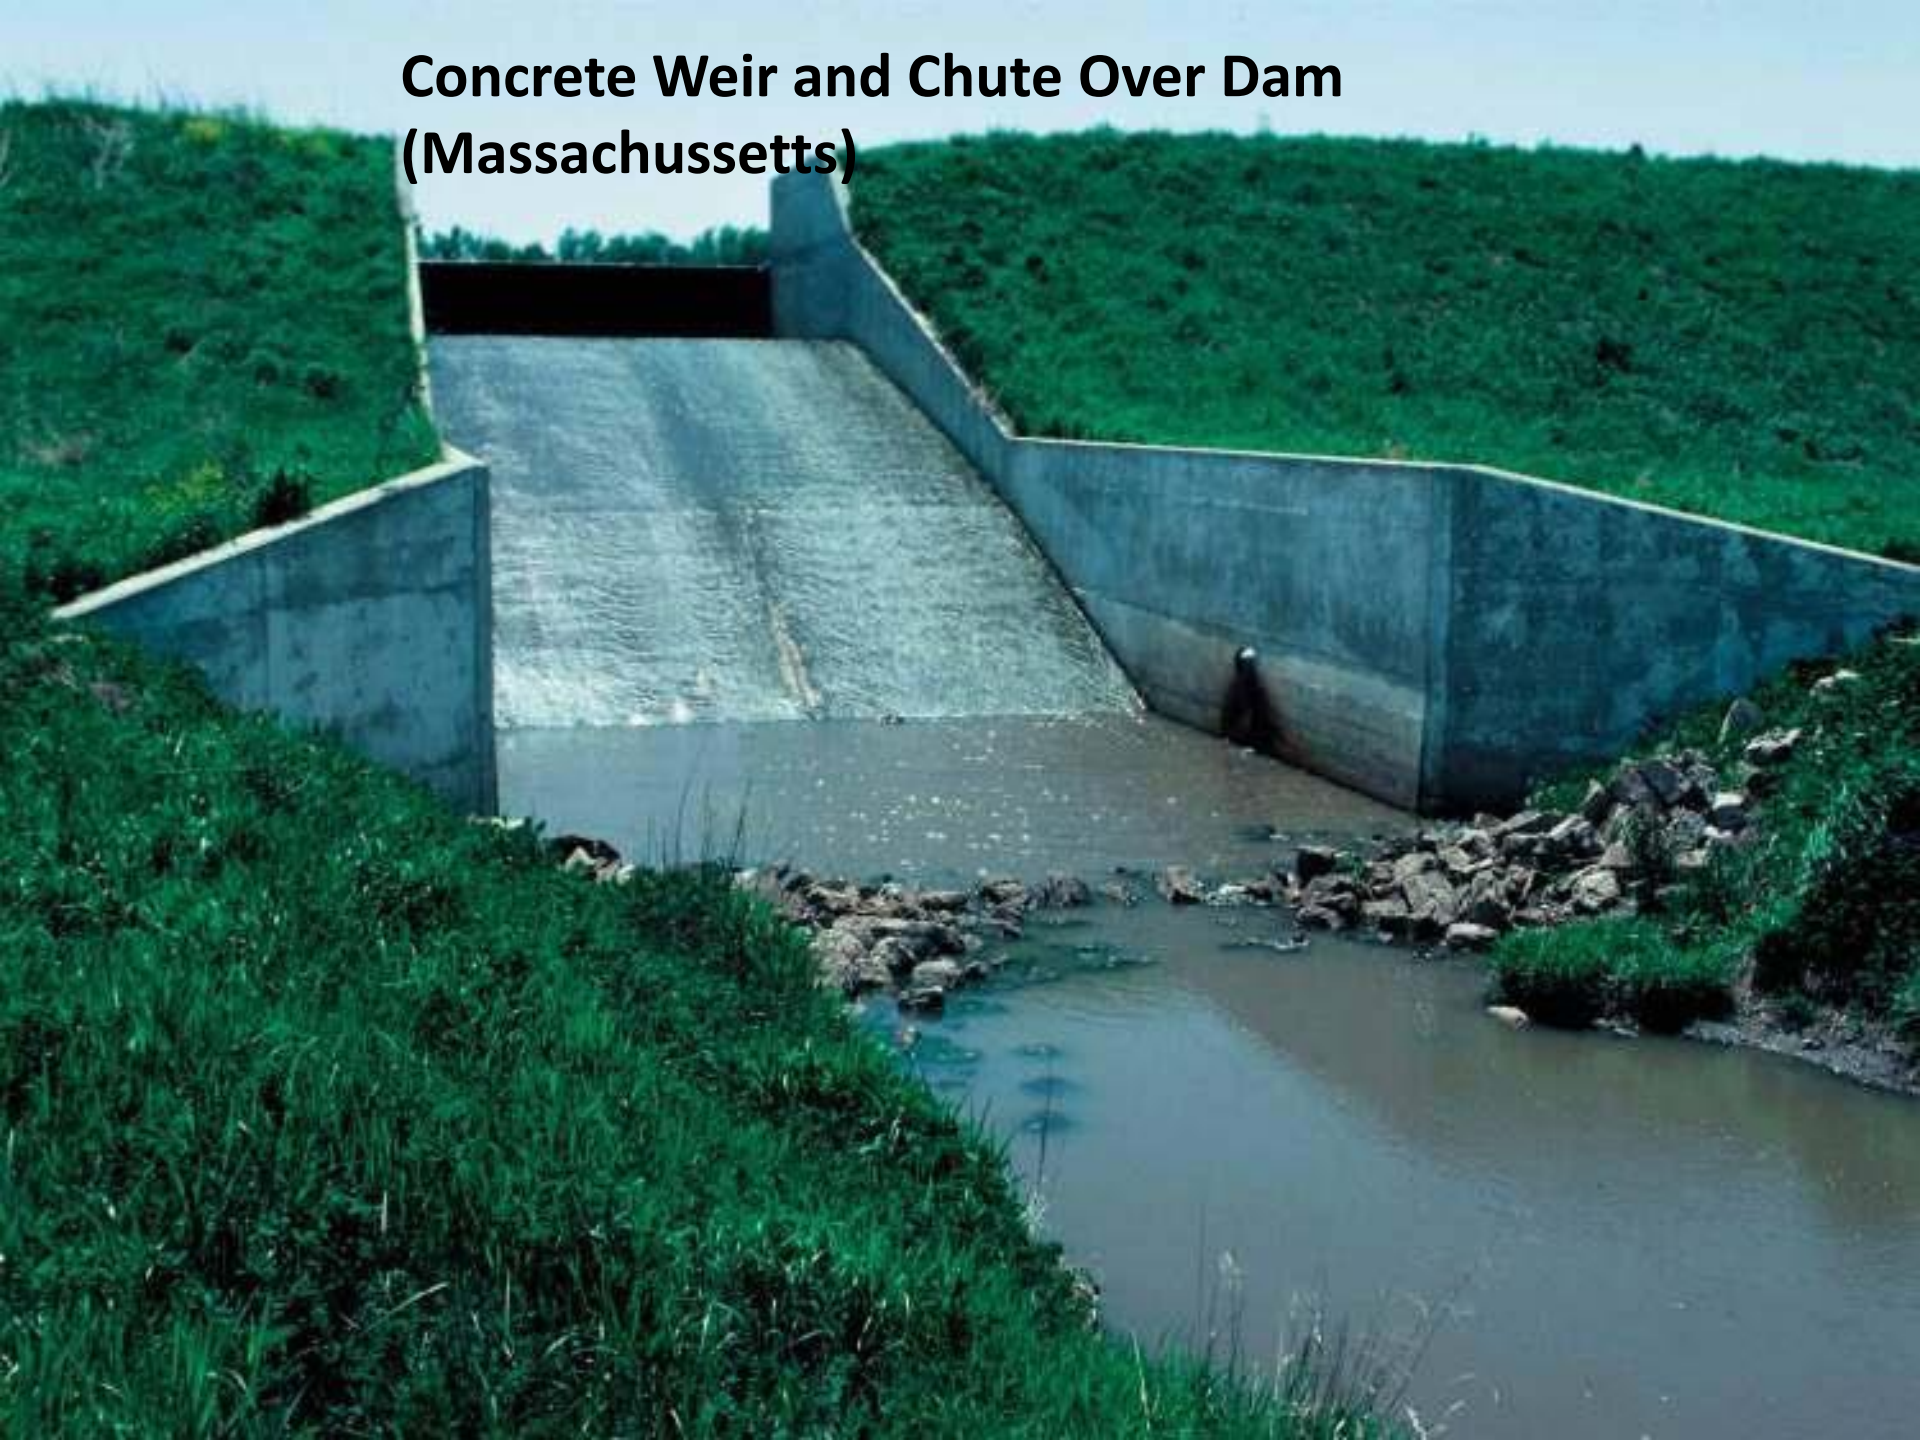
Concrete Weir and Chute Over Dam (Massachussetts)
