Your Inspection Report

Nice Town, MN

INSPECTION DATE:
Friday, December 20, 2013

RE: Report No. 1140, v.4

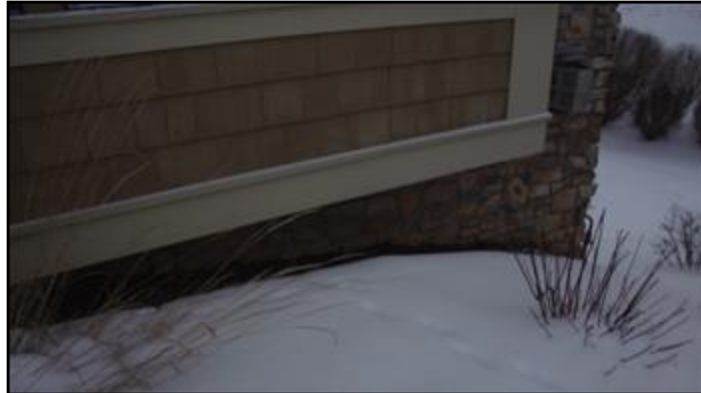
Too close to grade

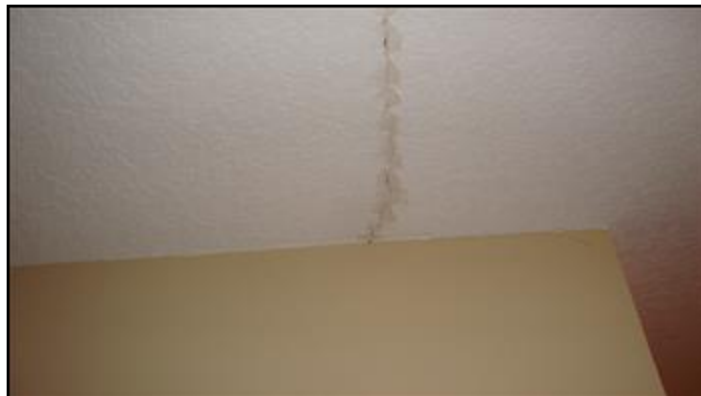
Typical minor settlement
