PROPERTY CONDITION ASSESSMENT REPORT

Sample Report
Minneapolis, MN

Wednesday, October 21, 2015

RE: Report No. 1480, v.2
Sample Report
Minneapolis, MN

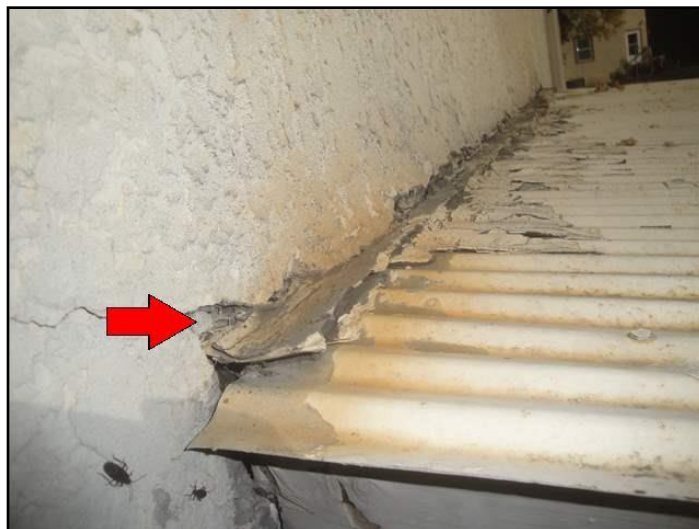
Condition: • [Loose, damaged, patched, open seams](#)

2. Loose, damaged, patched, open seams

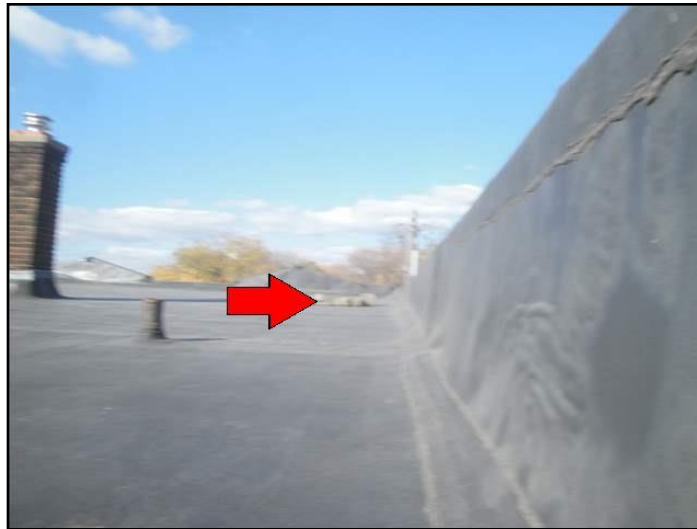
Condition: • [Debris/oil on roof](#)

6. Debris/oil on roof

Task: Remove

Time: Less than 1 year

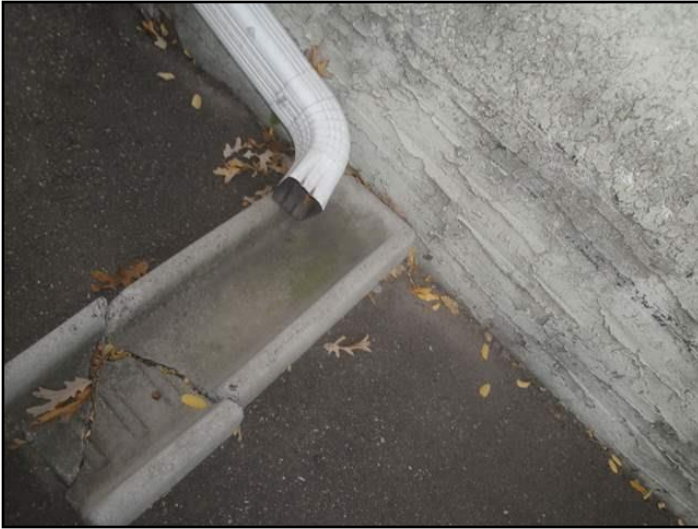
Condition: • [Downspouts end too close to building](#)

22. Downspouts end too close to building

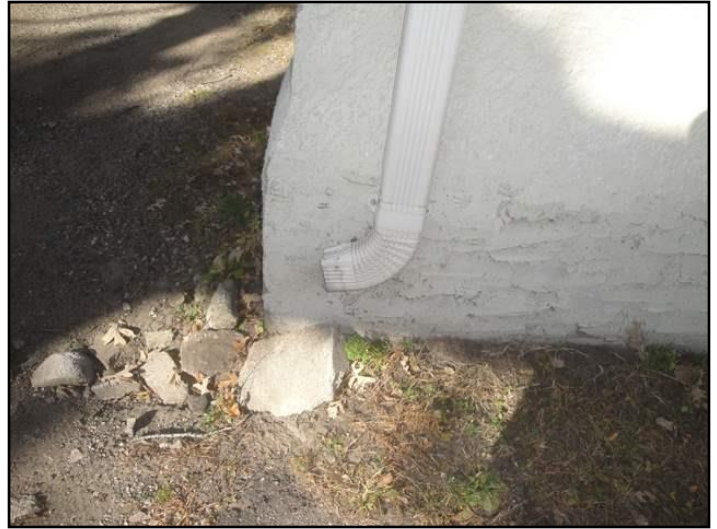
23. Downspouts end too close to building

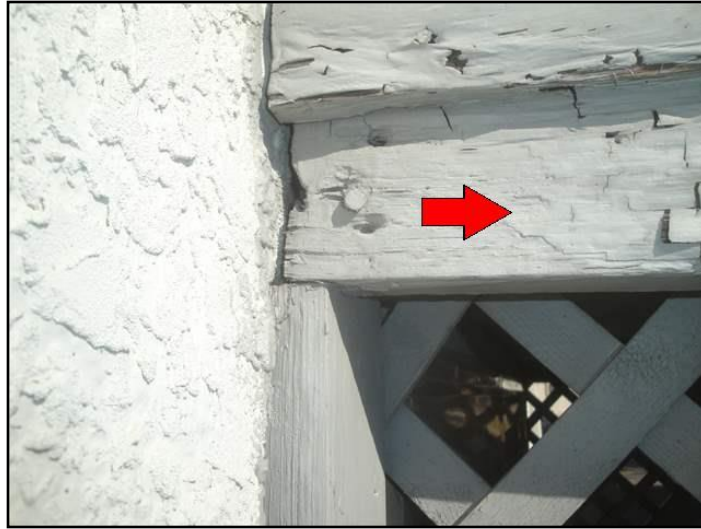
27. *Paint or stain needed*

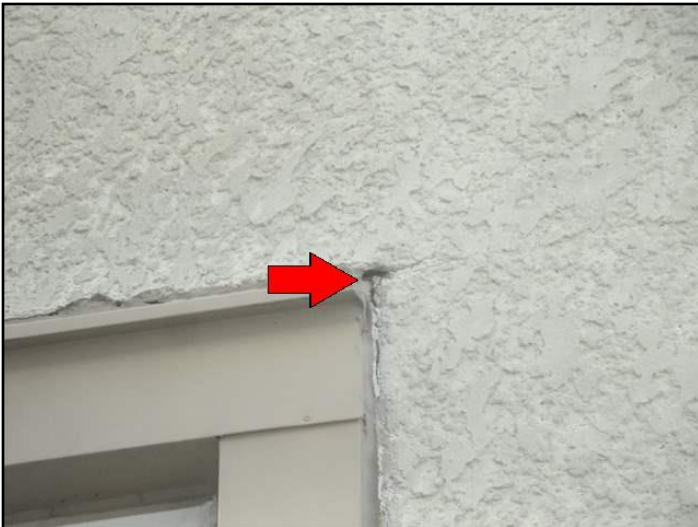
Missing at front and rear entry framing details. Caulk is also beginning to shrink in a small number of areas. Monitor and repair as necessary.

28. *Caulking missing or ineffective*

Task: Repair

Time: Less than 1 year

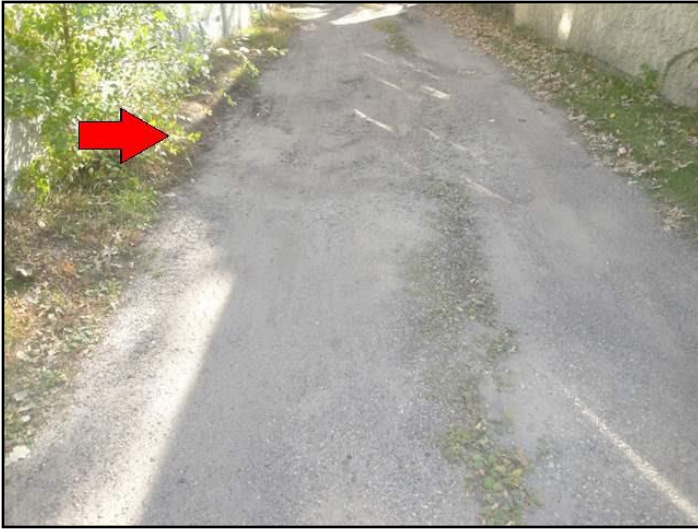
44. Improper slope

24. Condition: • [Improper slope](#)

Settled areas and areas of flat grade observed near foundations. Window sills were at or below grade. Evidence of significant moisture intrusion on interior basement walls.

Task: Improve

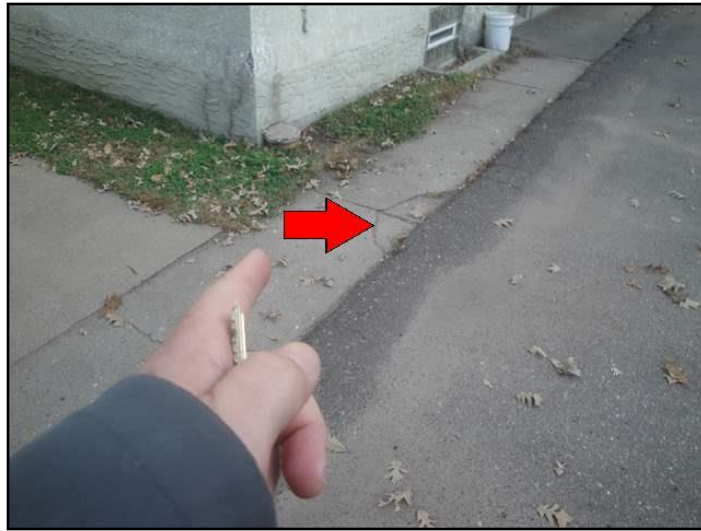
48. Cracked or damaged surfaces

26. Condition: • [Cracked or damaged surfaces](#)

Implication(s): Trip or fall hazard

Task: Repair

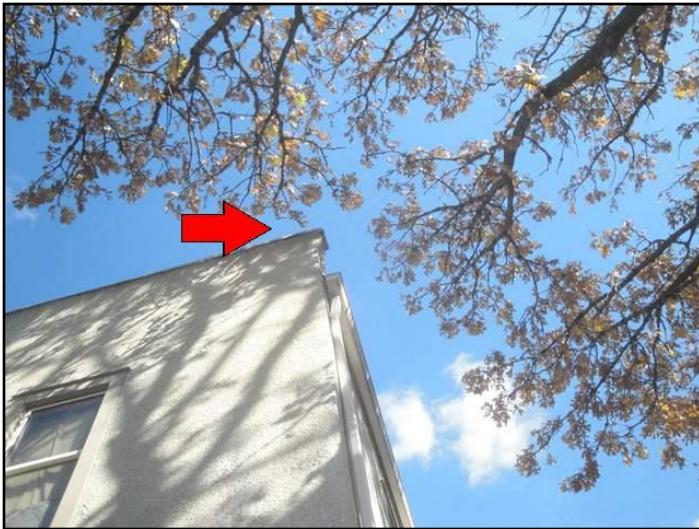
53. *Trees or shrubs too close to building*

29. Condition: • [Trees or shrubs too close to building](#)

Implication(s): Chance of water damage to contents, finishes and/or structure | Chance of pests entering building | Material deterioration

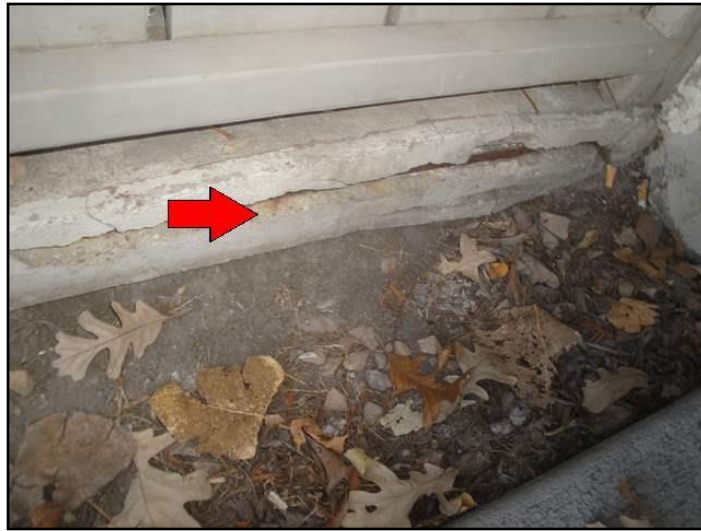
63. Spalling, crumbling or broken material

33. Condition: • [Spalling, crumbling or broken material](#)

Task: Repair

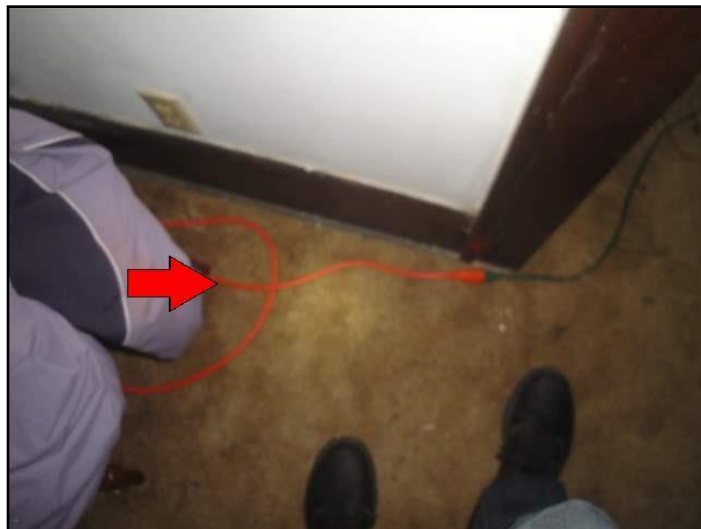
68. Extension cord used as permanent wiring

37. Condition: • [Extension cord used as permanent wiring](#)

Implication(s): Fire hazard | Electric shock

Task: Improve

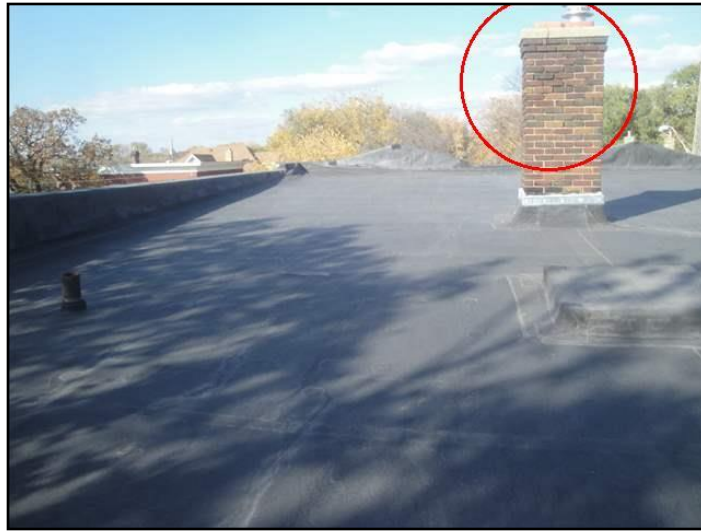
50. Condition: • [Loose, missing or deteriorated mortar](#)

Implication(s): Material deterioration

81. Loose, missing or deteriorated mortar

Task: Repair

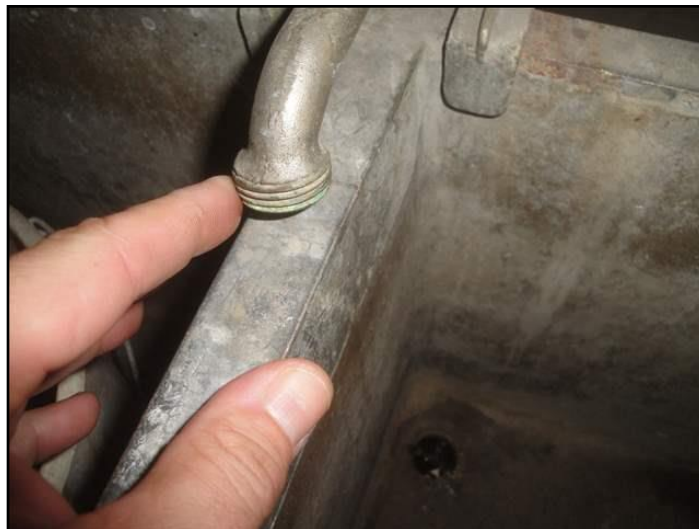
64. Condition: • Air gap defective

97. Air gap defective

Task: Improve

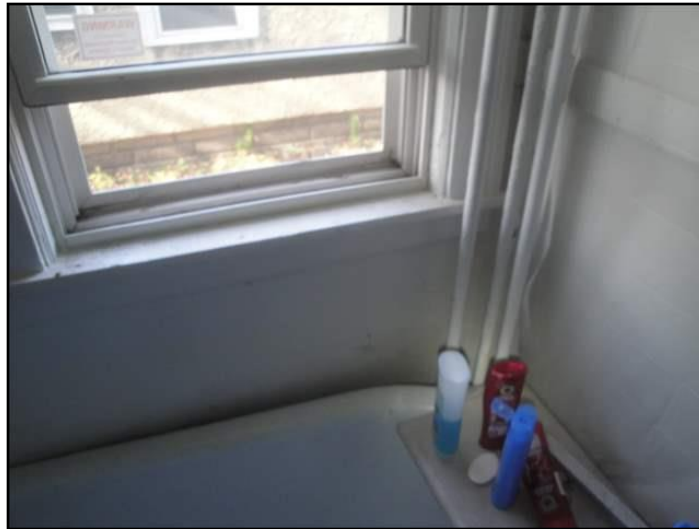
79. Condition: • Safety glass not installed

118. Safety glass not installed

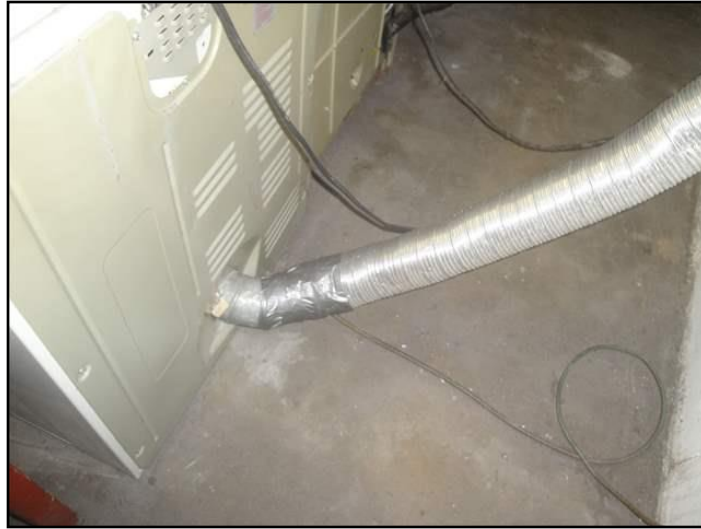
98. Condition: • Dryer vent material not smooth wall

Could not confirm vent meets UL2158A rating. Replace with smooth ridged metal.

Implication(s): Fire hazard | Equipment ineffective

140. *Dryer vent material not smooth wall*

Task: Replace

Time: Less than 1 year
