PROPERTY CONDITION ASSESSMENT REPORT

999

Minneapolis Area, MN

Friday, March 6, 2015

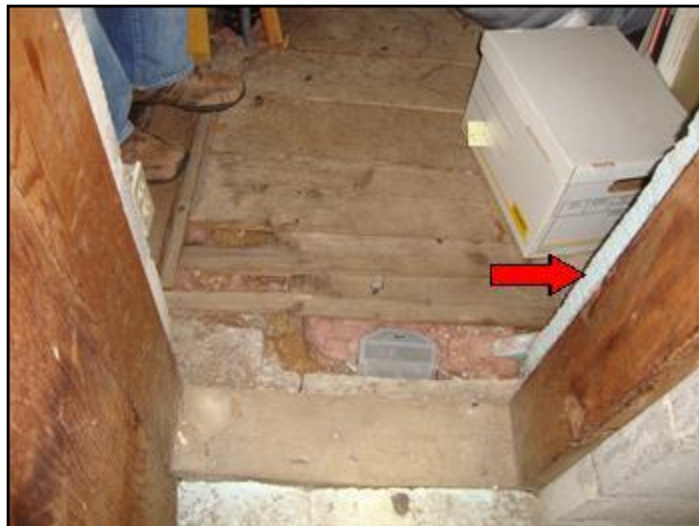
45. Exposed polystyrene foam insulation

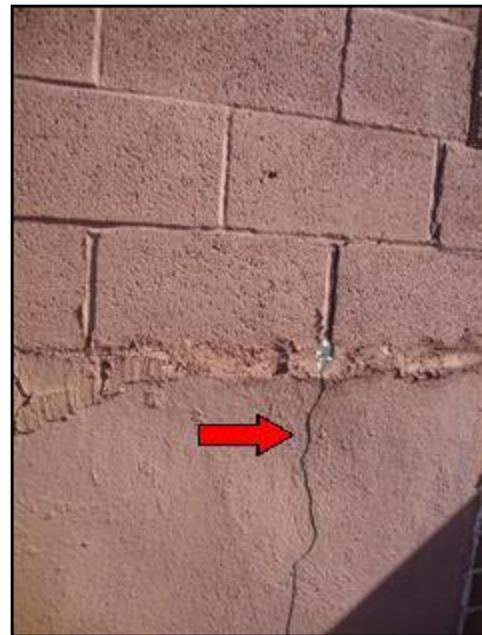
49. Settlement cracks noted
