# Inspection Report

**Beemal & Tara Vasani**

**Property Address:**  
23 Glen Eagle Dr.  
Bridgewater NJ 08807

<b>Date:</b> 1/7/2016	<b>Time:</b> 10:00 AM	<b>Report ID:</b>
<b>Property:</b> 23 Glen Eagle Dr. Bridgewater NJ 08807	<b>Customer:</b> Beemal & Tara Vasani	<b>Real Estate Professional:</b> Kevin Cary Golden Key Realty

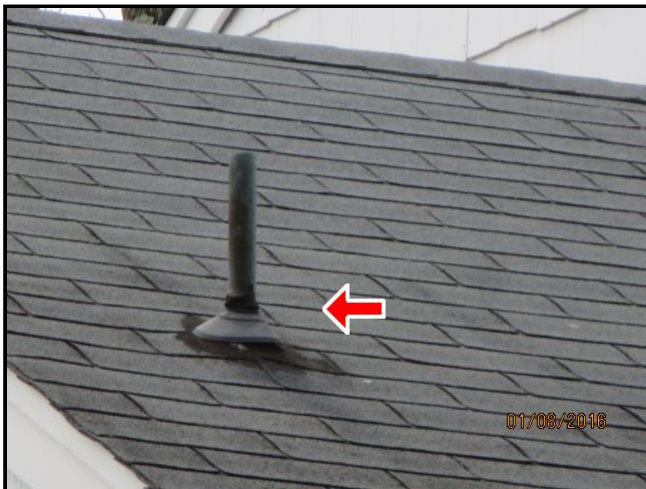
1.2 Item 1(Picture) Pipe Flashing

(1) The plumbing vent pipe flashing is installed improperly over the laundry room. Water intrusion can occur if not repaired. Recommend a roofing company further evaluate and repair.

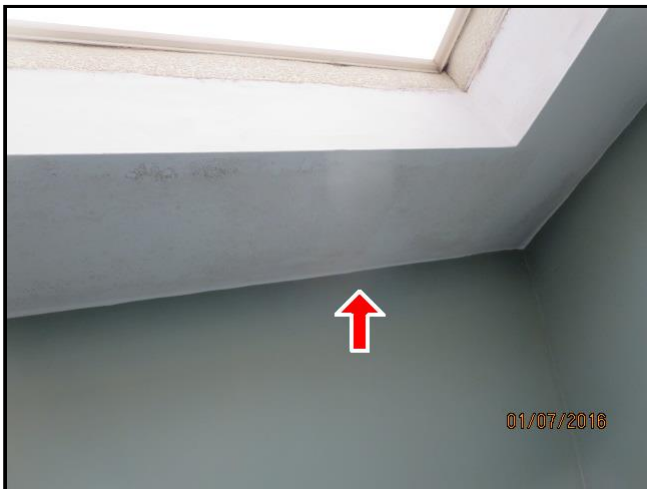
1.2 Item 7(Picture) Possible mold

(3) Two Skylights have stains indicating a leak did or does exist at the Master Bedroom bath. Further deterioration may occur if not repaired. A qualified contractor should repair or replace as needed. Possible mold was observed at the ceiling around the skylights and may be behind the walls. Recommend a mold specialist further evaluate.

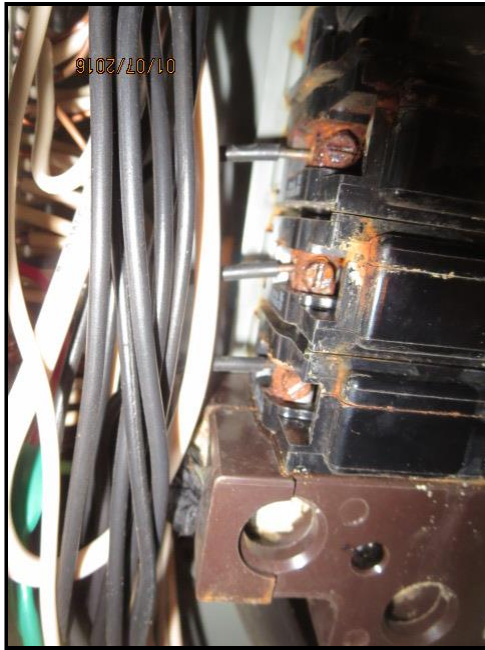
3.1 Item 2(Picture) Rusty Connections

The problem(s) discovered in the panel such as doubled wiring at breakers, rust and any other problems that an electrical contractor may discover while performing repairs need correcting. I recommend a licensed electrical contractor inspect further and correct as needed. Sub Panel is not wired correctly. Neutral and ground wires are on the same bus bar.

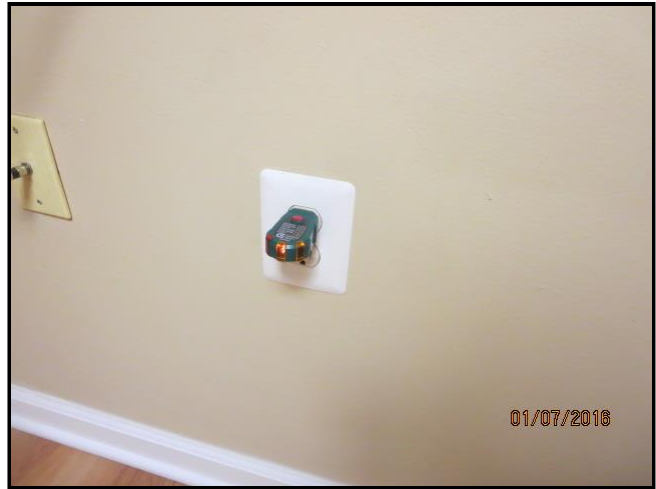
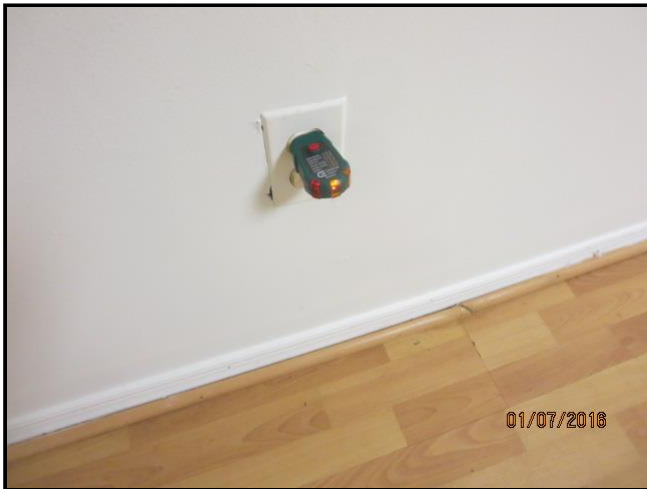
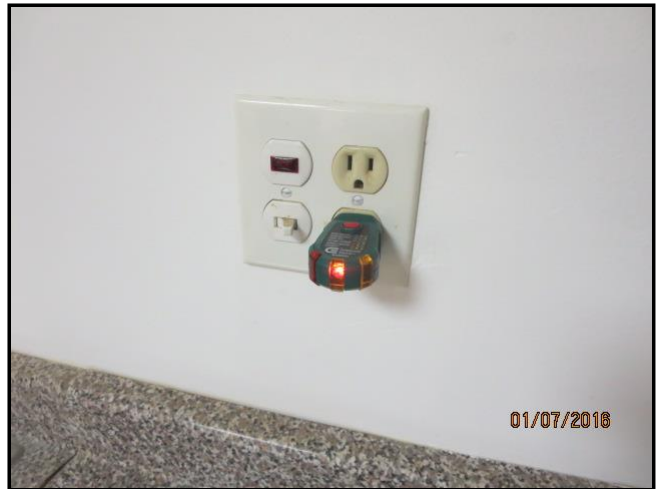
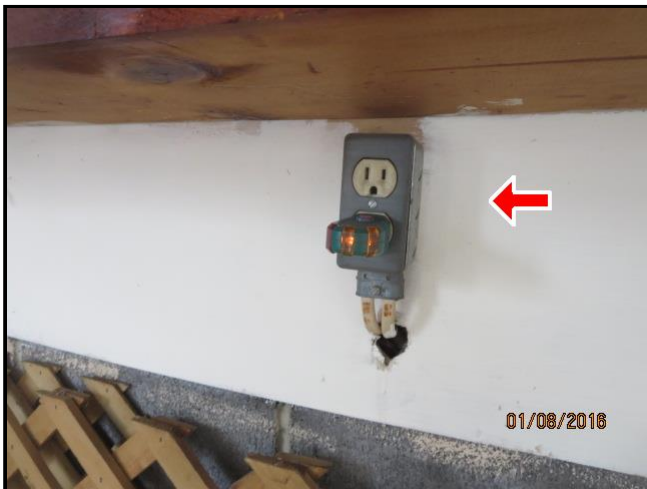
(1) At least 6 outlets in the basement and external are not grounded . This is a safety issue that needs to be corrected. A qualified licensed electrical contractor should perform repairs that involve wiring.

3.3 Item 2(Picture) open ground

3.3 Item 3(Picture) open ground

3.3 Item 4(Picture) open ground

3.3 Item 5(Picture) open ground

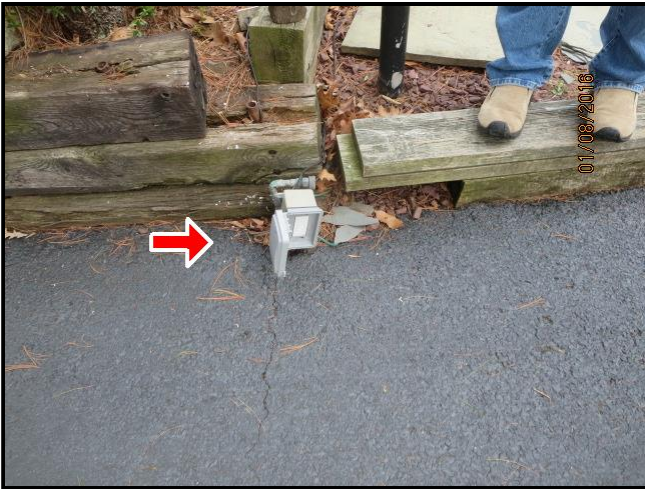
3.3 Item 7(Picture) Driveway outlet

(2) The electrical outlet at driveway is a major safety issues. The outlet is too close to the ground and not protected from getting damaged that can cause an electrical shock.

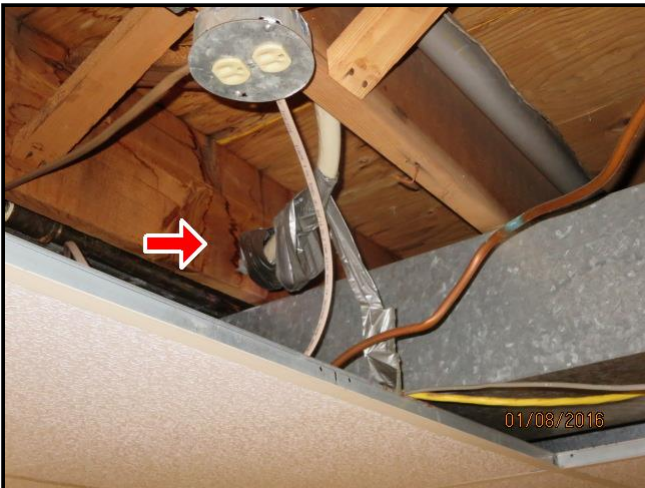
3.3 Item 8(Picture) Open splice

(3) Open splices were observed at the basement ceiling and under kitchen sink This is a safety concern that can lead to electric shock. Recommend a licensed electrician further evaluate.

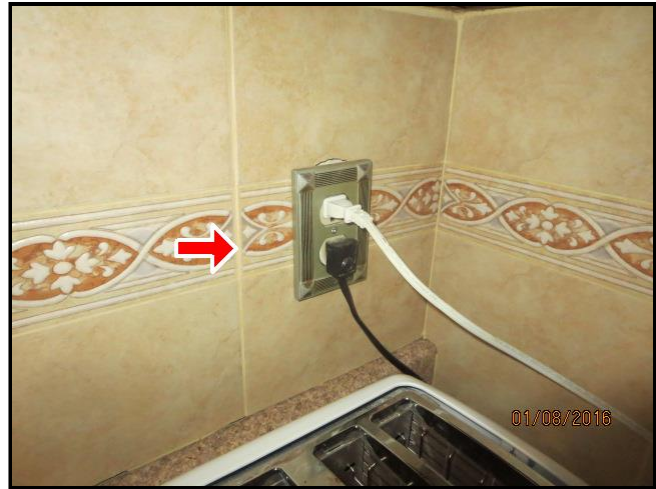
3.3 Item 11(Picture) Non GFCI

(4) All "three-prong" outlets are outdated and not a three-prong GFCI (Ground Fault Circuit Interrupt) in the kitchen and baths. These are a safety issue that needs to be corrected. A qualified licensed electrical contractor should perform repairs that involve wiring.

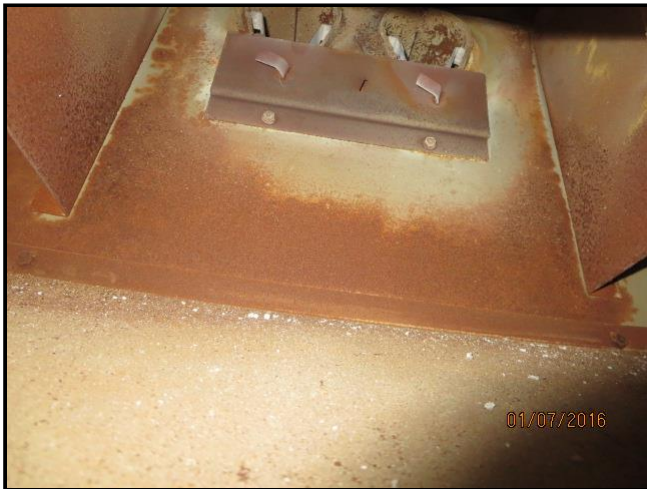
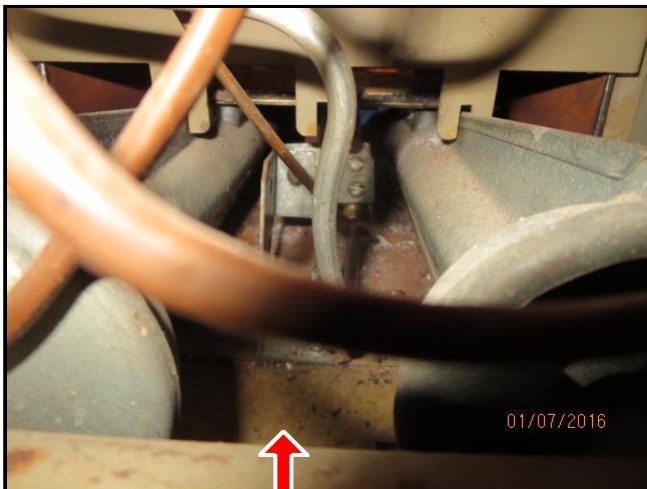
Both furnace have major heat exchanger rust conditions. A rusty heat exchanger can lead to carbon monoxide seeping into the home. This condition is a safety and health hazard issue. Recommend that the furnaces be shut down and not used till a HVAC contractor further evaluate. Both furnaces are very old and need to be replaced.

4.0 Item 3(Picture) Rust

4.0 Item 5(Picture) Rust

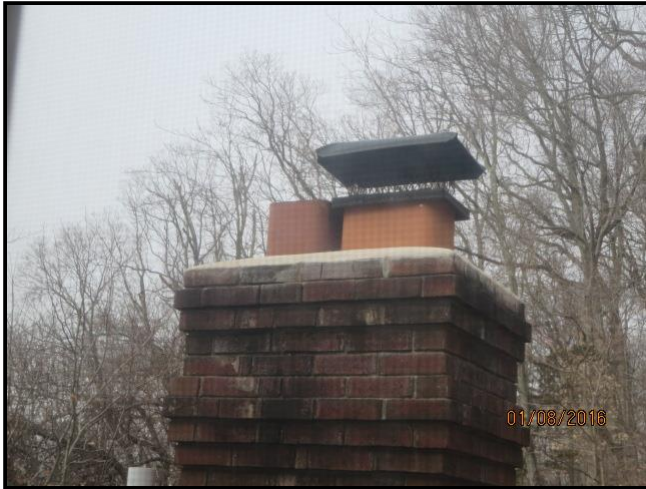
4.5 Item 1(Picture) Chimney

The liner was not inspected by our company. I recommend a qualified chimney sweep inspect for safety.

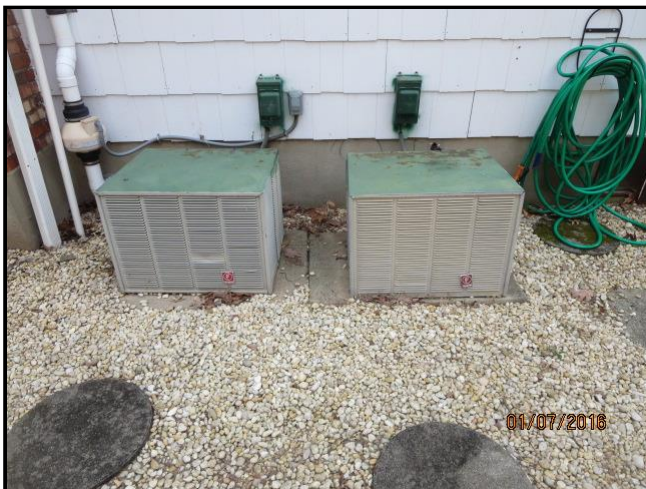
4.8 Item 1(Picture) Condensers

(1) The condenser outside (AC unit) is very old and may last a few years more, but maybe not. I have seen units fail shortly after a home inspection during the seasonal change from mild to hot weather. I cannot determine how long your AC will last before a replacement is necessary. Condenser are original life expectancy is 8-15 years

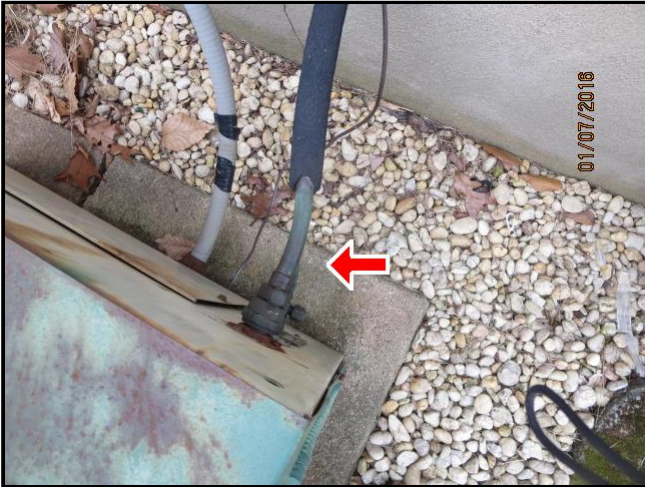
4.8 Item 2(Picture) Missing foam

(2) The foam sleeve on suction line is missing foam sleeve in area(s) at outside unit. Missing foam on suction line can cause energy loss and condensation. I recommend service or repair as needed.

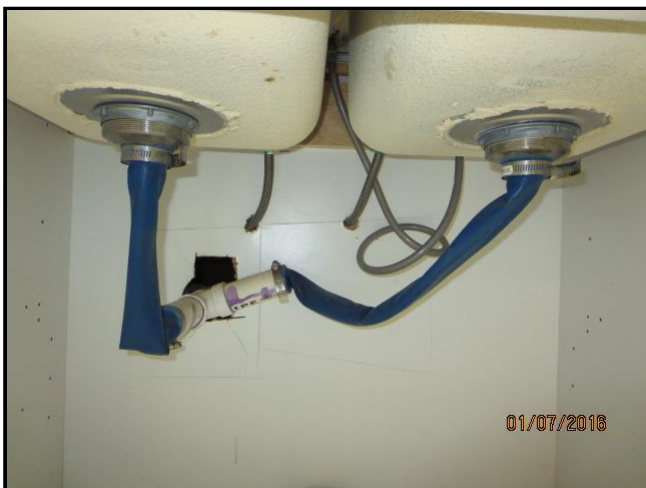
5.0 Item 1(Picture) Missing piping

Piping and a p-trap on waste line is missing at the Kitchen sink this does not meet today's standards. Repairs are needed. A qualified licensed plumber should repair or correct as needed.

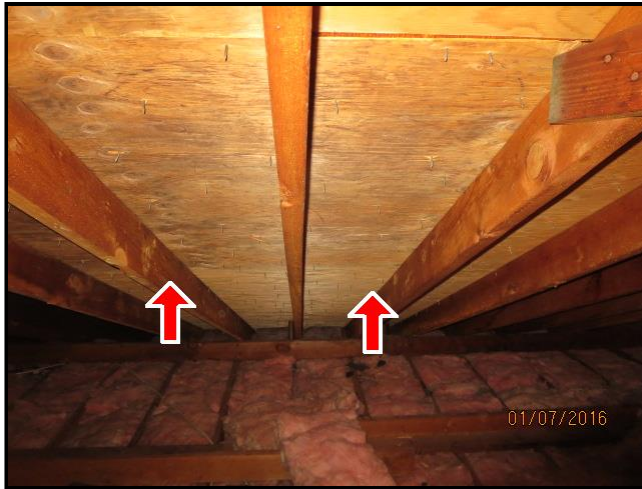
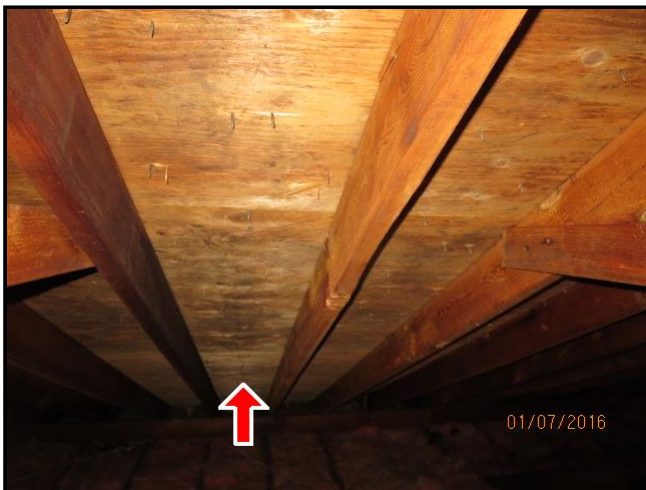
6.5 Item 2(Picture) Possible Mold

6.5 Item 3(Picture) Possible Mold

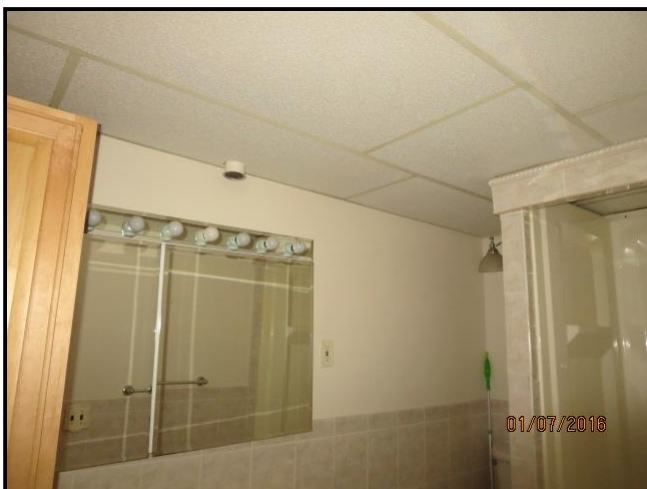
7.4 Item 1(Picture) Missing fan

The Exhaust fan is missing at the basement bath. This does not meet today's standards . A qualified contractor should inspect and repair as needed.

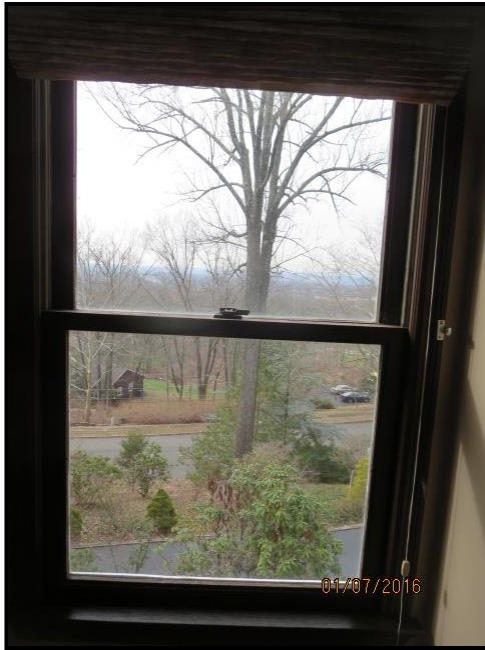
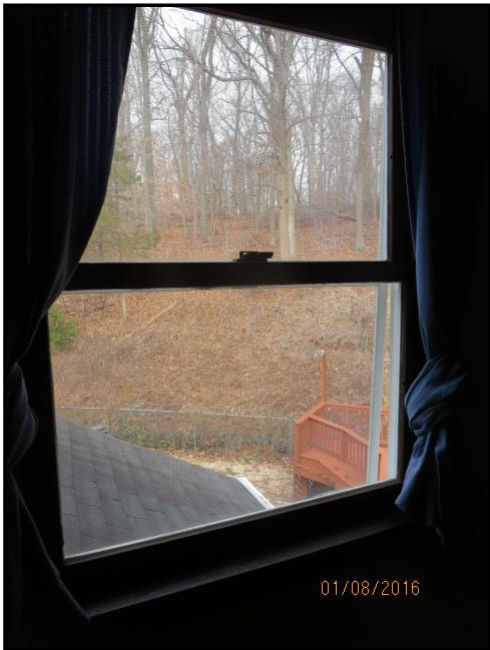
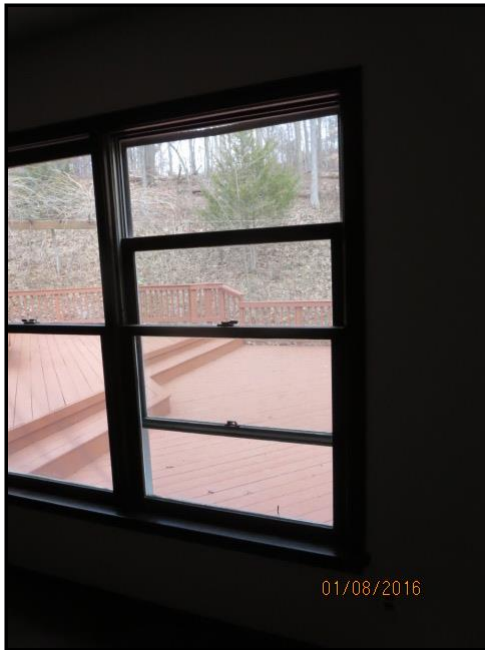
8.6 Item 2(Picture) Non working window

8.6 Item 3(Picture) non working window

8.6 Item 4(Picture) Non working window

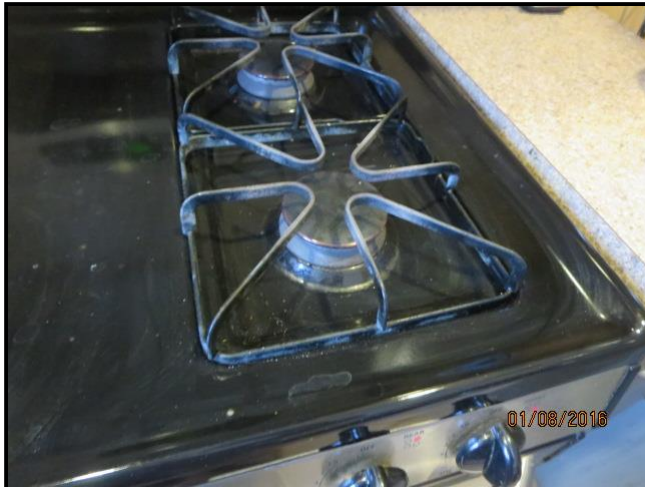
10.1 Item 1(Picture) Range

The front right burner (on range) did not work when tested. I recommend repair as needed.

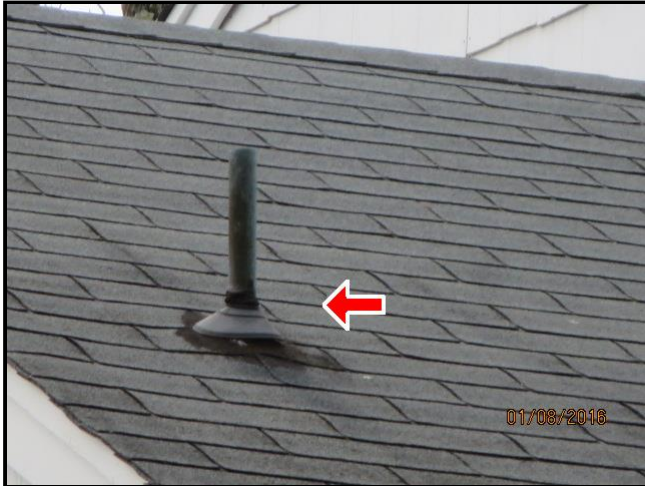
1.2 Item 1(Picture) Pipe Flashing

(1) The plumbing vent pipe flashing is installed improperly over the laundry room. Water intrusion can occur if not repaired. Recommend a roofing company further evaluate and repair.

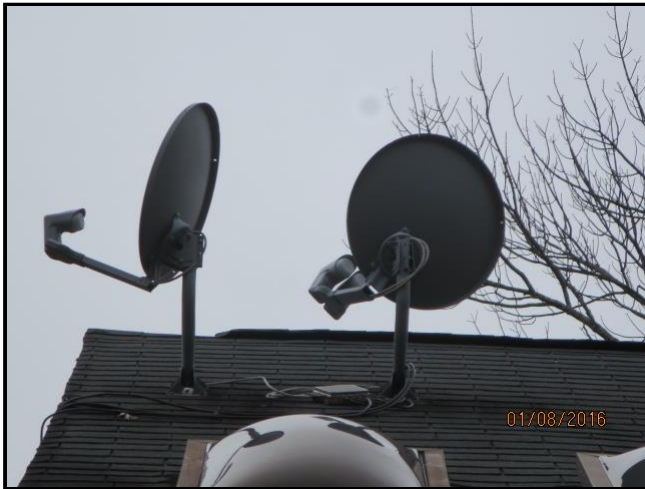
1.2 Item 2(Picture) Satellite dishes

(2) The sealant on the satellite dish at the roof needs to be maintained. Any penetration into the roof can cause water damage from leaks, This is a maintenance issue and is for your information. A qualified person should repair or replace

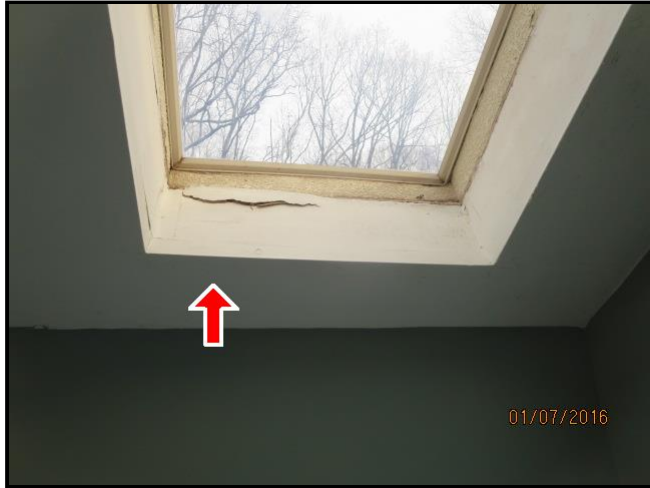
1.2 Item 3(Picture) Skylight damage

(3) Two Skylights have stains indicating a leak did or does exist at the Master Bedroom bath. Further deterioration may occur if not repaired. A qualified contractor should repair or replace as needed. Possible mold was observed at the ceiling around the skylights and may be behind the walls. Recommend a mold specialist further evaluate.

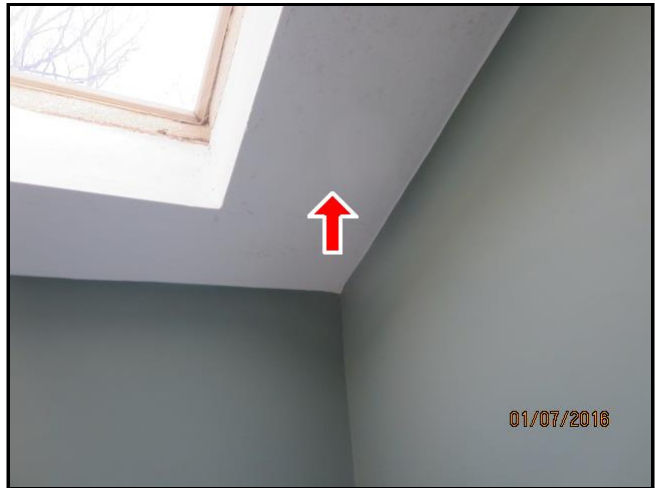
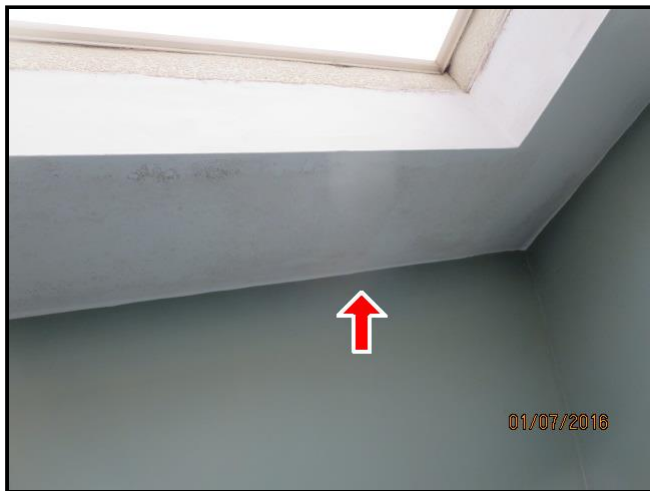
1.2 Item 6(Picture) Possible mold

1.2 Item 7(Picture) Possible mold

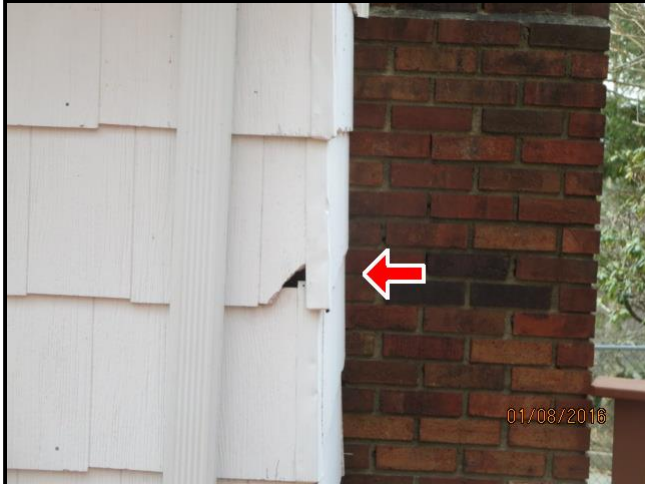
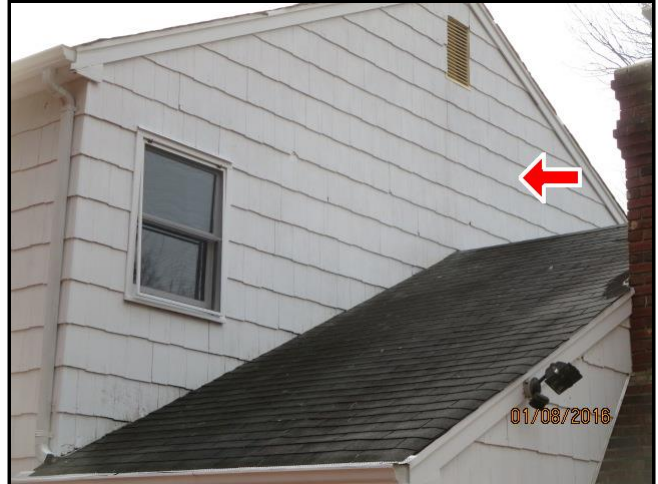
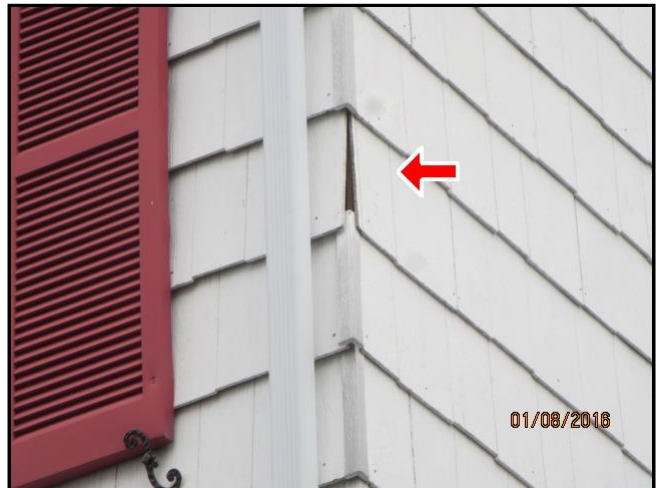
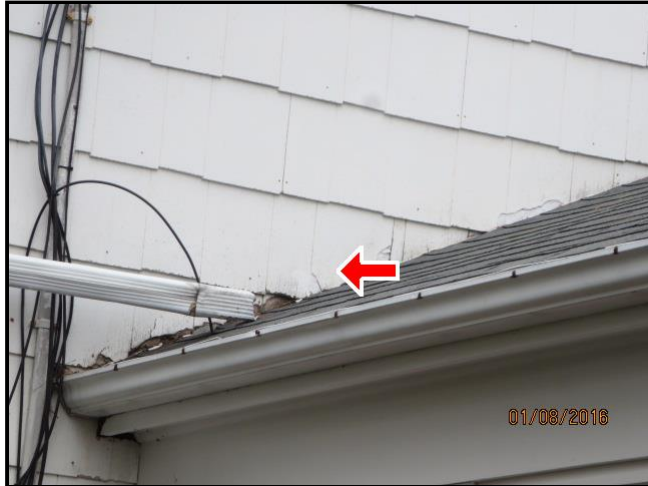
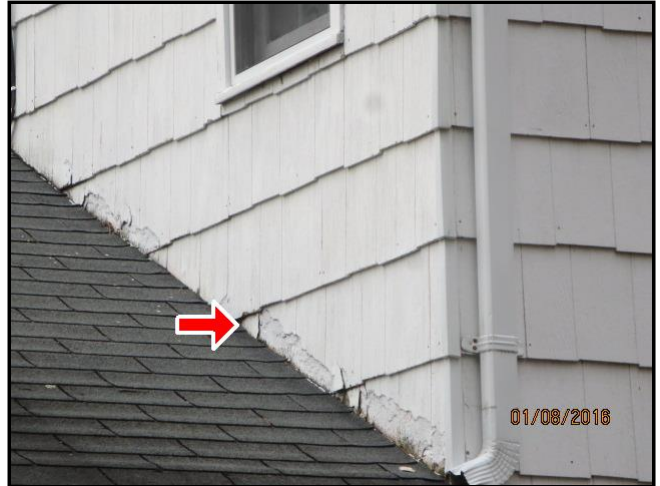
(1) The possible Asbestos slate siding at the exterior in areas is damaged, deteriorated missing and loose. Further deterioration that can lead to water and insect intrusion if not corrected. A qualified contractor should inspect and repair as needed.

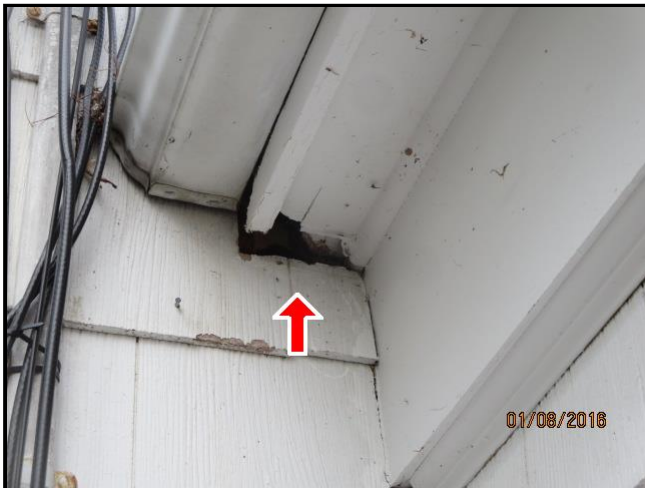
2.0 Item 3(Picture) Hole in siding

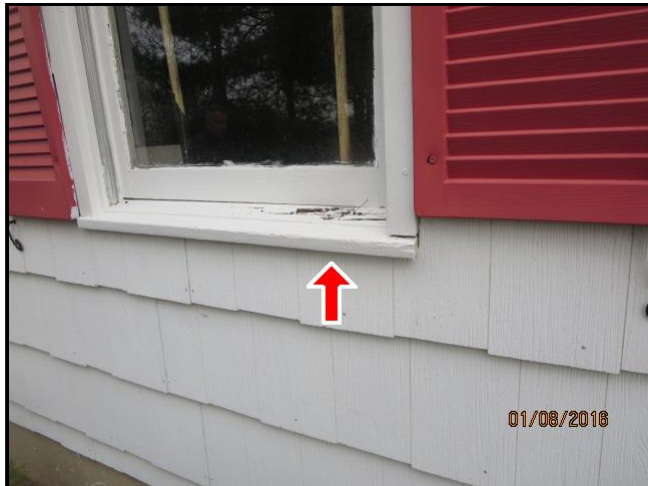
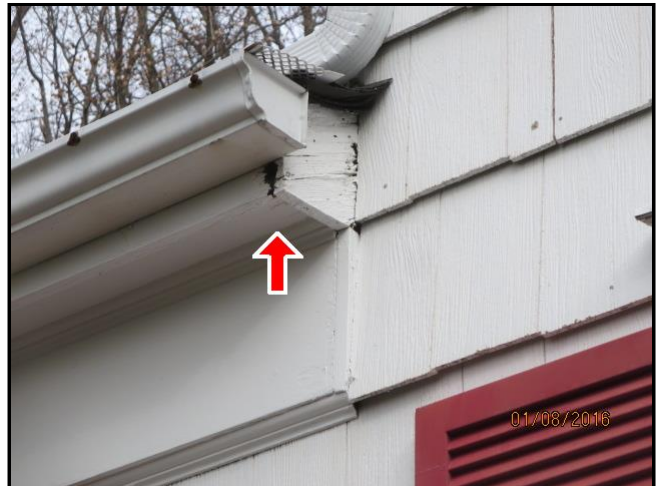
2.0 Item 7(Picture) Rotted trim

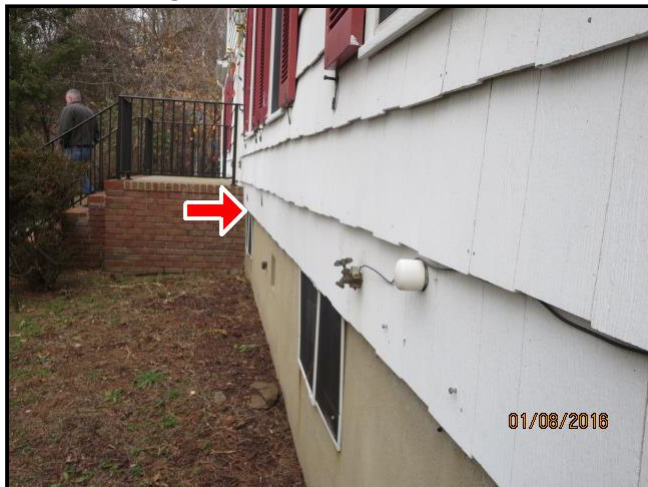
(2) The siding at the front of the home is buckled. This could be a structural problem. Recommend an structural engineer further evaluate.

2.0 Item 9(Picture) Buckled siding

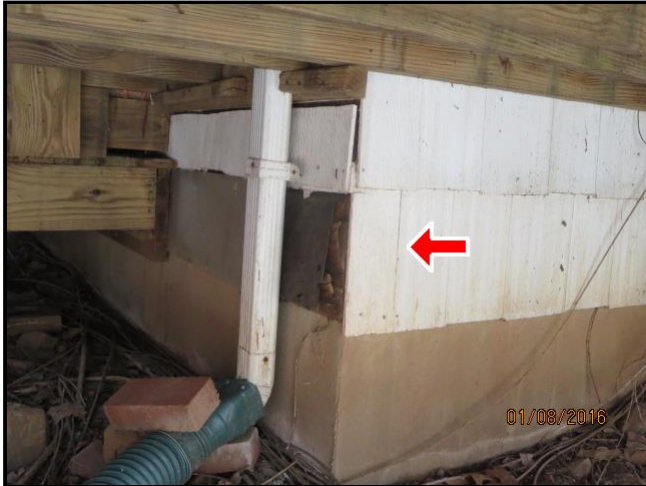
(3) Rotted wood siding under deck. Further deterioration will occur that can lead to water intrusion and mold if not corrected. Recommend a GC further evaluate.

2.0 Item 10(Picture) Wood rot

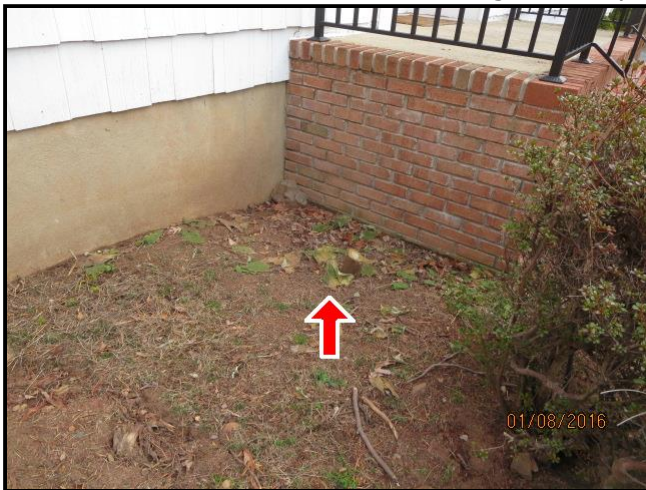
There is a negative slope at the front of home and can cause or contribute to water intrusion or deterioration. I recommend correcting landscape to drain water away from home.

2.4 Item 1(Picture) Negative slope

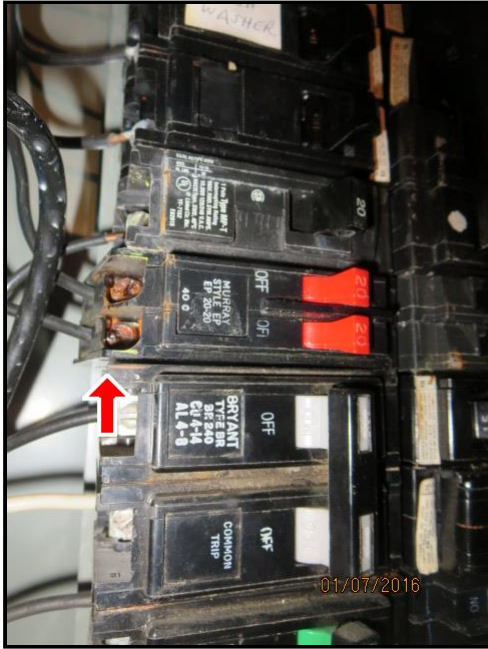
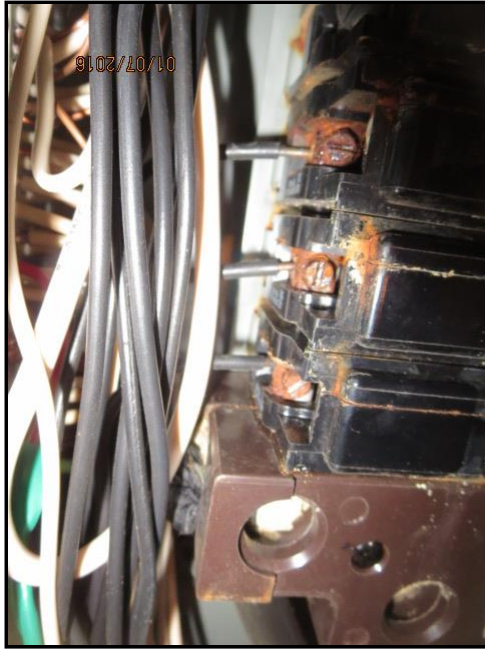
The problem(s) discovered in the panel such as doubled wiring at breakers, rust and any other problems that an electrical contractor may discover while performing repairs need correcting. I recommend a licensed electrical contractor inspect further and correct as needed. Sub Panel is not wired correctly. Neutral and ground wires are on the same bus bar.

3.1 Item 1(Picture) Rusty connections

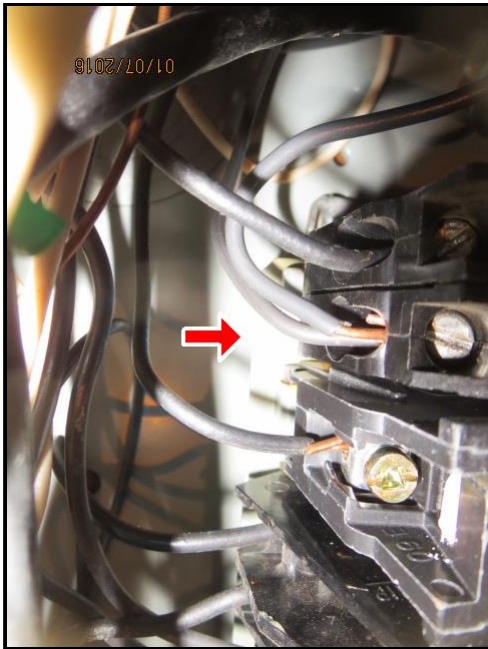
3.1 Item 3(Picture) Double wire connection

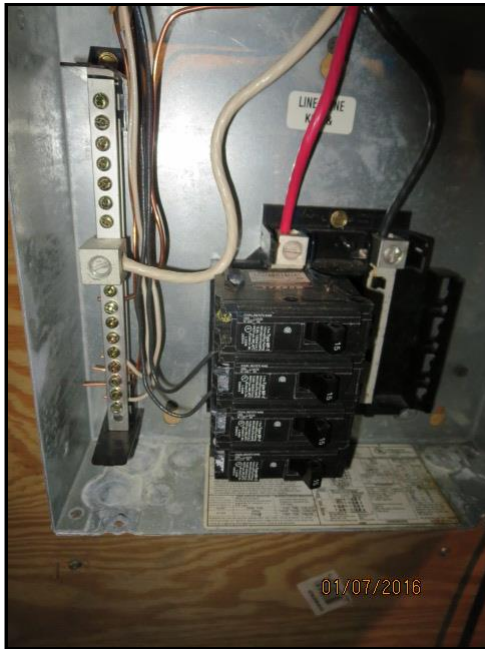
3.1 Item 4(Picture) Sub Panel

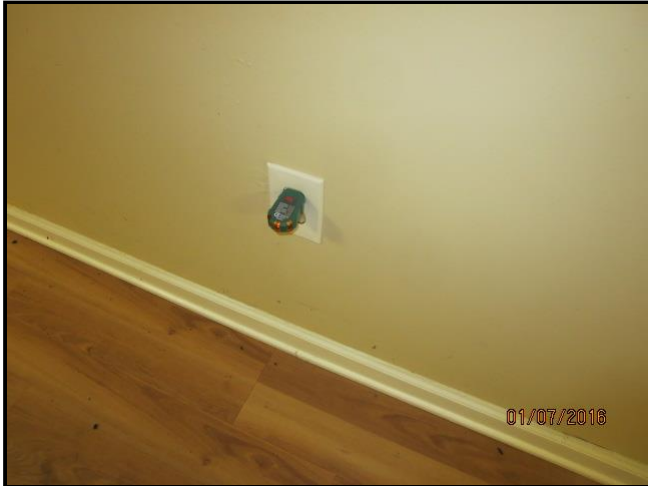
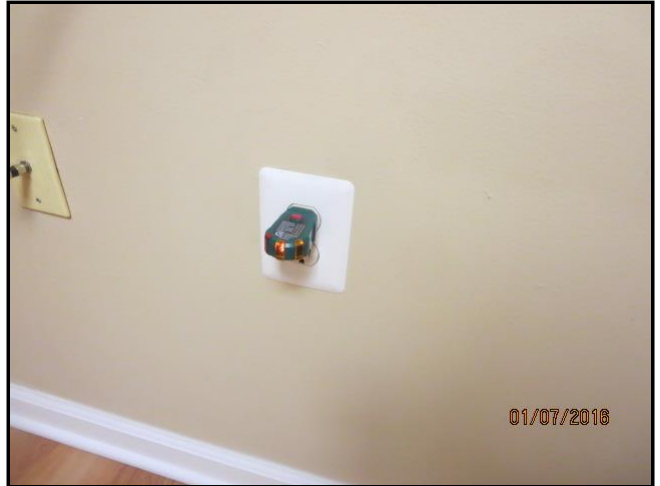
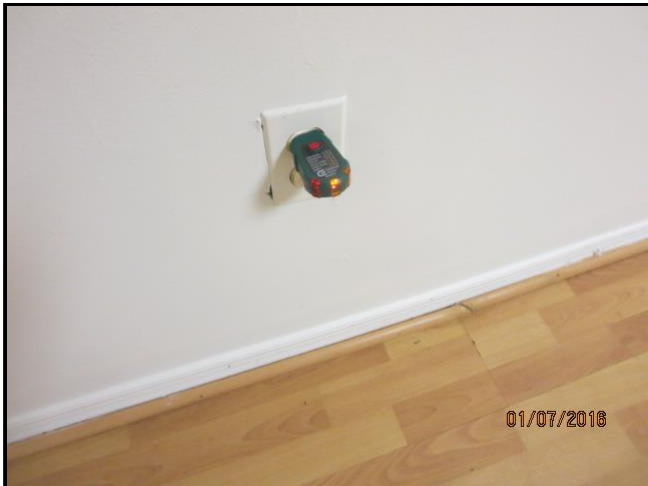
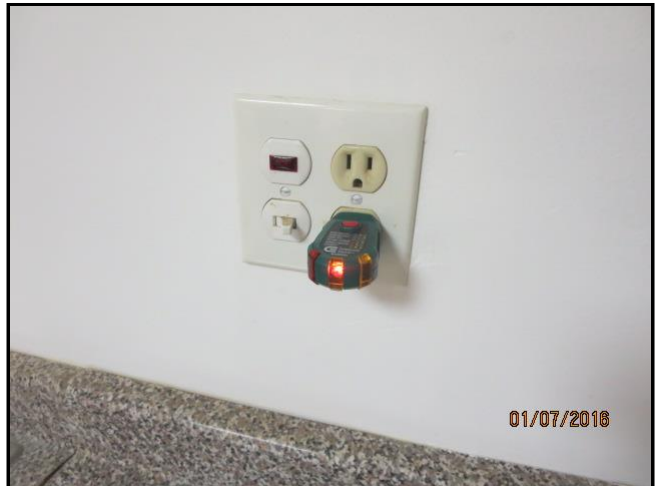
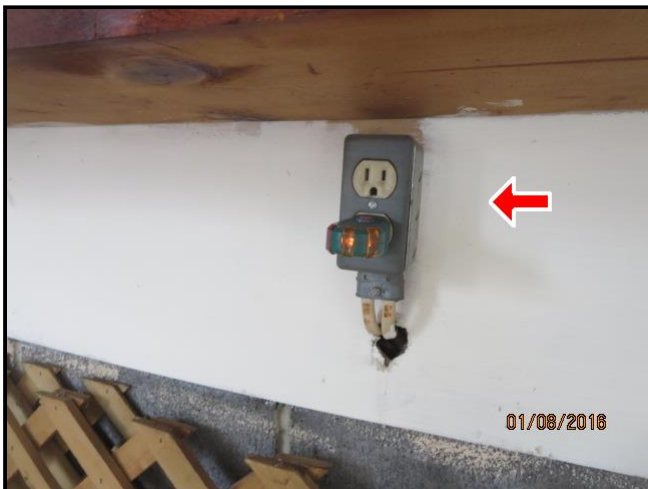
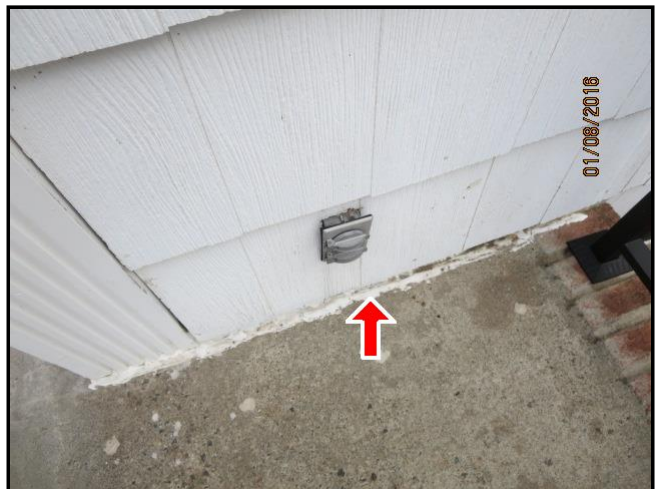
(1) At least 6 outlets in the basement and external are not grounded . This is a safety issue that needs to be corrected. A qualified licensed electrical contractor should perform repairs that involve wiring.

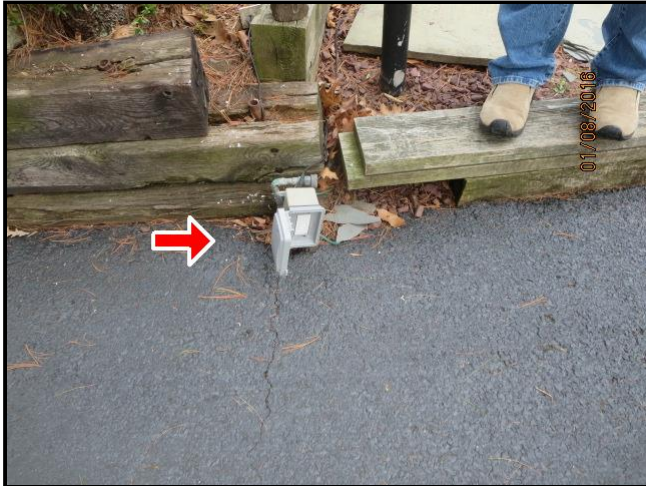
(2) The electrical outlet at driveway is a major safety issues. The outlet is too close to the ground and not protected from getting damaged that can cause an electrical shock.

3.3 Item 7(Picture) Driveway outlet

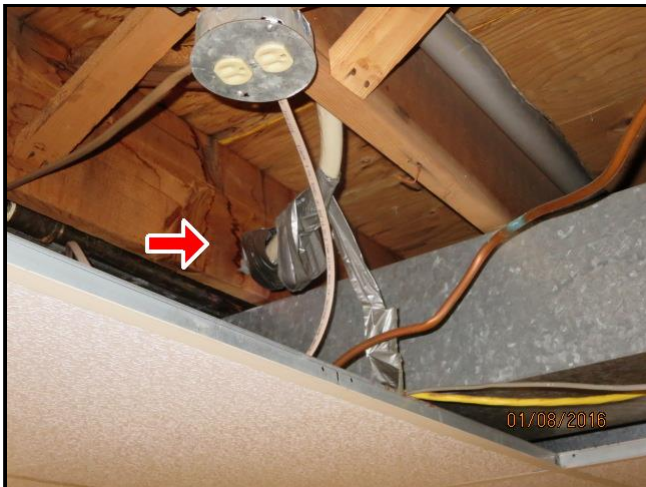
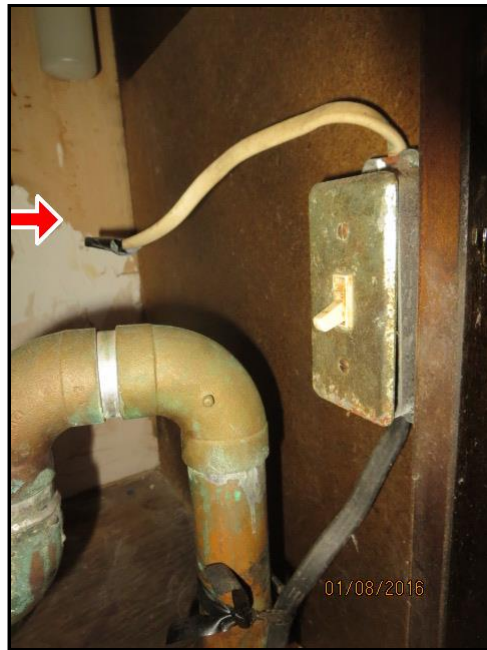
(3) Open splices were observed at the basement ceiling and under kitchen sink This is a safety concern that can lead to electric shock. Recommend a licensed electrician further evaluate.

3.3 Item 8(Picture) Open splice

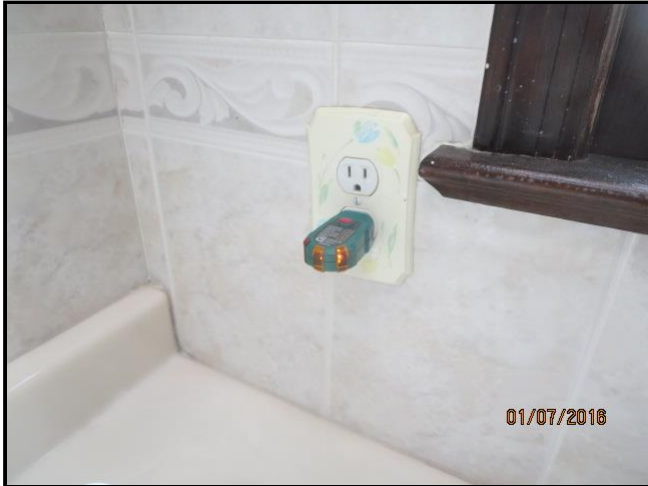
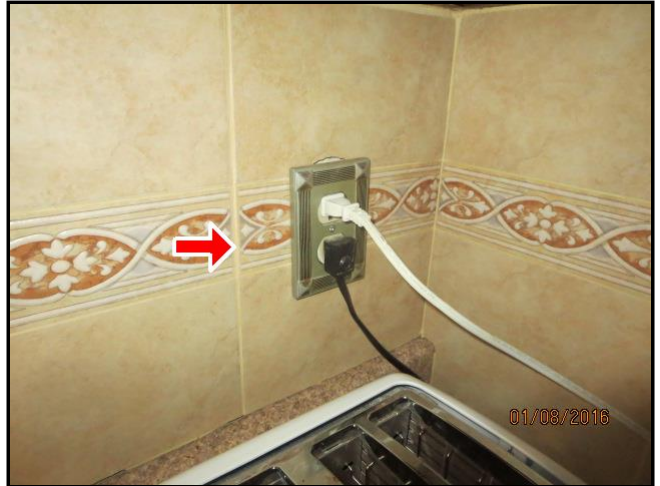
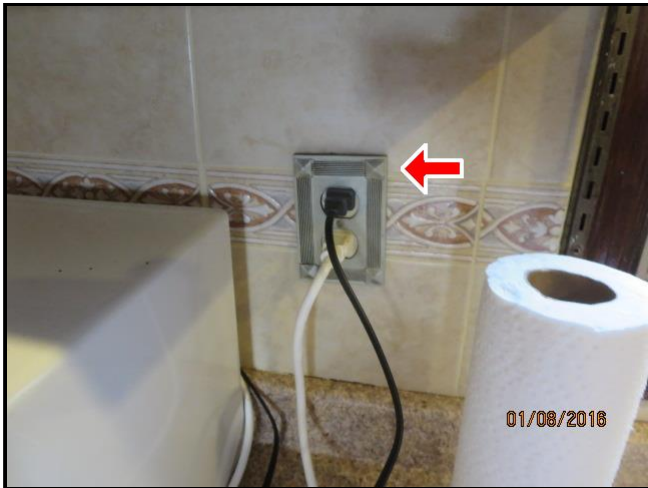
(4) All "three-prong" outlets are outdated and not a three-prong GFCI (Ground Fault Circuit Interrupt) in the kitchen and baths. These are a safety issue that needs to be corrected. A qualified licensed electrical contractor should perform repairs that involve wiring.

3.3 Item 10(Picture) Non GFCI

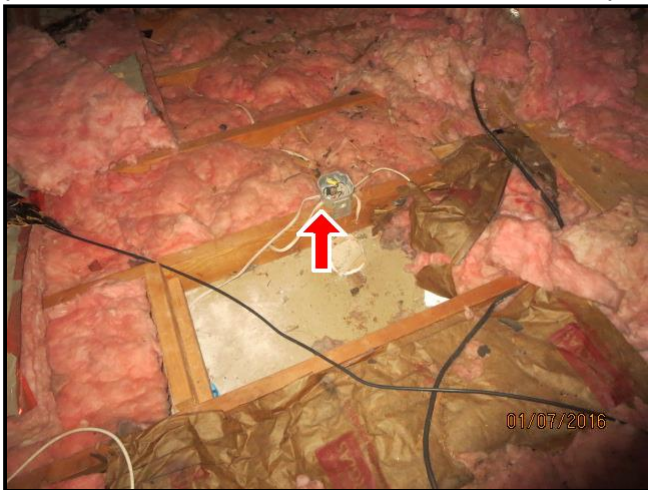
(5) Exposed wiring at the attic needs a cover plate . This is a safety issue that needs to be corrected. A qualified licensed electrical contractor should perform repairs that involve wiring.

3.3 Item 13(Picture) Needs cover plate

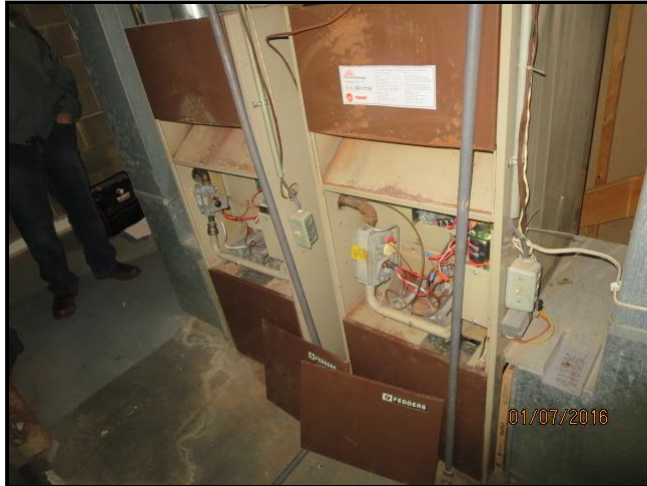
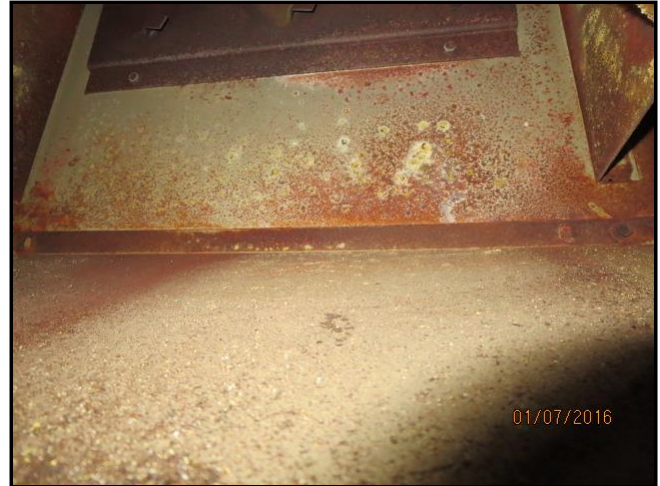
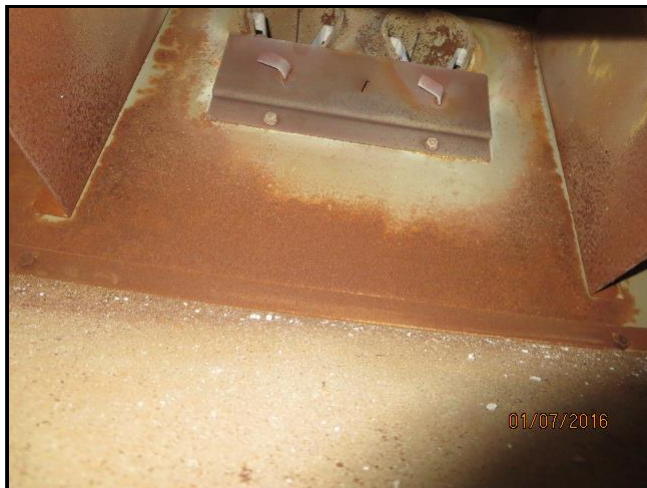
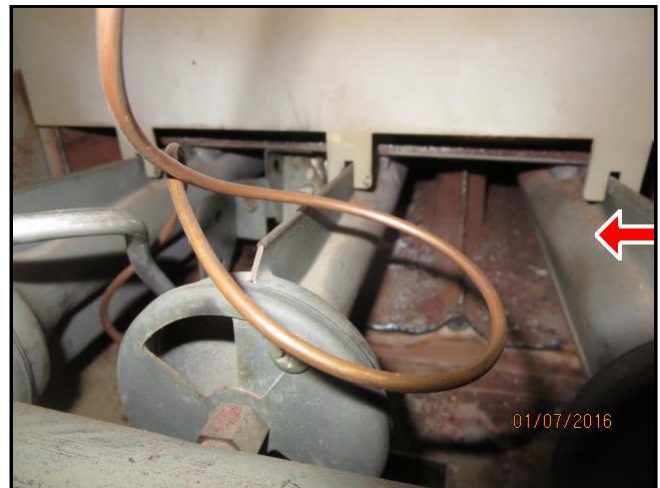
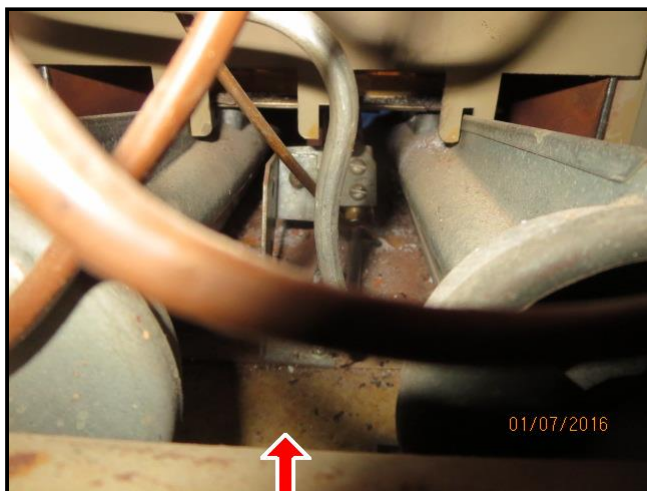
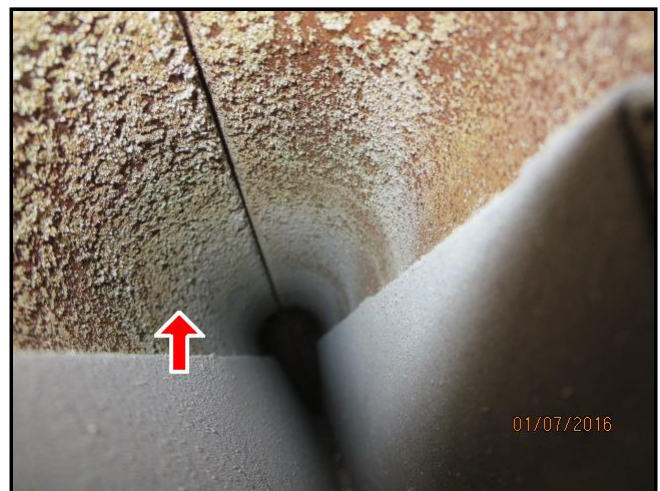
Both furnace have major heat exchanger rust conditions. A rusty heat exchanger can lead to carbon monoxide seeping into the home. This condition is a safety and health hazard issue. Recommend that the furnaces be shut down and not used till a HVAC contractor further evaluate. Both furnaces are very old and need to be replaced.

Furnaces were not inspected due to there safety conditions

4.0 Item 1(Picture) Rusty Furnaces

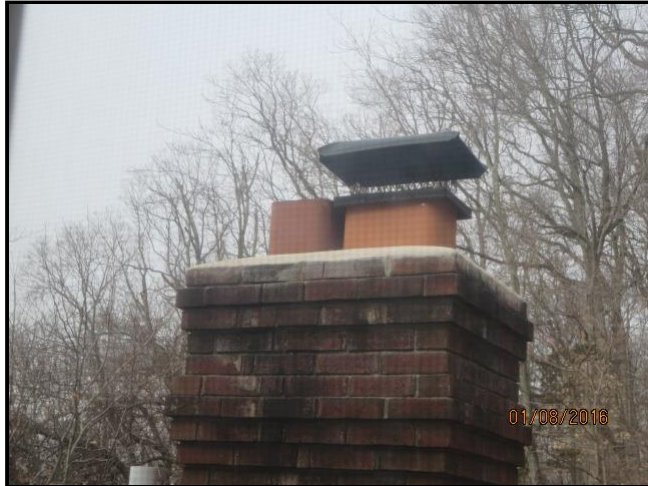
4.5 Item 1(Picture) Chimney

The liner was not inspected by our company. I recommend a qualified chimney sweep inspect for safety.

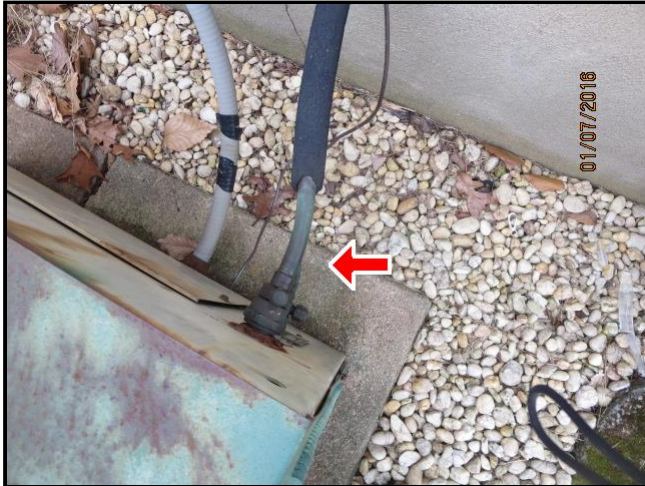
(2) The foam sleeve on suction line is missing foam sleeve in area(s) at outside unit. Missing foam on suction line can cause energy loss and condensation. I recommend service or repair as needed.

4.8 Item 2(Picture) Missing foam

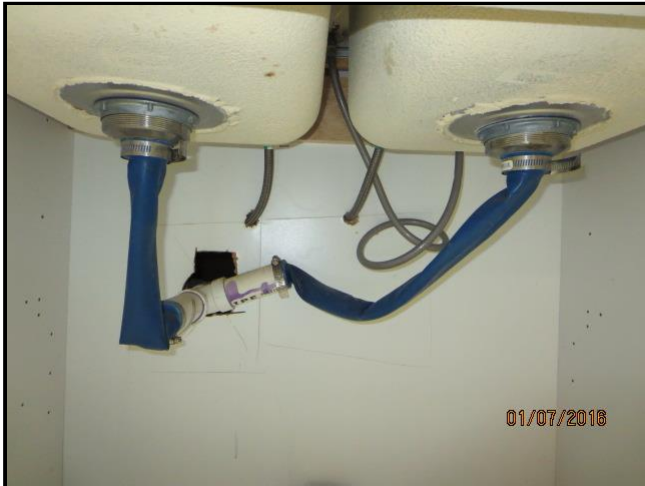
Piping and a p-trap on waste line is missing at the Kitchen sink this does not meet today's standards. Repairs are needed. A qualified licensed plumber should repair or correct as needed.

5.0 Item 1(Picture) Missing piping
