# Inspection Report

**Beemal & Tara Vasani**

**Property Address:**  
23 Glen Eagle Dr.  
Bridgewater NJ 08807

<b>Date:</b> 1/7/2016	<b>Time:</b> 10:00 AM	<b>Report ID:</b>
<b>Property:</b> 23 Glen Eagle Dr. Bridgewater NJ 08807	<b>Customer:</b> Beemal & Tara Vasani	<b>Real Estate Professional:</b> Kevin Cary Golden Key Realty

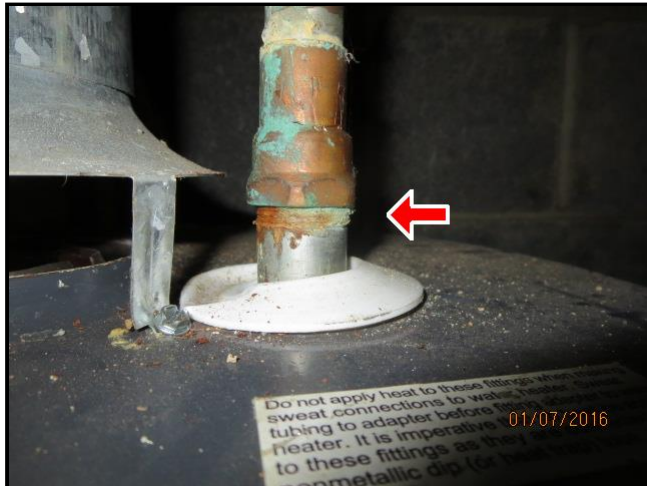
Plumbing connection at the water heater is corroded. Corroded pipes can lead to water leaks. Recommend a licensed plumber further evaluate and repair.

5.1 Item 1(Picture) Pipe corrosion

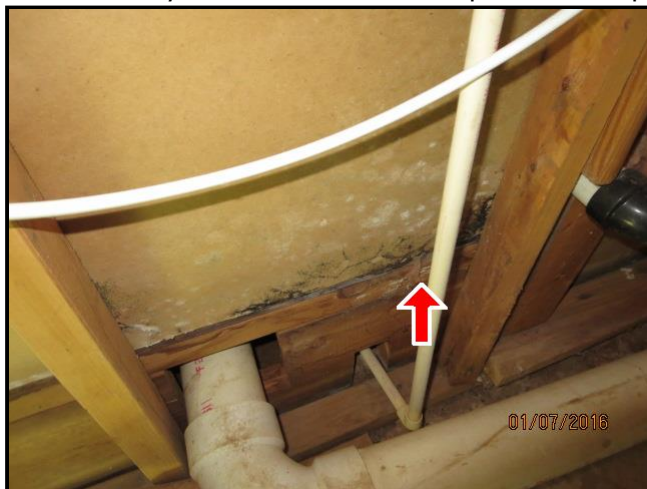
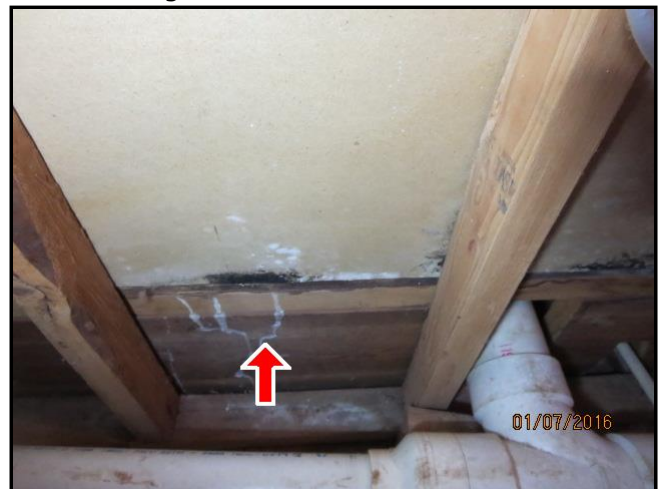
(1) Signs of fungi growth is present on the walls along basement in several areas. We did not inspect, test or determine if this growth is or is not a health hazard. The underlying cause is moisture. I recommend you contact a mold inspector or expert for investigation or correction if needed.

6.0 Item 1(Picture) Possible Mold

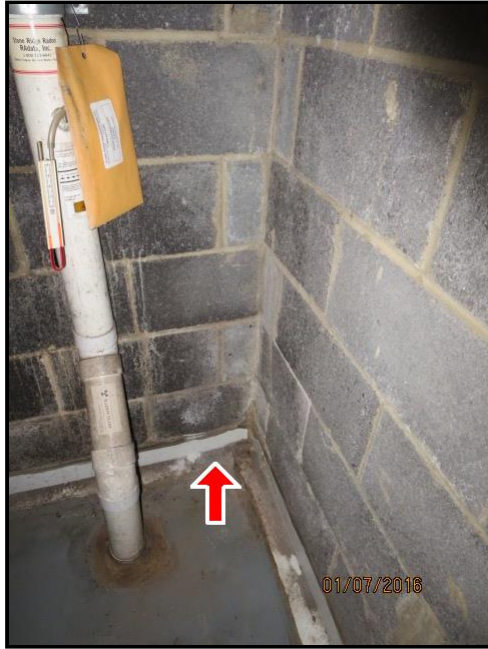
(2) White efflorescence (powder substance) on block wall indicates moisture is in contact with the masonry. This does not necessarily indicate that intrusion will occur. I recommend checking the gutters and the downspout drain lines for proper operation. Also, a water proofing paint could be applied to the interior side of the block if necessary. Efflorescence is found on many homes without water intrusion occurring inside the home. But, it should alert you to the possibility that future steps may be needed.

6.0 Item 3(Picture) Efflorescence

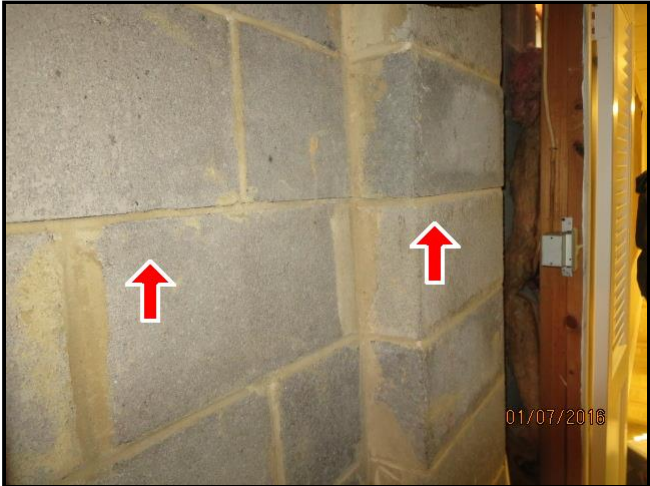
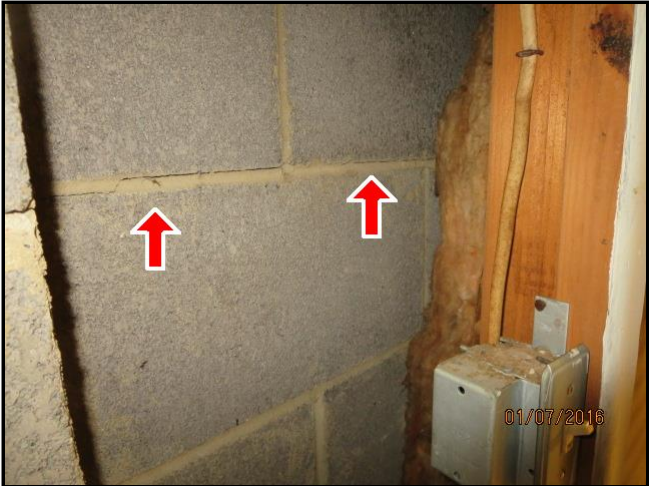
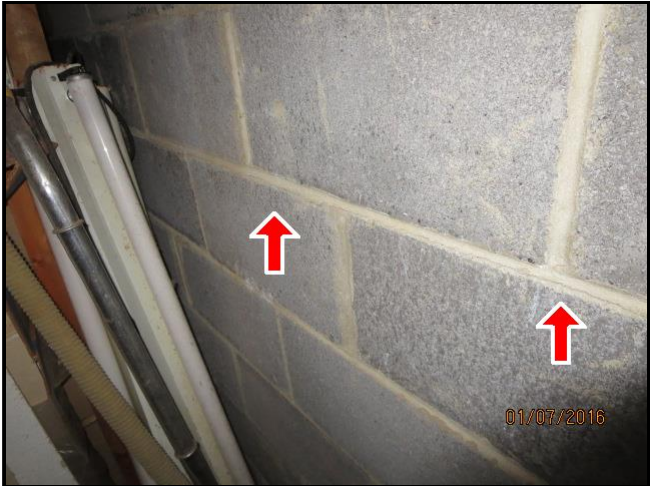
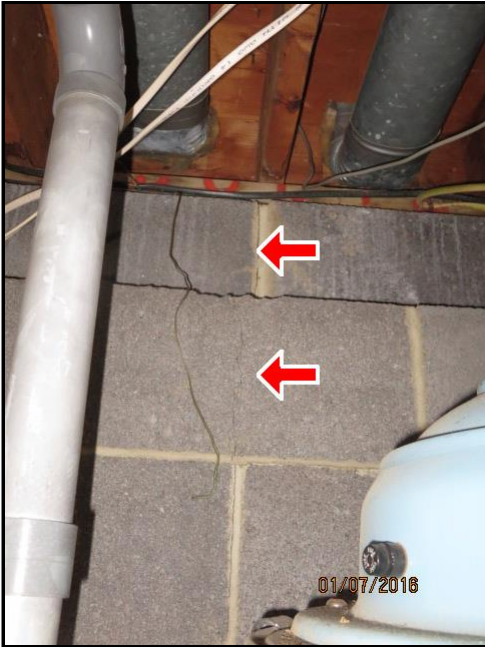
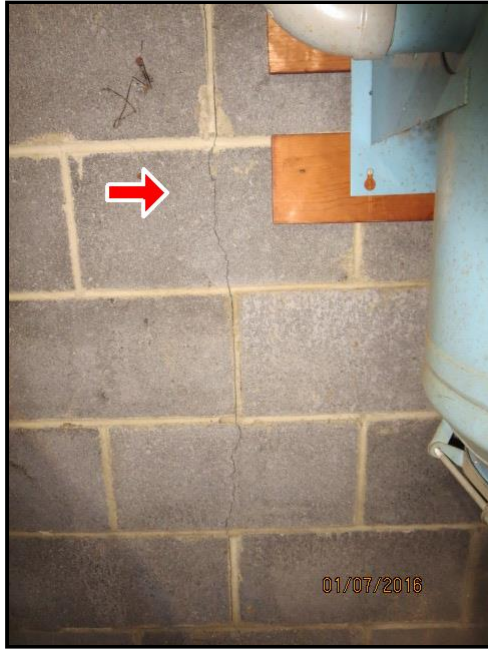
(1) The foundation walls at the front and left side (facing front) of home, has structural cracks these cracks may need reinforcement . A qualified engineer should inspect and repair or replace as needed.

6.1 Item 1(Picture) Crack

6.1 Item 2(Picture) Crack

6.1 Item 3(Picture) Crack

6.1 Item 4(Picture) Crackl

6.1 Item 5(Picture) Crack

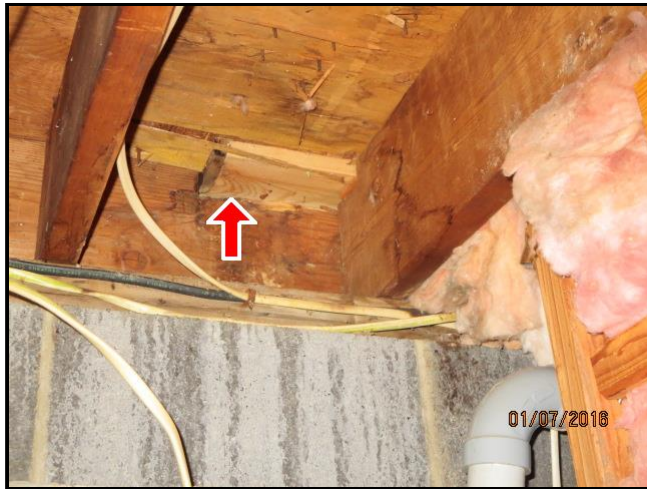
(2) Repair was made at the floor joist under rear door. Recommend that the repair be monitored and repair and replace as needed.

6.1 Item 6(Picture) Joist Repair

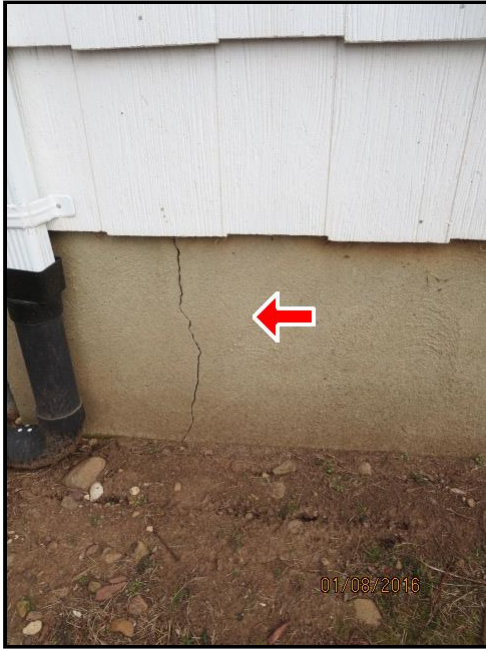
(3) The foundation wall at the front of home is damaged with a crack. This crack does not appear significant to require repairs at this time but does need to be sealed. A qualified engineer should inspect and repair or replace as needed.

6.1 Item 7(Picture) Foundation crack

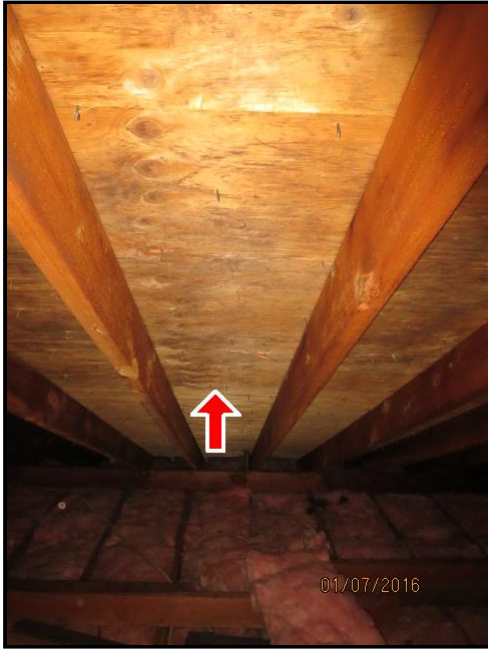
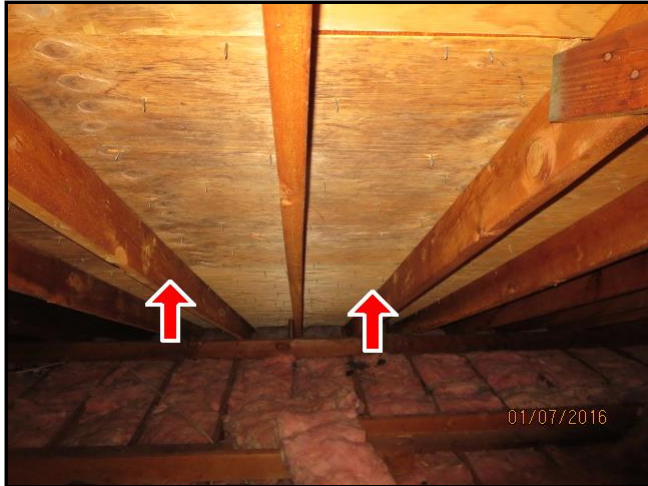
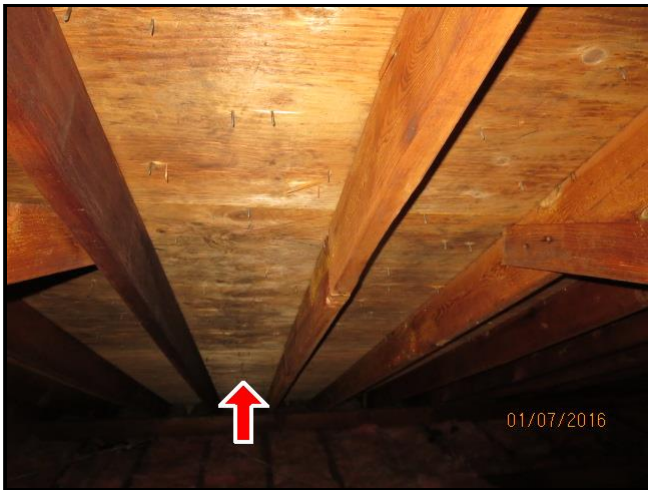
The roof sheathing in the attic may have mold. Mold can be a health hazard. Recommend a mold specialist further evaluate.

6.5 Item 1(Picture) Possible Mold

6.5 Item 2(Picture) Possible Mold

6.5 Item 3(Picture) Possible Mold

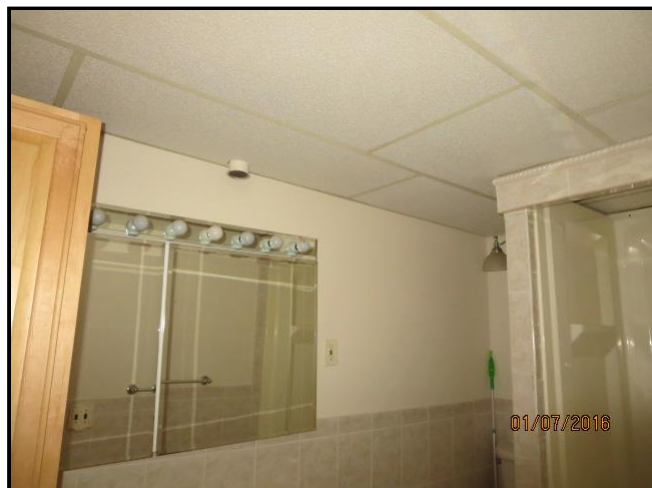
The Exhaust fan is missing at the basement bath. This does not meet today's standards . A qualified contractor should inspect and repair as needed.

7.4 Item 1(Picture) Missing fan

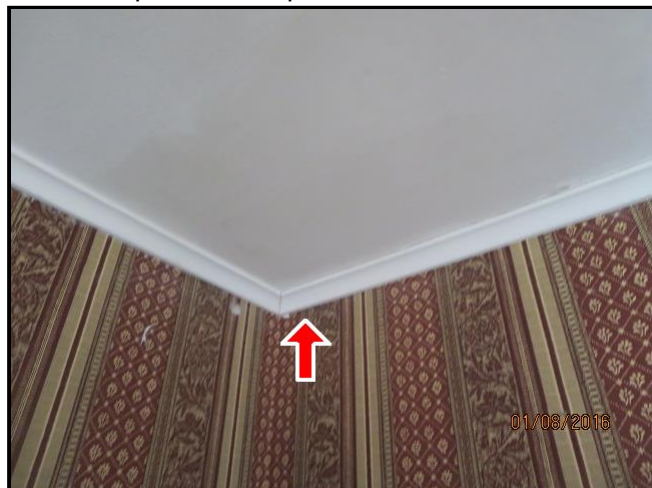
The Drywall on the ceiling reveals a water stain indicating a leak did or still exists at the Washer/Dryer room. Repairs were done. Water leak may be coming from vent pipe at roof A qualified contractor should inspect and repair as needed.

8.0 Item 1(Picture) Water stain

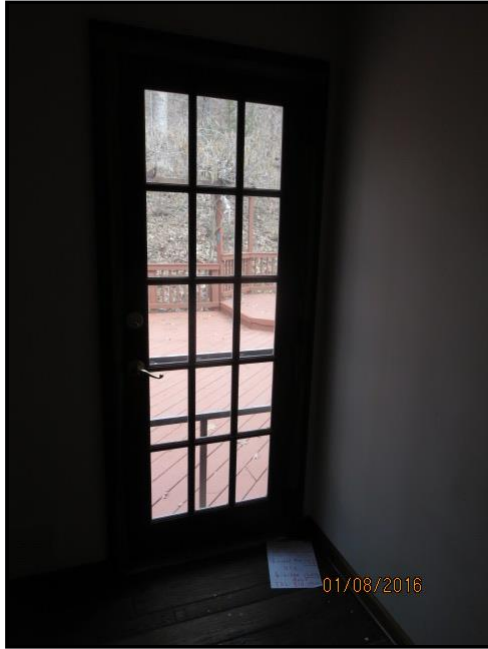
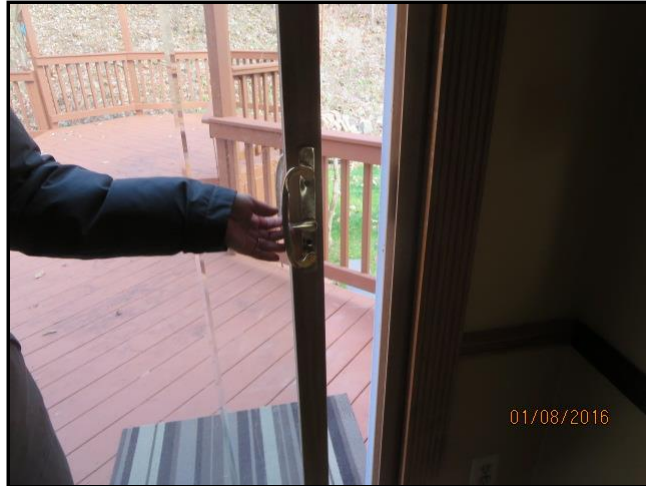
The Entry doors are defective at the Kitchen and family Room. This is considered unsafe and needs correcting. A qualified contractor should inspect and repair as needed.

8.5 Item 1(Picture) Non working door

8.5 Item 2(Picture) Broken lock

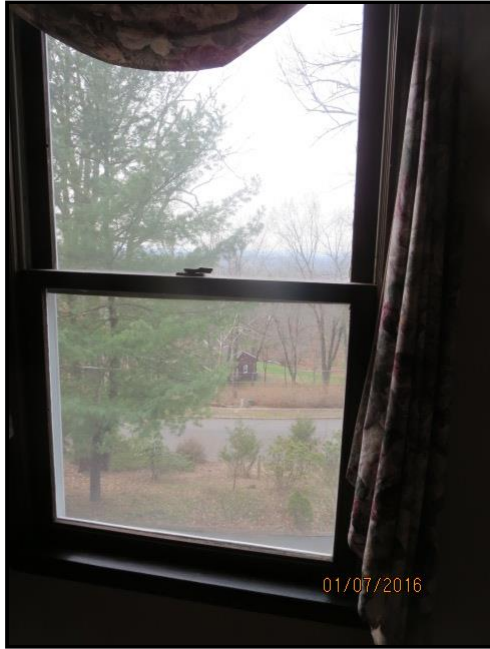
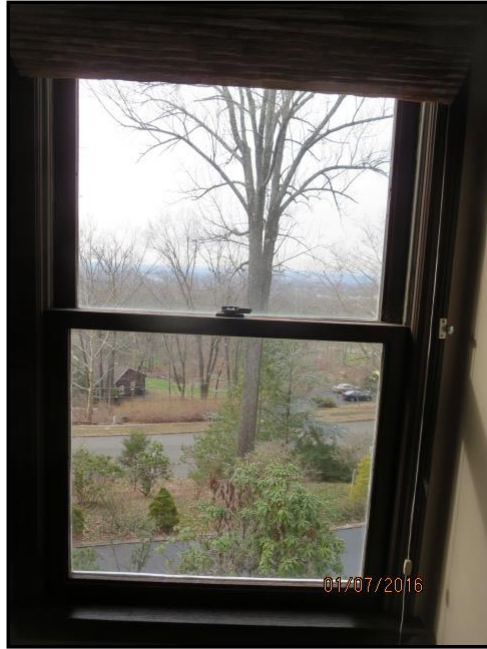
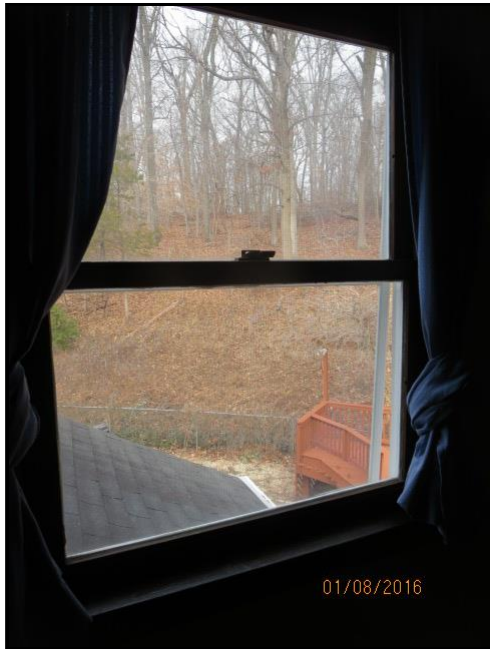
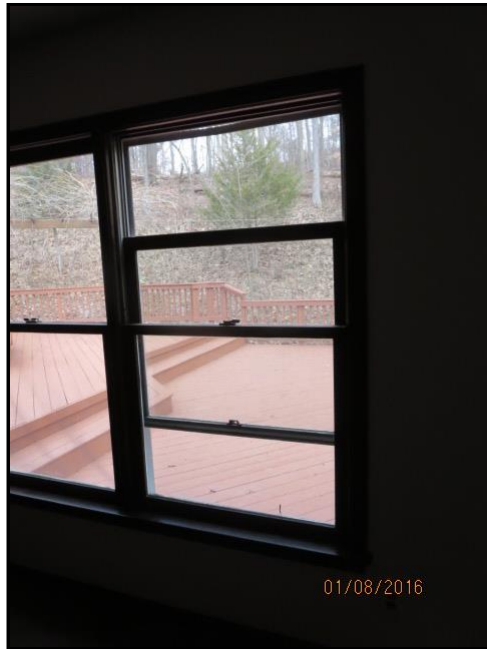
Four windows stuck or painted shut at the Bedroom and family Room. Further deterioration may occur if not repaired. A qualified contractor should inspect and repair as needed.

8.6 Item 1(Picture) Non working window

8.6 Item 2(Picture) Non working window

8.6 Item 3(Picture) non working window

8.6 Item 4(Picture) Non working window

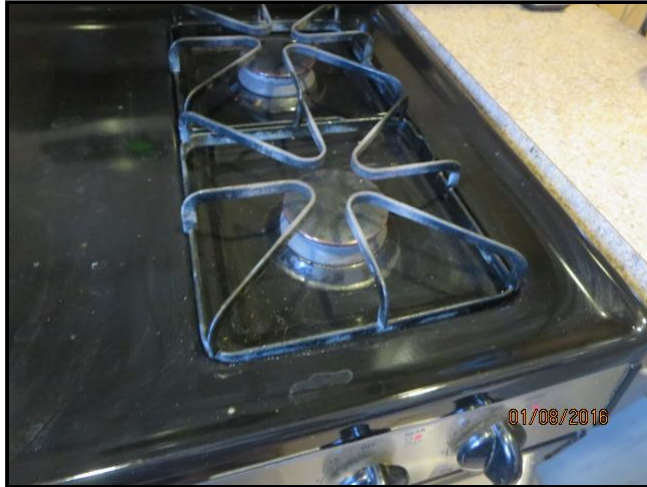
The front right burner (on range) did not work when tested. I recommend repair as needed.

10.1 Item 1(Picture) Range
