LAKE AREA HOME INSPECTIONS

PROPERTY INSPECTION REPORT

Concerning: 134 Lakeside Dr., Mabank, TX 75156
(Address or Other Identification of Inspected Property)

By: Shawn Phares, Lic #Trec#20825 10/20/2018
(Name and License Number of Inspector) (Date)

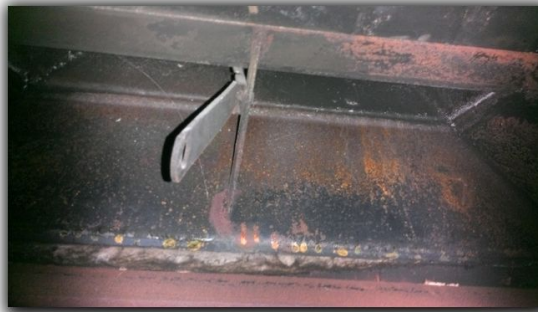
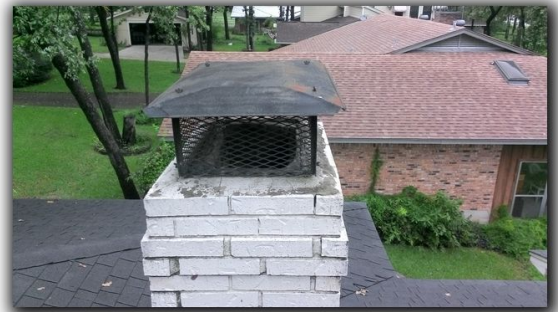
J. Fireplaces and Chimneys

Comments: This is a wood burning fireplace built with the house. It has a functioning damper as well as a proper spark arrestor the chimney. It is clean and in good condition.

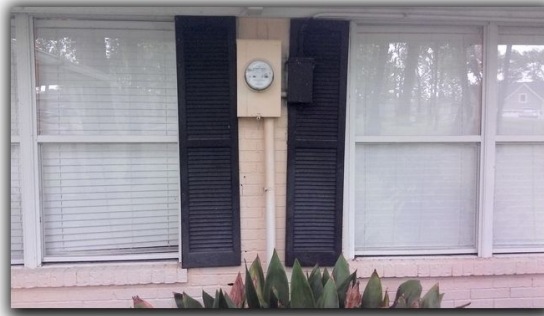
A. Service Entrance and Panels
Service Entrance

Comments: This is a standard 200 amp service entrance entering from below ground on the west side of the house.

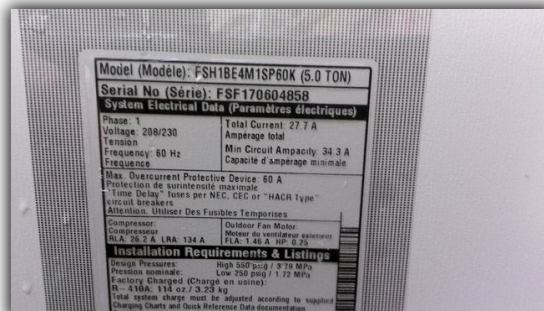
B. Cooling Equipment

Comments: This is a 5 ton heat pump HVAC system. According to the serial number was manufactured in 2017.

It is universally accepted by manufacturers as well as technicians that operating HVAC systems in the cooling mode when the outside temperature is below 60° can damage the the unit. This applies to both heat pump and forced air units.

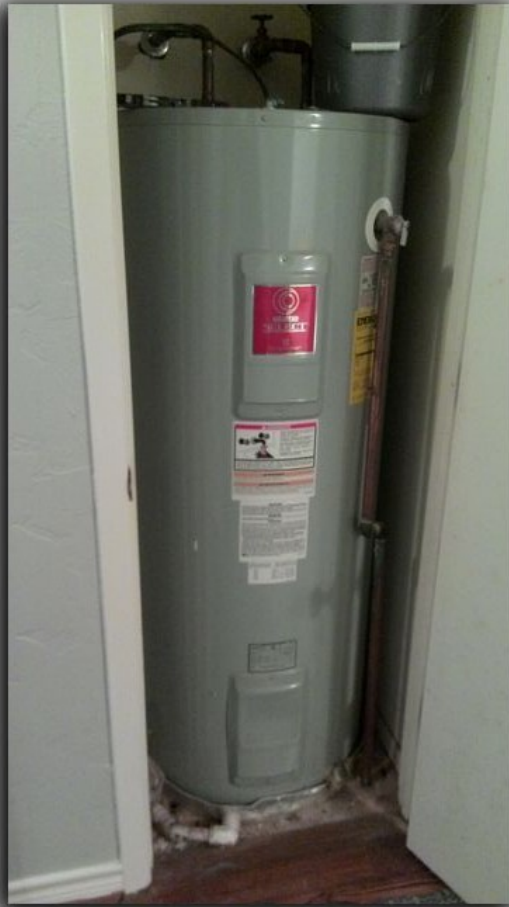
Comments: The water is an 80 gallon capacity State Select, according to the serial number it was manufactured in 2004. It is professionally installed according to current building codes however the breaker to it was turned off so I did not tested operating.

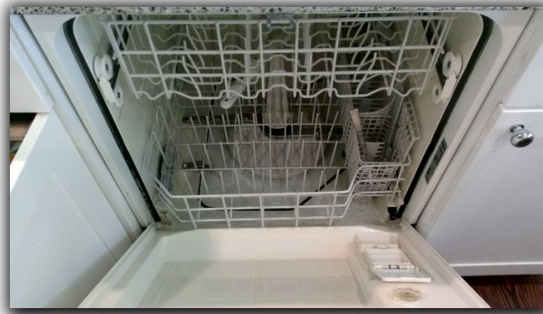
A. Dishwashers

Comments: The dishwasher was fully cycled and operating at the time of the inspection.

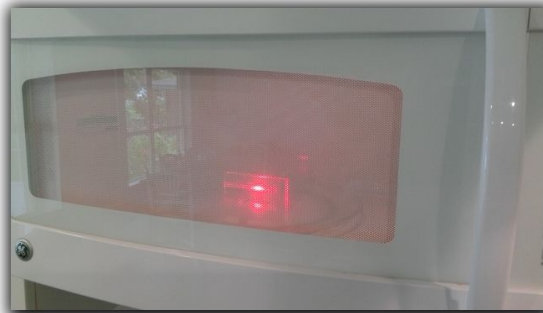
C. Range Hood and Exhaust Systems

Comments: This is a microwave/range hood exhaust system combination unit. The unit was tested and is in good working condition.

Note: This is a recirculating type of unit and therefore does not terminate to the exterior of the house.

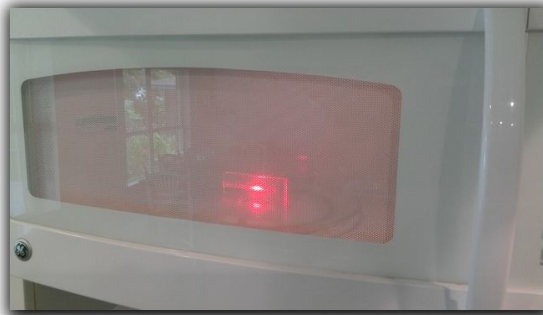
E. Microwave Ovens

Comments: The microwave oven was tested and operating at the time of the inspection.

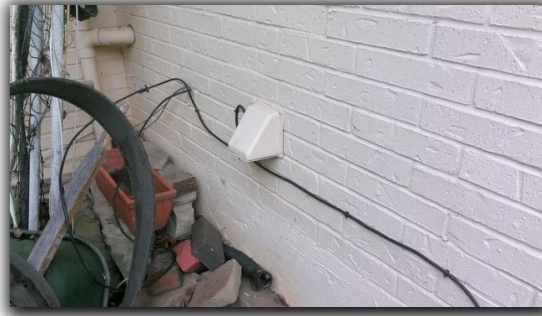
H. Dryer Exhaust Systems

Comments: The dryer exhaust vent is present and terminates properly to the exterior of the house.
