PROPERTY CONDITION ASSESSMENT REPORT

Sample Report
Watertown, MN

Monday, November 23, 2015

RE: Report No. 1493, v.3
Sample Report
Watertown, MN

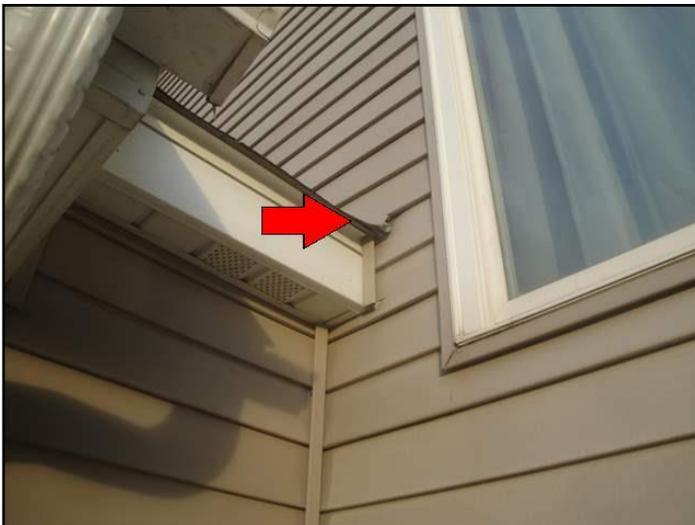
1. No kickout flashing

Implication(s): Chance of water damage to contents, finishes and/or structure

2. Condition: • [No kickout flashing](#)

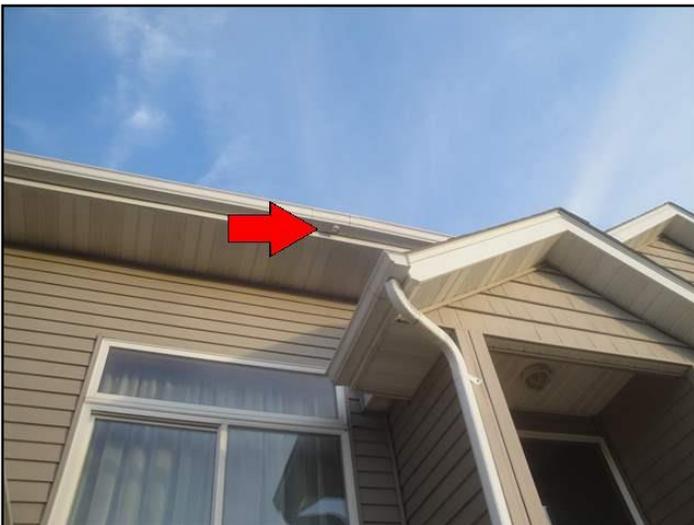
4. *Too few*

Condition: • [Too few](#)

Implication(s): Chance of water damage to contents, finishes and/or structure

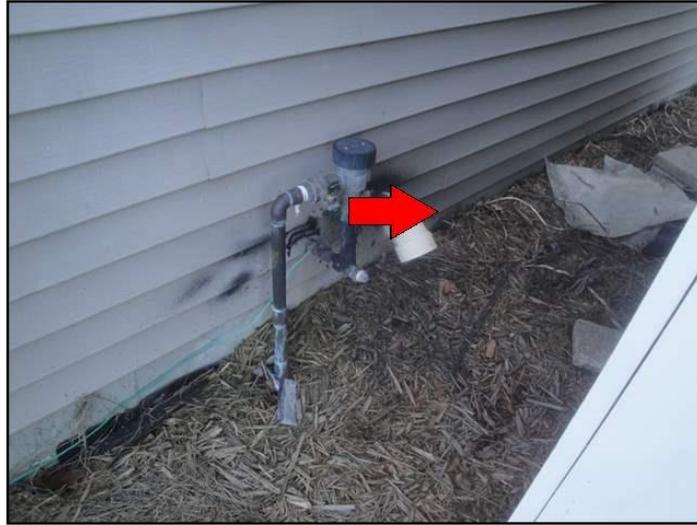
10. Too close to grade

Condition: • [Too close to grade](#)

Areas of siding were below grade. Over time, this condition has the potential to rot the wood sheathing and framing.

Implication(s): Chance of water damage to contents, finishes and/or structure

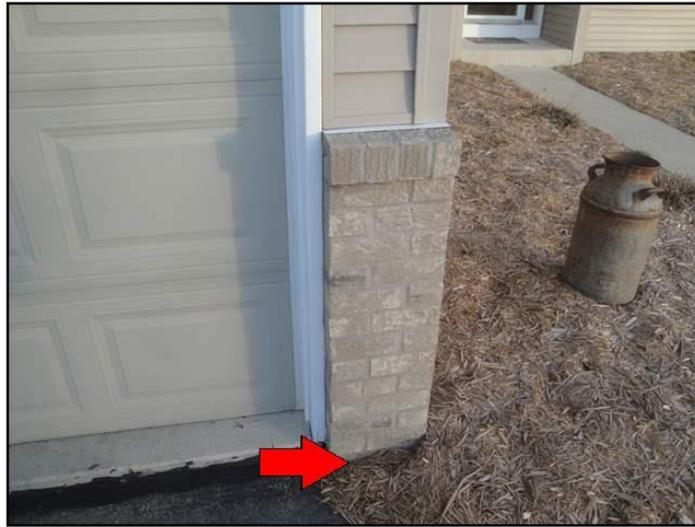
11. Too close to grade

11. Condition: • [Too close to grade](#)

Implication(s): Chance of water entering building | Weakened structure | Rot

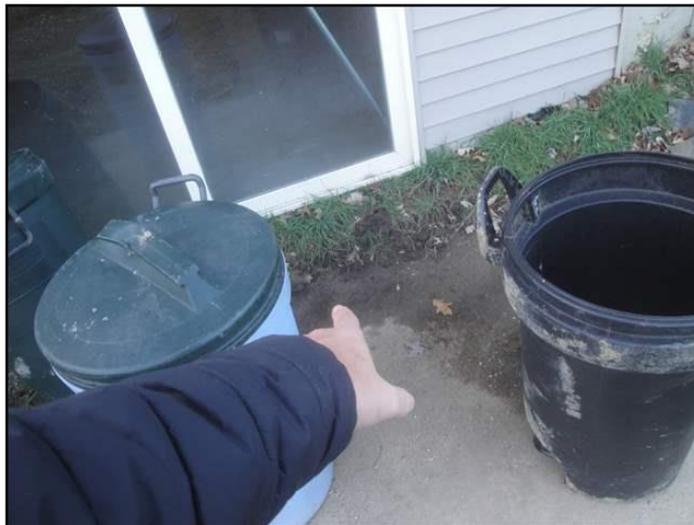
19. Slope toward building

Implication(s): Chance of water damage to contents, finishes and/or structure

22. Condition: • [Slope toward building](#)

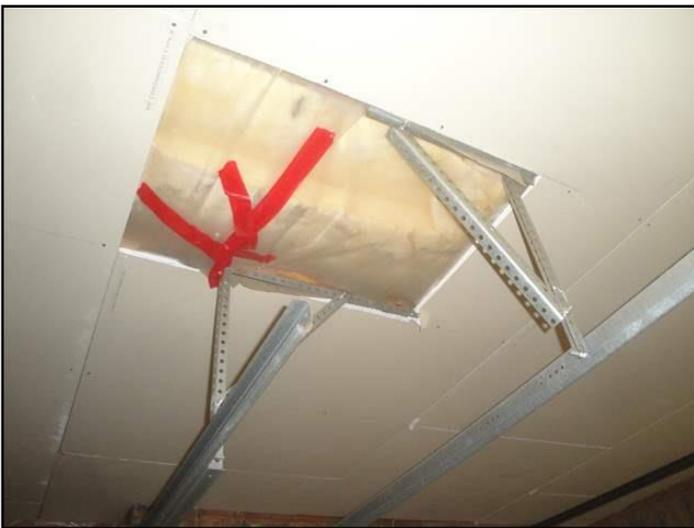
23. Not fireproof

Condition: • Not fireproof

Implication(s): Fire hazard

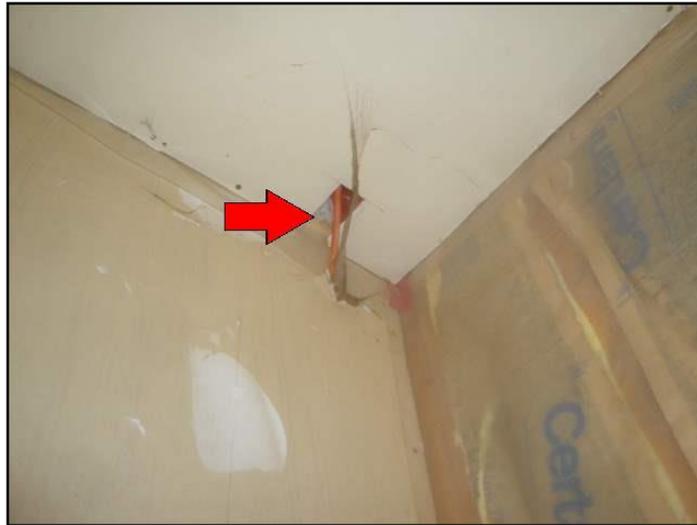
33. Exposed on walls or ceilings

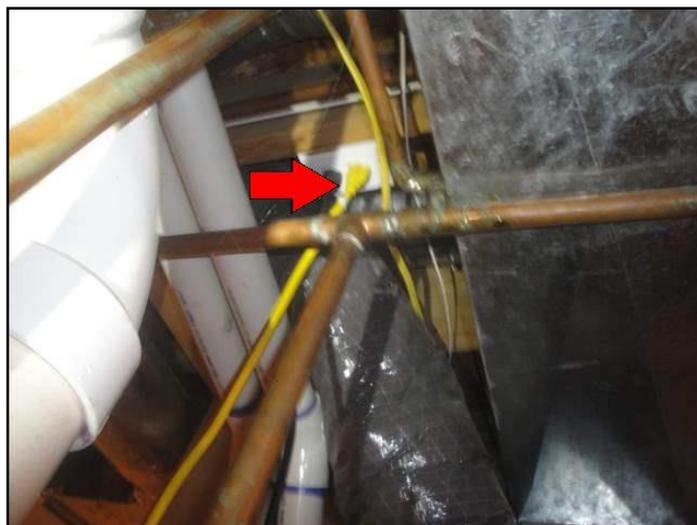
34. Extension cord used as permanent wiring

Task: Remove

Time: Immediate

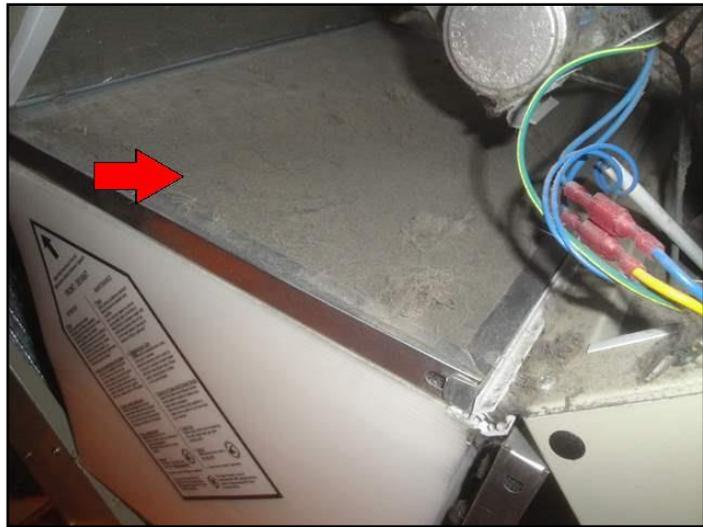
45. Condition: • [Dirty](#)

39. Dirty

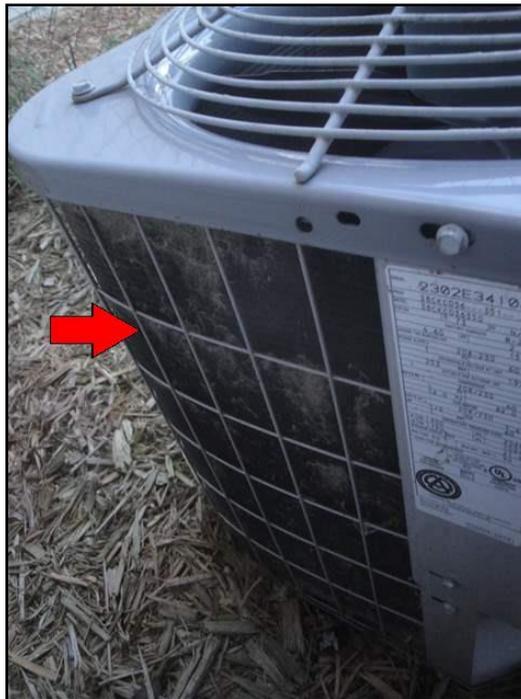
47. **Condition:** • [Dirty](#)

40. Dirty

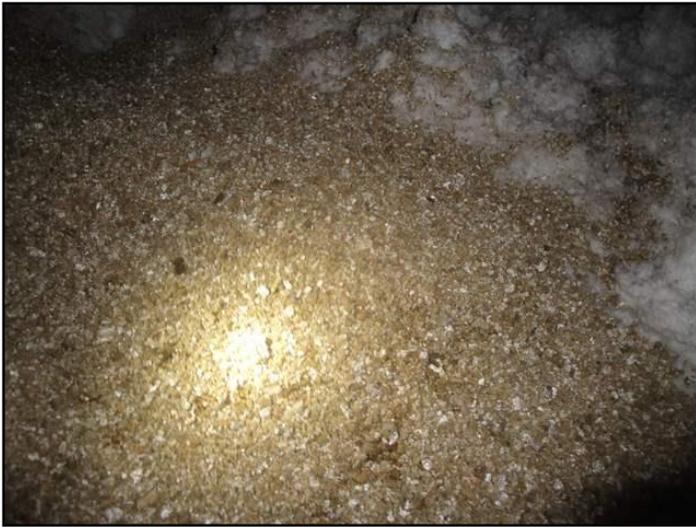
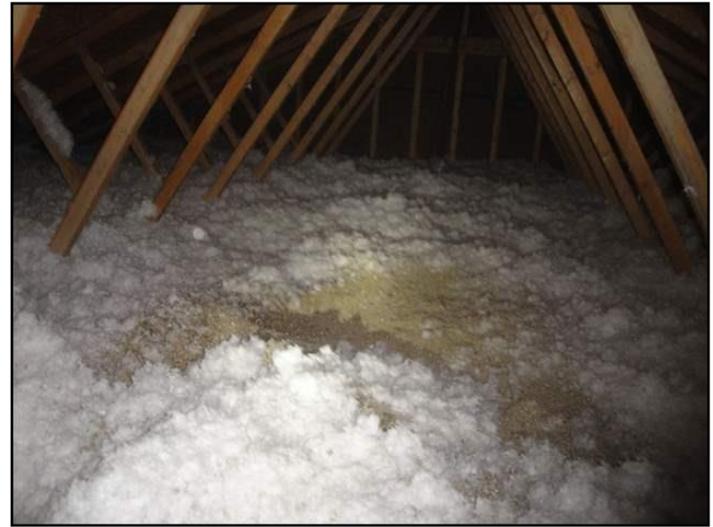
49. Condition: • [Possible Zonolite](#)

A small amount of vermiculite insulation was observed in the attic. Recommend testing the vermiculite to determine if it is contaminated with asbestos.

42. Possible Zonolite

43. Possible Zonolite

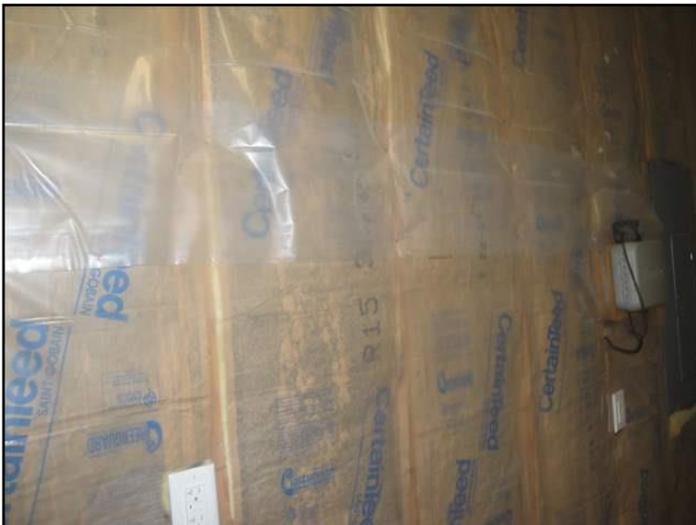
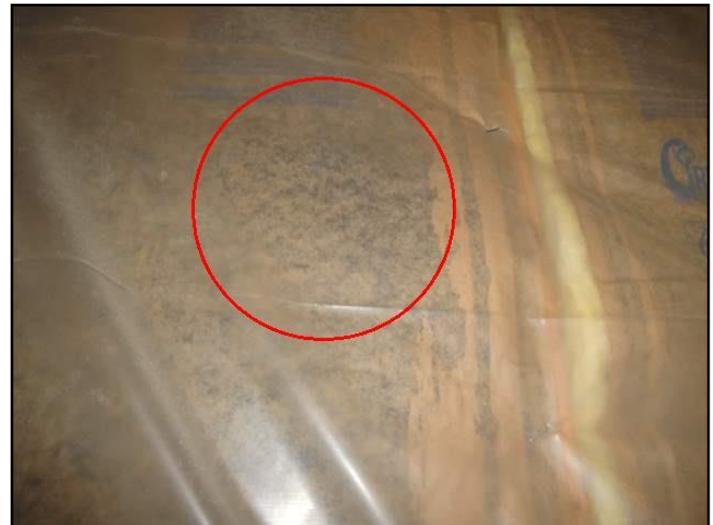
50. Condition: • Double vapor barrier. Potential mold observed on the Kraft paper located behind the plastic.

Task: Remove

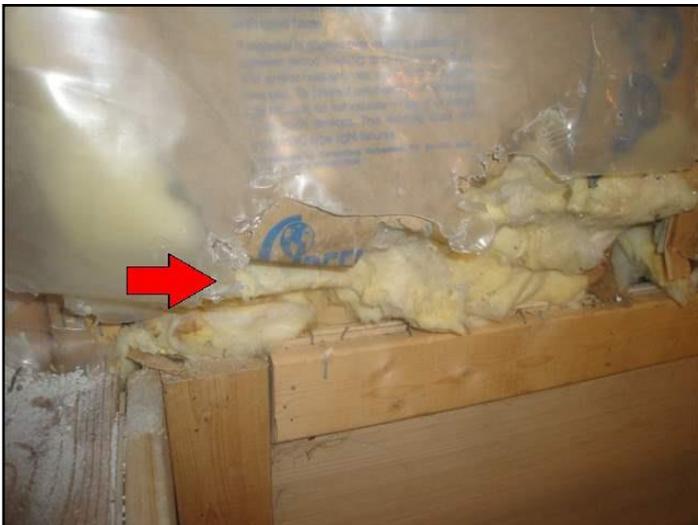
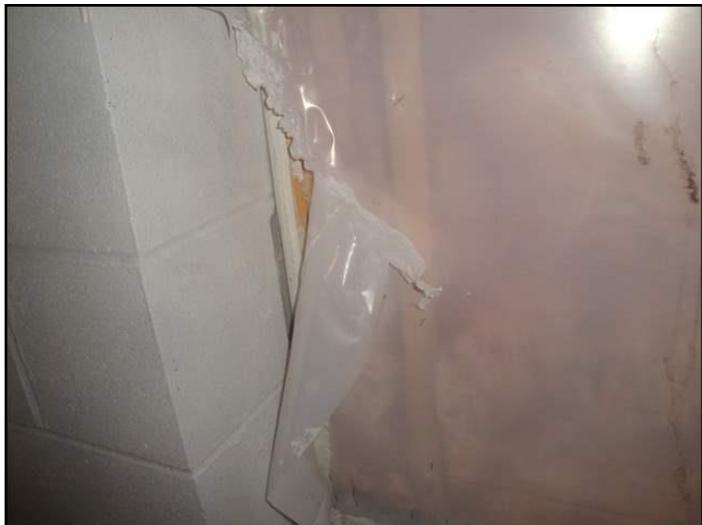
51. Condition: • [Incomplete](#)

Lacks approved mastic for sealing to top and bottom plate. Voids and missing areas were observed. Seal seams and small voids with approved tape.

46. Incomplete

47. Incomplete

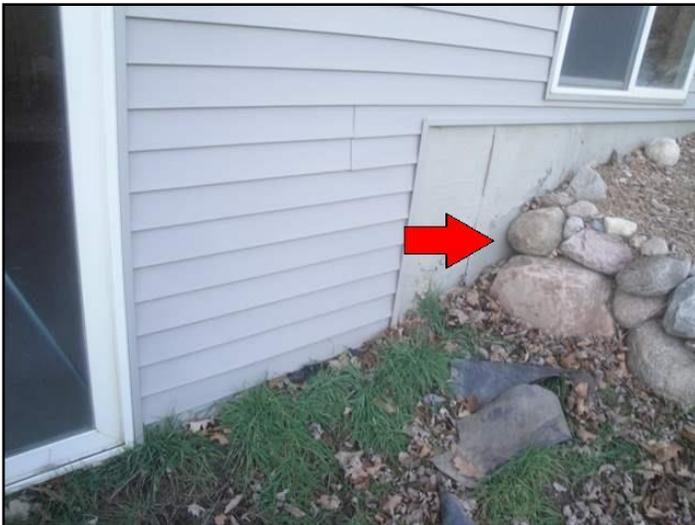
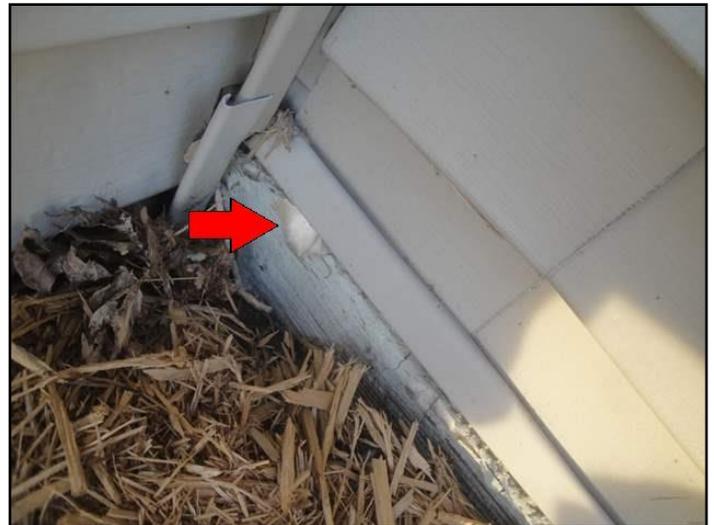
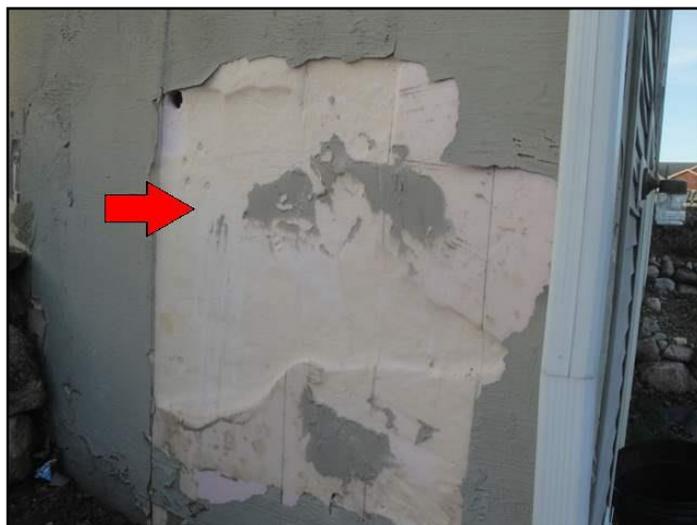
52. Condition: • [Not protected at top](#)

Protective coating is damaged or deteriorated. Link to article:
<http://www.greenbuildingadvisor.com/blogs/dept/qa-spotlight/how-finish-exterior-foundation-insulation>

48. Not protected at top

49. Not protected at top

50. *Not protected at top*

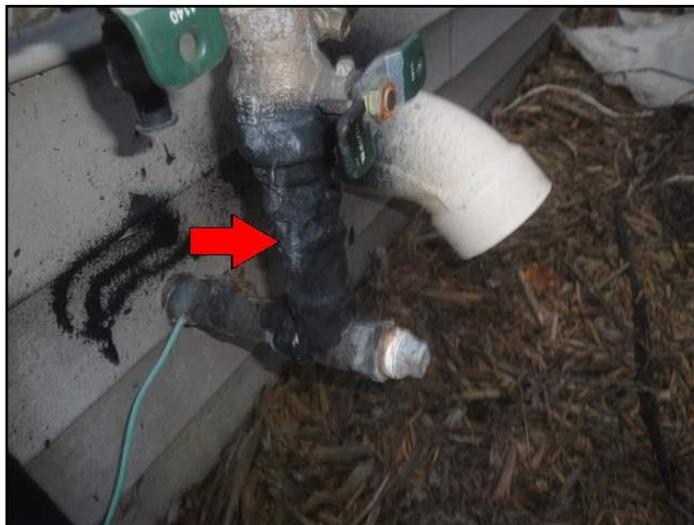
54. Condition: • [Non-standard material](#)

Appears to be a temporary repair

52. Non-standard material

Task: Further evaluation

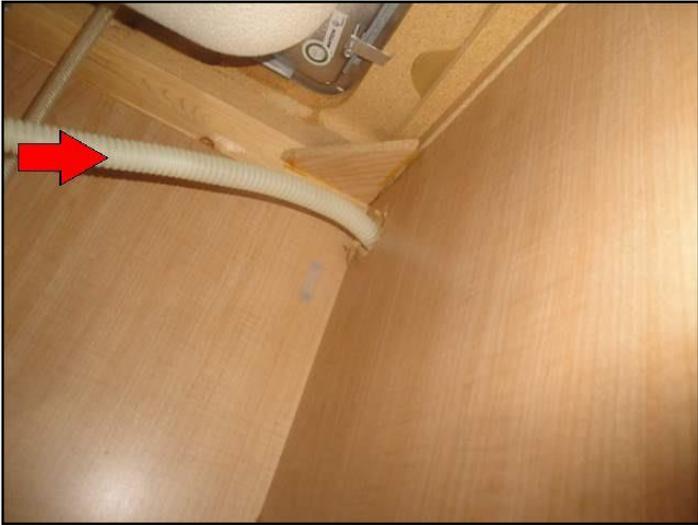
55. Condition: • [Dishwasher drain connections](#)

53. Dishwasher drain connections

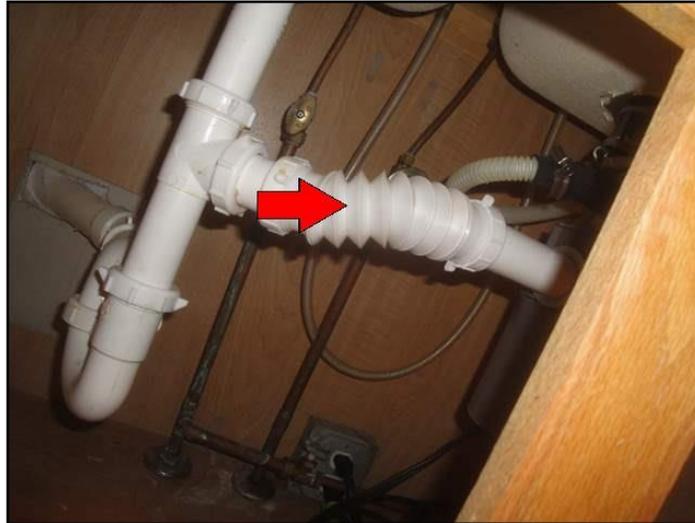
56. Condition: • [Nonstandard materials and patches](#)
Flexible drain connector.

54. *Nonstandard materials and patches*

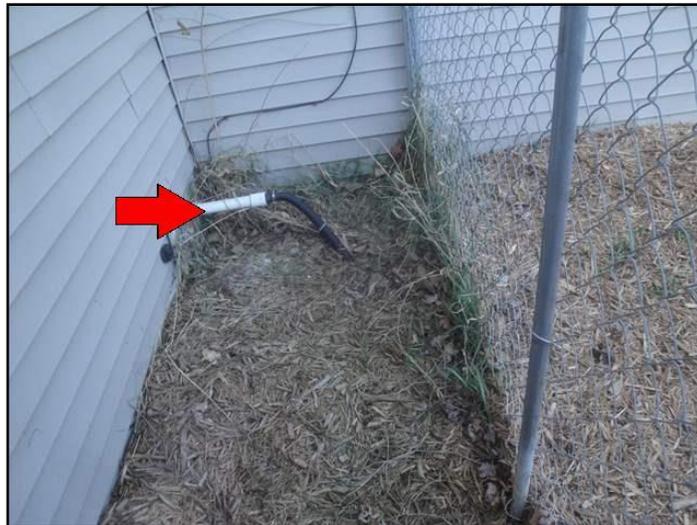
58. Condition: • [Discharge pipe problems](#)

Appears to discharge below grade near the foundation. Excavate the area to determine where the pipe terminates or disconnect below grade portion and replace with a corrugated hose that discharges to grade.

55. Discharge pipe problems

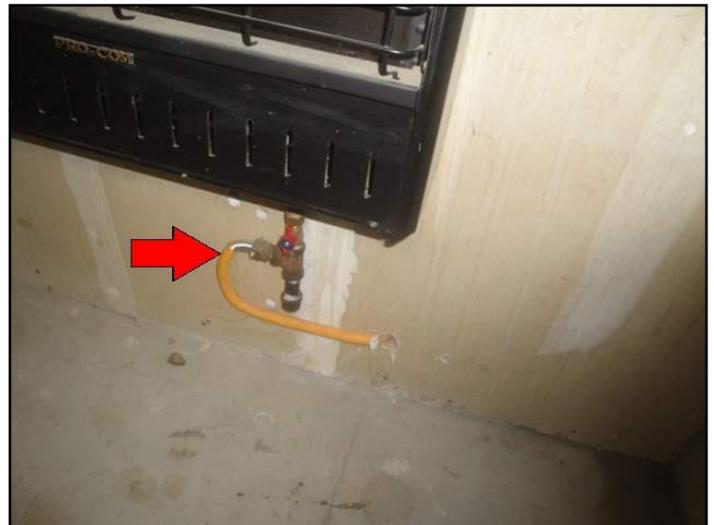
63. Condition: • Piping not properly bonded

CSST gas pipe that is not bonded is a potential fire hazard if affected by a lightning strike. Visit: <http://www.csstsafety.com/Images/CSST-Direct-Bonding-Tech-Bulletin.pdf>

59. Piping not properly bonded

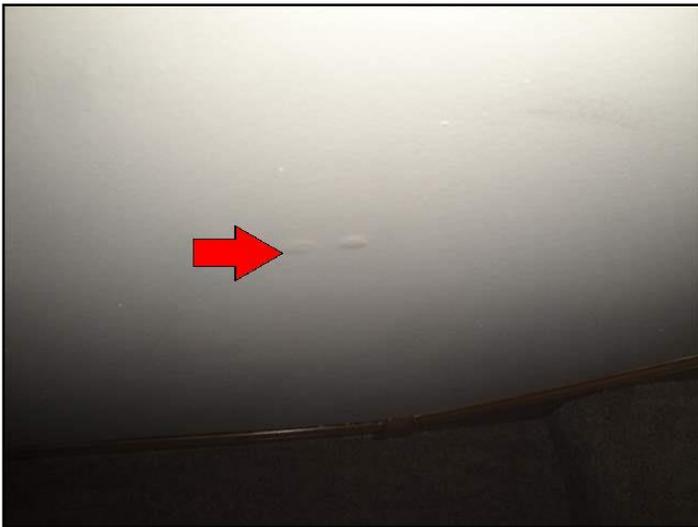
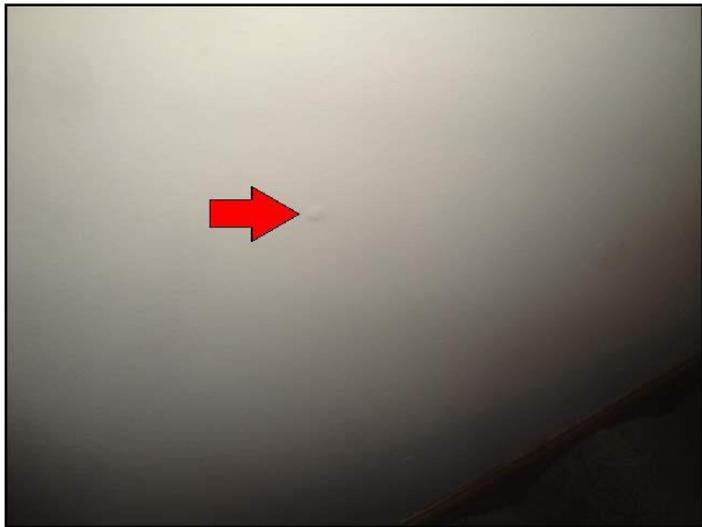
66. Condition: • [Nail pops](#)

60. Nail pops

61. Nail pops

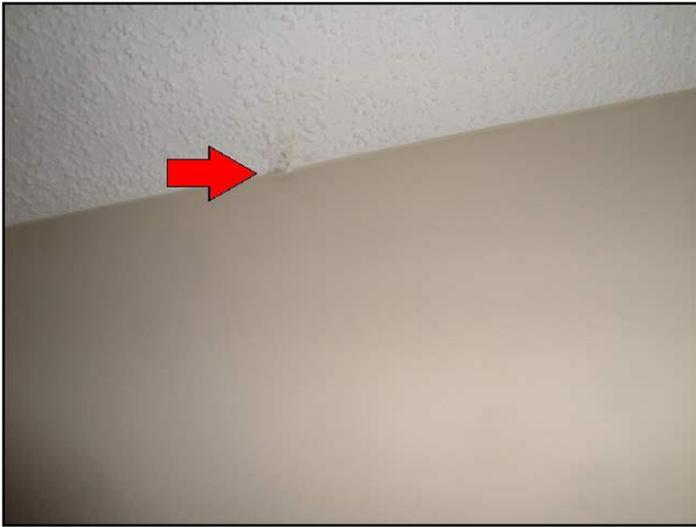
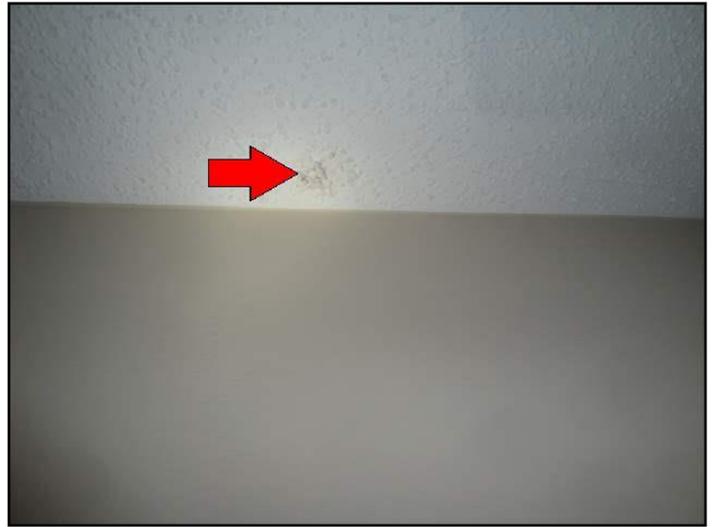
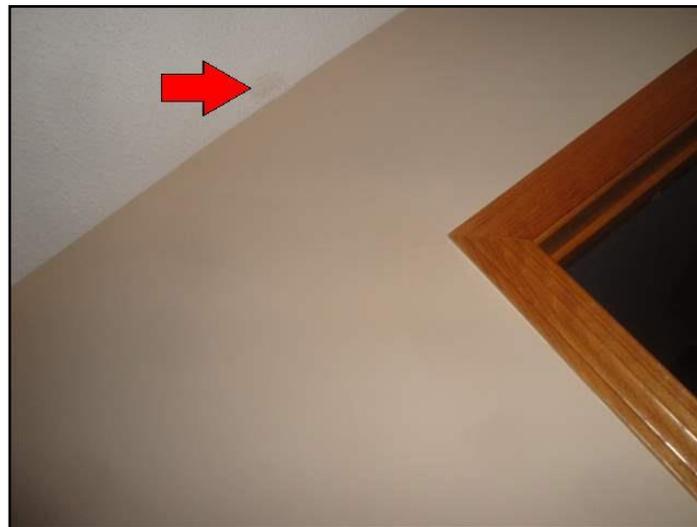
68. Condition: • [Nail pops](#)

Stains may indicate a past leak.

62. Nail pops

63. Nail pops

64. Nail pops

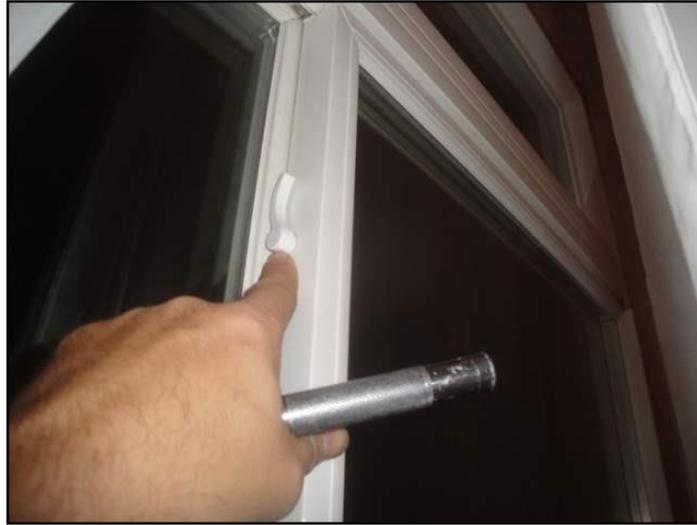
69. Condition: • [Inoperable](#)

65. Inoperable

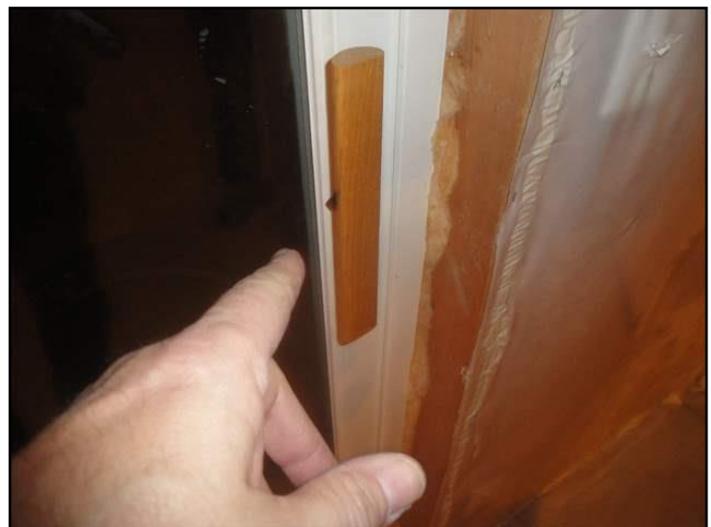
73. Condition: • Lock not effective on exterior door

71. Lock not effective on exterior door

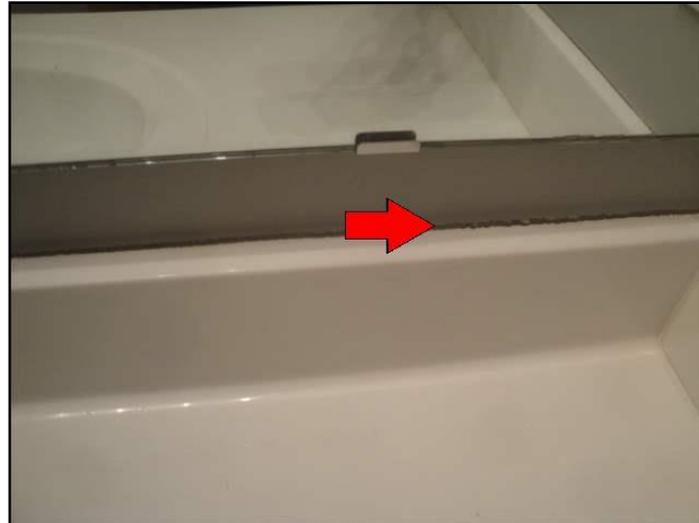
72.

74. Condition: • Damaged or missing sealant
