<b>Client</b> John & Kathleen Driscoll 12 Tommy Luther Dr Saratoga , 12866 HIN™: 128665433 Email: <a href="mailto:dosborn@catsofalbany.com">dosborn@catsofalbany.com</a> Inspection Date: 02-21-2015	 
<b>Inspector</b>  Phone: _____ E-Mail: _____

Thank you for choosing Zielinski Home Inspection. With 30 plus years of experience in the building trades, I will bring you, my experience and the integrity that I have to every client in the past.

# Report Summary

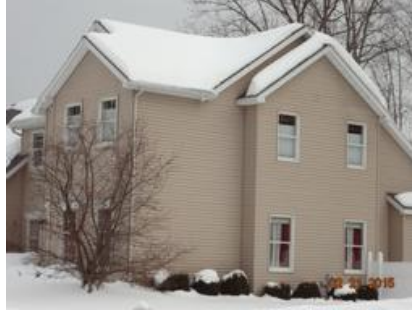
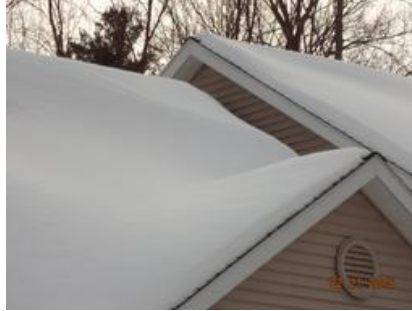
02/22/2015 At time of inspection a majority of roof was covered with snow. This limited the visibility and could not properly inspect the roof. When the snow melts,I could come back out and do a visual inspection.

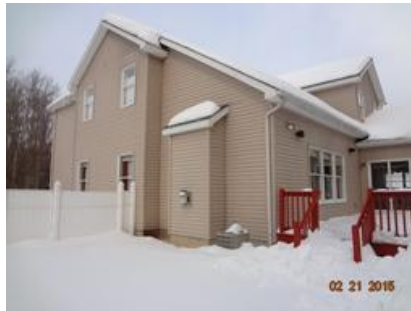
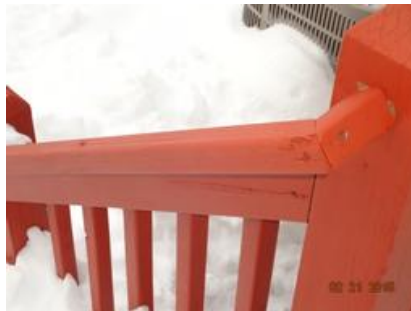
At the time of the home inspection the deck was snow covered and could not be total evaluated. But noted the hand rail was lose on the side entry of the deck. This may lead to personal injury. Recommend contacting a qualified contractor to evaluate and or replace as necessary.

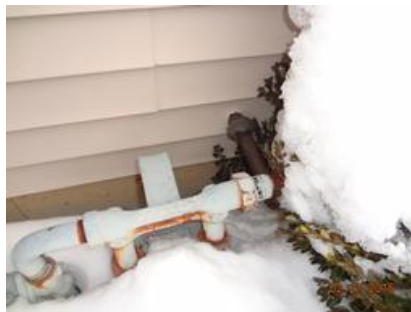
Caulking was loose and missing around gas meter entry point of the house. This may allow water penetration and may destroy your wall or building structure. Recommend repair as necessary to prevent further damage.

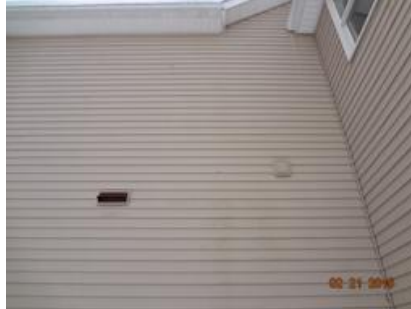
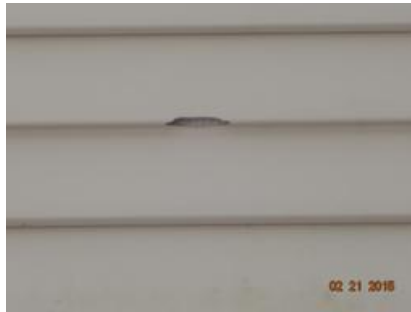
Vinyl Siding is damaged in one or more areas and may lead to water penetration and may allow dampness to set in, as well as a leaving a direct path for pest and insect intrusion. Contact a qualified contractor to evaluate and make repairs and /or replace siding as necessary.

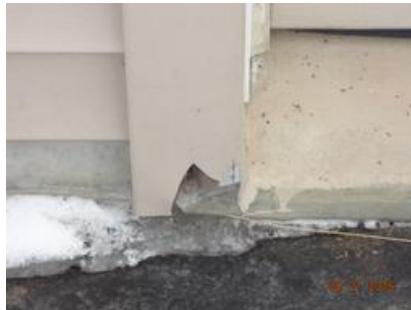
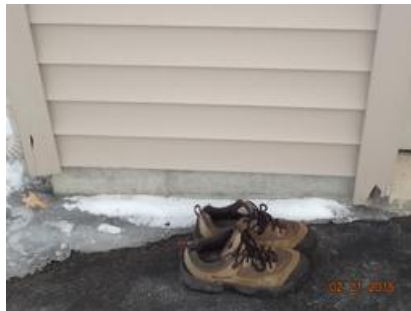
Vinyl trim is damaged in one or more areas and may lead to water infestation and may also allow a direct path for pest and insect intrusion therefore allow dampness to set in. Contact a qualified contractor to evaluate and make repairs and/or replace siding as necessary.

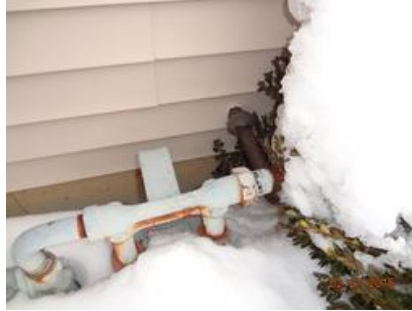
02/23/2015 Shrubs are in contact with siding. Recommend pruning or moving shrubs so there's at least a one foot gap between shrubs and siding. Recommend contacting a qualified contractor to evaluate and or trim back as necessary.

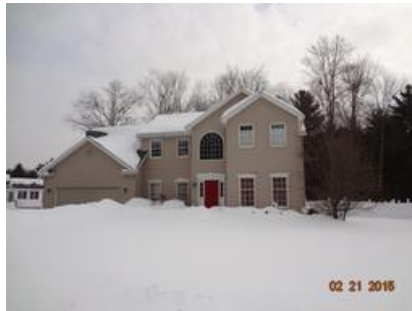
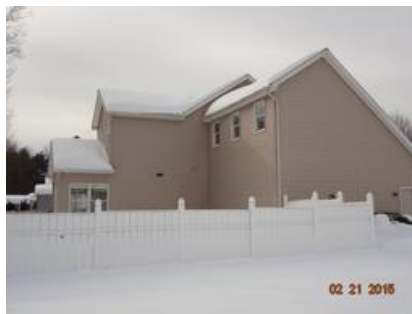
02/22/2015 At the time of the home inspection there was Snow covered ground prohibiting a thorough inspection of the grounds, driveway, walkway, patio etc.

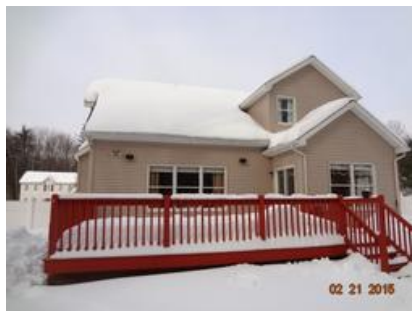
02/25/2015 At the time of the inspection the deck and grounds were covered by snow and prohibited a thorough visual inspection. I will gladly come back once the snow clears to provide a visual inspection.

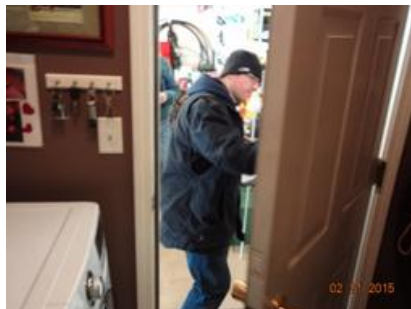
Garage-house door is an auto-closing door but does not close by it self. Recommend adjusting the hinges on the automatic door closing device so door closes automatically to prevent vehicle fumes from entering building. Recommend contacting a qualified contractor to evaluate and or replace as necessary.

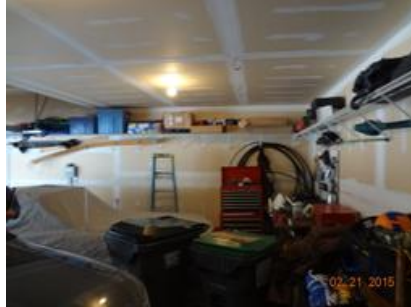
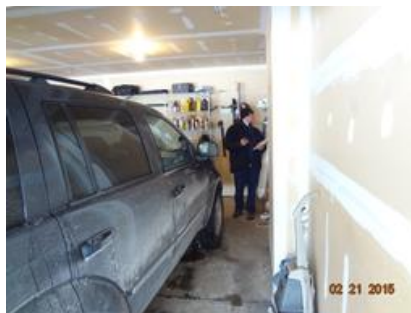
02/22/2015 At the time of the home inspection accessibility was limited to the visibility threw out the garage by vehicles,furniture and/or stored items. This prevented a full evaluation.

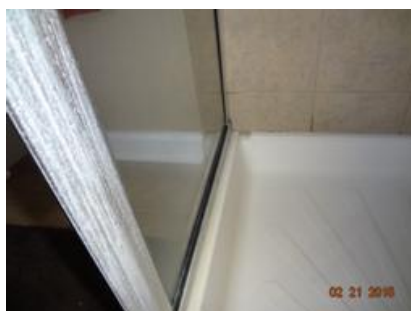
Missing, Cracked, and brittle grout joints are an open invitation for mold, mildew and stains to set in. The intrusion of water through the open grout joints may start the decaying under the tile. Recommend contacting a qualified contractor to evaluate and or replace as necessary.

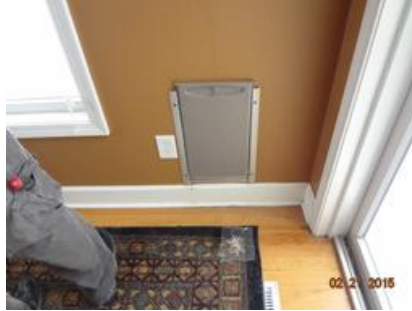
02/23/2015 There is a doggie door on the back side of the kitchen were there is no lock present. This may be an access for an unwanted intruder (persons)that would like to gain access to your home. Recommend adding some type of a lock for you safety. Recommend contacting a qualified contractor to evaluate and or replace as necessary.

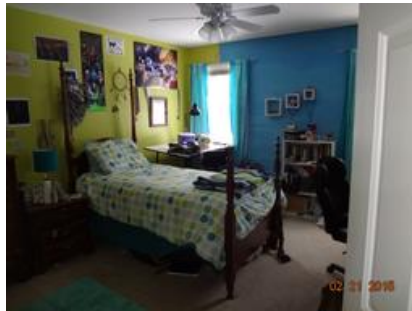
02/23/2015 At the time of the inspections there were multiple doors that were rubbing when trying to close. Recommend contacting a qualified contractor to evaluate and repair as necessary.

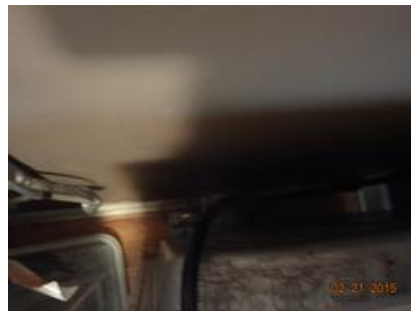
02/22/2015 The dryer vent is a flexible foil duct with multiple connections in the basement. This may cause a clog with the lint build up and cause a fire. (Refer to Basement pictures). Recommend contacting a qualified contractor to evaluate and repair as necessary.

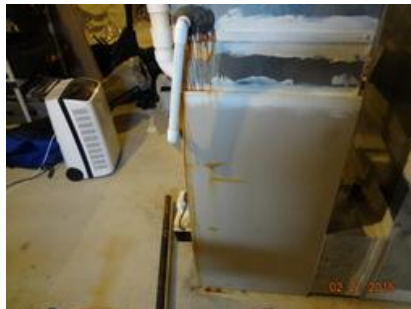
At the time of the inspection there was rust stains on the rear of the furnace. This could of been caused by the indoor evaporator coil and the suction line (the large copper refrigerant line in black insulation) sweats. This looked to be taken care of according to the log records that are posted on of the heating unit. Recommend monitoring this in the future. If there are any changes please contacting a qualified heating contractor to evaluate and or replace as necessary.

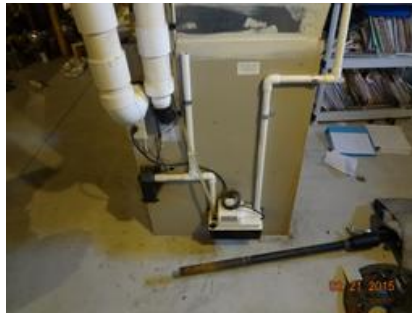
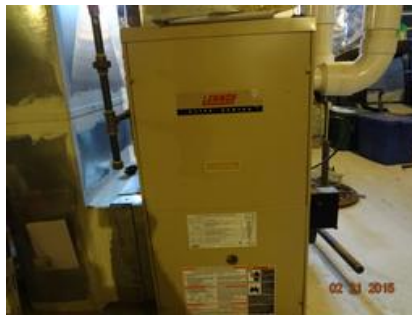
02/23/2015 At the time of the inspection the furnace had worked as designed. It was 12 Deg outside and was 72 inside.

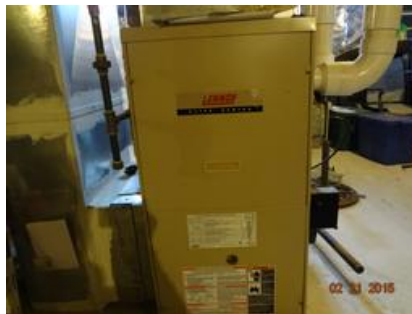
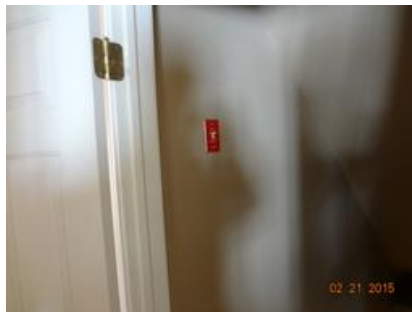
02/23/2015 Emergency switch plate was noted at the top of the basement stairs.

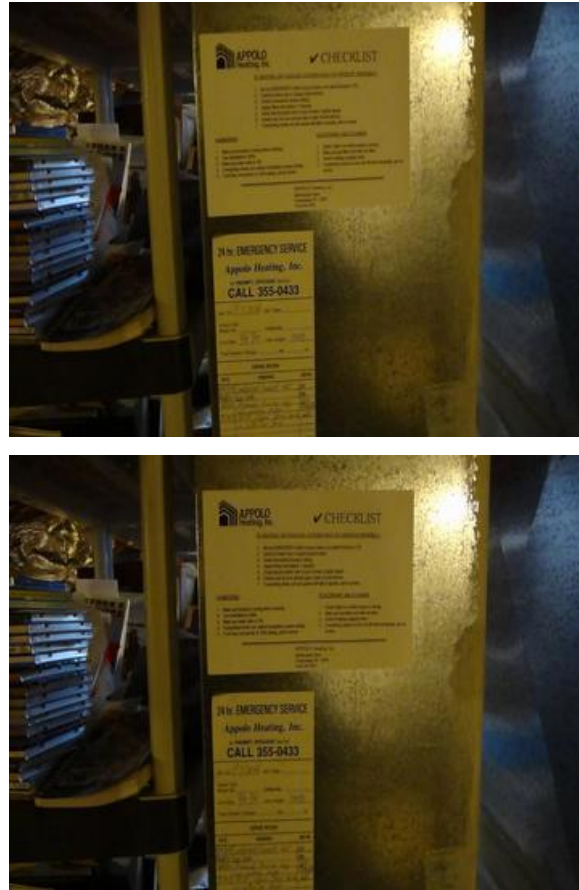
02/23/2015 Noted was a maintenance schedule on the side of the furnace. Reading the owners manual will help to determine the appropriate maintenance schedule needed for this unit. Recommend consider a yearly service plan that may be offered by a local heating and cooling contractor.

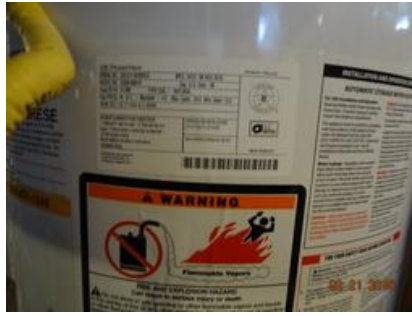
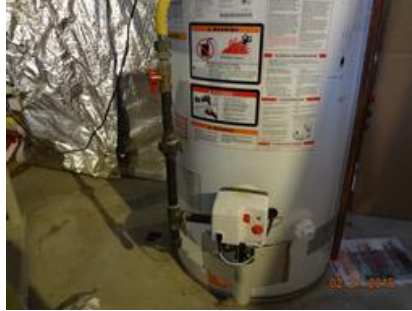
02/22/2015 At the time of the home inspection the water heater operated as designed on the day of the inspection.

02/23/2015 Recommend reading the owners manual to determine the appropriate maintenance schedule needed for this unit. Most hot water tanks are warranted between 6 to 10 years and may go in any time. Think about budgeting for a new one in the future. Consider a service plan that may be offered by a qualified heating and cooling technician.

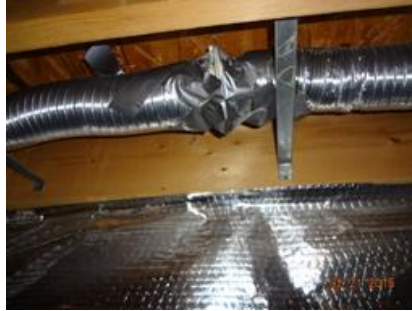
In all cases the longest possible working vent should be made of rigid metal vent material with a large mouth or louvered outdoor hood. Flexible metal ducting although a bit easier to work with causes but reduces air flow due to its corrugated design and will contribute to a lint buildup in the ducting over time. This type of dryer duct materials are more likely to sag and let lint, or even water to build up at low points. A dryer on average will remove 1 gallon of water per load of laundry dried. Recommend contacting a qualified contractor to evaluate and or replace as necessary.

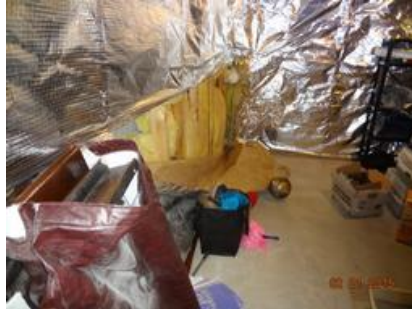
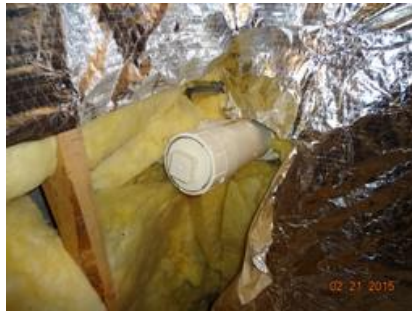
02/23/2015 This is the sewer pipe line as well as the clean-out plug, if in fact your sewer line is clogged between the house and the street.

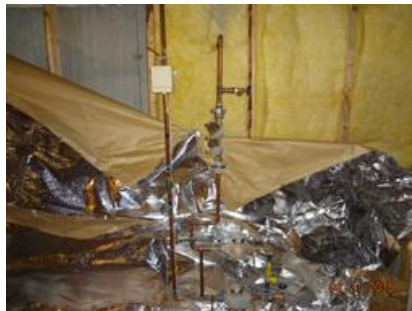
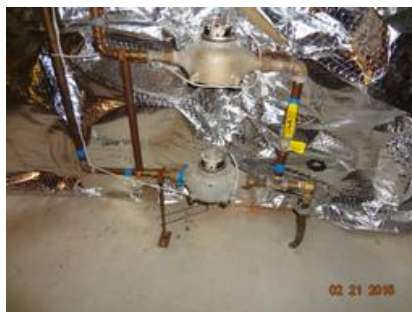
02/23/2015 There are (2) water meters. One is for metering the water for the house and one is for metering the water from your sprinklers, and the silk cocks on the outside of the house. For any further instructions or information contact your towns municipality.

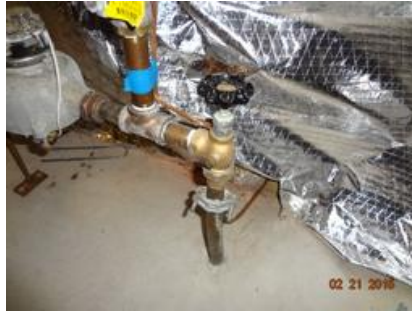
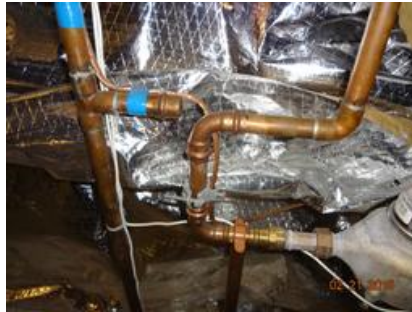
Here are some pictures of the water shut off that is in the front of the basement close to the floor. The 1" copper line comes through the floor of the basement up to your shut off valve.
