PROPERTY CONDITION ASSESSMENT REPORT

Sample Report

St. Paul, MN

Wednesday, December 30, 2015

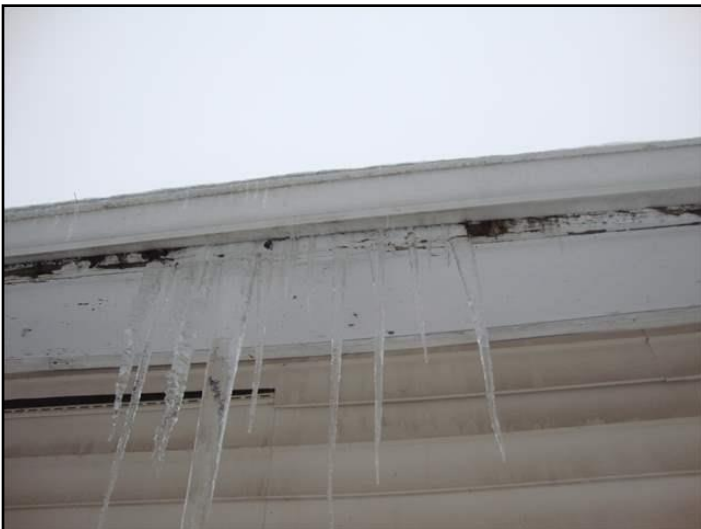
7. Vulnerable to ice damming

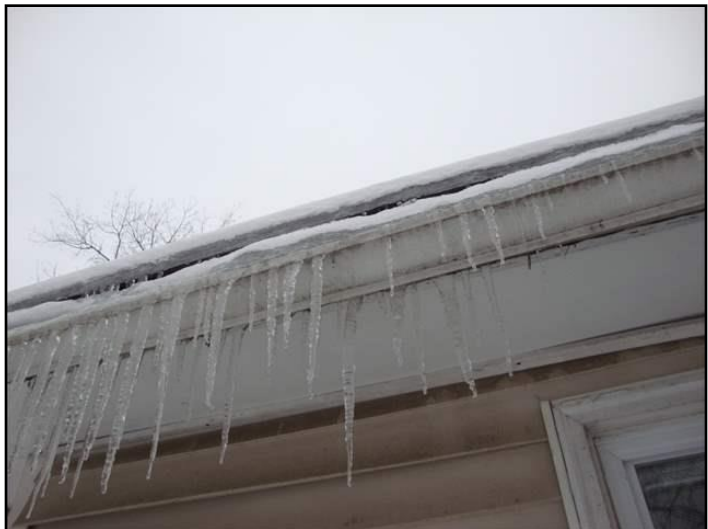
8. Vulnerable to ice damming

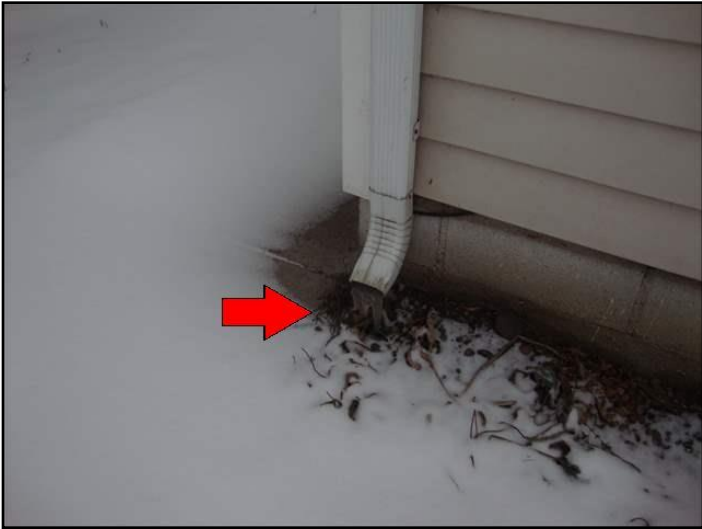
11. Downspouts end too close to building

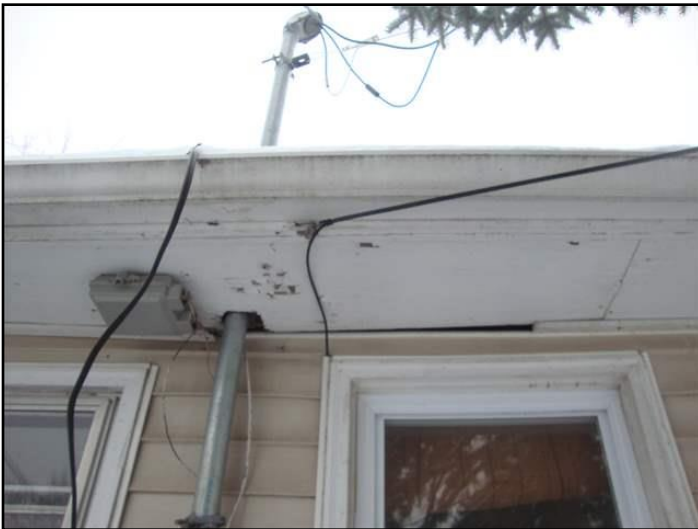
13. Paint or stain needed

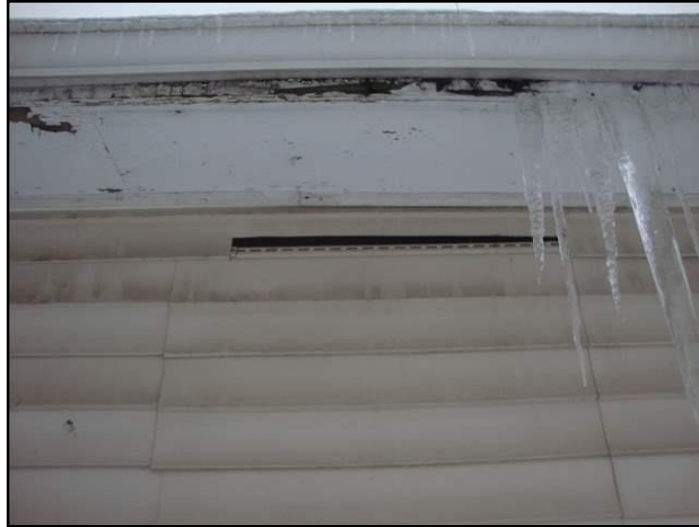
19. Loose or missing pieces

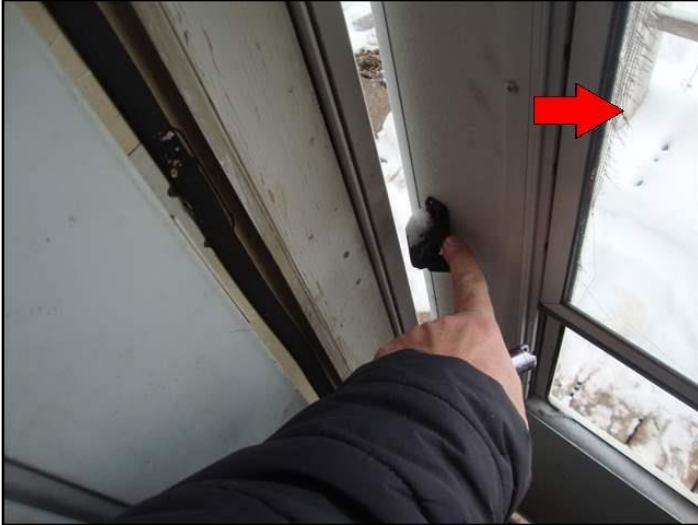
23. Torn or holes

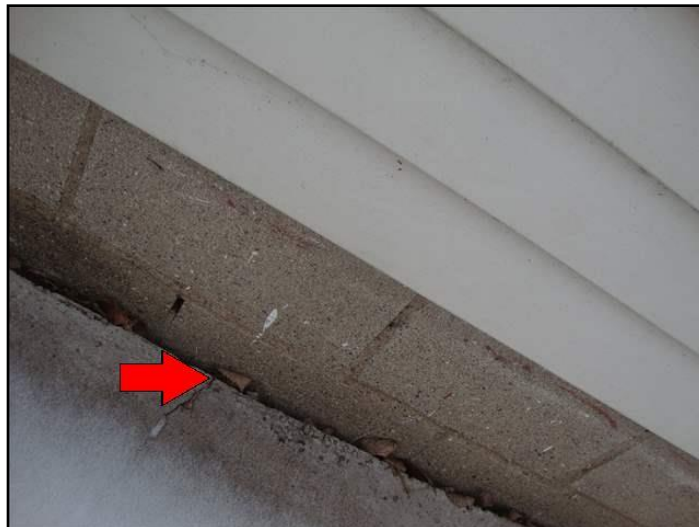
28. Unsealed gap at building

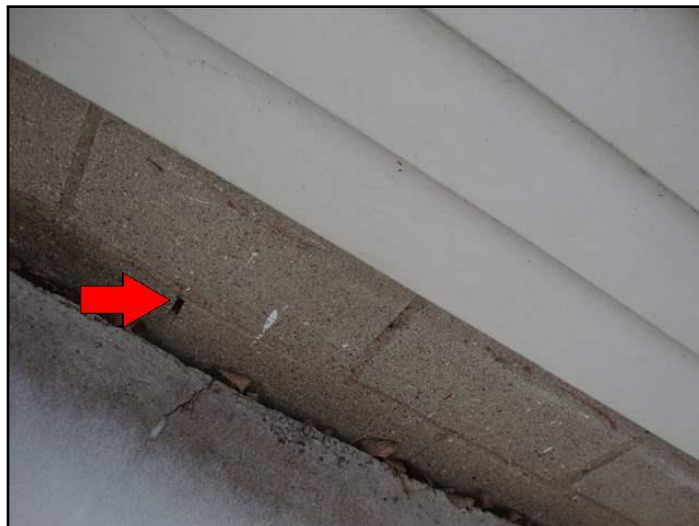
34. *Mortar deteriorating or missing*

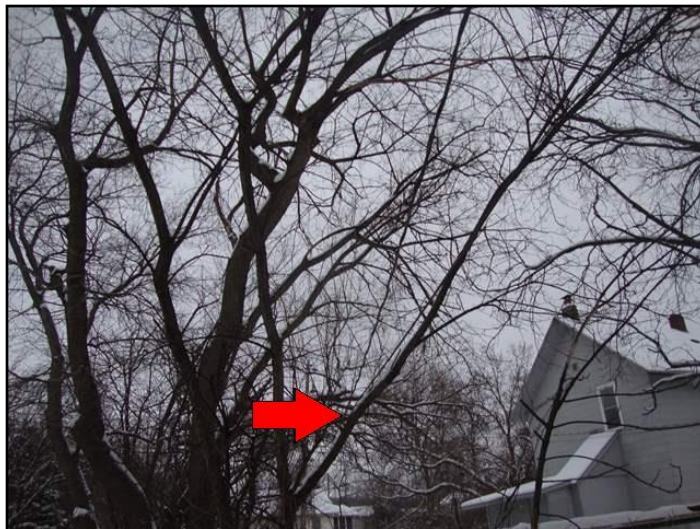
42. Branches, vines interfering with wires

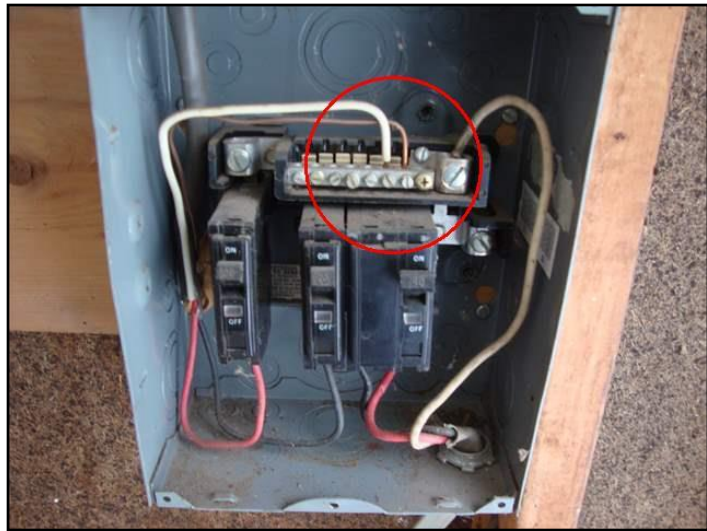
43. Neutral bonded to ground downstream of box

42. Condition: • [Neutral bonded to ground downstream of box](#)

Task: Repair

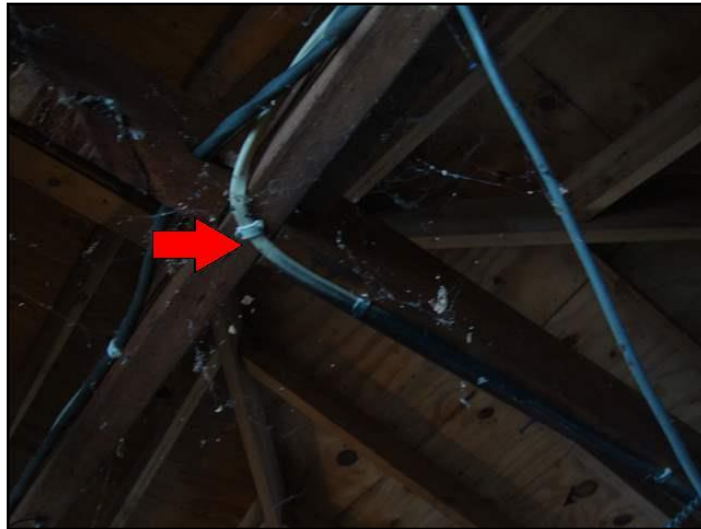
47. Exposed on walls or ceilings

46. Condition: • [Exposed on walls or ceilings](#)

Task: Improve

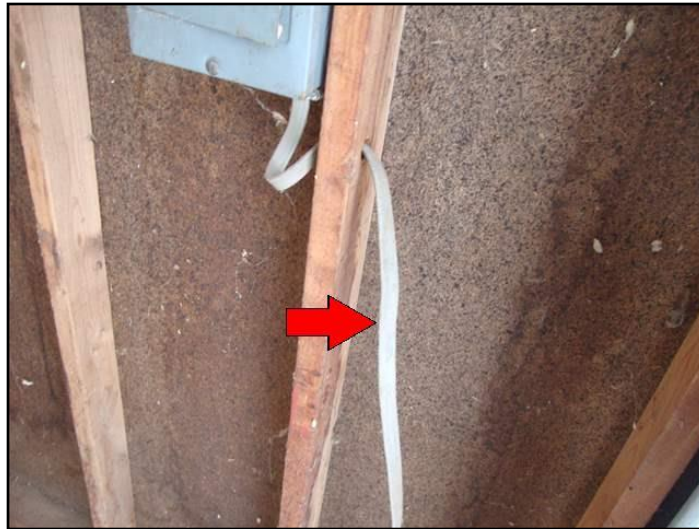
49. *Not well secured*

48. Condition: • [Not well secured](#)

Implication(s): Electric shock | Fire hazard

Task: Repair

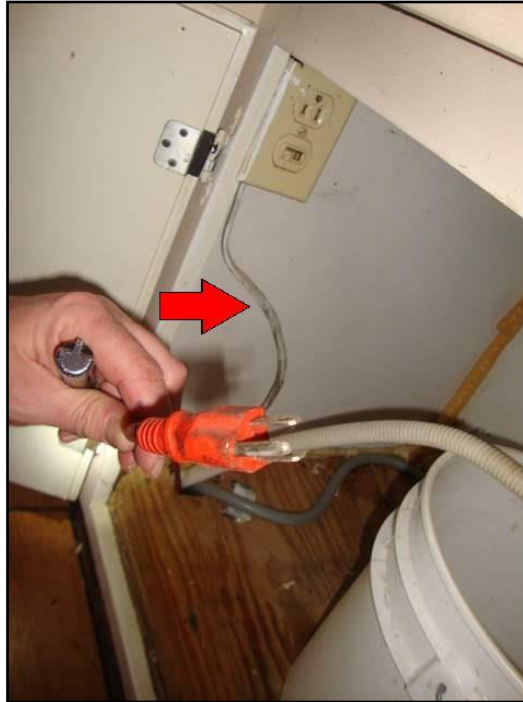
52. Flexible conduit needed

50. **Condition:** • [Flexible conduit needed](#)

Location: Kitchen
Task: Provide
Time: Less than 1 year

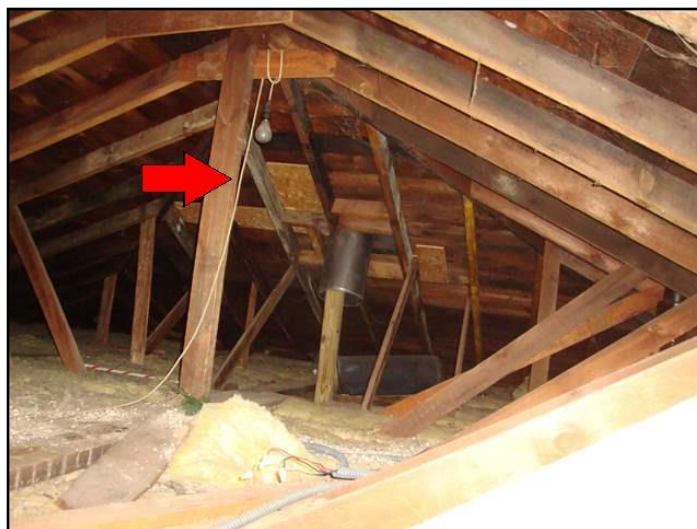
53. Extension cord used as permanent wiring

51. Condition: • [Extension cord used as permanent wiring](#)

Implication(s): Electric shock | Fire hazard

Task: Repair

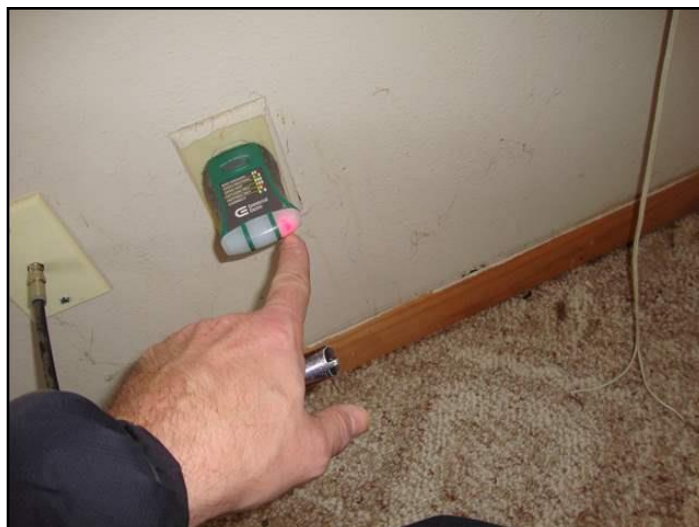
57. Ground needed for 3-slot outlet

56. Condition: • [Ground needed for 3-slot outlet](#)

Task: Replace

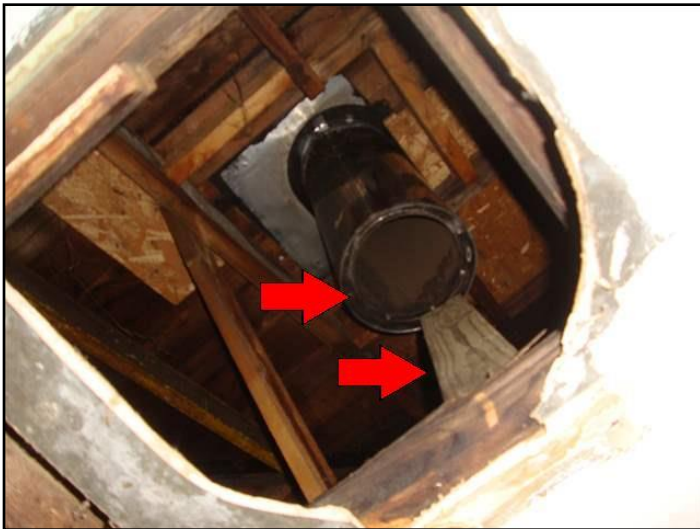
72. Sections not well secured

76. Condition: • [Sections not well secured](#)

Implication(s): Equipment not operating properly | Hazardous combustion products entering home | Increased fire hazard

Task: Remove

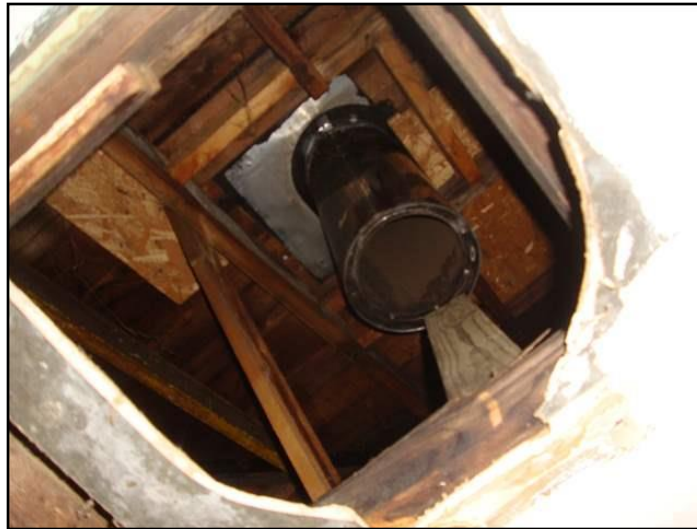
74. Gaps or voids

79. **Condition:** • [Gaps or voids](#)

Task: Repair

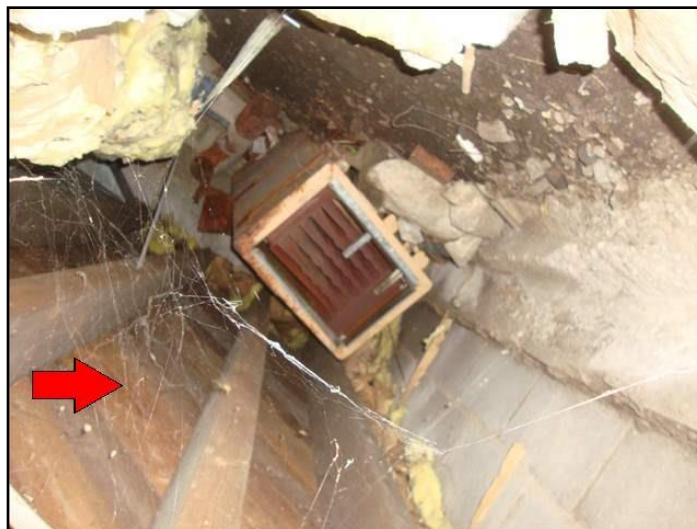
77. Too little insulation

83. Condition: • [Too little insulation](#)

Missing in most areas between joists.

Task: Provide

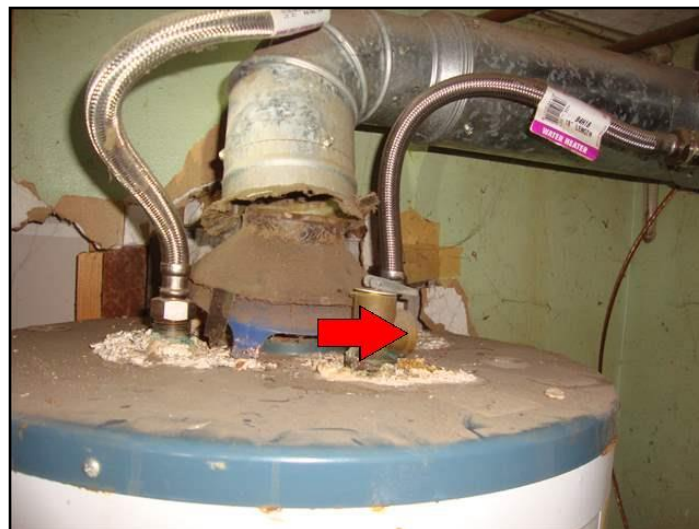
82. Discharge tube missing

93. Condition: • [Discharge tube missing](#)

Task: Provide

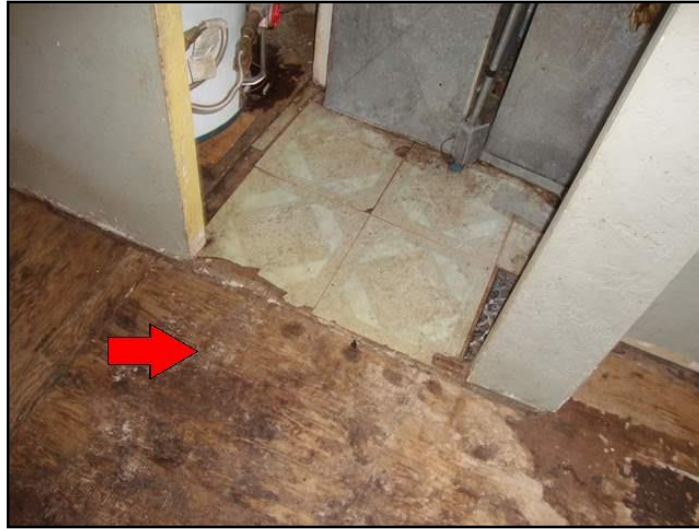
96. Loose or missing pieces

115. **Condition:** • [Loose or missing pieces](#)

Implication(s): Cosmetic defects | Trip or fall hazard

Task: Replace
