Home Inspection Report

123 Main Street, Pensacola, AL 32506

Tuesday, May 14, 2019

2800

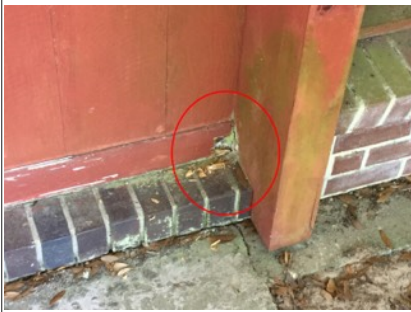
Wood rot on wood siding adjacent to front porch

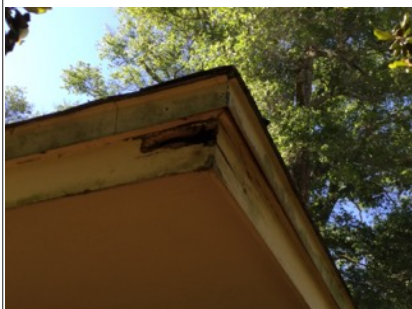
6. Fascia on South West corner is rotted. Recommend repair

Wood rot on Fascia on South West corner

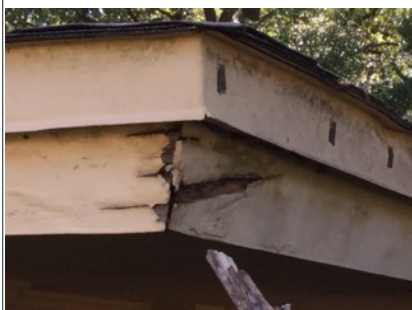
Wood rot on Fascia

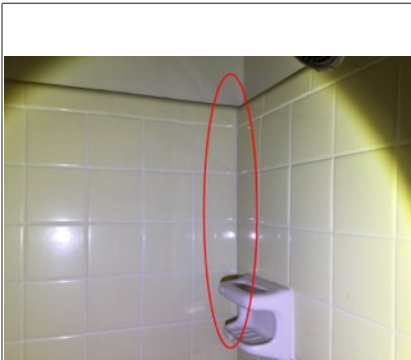
Recommend caulk in master shower as needed

Recommend caulk/grout as needed

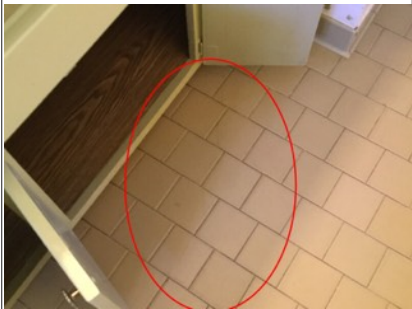
Floor tile cracked in several spots in Hall bathroom. Recommend repair

Cracked floor tile
