Three Rivers Team Home Inspections

123 Sky Ridge View
Vancouver, WA. 98685

11:08 October 03, 2018

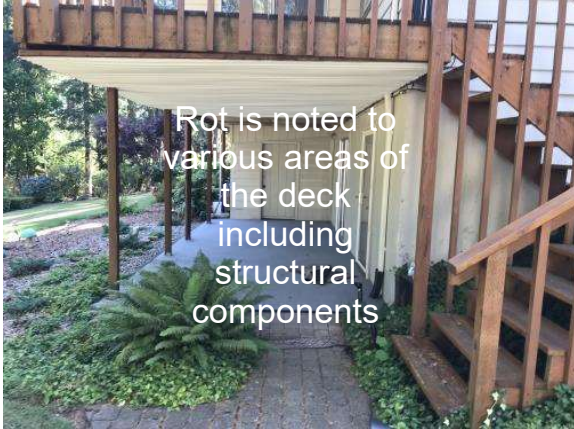
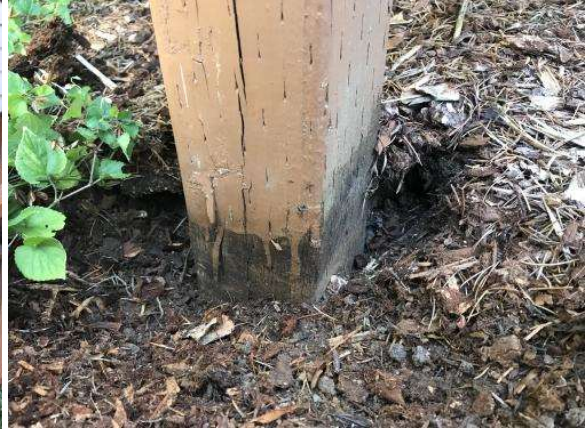
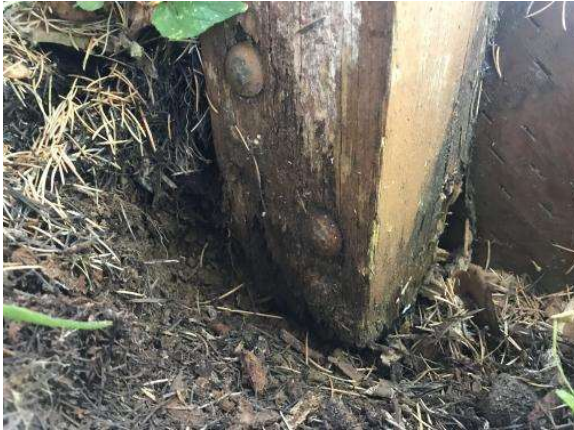
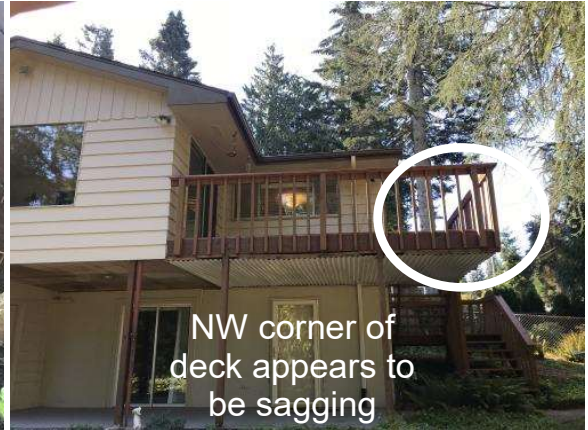
9. Defective Deck: Wood - **Rot is noted to various areas of the deck including structural components.**
Weathered/damaged: Repair/seal all exposed/damaged decking to reduce deterioration and rot.
Replace areas of damage that are beyond being responsive to normal repairs.

NW corner of deck appears to be sagging. Recommend adding a support post below corner of deck to promote added structural durability.

Avoid earth to wood contact to prevent moisture damage and invitation of wood destroying organisms.

Recommend bolting the deck and balcony to the house for added safety.

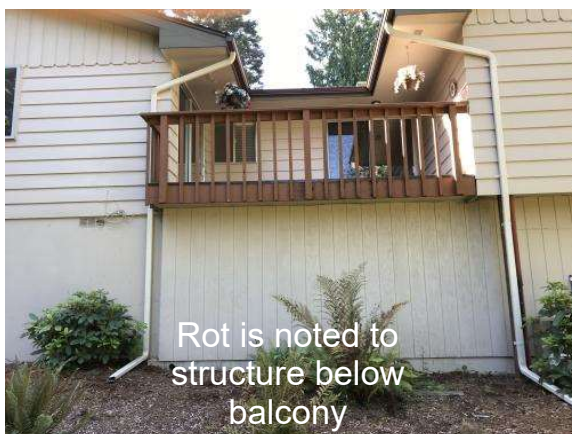
Balcony: Wood - *Rot is noted to secondary storage structure below the balcony including its leaking ceiling and structural components.

*Damaged structure below the balcony also appears to serve as the balconies support system.

*Rot noted to ceiling of structure below balcony / ceiling is leaking.

Recommend consulting a structural contractor to further assess and advise repairs to ensure structural durability and to prevent further subsequent damages.

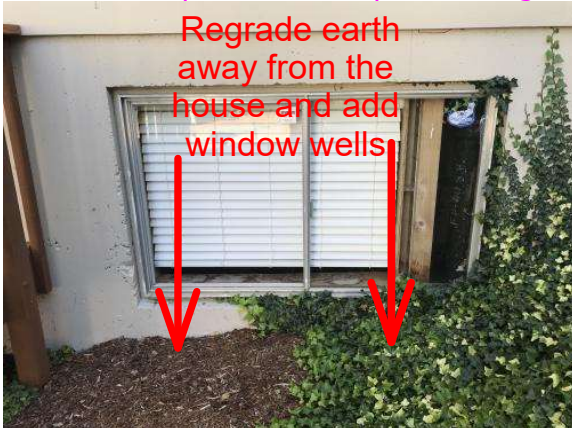
Basement Windows: Aluminum - Foundation is Mostly concealed below grade causing earth is making contact with window trim. Moisture damage noted to interior window sill. Regrade earth away from the house and add window wells to prevent entry of water into the house and to prevent subsequent damages to the siding/trim.

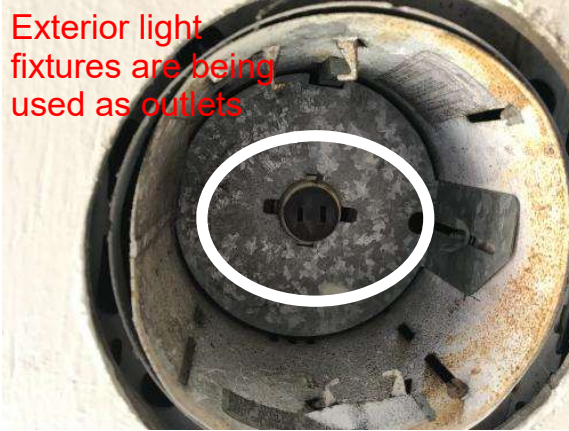
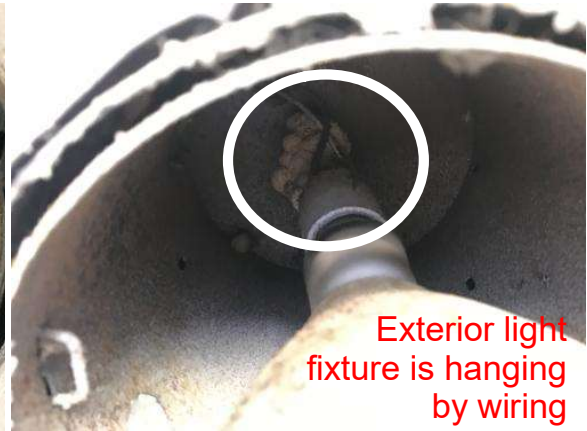
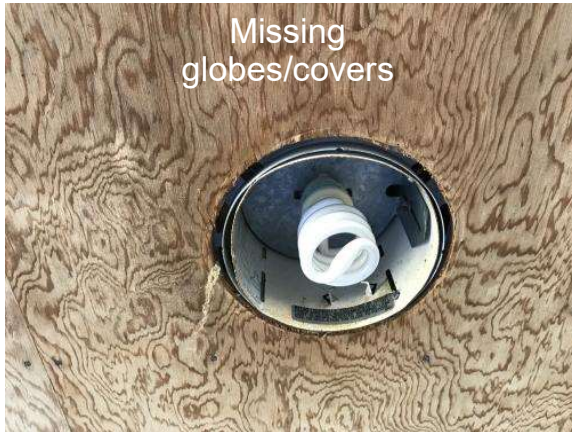
Exterior Lighting: Operational - Front and Rear exterior light fixtures are being used as outlets. Rear exterior light fixture over balcony bulb is hanging by its wiring. Consult a qualified electrical contractor to further assess and advise repairs to ensure intended and safe operation.

Missing globes/covers. Provide globes/covers to provide intended bulb protection

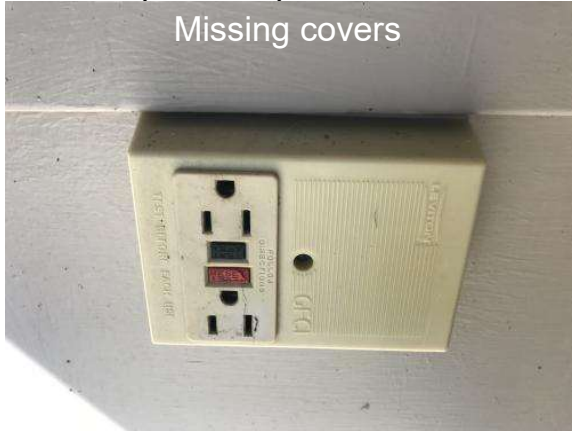
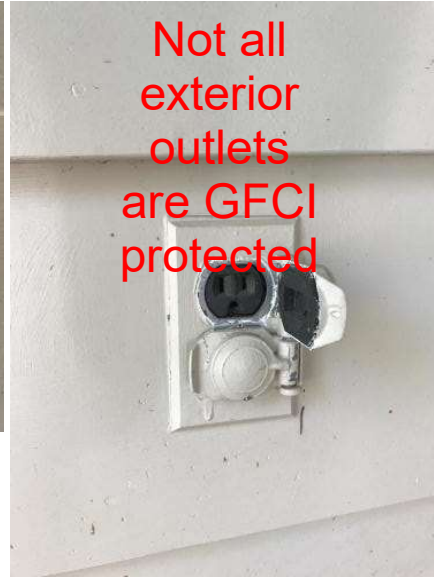
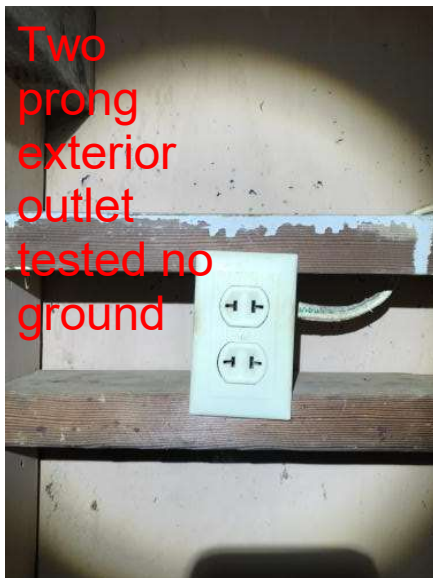
Exterior Electric Outlets: Operational - Not all exterior outlets are GFCI protected. Install GFCI unit/s to promote intended shock protection.

Some exterior outlets are missing covers.
Replace missing outlet covers for intended shock protection.

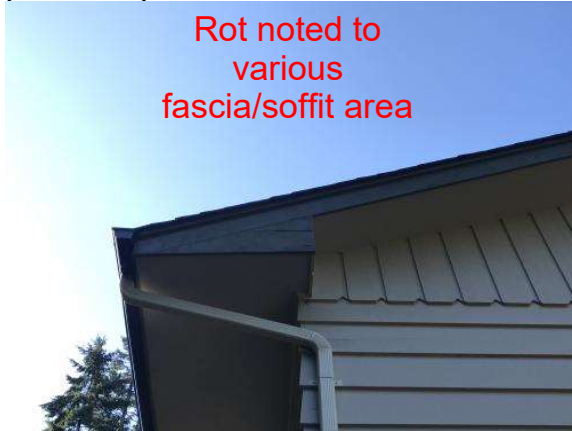
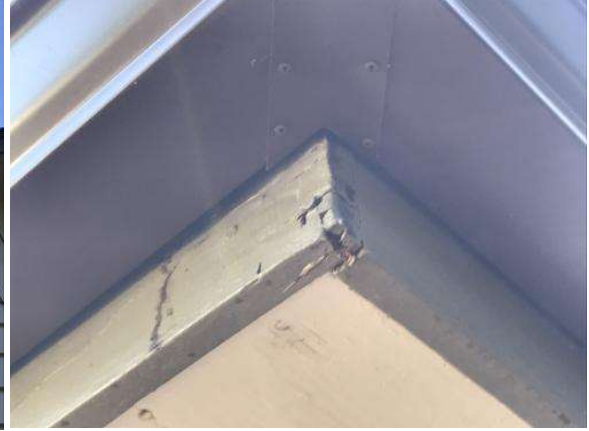
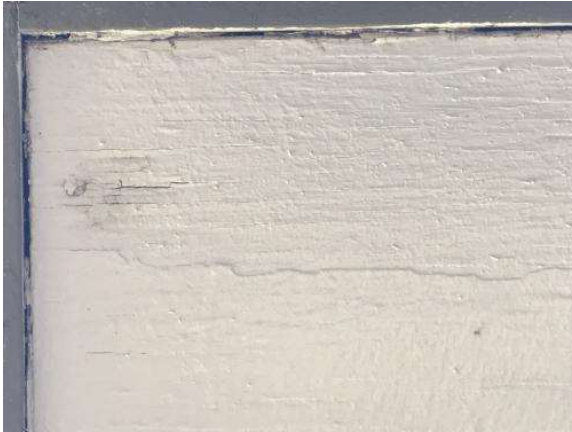
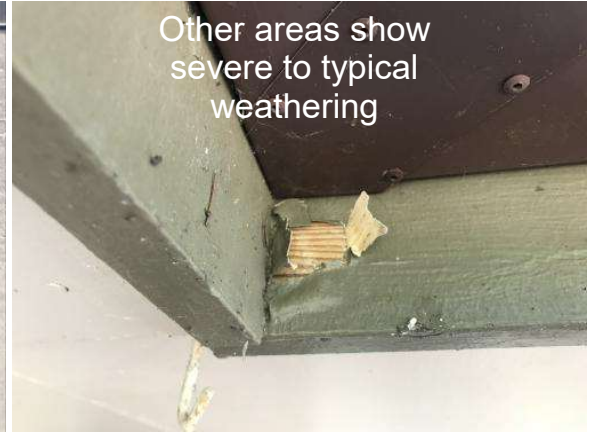
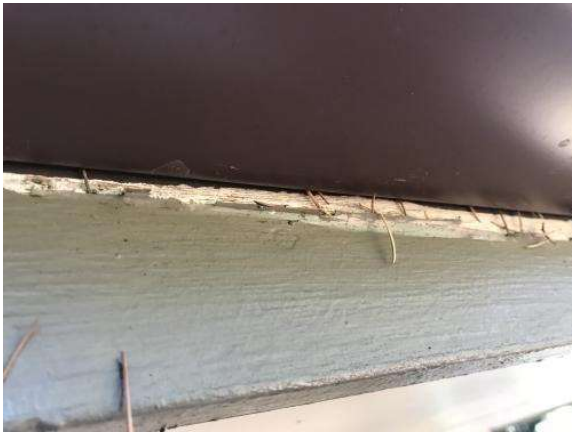
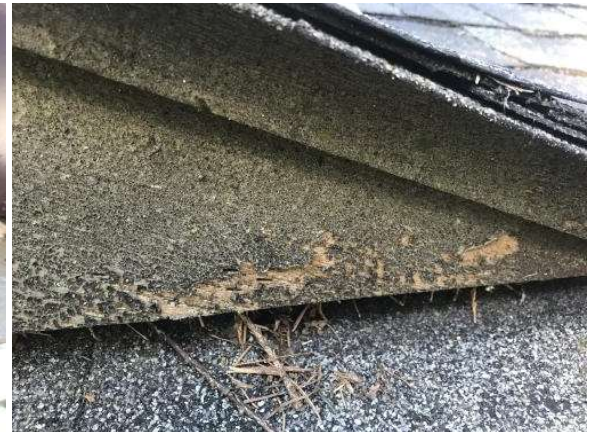
3. Acceptable
 4. Defective
- Gutters/Downspouts: Metal, Above Ground, Below Ground**
Fascia/soffits: Wood, Vented soffits - **Rot noted to various fascia/soffit areas.**
Other areas show severe to typical weathering.
Weathered/damaged: Repair/caulk/paint all exposed/damaged wood fascias/soffits to reduce deterioration and rot. Replace areas of damage that are beyond being responsive to normal repairs.

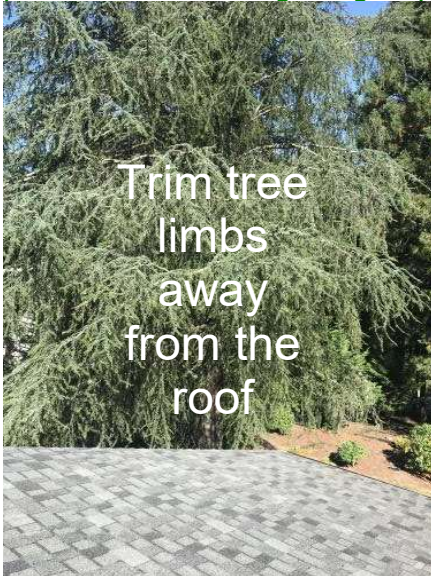
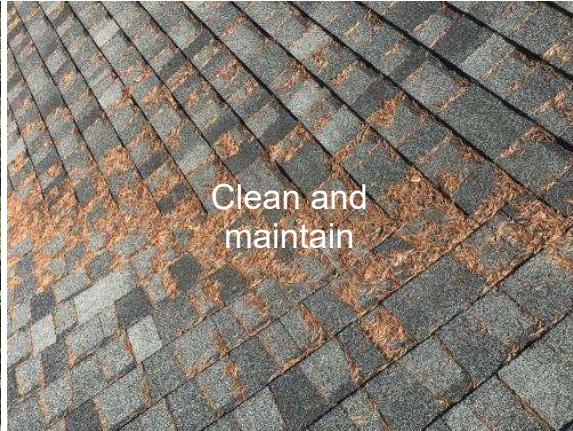
6. Acceptable Covering: Asphalt / fiberglass shingle - Trim tree limbs away from the roof, Clean leaf/pineneedle debris and maintain to aid roof drainage, reduce shingle deterioration, and to promote roof coverings longevity.

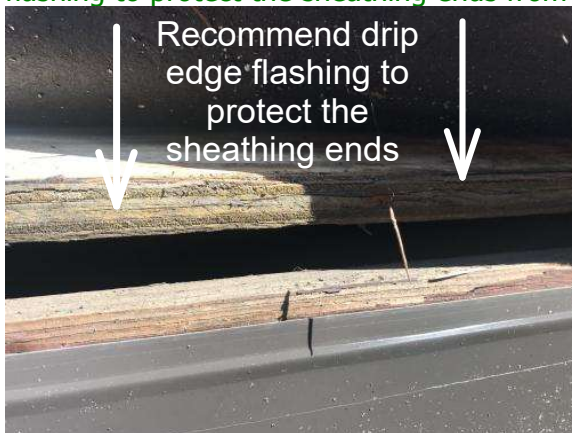
9. Acceptable Flashing: Roof to wall, Chimney, Vent/vent stack - Drip edge Flashing: Recommend drip edge flashing to protect the sheathing ends from further moisture damage.

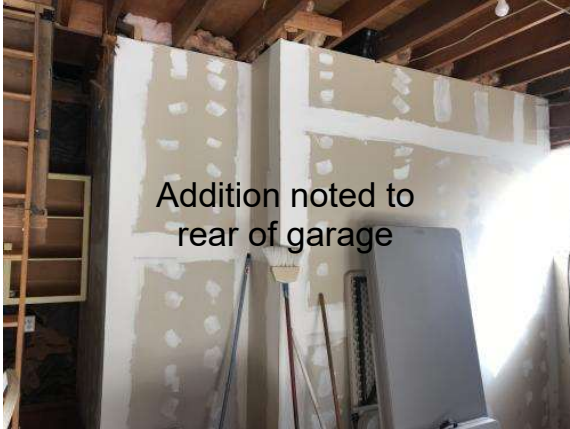
- Walls: Exposed framing - Addition noted to rear of garage. Addition accommodates master bedroom/bathroom.
 - Recommend obtaining structural/electrical/plumbing permits to ensure proper construction/installations.

- Fire damage noted to exposed framing at rear of garage.
 - Consult a structural contractor to further assess damages and advise repairs to ensure structural durability.

- Recommend determining cause of damage to ensure that under lying conditions do not exist.
 - Extreme Clutter/stored items limited visibility to walls and stem walls

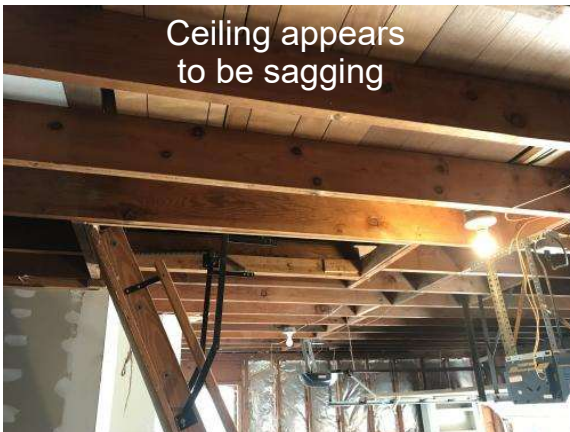
Ceiling: Exposed framing - **Garage ceiling joist appears to have been compromised to accommodate a pull down attic access. Ceiling appears to be sagging as a result. Consult a qualified structural contractor to further assess and advise repairs to ensure structural durability and to prevent further subsequent damages.**

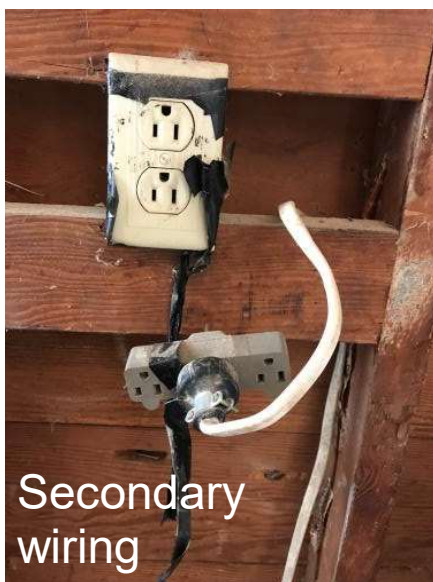
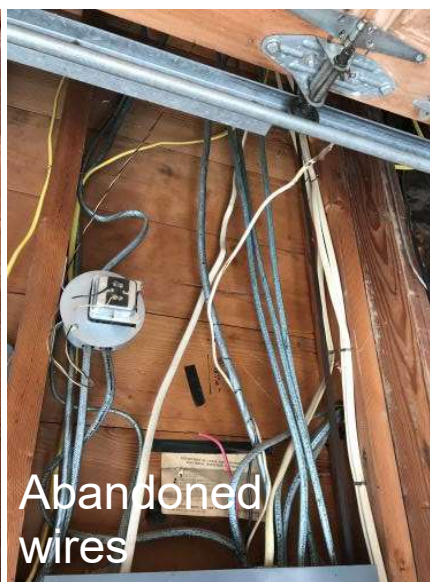
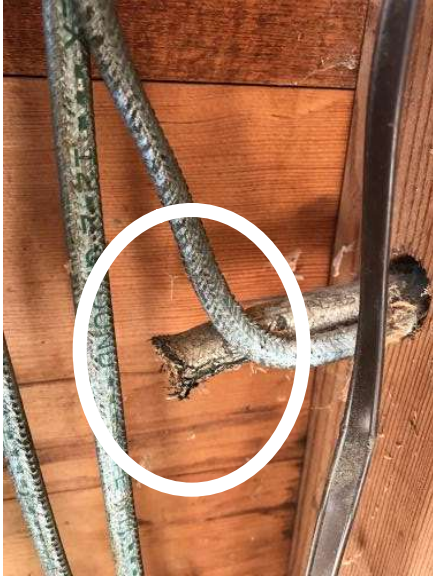
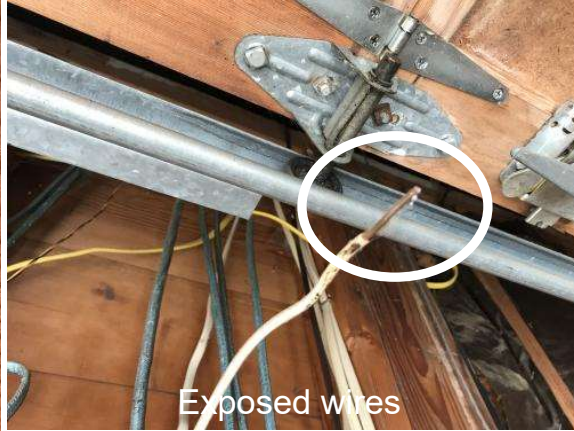
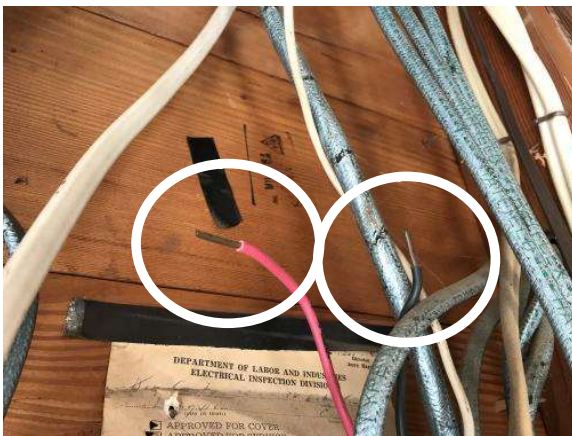
8. Lighting Minimal Replace bad bulb/s to provide intended light and to prevent shock hazards.
9. Marginal Outlets: Tested "no ground", Not GFCI protected - **Consult an electrician to further assess and advise to ensure intended ground protection. Install GFCI units to promote intended shock protection**
10. Defective Curcuit Wire: Improper - **Secondary wiring and abandoned/exposed wiring noted through out the garage. Consult a qualified electrical contractor to further assess and advise repairs to ensure safe operation.**

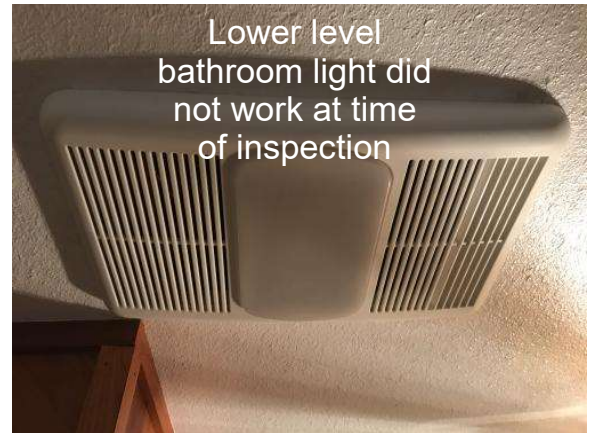
1. Water flow: Normal
2. Acceptable Floor: Laminate, Ceramic
3. Acceptable Walls: Dry wall / Plaster / Painted, Wood
4. Acceptable Ceiling: Dry wall / Plaster / Painted
5. Acceptable Windows: Metal, sliding - Window has fogging between the layers of glass
6. Acceptable Doors: Hinged, Pocket, Wood product, Operational
7. Lighting: none Lower level bathroom light did not work at time of inspection. (Bad bulb?)

8. Marginal Outlets: GFCI protected, Not operational - Lower bathroom outlets are not GFCI protected. Install GFCI units to promote intended shock protection

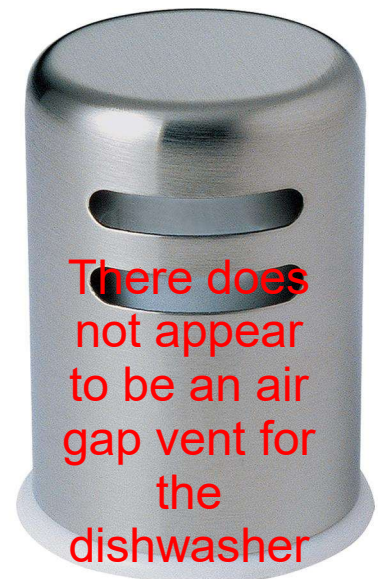
1. Acceptable Floor: Ceramic
2. Acceptable Walls: Dry wall / Plaster / Painted, Ceramic back splash
3. Acceptable Ceiling: Dry wall / Plaster / Painted
4. Acceptable Windows: Metal, sliding
5. Lighting: Operational
6. Ceiling fan: None
7. Acceptable Outlets: GFCI protected, Operational
8. Acceptable Sink: Stainless Steel double
9. Marginal Plumbing/Fixtures: No visible damage, operational -
There does not appear to be an air gap vent for the dishwasher.
A licensed plumber is recommended to evaluate and advise repairs to ensure proper drainage and to prevent back flow

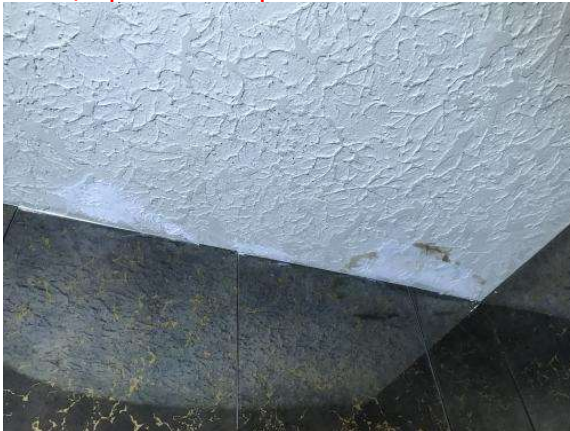
- 1. Acceptable Floor: Carpet, Laminate
- 2. Acceptable Walls: Dry wall / Plaster / Painted
- 3. Defective Ceiling: Dry wall, Dry wall / Plaster / Painted - Moisture stains around the chimney. Recommend determining of origin of stains to ensure that under lying conditions do not exist.
*No moisture reading at time of inspection.

Crack/s present: Repair cracks to reduce further separation/deterioration.

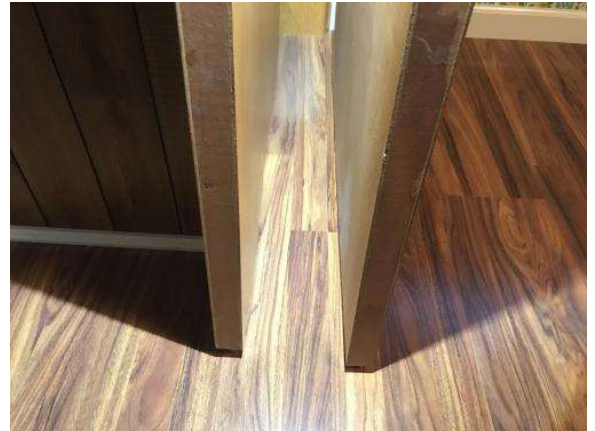
- 1. Acceptable Floors: Laminate
- 2. Acceptable Walls: Dry wall / Plaster / Painted, Wall paper
- 3. Acceptable Ceilings: Dry wall / Plaster / Painted
- 4. Acceptable Windows: Metal, sliding
- 5. Acceptable Doors: Hinged, Wood product, Operational
- 6. Acceptable Closets/doors: sliding - **Missing/defective bottom tracks. Add tracks to sliding closet door to prevent subsequent damages to the doors and upper hardware.**

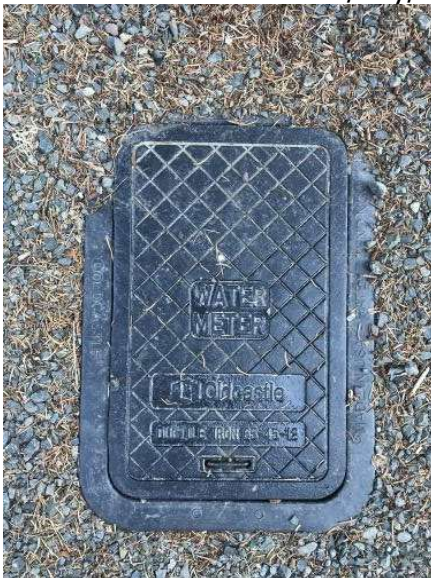
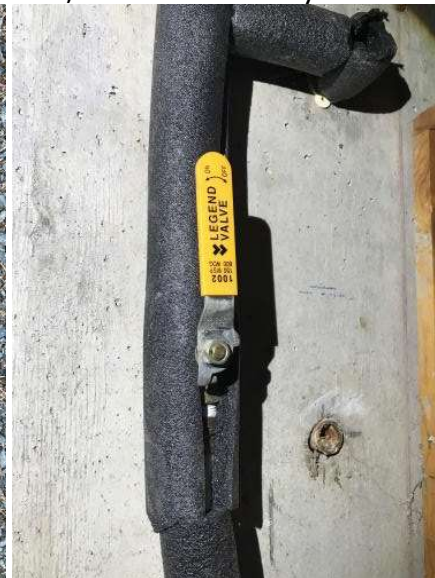
1. Water source: City
2. Sewage disposal: Sewer
3. Acceptable Public Supply: Concealed/insulated
4. Acceptable Main Water Shutoff: Meter/City/Street, Basement laundry room

5. Acceptable Water Lines: Mostly Concealed/insulated, Plastic/PVC, PEX/Polly, Copper
6. Marginal Waste drainage: Mostly Concealed/insulated, Galvanized, Cast iron, Plastic - **Galvanized drainpipes present.**

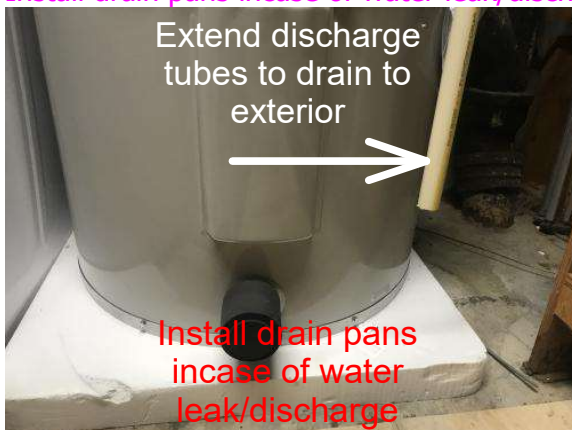
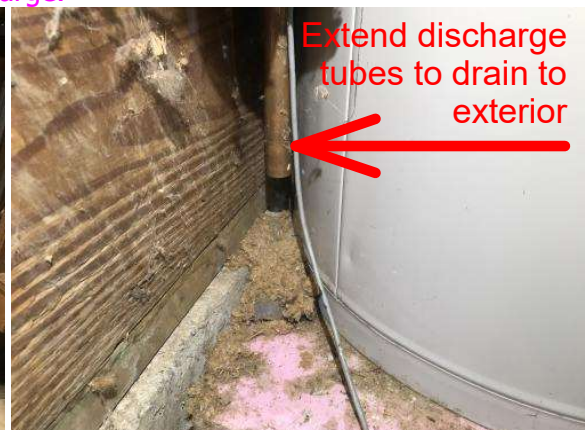
Accessories: TPR Valve Present but not tested, Discharge tube present, Stability straps present -

Extend discharge tubes to drain to exterior incase of water discharge.

Install drain pans incase of water leak/discharge.

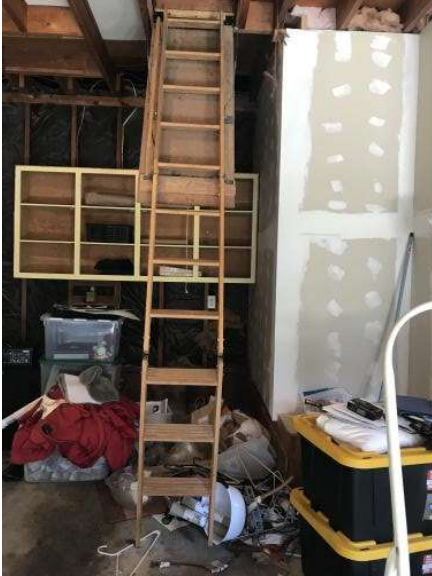
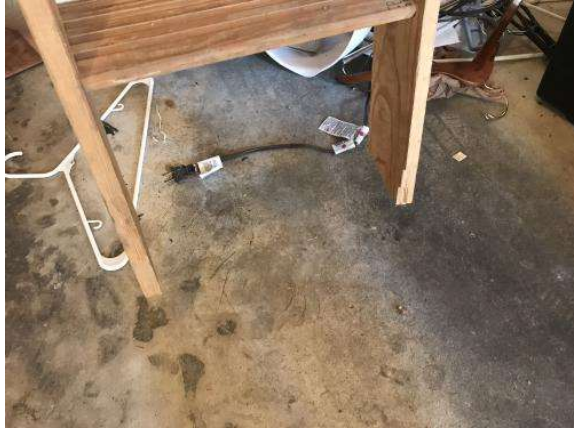
Pull down garage Attic

1. Note: Pull down ladder for attic access in garage does not make contact with floor.
Alternative step ladder is being to used to accommodate inefficiency.
Advise repairs to ensure intended safe operation.

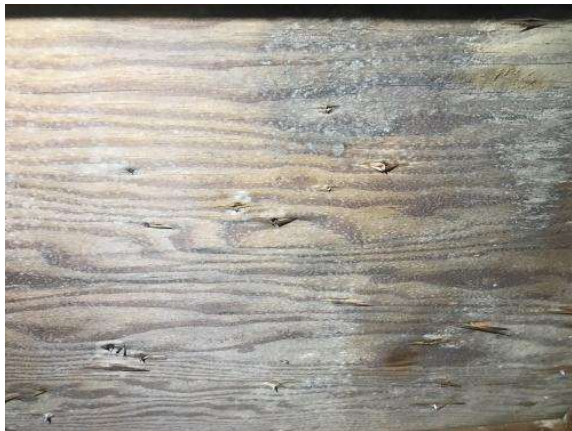
Sheathing: Plywood, Stained - Stained and soft/sagging sheathing visible from the attic. most likely due to moisture from poor ventilation.
See attic ventalaion section for related notes.

Black and white Discoloring most likely due to moisture from poor ventilation.
Black/white substance noted that shares the same characteristic of mold/mildew.
Stained sheathing: Recommend consulting a qualified contractor to further assess stained sheathing and advise cleaning solutions to prevent further subsequent damages and to ensure personal health and safety.

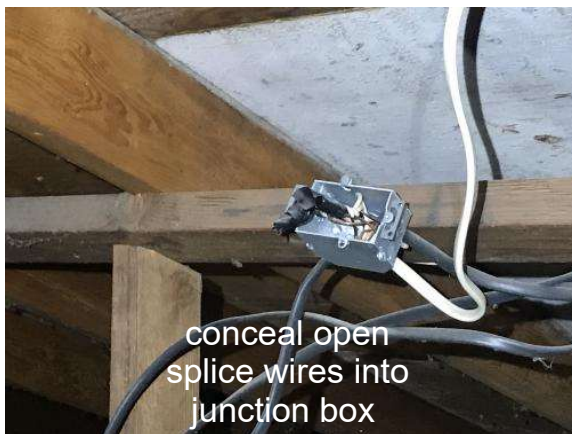
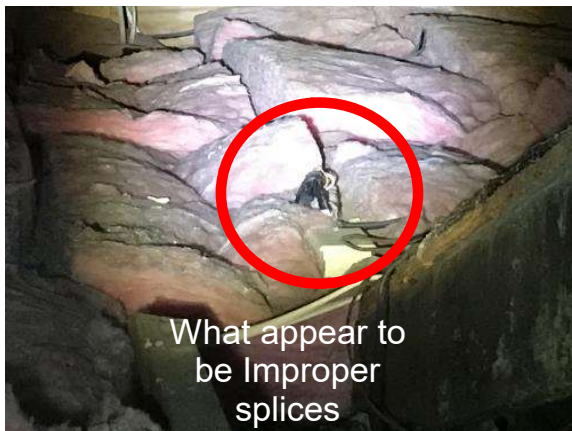
What appear to be Improper splices noted above addition/s.

Consult a qualified electrical contractor to further assess and advise repairs to ensure safe operation.

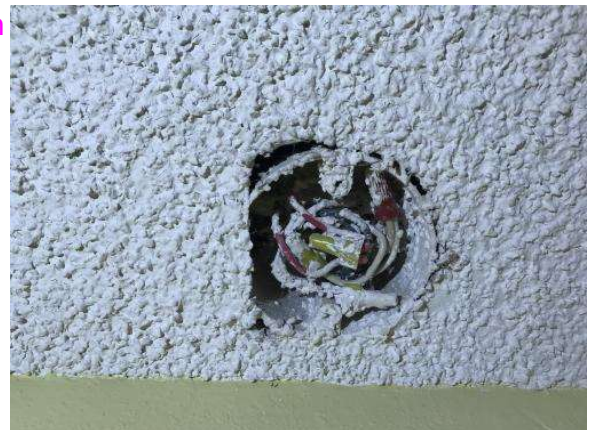
9. Marginal Curcuit Wire: Mostly concealed - Seal open junction box to promote intended shock protection.

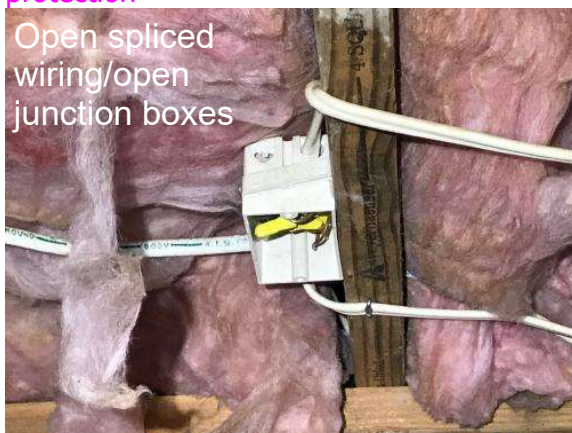
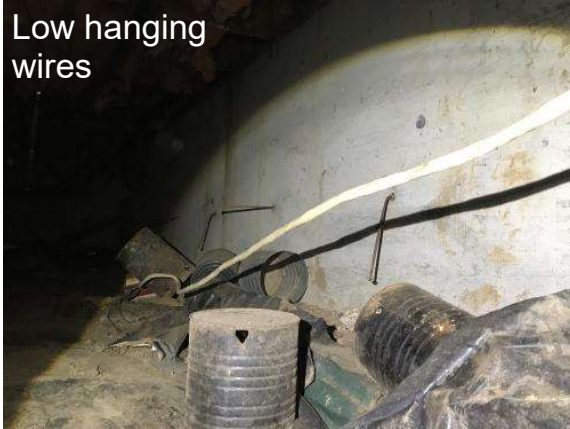
5. Acceptable Insulation: Present
6. Acceptable Vapor Barrier: Present
7. Marginal Electrical: Mostly concealed - **Open splices: Consult an electrician to conceal open splice wires into a junction box for intended fire and shock protection.**

Low hanging/grounded wires noted. Recommend securing wires up to promote intended shock protection

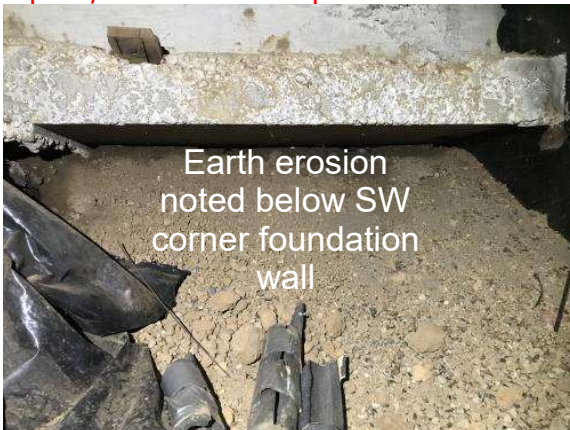
| 6. Defective | Foundation/Bearing walls: Poured Concrete, Concealed poured concrete slab & walls - Earth erosion noted below SW corner foundation wall visible from crawl space

Crack with separation noted to foundation wall at SW corner most likely as a result.
Recommend consulting a foundation contractor to further assess and advise repairs/maintenance to prevent further subsequent damages and to promote system longevity. |

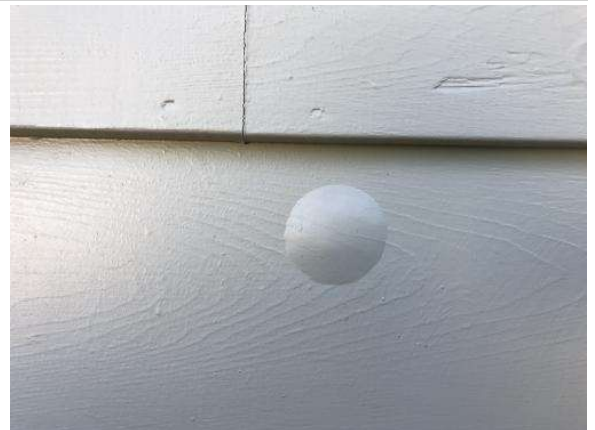
1. Wall surface/Trim: Wood siding, Wood trim - **Weathering noted to various areas of siding.**
Paint is blistering in various areas.
Weathered/damaged: Recommend further assessment to Repair/caulk/paint all exposed/damaged wood siding/trim to reduce deterioration and rot.

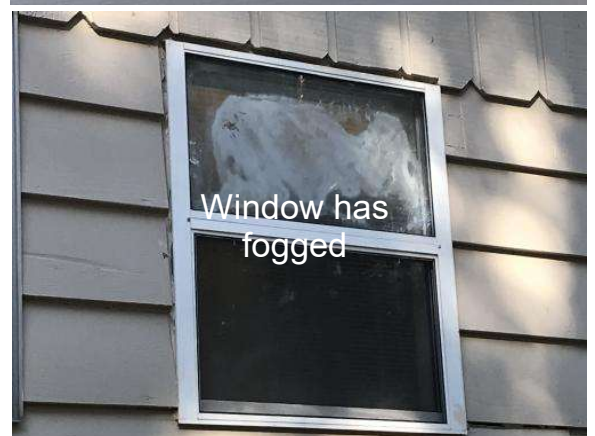
2. Windows: Metal/aluminum - **Failed seals between double panes of glass. Windows have fogged.**

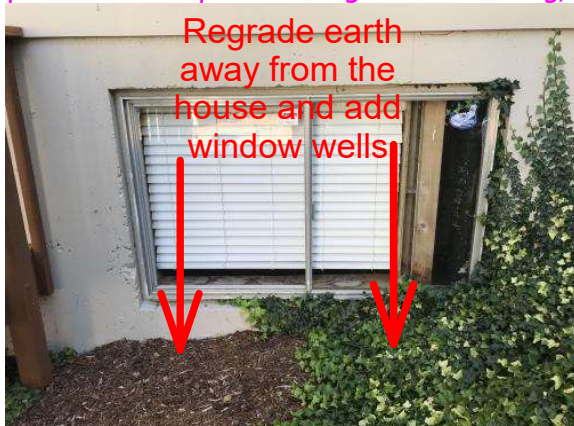
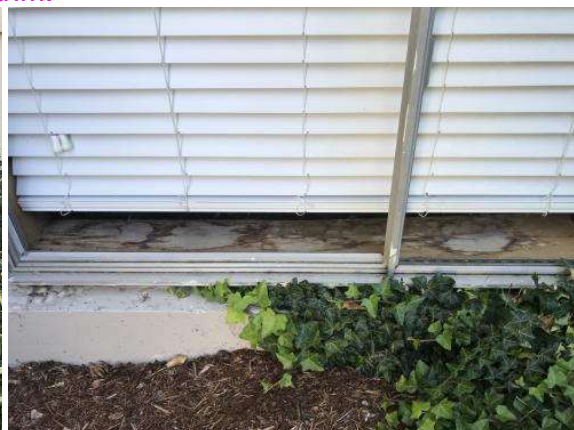
3. Basement Windows: Aluminum - **Foundation is Mostly concealed below grade causing earth is making contact with window trim. Moisture damage noted to interior window sill.**
Regrade earth away from the house and add window wells to prevent entry of water into the house and to prevent subsequent damages to the siding/trim.

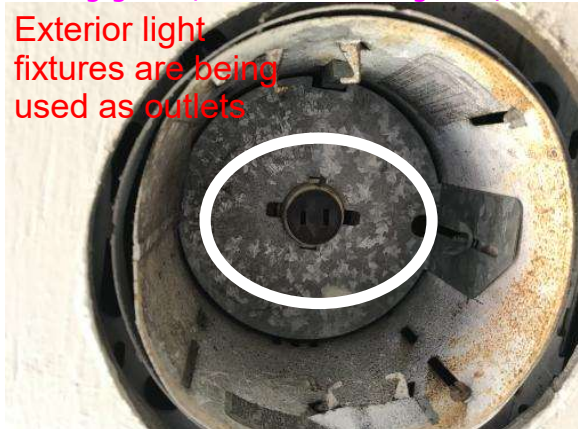
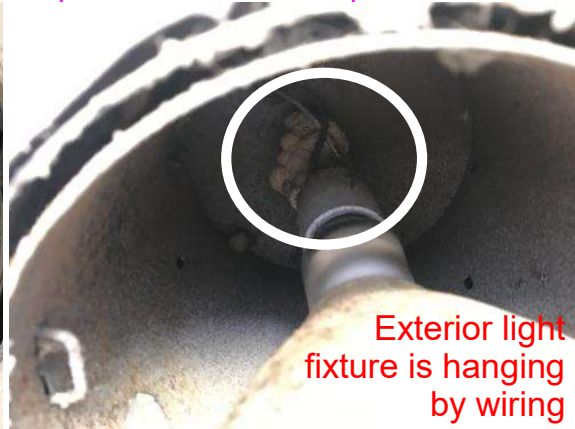
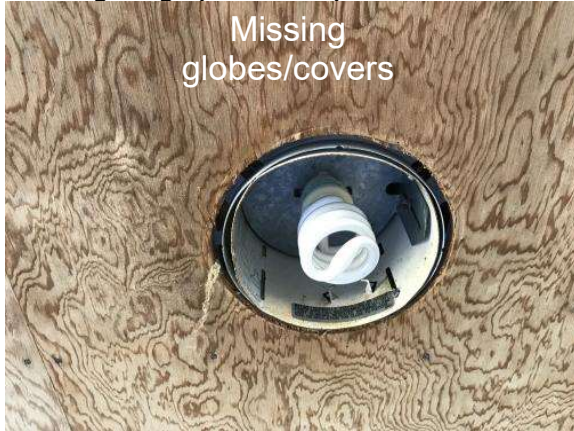
5. Exterior Lighting: Operational - Front and Rear exterior light fixtures are being used as outlets. Rear exterior light fixture over balcony bulb is hanging by its wiring. Consult a qualified electrical contractor to further assess and advise repairs to ensure intended and safe operation.

Missing globes/covers. Provide globes/covers to provide intended bulb protection

Exterior light
fixtures are being
used as outlets

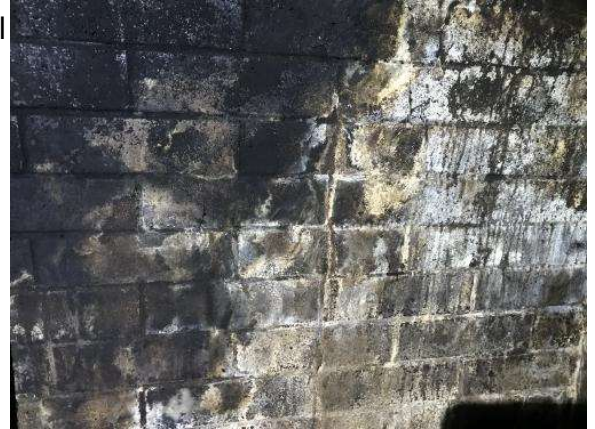
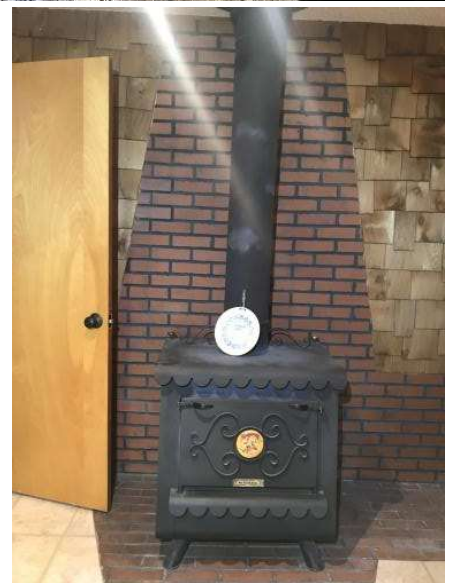
10. upper level living room, lower level Fireplace Fire box: Brick, Metal
- Cracks and deterioration noted to Built in fireplace fire box.
Repair firebox to promote structural safety/stability and safe exhaust
11. upper level living room, lower level Fireplace Freestanding Stove: Wood burning - Installation Certification not apparent, One might consider Consulting a certified technician to review installation in accordance with manufacturers specification to ensure proper installation and safe operation.

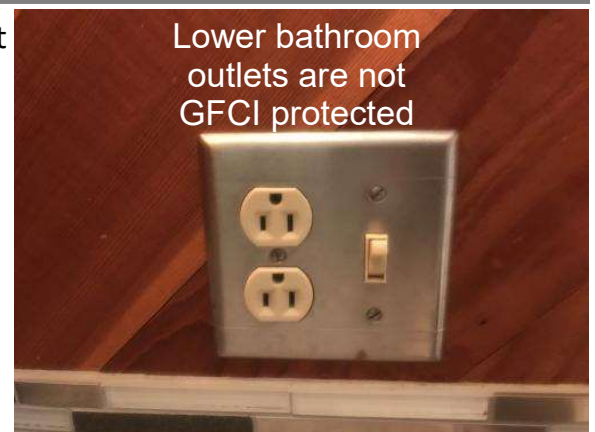
12. 1st floor main, Lower level Bathroom Outlets: GFCI protected, Not operational - Lower bathroom outlets are not GFCI protected.
Install GFCI units to promote intended shock protection

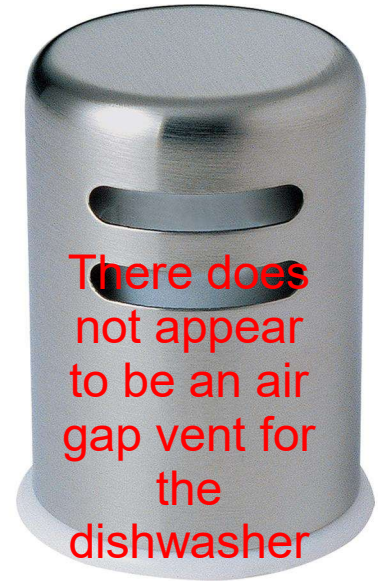
13. 1st Floor Main Kitchen Plumbing/Fixtures: No visible damage, operational - There does not appear to be an air gap vent for the dishwasher.
A licensed plumber is recommended to evaluate and advise repairs to ensure proper drainage and to prevent back flow

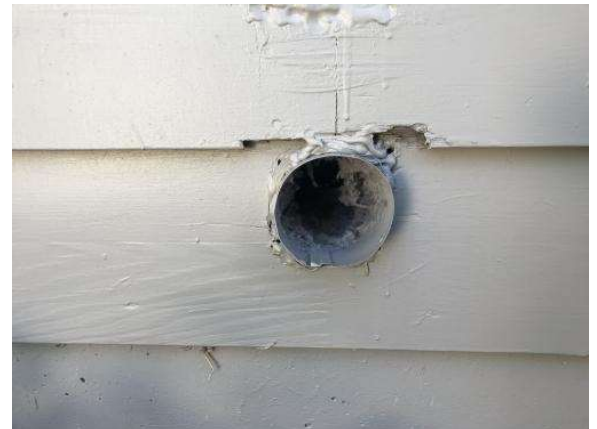
14. Lower level/basement Laundry Room/Area Outlets: Not GFCI protected, Operational - Install GFCI units to promote intended shock protection
15. Lower level/basement Laundry Room/Area Dryer Vent: Metal flex, To exterior - Repair exterior vent to prevent entry of vermin

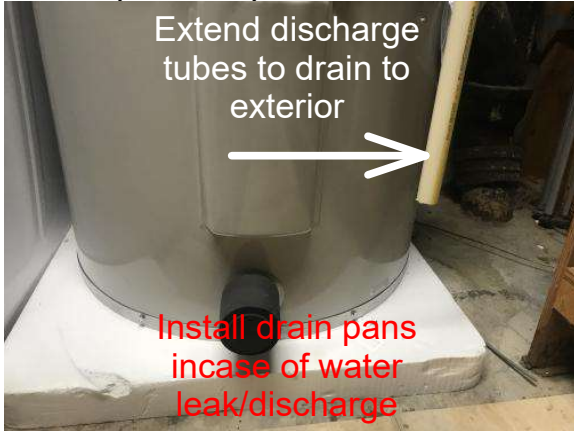
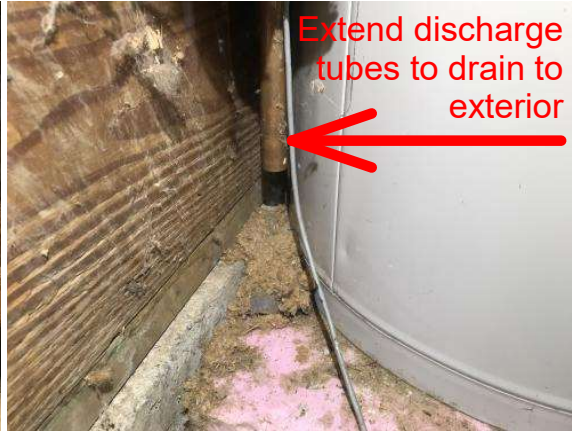
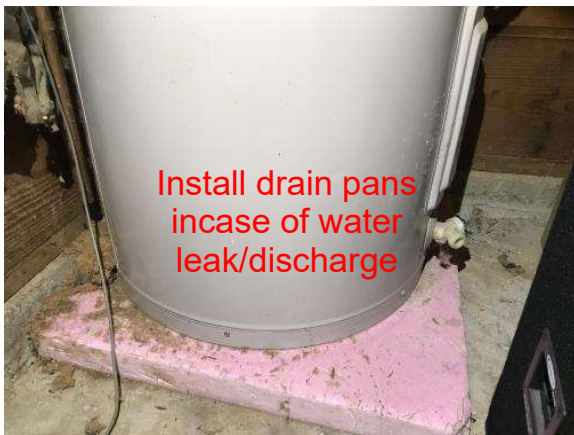
16. Waste drainage: Mostly Concealed/insulated, Galvanized, Cast iron, Plastic - Galvanized drainpipes present. Galvanized drain lines corrode from inside and will eventually require updating.
17. Basement, Garage Water Heater Accessories: TPR Valve Present but not tested, Discharge tube present, Stability straps present - There does not appear to be a floor drain in the garage or basement. Extend discharge tubes to drain to exterior incase of water discharge. Install drain pans incase of water leak/discharge.

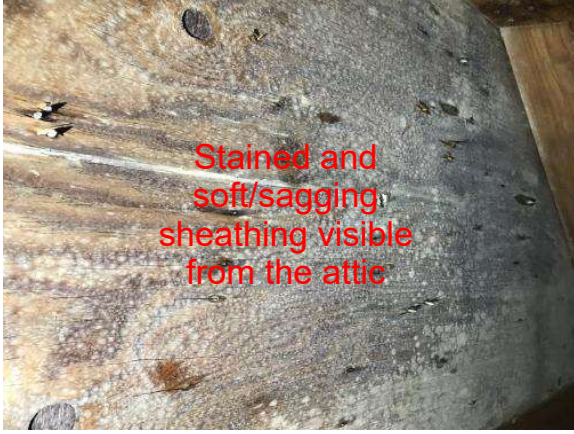
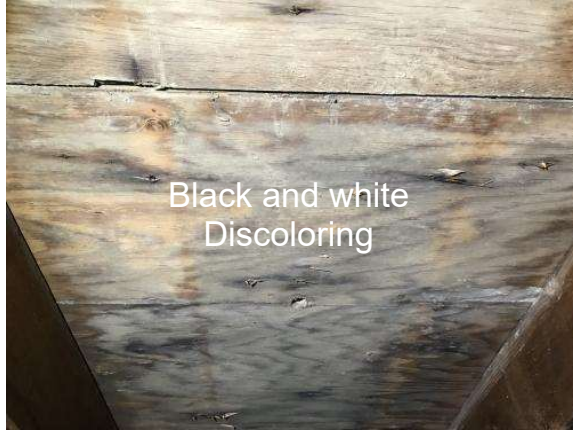
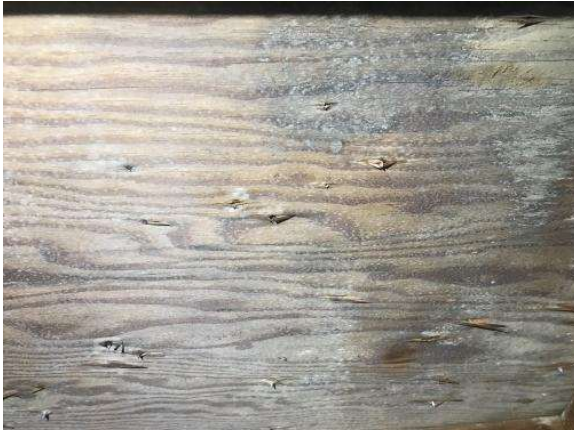
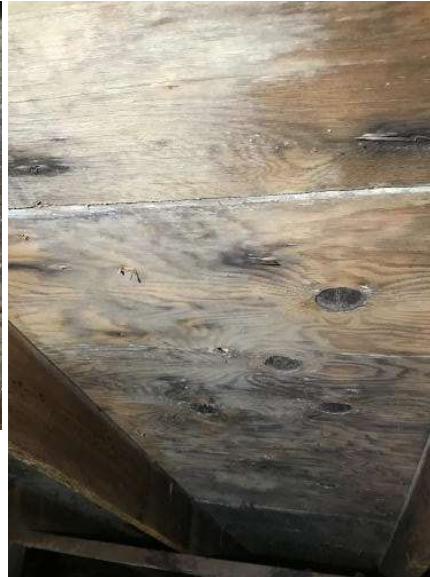
18. Pull down garage Attic Sheathing: Plywood, Stained - Stained and soft/sagging sheathing visible from the attic.
most likely due to moisture from poor ventilation.
See attic ventalaion section for related notes.

Black and white Discoloring most likely due to moisture from poor ventilation.

Black/white substance noted that shares the same characteristic of mold/mildew.

Stained sheathing: Recommend consulting a qualified contractor to further assess stained sheathing and advise cleaning solutions to prevent further subsequent damages and to ensure personal health and safety.

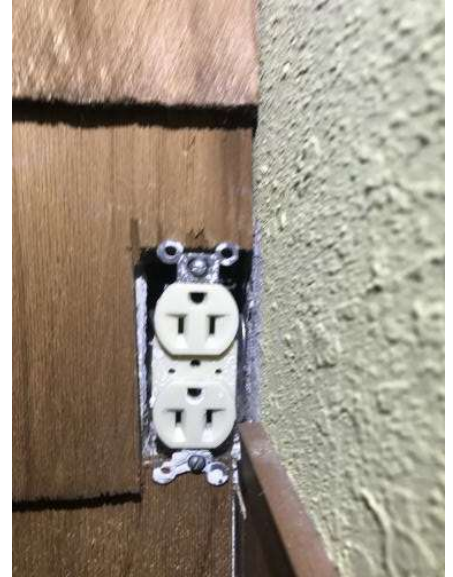
19. Basement/lower level/family room Basement Outlets: Operational - **Replace missing outlet covers for intended shock protection**

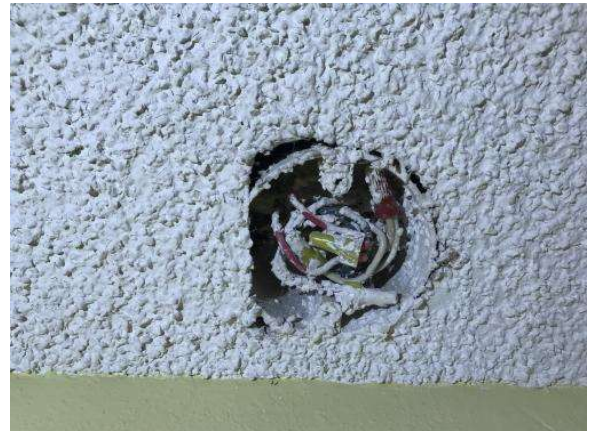
20. Basement/lower level/family room Basement Curcuit Wire: Mostly concealed - **Seal open junction box to promote intended shock protection.**

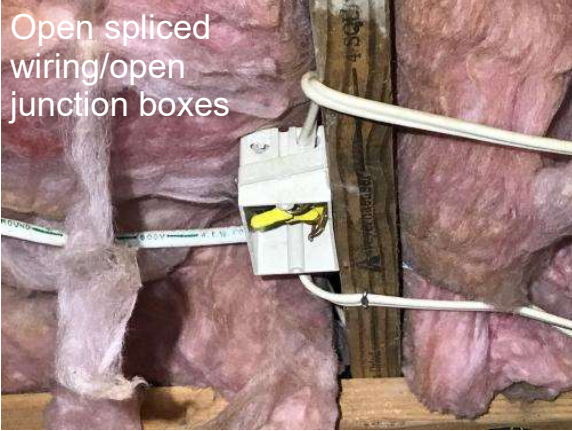
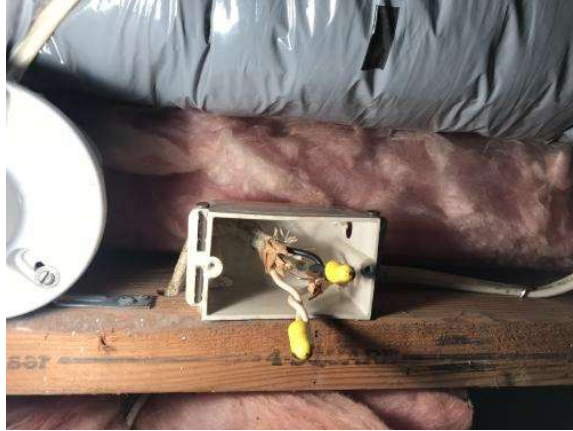
21. Electrical: Mostly concealed - **Open splices: Consult an electrician to conceal open splice wires into a junction box for intended fire and shock protection.**

Open spliced
wiring/open
junction boxes

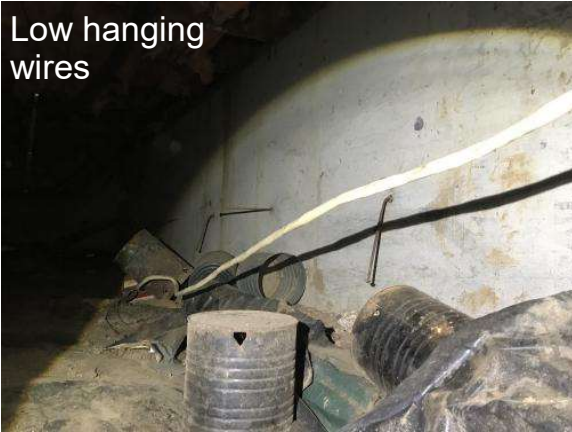
Low hanging/grounded wires noted. Recommend securing wires up to promote intended shock protection

Low hanging
wires

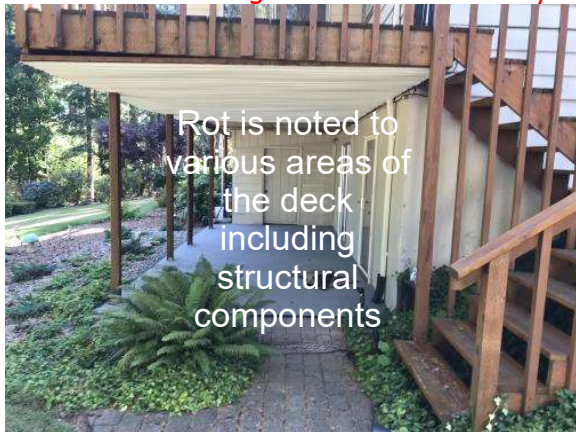
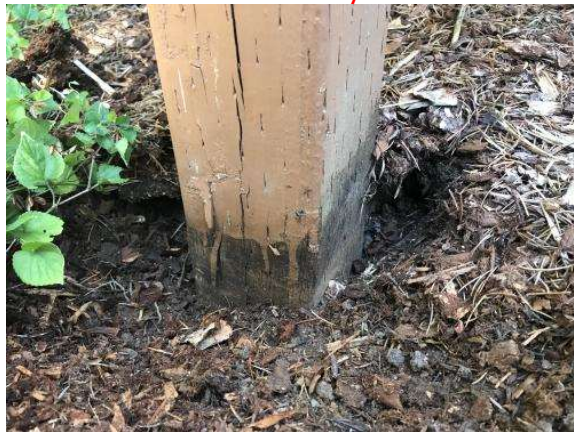
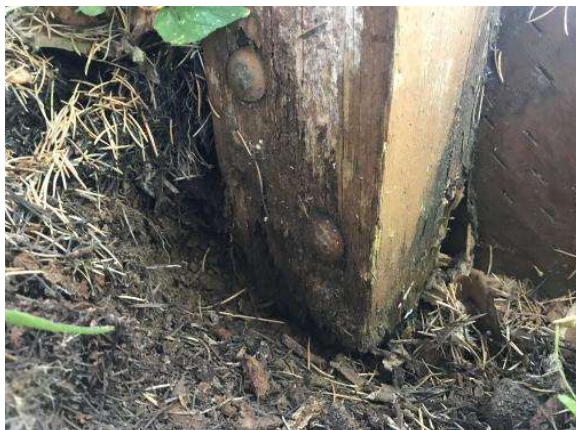
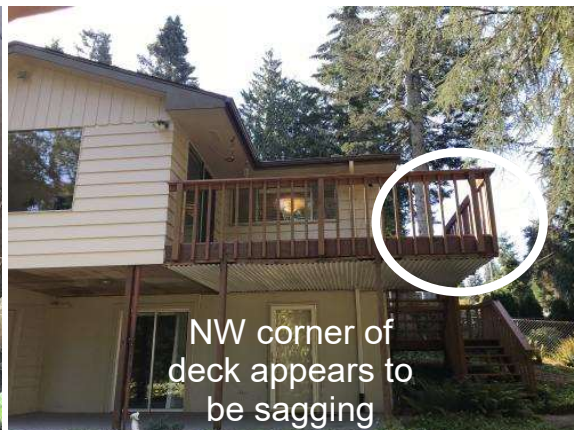
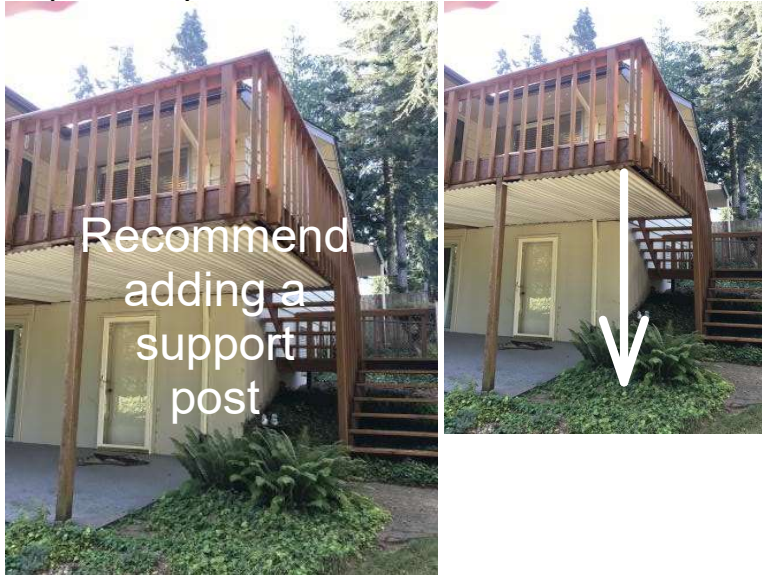
1. Landscaping: Flower bed, Hedge/shrub/bush, Lawn, Hill, Site erosion, Slopes to house - **Front property slopes towards the house.**
Earth erosion noted below front foundation wall visible from crawl space.
Damp soil and erosion below wall is evidence of exterior moisture intrusion into the crawl space.
Recommend consulting a qualified contractor to advise exterior drainage solutions to prevent water from entering the crawl space and causing subsequent foundation problems.
2. Deck: Wood - Rot is noted to various areas of the deck including structural components.
Weathered/damaged: Repair/seal all exposed/damaged decking to reduce deterioration and rot. Replace areas of damage that are beyond being responsive to normal repairs.

NW corner of deck appears to be sagging. Recommend adding a support post below corner of deck to promote added structural durability.

Avoid earth to wood contact to prevent moisture damage and invitation of wood destroying organisms.

Recommend bolting the deck and balcony to the house for added safety.
