Three Rivers Team Home Inspections

123 Sky Ridge View
Vancouver, WA. 98685

11:08 October 03, 2018

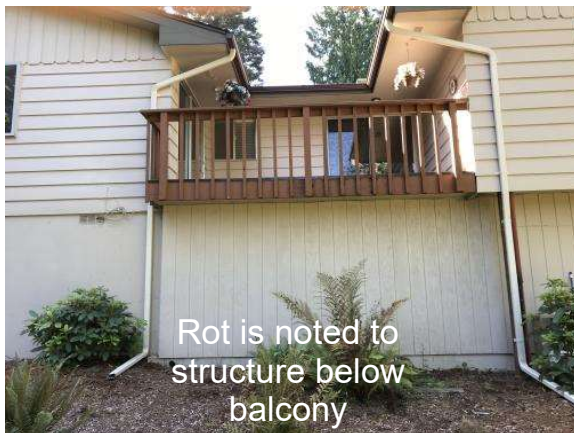
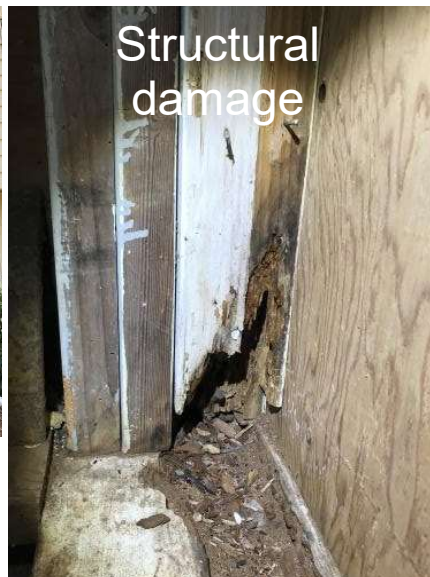
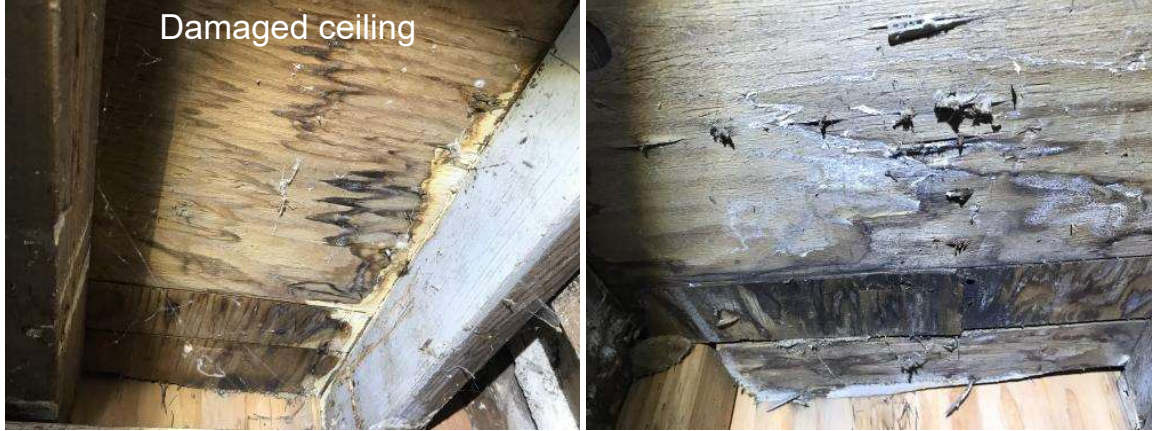
3. Balcony: Wood - *Rot is noted to secondary storage structure below the balcony including its leaking ceiling and structural components.
*Damaged structure below the balcony also appears to serve as the balconies support system.
*Rot noted to ceiling of structure below balcony / ceiling is leaking.
Recommend consulting a structural contractor to further assess and advise repairs to ensure structural durability and to prevent further subsequent damages.

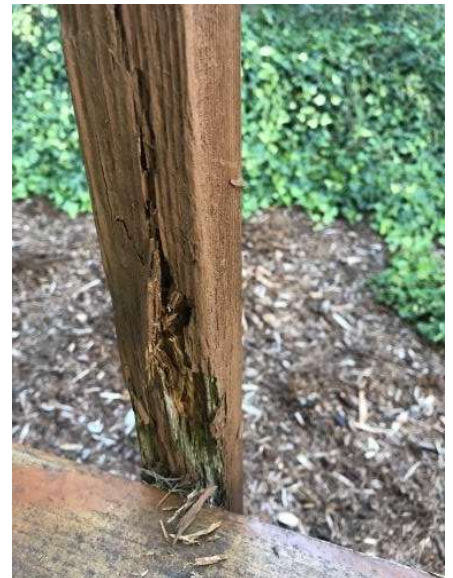
4. Railing: Wood - Rot is noted to various areas of wood railing.
Weathered/damaged: Repair/seal all exposed/damaged railing to reduce deterioration and rot. Replace areas of damage that are beyond being responsive to normal repairs.

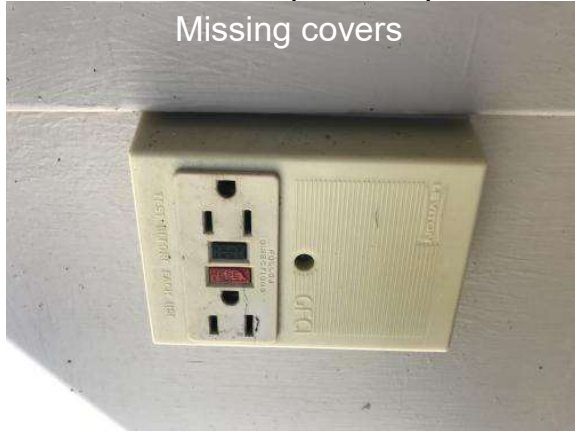
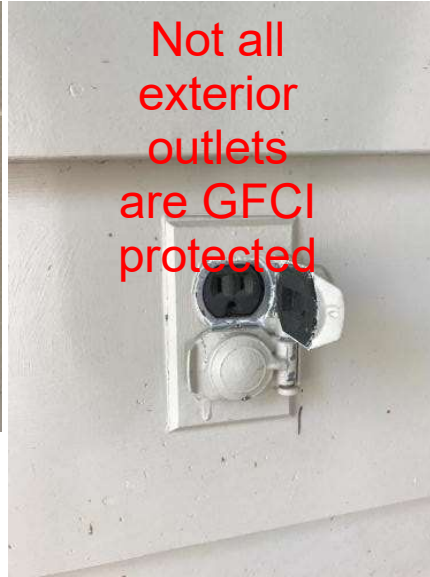
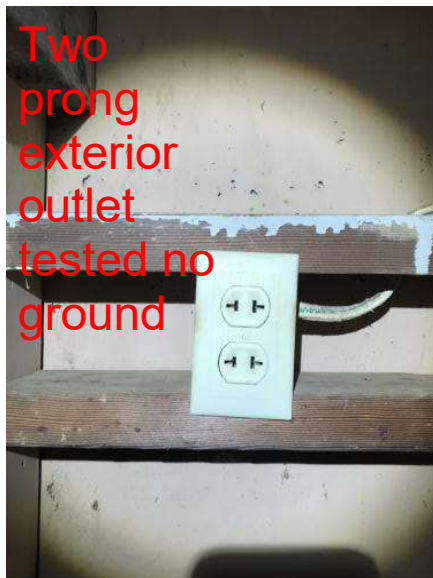
5. Exterior Electric Outlets: Operational - Not all exterior outlets are GFCI protected.
Install GFCI unit/s to promote intended shock protection.

Some exterior outlets are missing covers.
Replace missing outlet covers for intended shock protection.

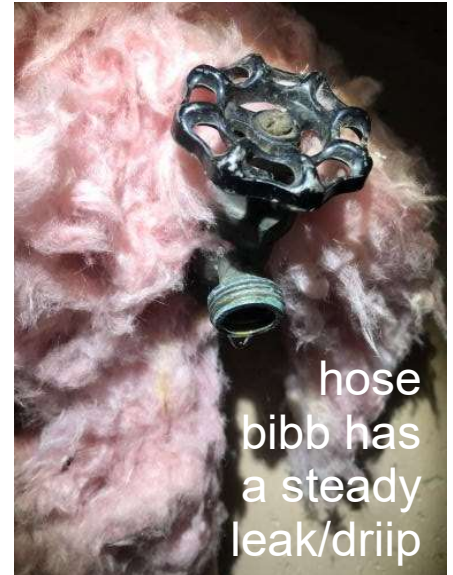
6. Hose Bibbs: Operational - Rear hose bibb has a steady leak/driip.
A licensed plumber is recommended to evaluate and advise repairs.

Not all hose bibbs are anti siphon.

Recommend installing anti siphon hose bibbs to prevent outside water from siphoning through an outside faucet and contaminating the drinking water used in your home.

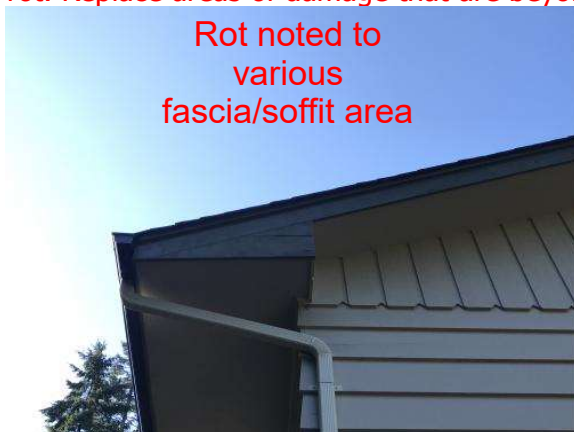
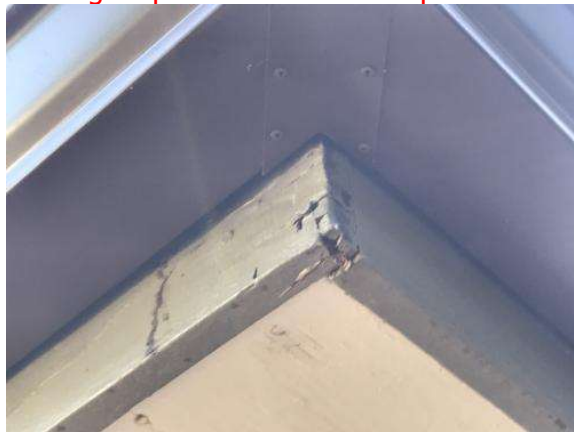
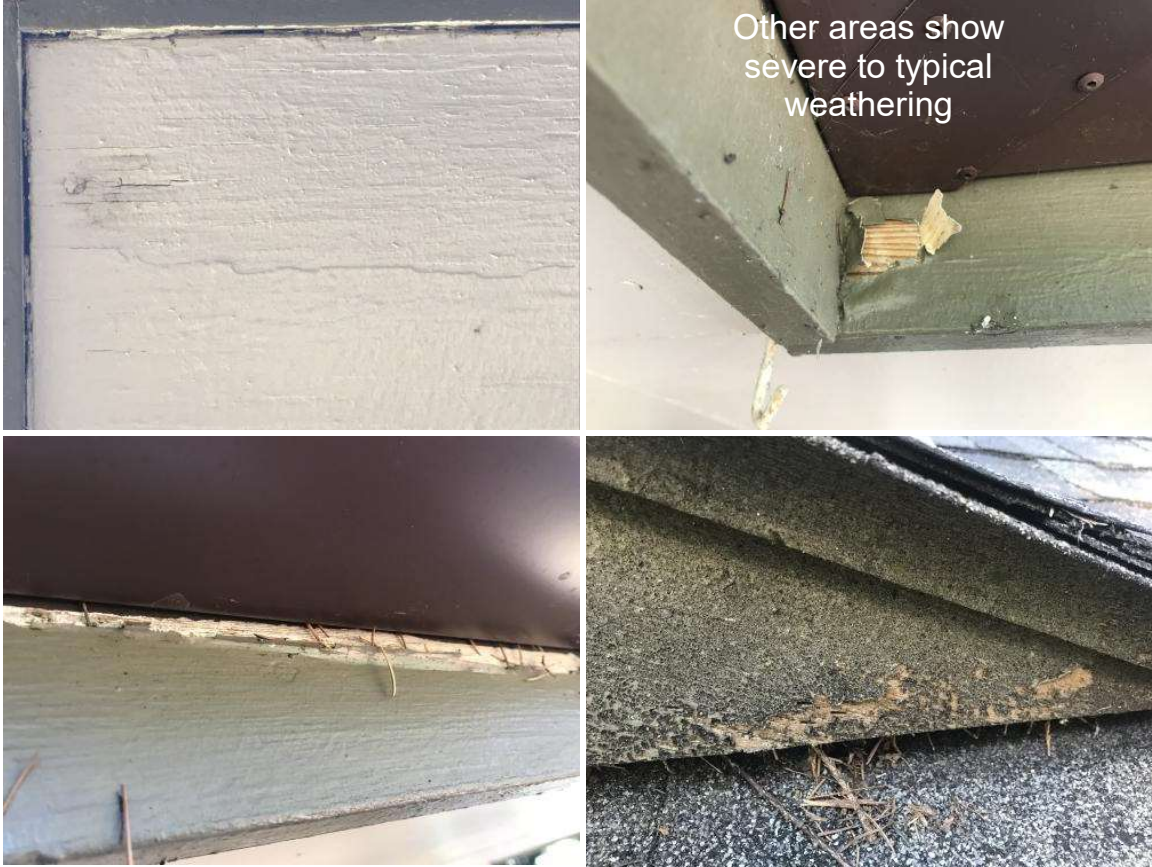
7. Fascia/soffits: Wood, Vented soffits - Rot noted to various fascia/soffit areas.
Other areas show severe to typical weathering.
Weathered/damaged: Repair/caulk/paint all exposed/damaged wood fascias/soffits to reduce deterioration and rot. Replace areas of damage that are beyond being responsive to normal repairs.

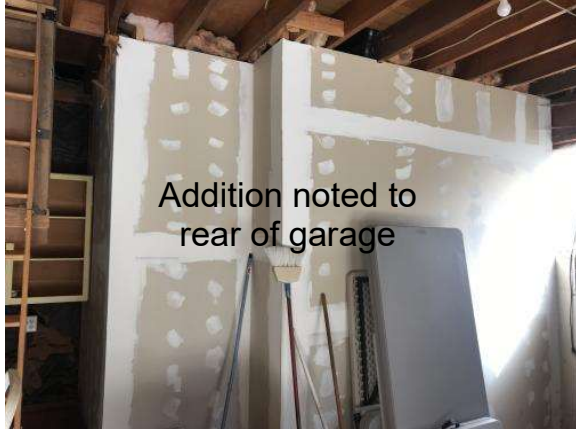
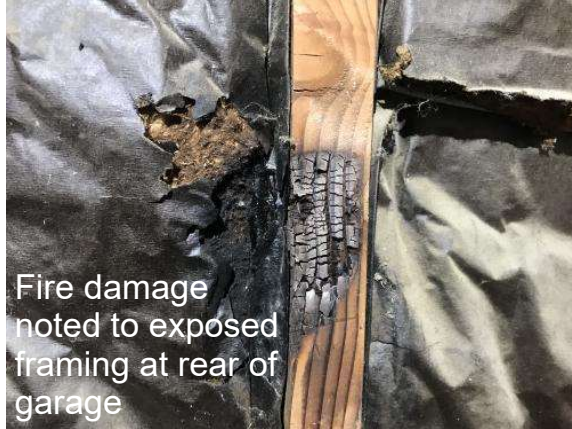
8. Garage Walls: Exposed framing - Addition noted to rear of garage. Addition accommodates master bedroom/bathroom.
Recommend obtaining structural/electrical/plumbing permits to ensure proper construction/installations.

Fire damage noted to exposed framing at rear of garage.
Consult a structural contractor to further assess damages and advise repairs to ensure structural durability.
Recommend determining cause of damage to ensure that underlying conditions do not exist.

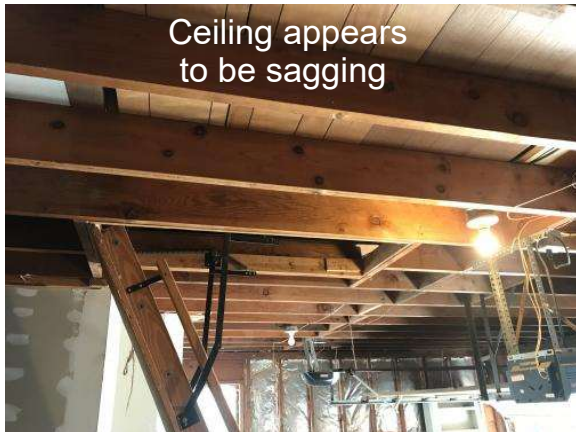
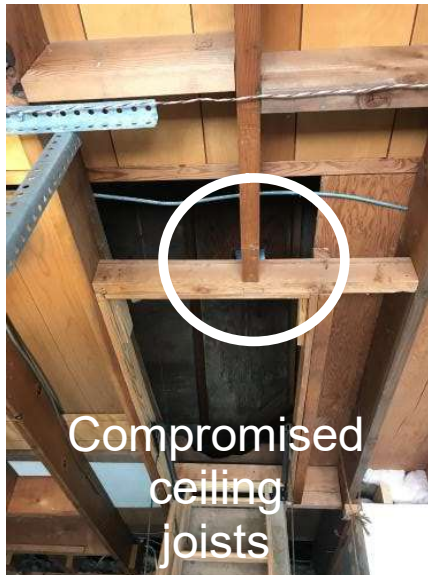
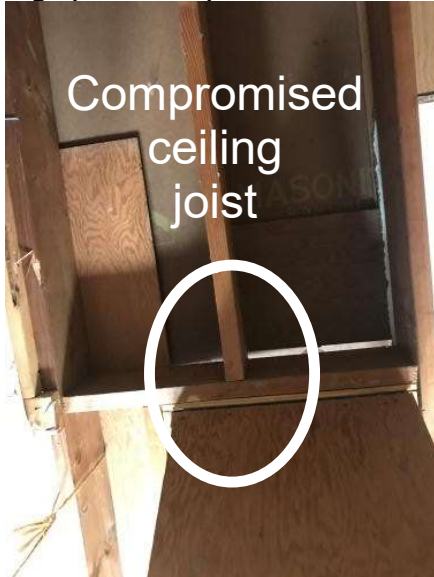
9. Garage Ceiling: Exposed framing - Garage ceiling joist appears to have been compromised to accommodate a pull down attic access. Ceiling appears to be sagging as a result. Consult a qualified structural contractor to further assess and advise repairs to ensure structural durability and to prevent further subsequent damages.

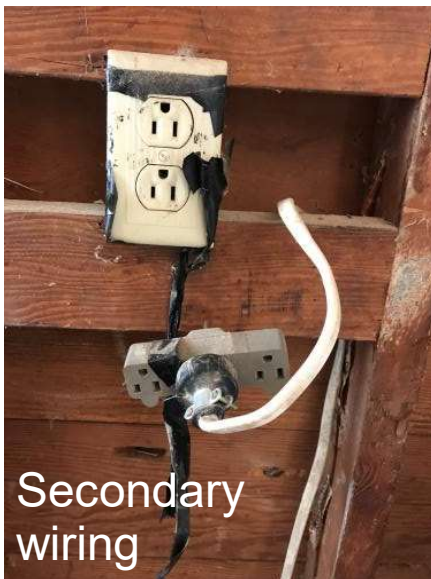
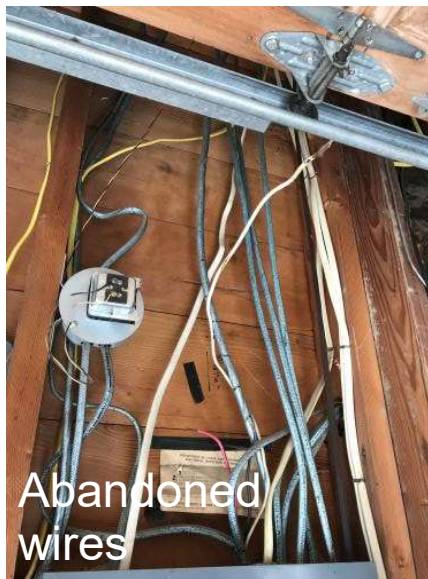
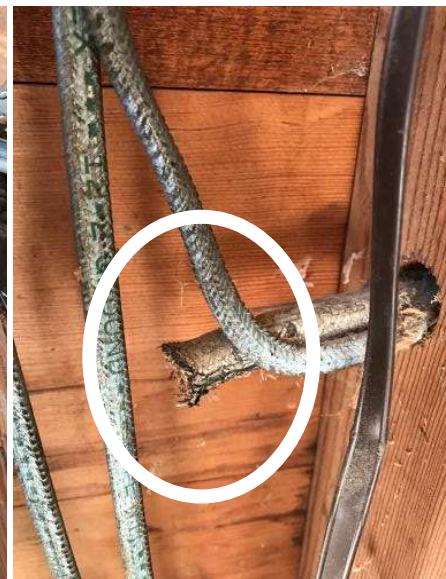
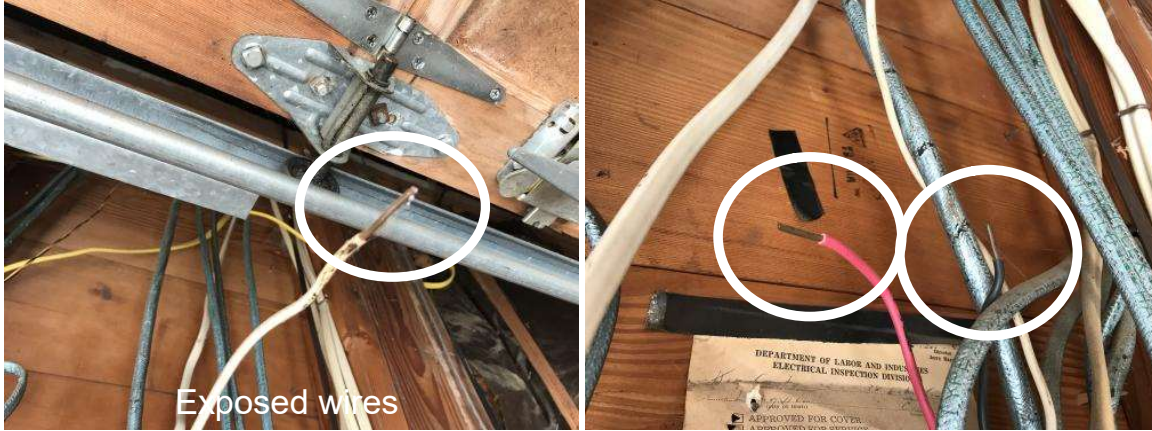
10. Garage Curcuit Wire: Improper - Secondary wiring and abandoned/exposed wiring noted through out the garage. Consult a qualified electrical contractor to further assess and advise repairs to ensure safe operation.

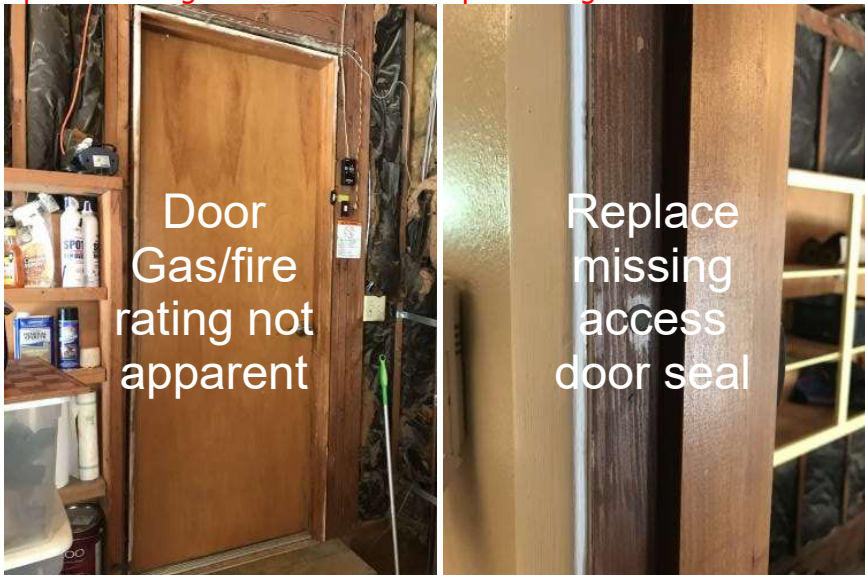
11. Garage Service Doors: Wood, hinged, not self closing, to kitchen - Door Gas/fire rating not apparent. Replace door with an approved fire rated unit combined with associated hardware for self closing to promote gas/fire barrier.

Replace missing access door seal to promote gas barrier

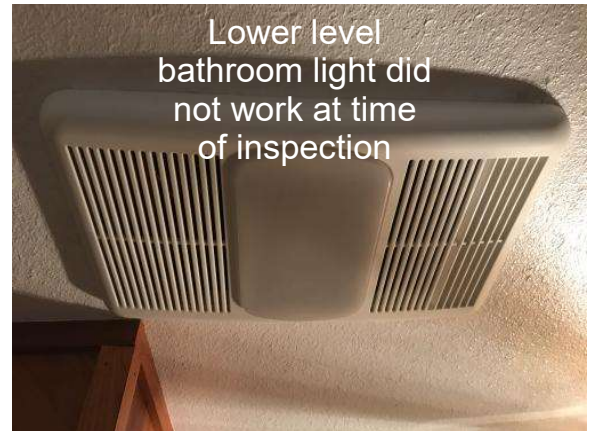
12. 1st floor main, Lower level Bathroom Lighting: none Lower level bathroom light did not work at time of inspection. (Bad bulb?)

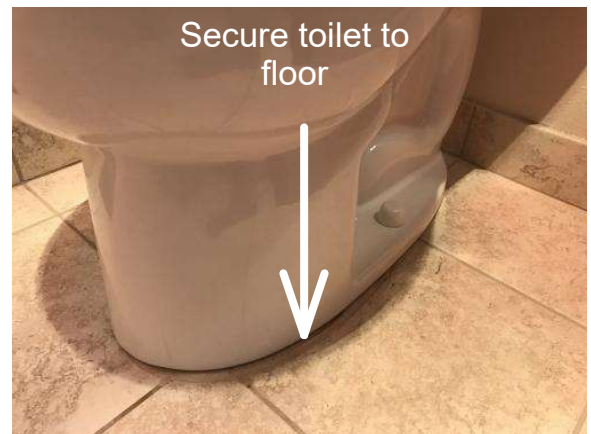
13. 1st floor main, Lower level Bathroom Exhaust fan: Operational, None - Upper hallway bathroom: No ventilation present, Install exhaust fan to remove excess moisture, reduce related damages/deterioration and discourage an environment conducive to mold growth
14. 1st floor main, Lower level Bathroom Toilets: Operational - Toilet/s loose at bases. Secure toilets to floor to prevent leaks, subsequent damages, and to promote personal safety.

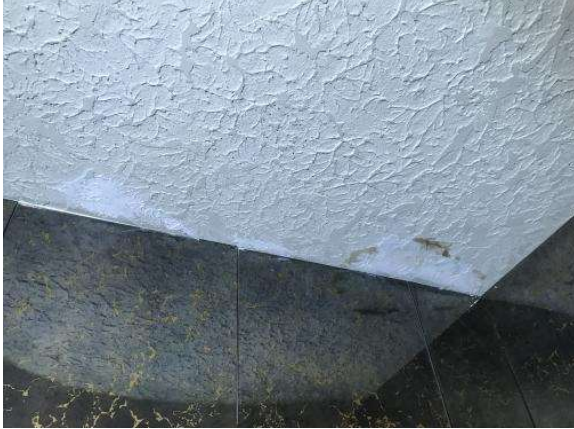
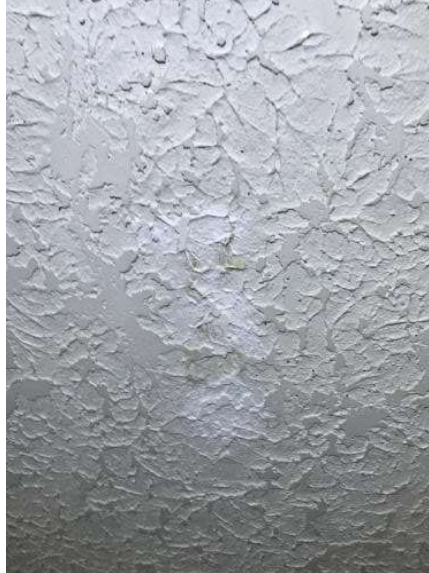
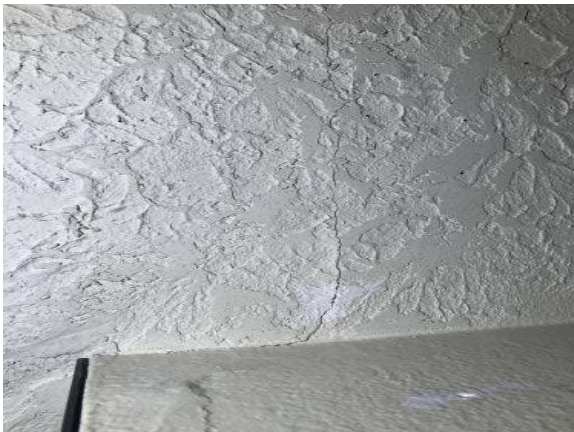
15. Living Room and rear bonus room, upper level Living Space Ceiling: Dry wall, Dry wall / Plaster / Painted - Moisture stains around the chimney. Recommend determining of origin of stains to ensure that under lying conditions do not exist.
*No moisture reading at time of inspection.

Crack/s present: Repair cracks to reduce further separation/deterioration.

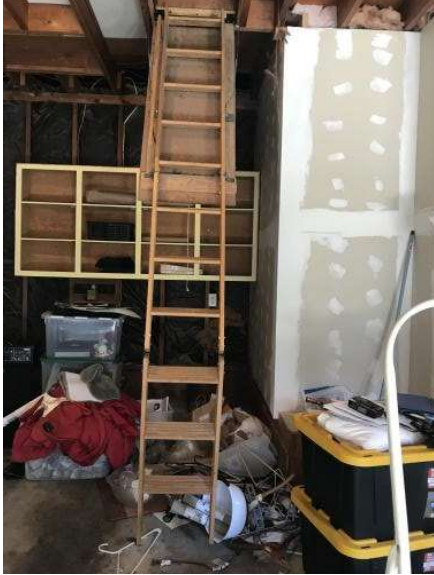
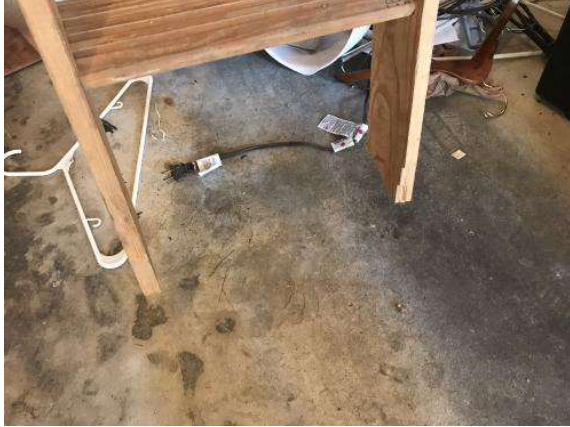
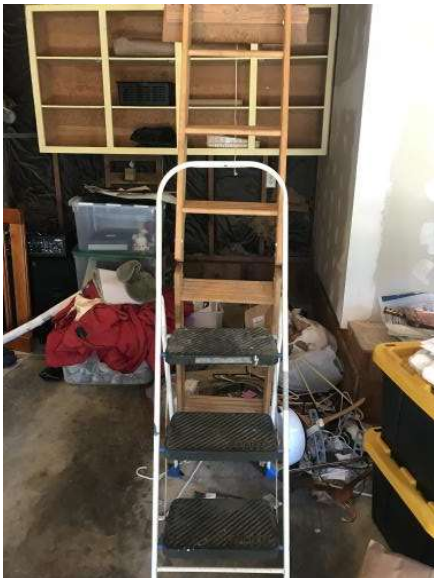
16. Note: Pull down ladder for attic access in garage does not make contact with floor.
Alternative step ladder is being to used to accommodate inefficiency.
Advise repairs to ensure intended safe operation.

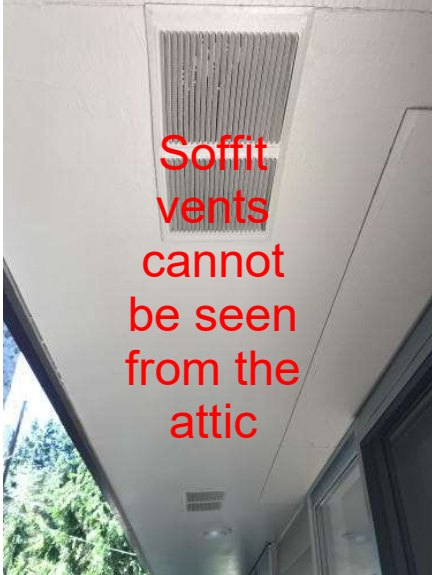
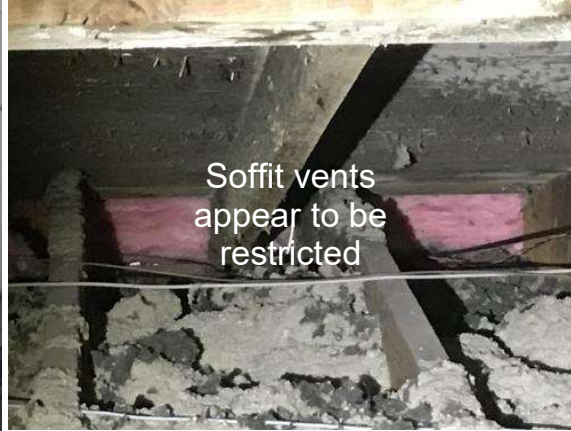
17. Pull down garage Attic Ventilation: Roof, Soffit - Soffit vents cannot be seen from the attic.
Soffit vents appear to be restricted.
Clear restricted soffit vents and provide baffles to reduce potential obstruction and subsequent moisture/condensation related damages.

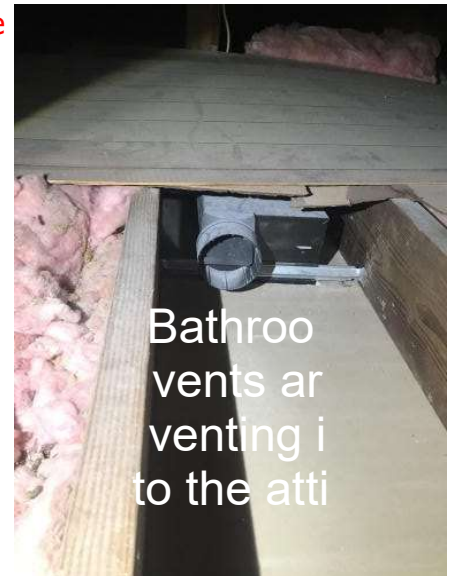
18. Pull down garage Attic Exhaust/Fan Venting: Into attic - Bathroom vents are venting into the attic.
Extend exhaust vent to discharge to the exterior to prevent an atmosphere conducive to mold/mildew and to prevent further moisture/condensation related damages.

Exhaust vents should have designated exterior sources and should not utilize roof vents intended for attic ventilaion.

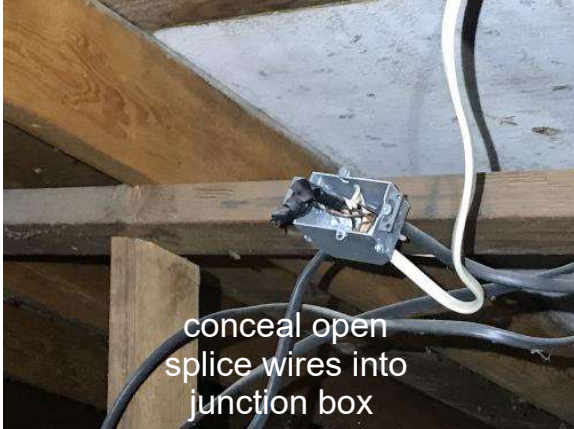
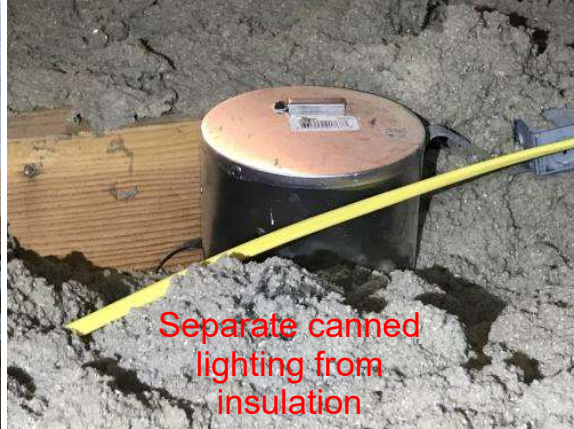
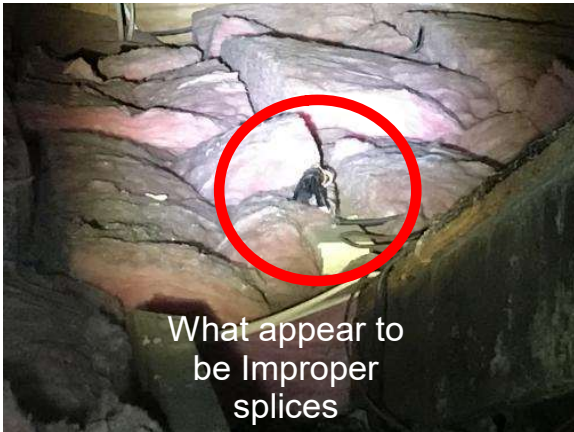
19. Pull down garage Attic Electrical: Mostly Concealed - Open splices/junction box/es: Consult an electrician to conceal open splice wires into a junction box for intended fire and shock protection.

Canned lighting rating is not apparent.
Separate canned lighting from insulation with round barrier for intended fire protection.

What appear to be Improper splices noted above addition/s.
Consult a qualified electrical contractor to further assess and advise repairs to ensure safe operation.

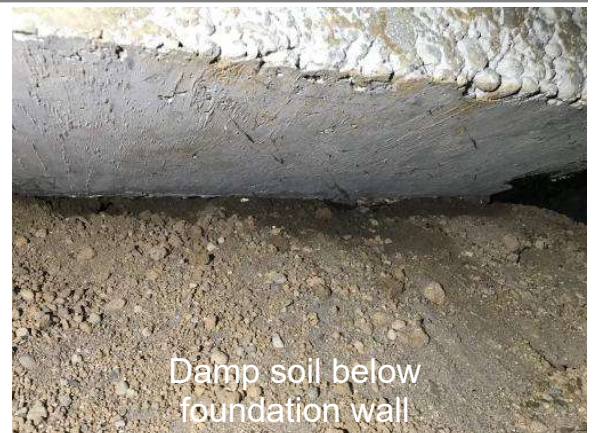
20. Moisture Penetration: Damp - Damp soil noted below foundation wall at SW corner of crawl space. Earth erosion below wall is also evident. Recommend consulting a qualified contractor to further assess, determine point of water entry, and advise exterior drainage solutions to prevent water from entering the crawl space and causing subsequent foundation problems.

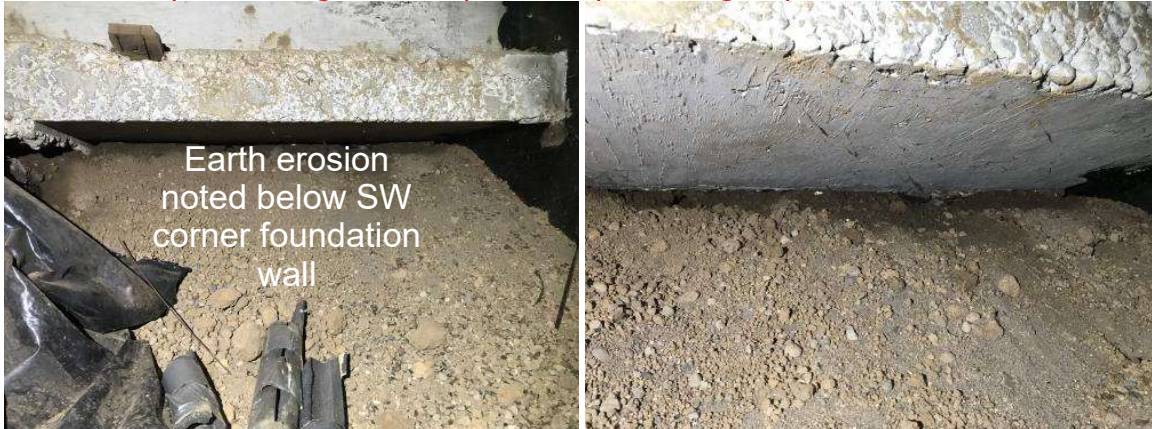
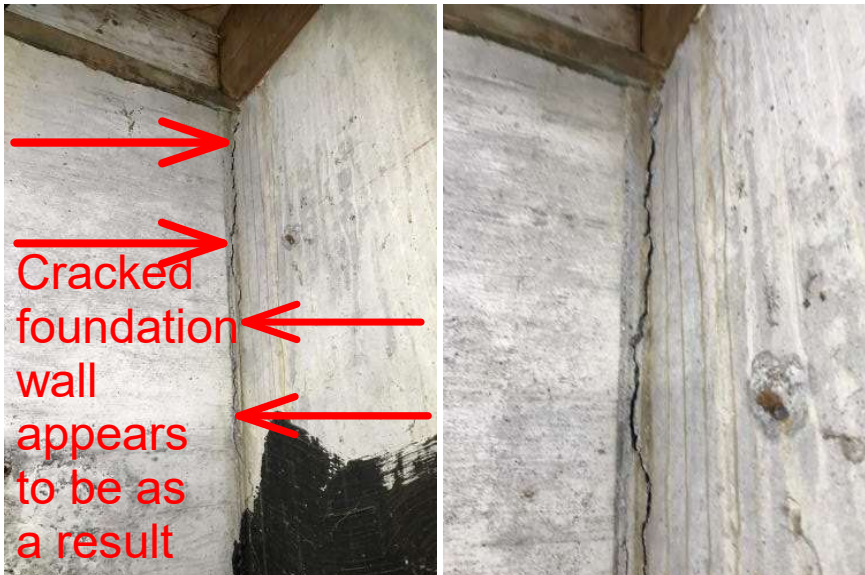
21. Foundation/Bearing walls: Poured Concrete, Concealed poured concrete slab & walls - Earth erosion noted below SW corner foundation wall visible from crawl space. Crack with separation noted to foundation wall at SW corner most likely as a result. Recommend consulting a foundation contractor to further assess and advise repairs/maintenance to prevent

further subsequent damages and to promote system longevity.
