# PROPERTY CONDITION ASSESSMENT REPORT

Sample Report  
Minneapolis, MN

Tuesday, December 1, 2015

RE: Report No. 1497  
Sample Report  
Minneapolis, MN

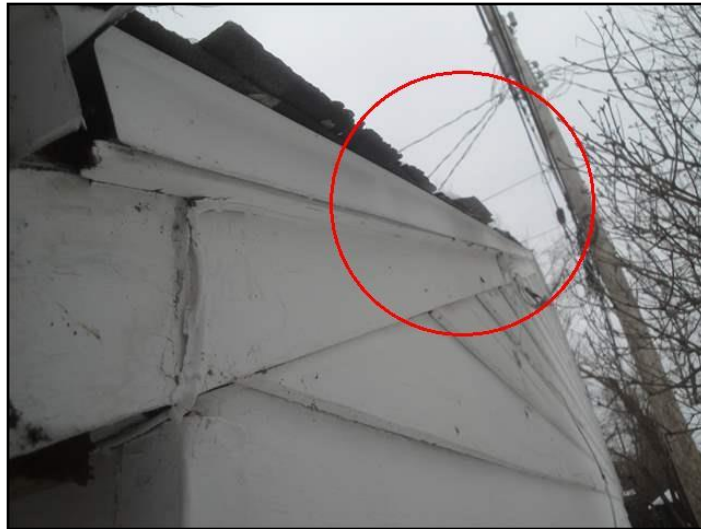
**Condition:** • [Overhangs too big or too small](#)

**Implication(s):** Chance of water damage to contents, finishes and/or structure

1. Overhangs too big or too small

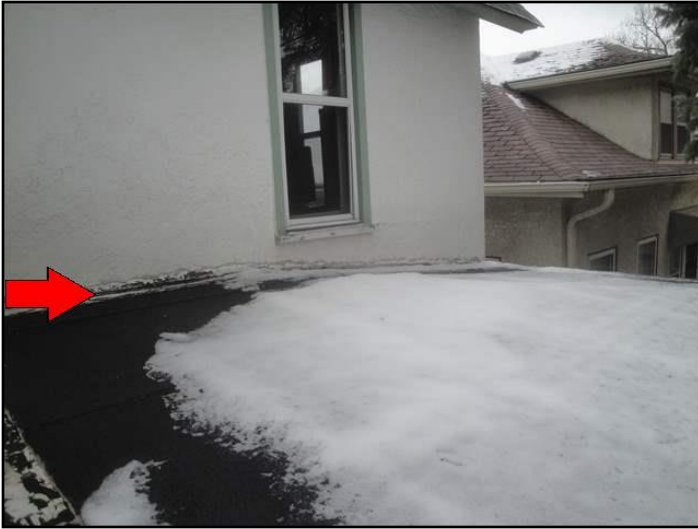
**Condition:** • [Missing](#)

Metal dormer flashing was not visible and appeared to be missing. Monitor this area and repair the sealant at the wall as needed until the porch is re-roofed. This area may be vulnerable to leaks.

**Implication(s):** Chance of water damage to contents, finishes and/or structure

2. Missing

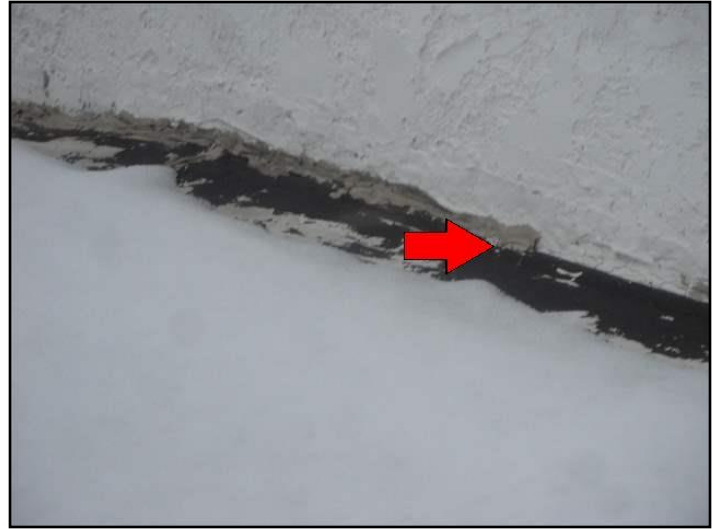
3. Missing

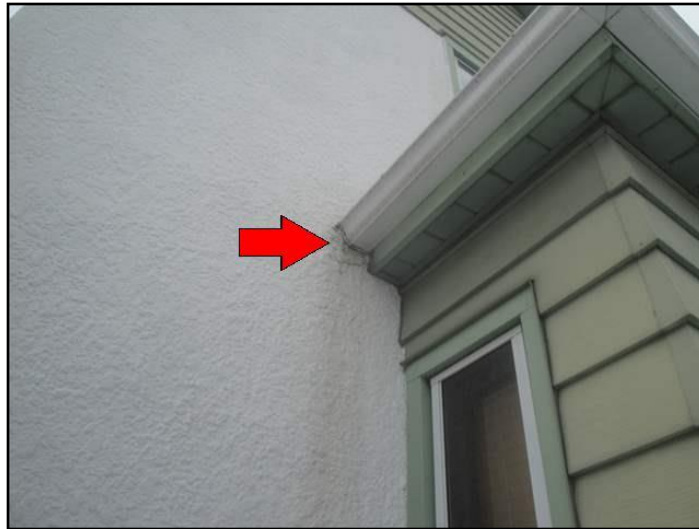
**Condition:** • [No kickout flashing](#)

**Implication(s):** Chance of water damage to contents, finishes and/or structure

4. No kickout flashing

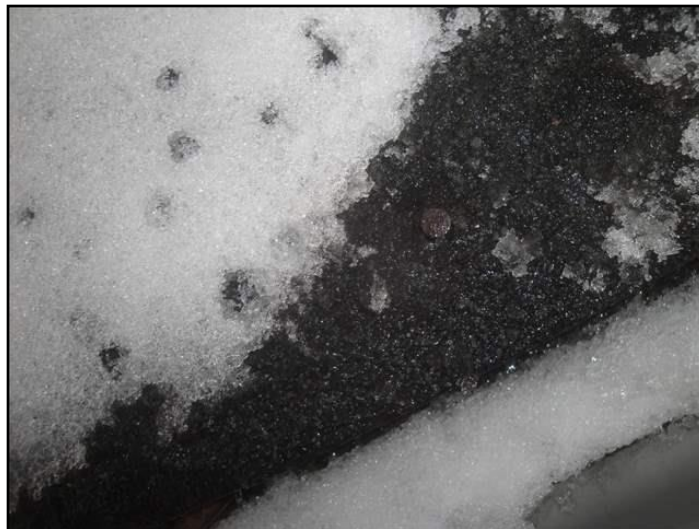
5.

**Condition:** • [Near end of life expectancy](#)

Visible areas were brittle and in poor condition.

**Implication(s):** Chance of water damage to contents, finishes and/or structure

**Task:** Replace

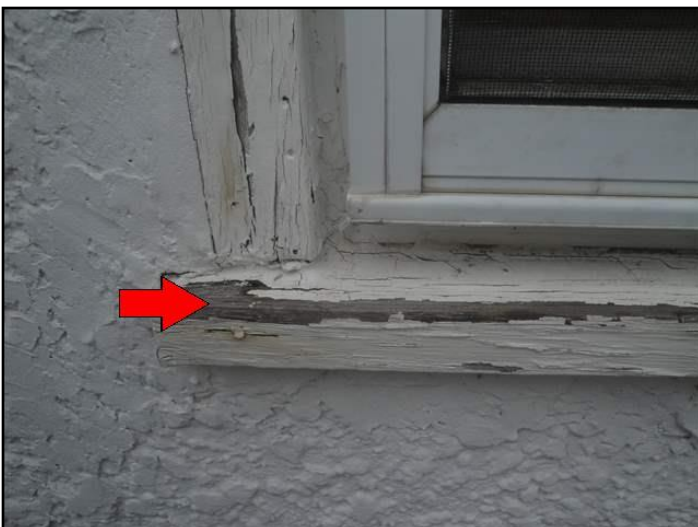
**Condition:** • Paint or stain needed

**Implication(s):** Chance of water damage to contents, finishes and/or structure | Material deterioration

6. *Paint or stain needed*

**Task:** Repair

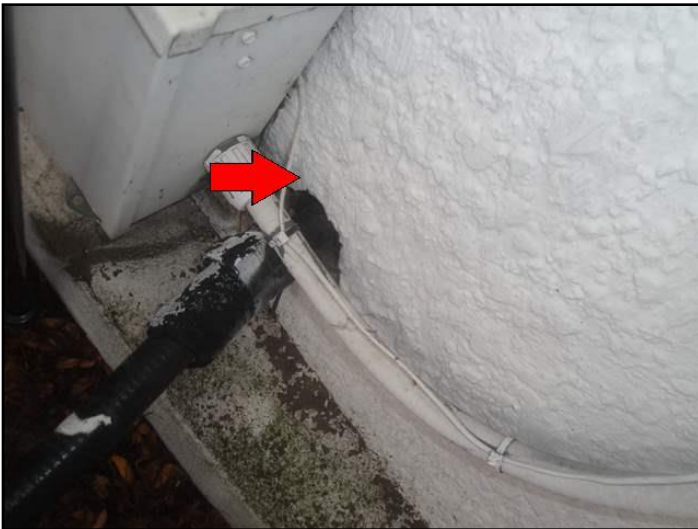
**Condition:** • [Caulking missing or ineffective](#)

Caulk is beginning to shrink or is missing in areas. Monitor and repair/replace as necessary. It is important to keep vulnerable areas sealed to prevent moisture intrusion.

**Implication(s):** Chance of water damage to contents, finishes and/or structure

8. Caulking missing or ineffective

**Task:** Repair

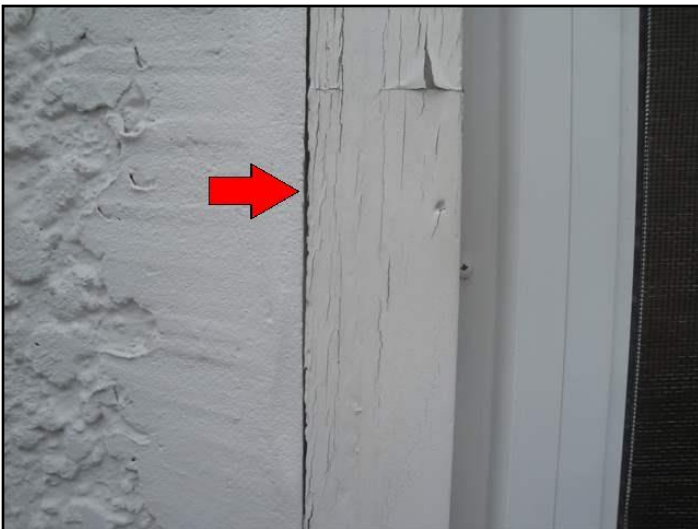
10. Caulking missing or ineffective

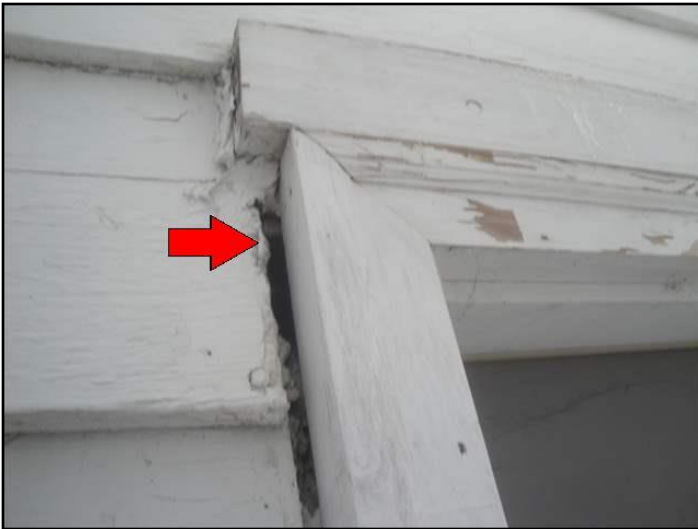
12. Caulking missing or ineffective

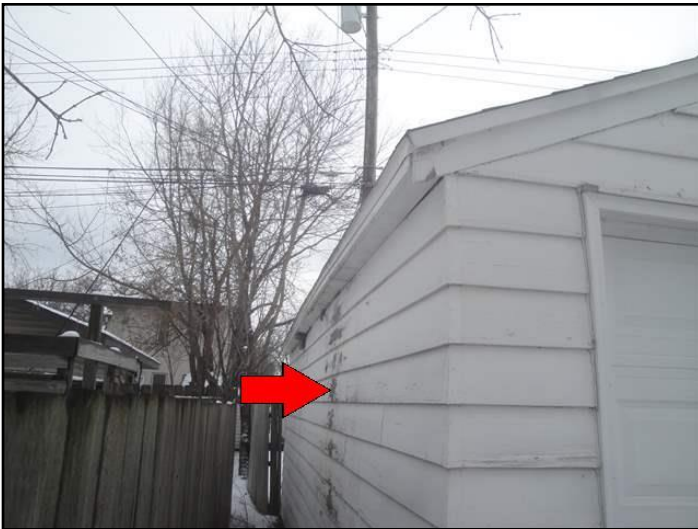
**Condition:** • [Paint or stain - needed](#)

14. Paint or stain - needed

**Task:** Repair

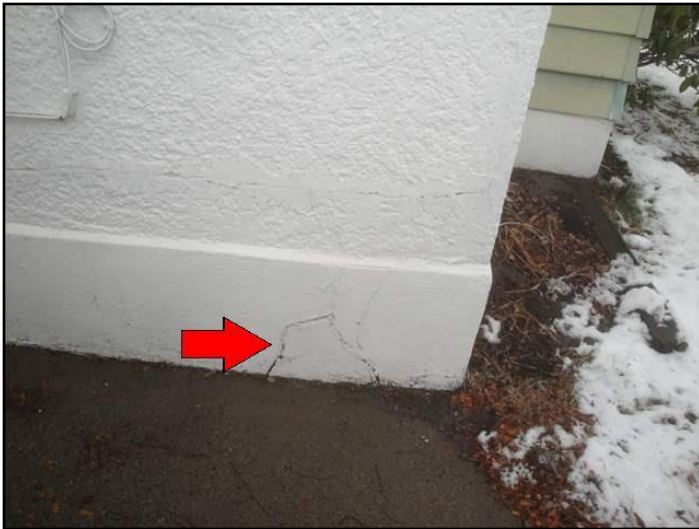
**Condition:** • [Cracked](#)

Minor to moderate cracks observed in various areas of the building. There is a potential for moisture penetration and further damage to stucco and hard coat surfaces. Seal cracks and voids with an approved sealant or repair or replace affected areas with a masonry repair.

**Implication(s):** Chance of water damage to contents, finishes and/or structure | Material deterioration

19. Cracked

**Task:** Repair

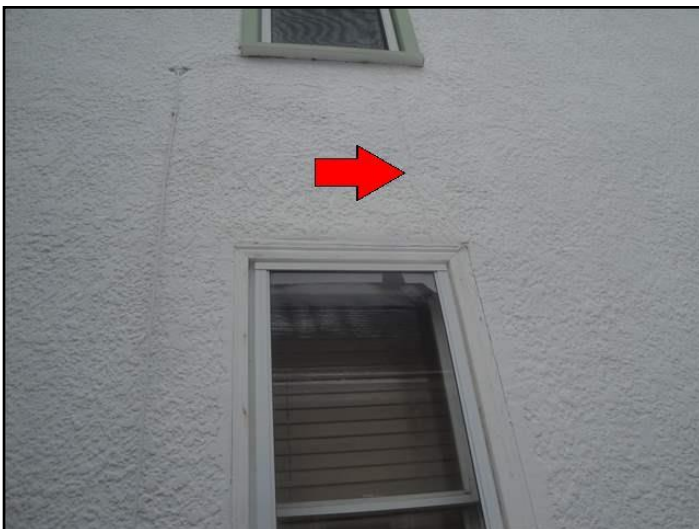
21. Cracked

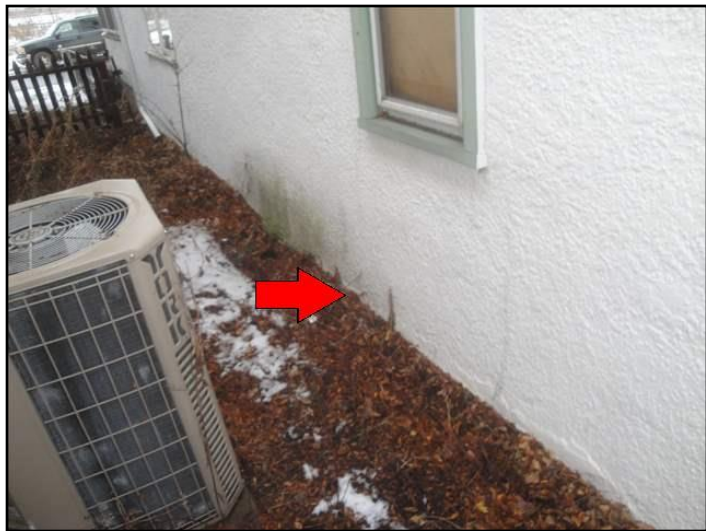
**Condition:** • [No drip screed](#)

**Implication(s):** Chance of water damage to contents, finishes and/or structure | Material deterioration

24. No drip screed

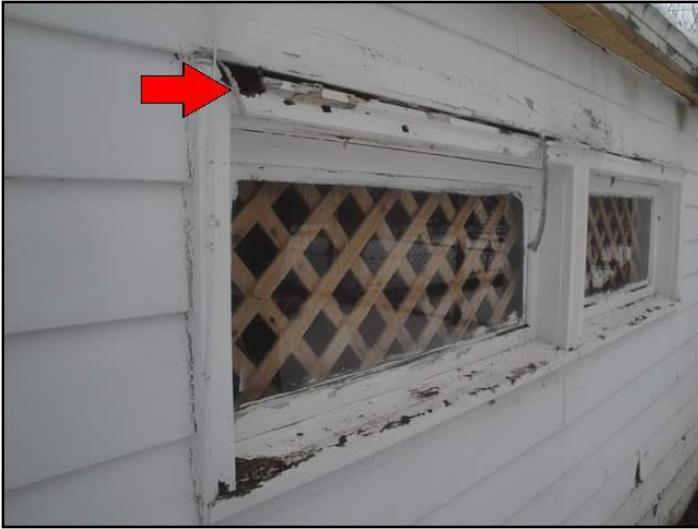
**Condition:** • Rot

**Implication(s):** Material deterioration

25. Rot

**Task:** Repair or replace

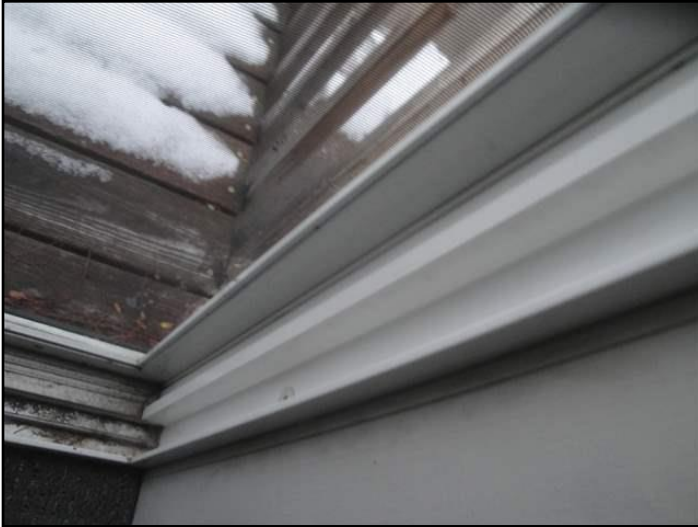
**Condition:** • [Holes](#)

27. Holes

**Task:** Repair

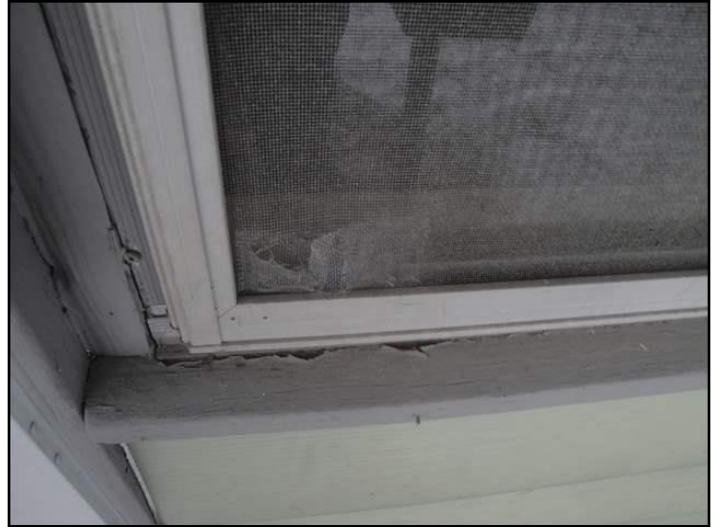
28. Holes

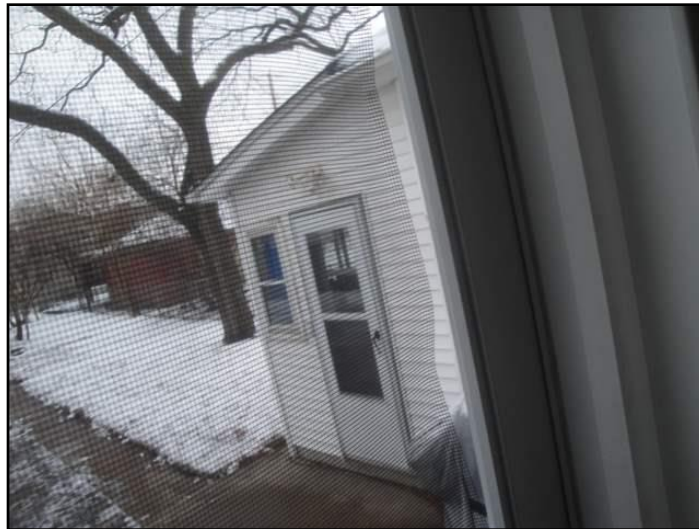
29. Holes

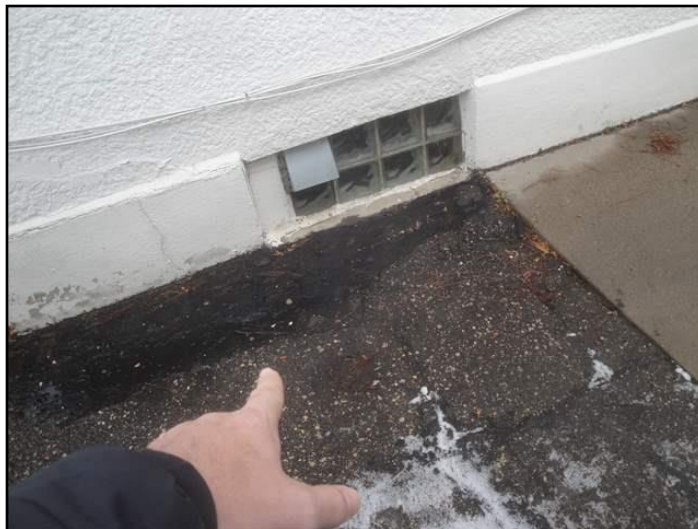
31. *Improper slope or drainage*

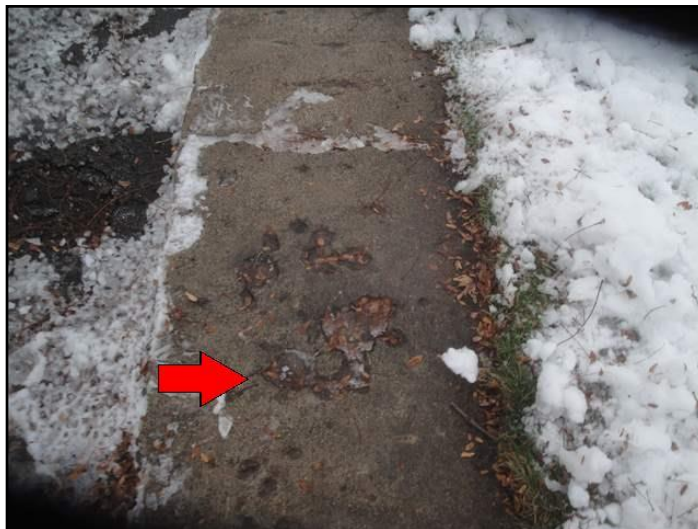
32. *Cracked or damaged surfaces*

**Task:** Repair or replace

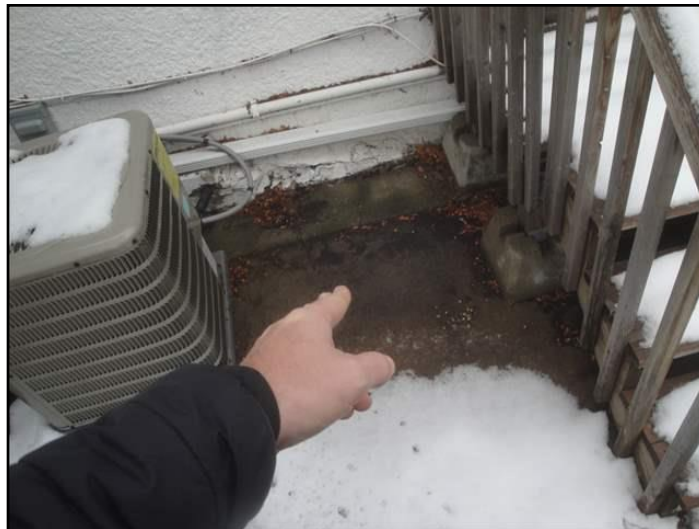
## Walk/patio sloping toward house

33. *Improper slope or drainage*

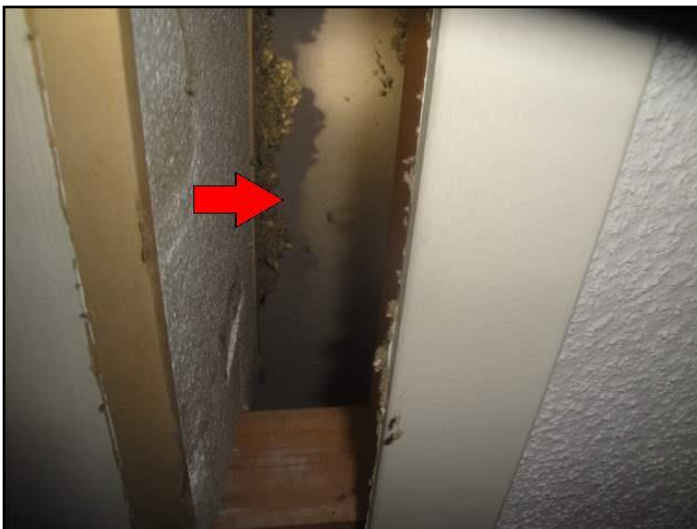
Ceiling above the hatch restricted access.

35. No access

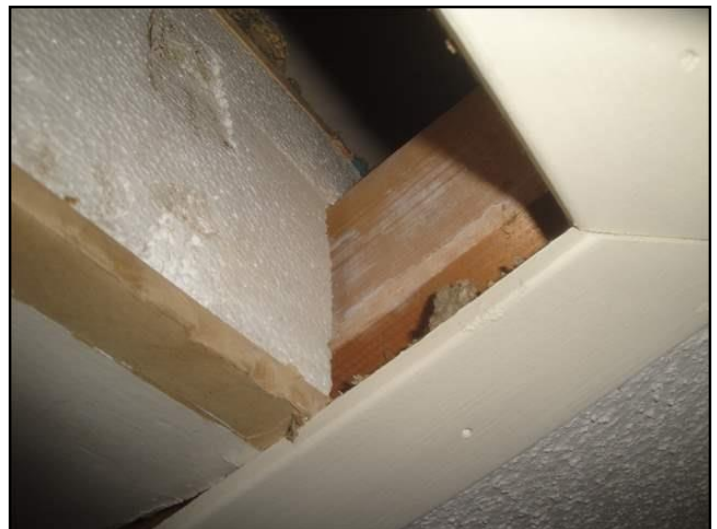
36. No access

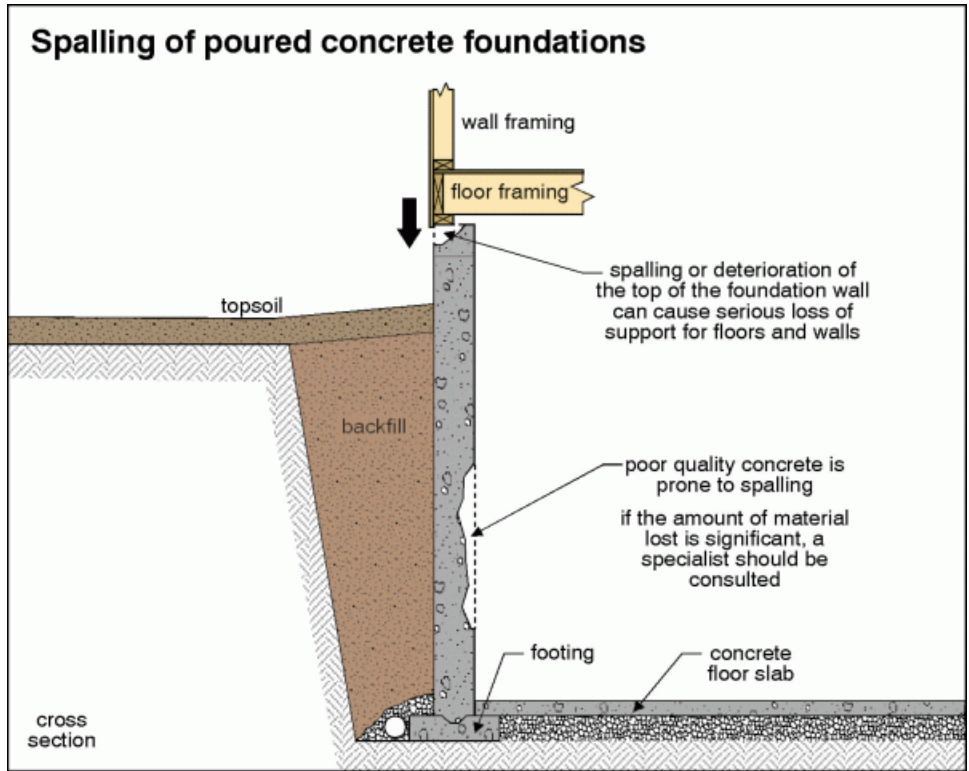
**28. Condition:** • [Spalling, crumbling or broken material](#)

The old stone foundation will likely require regular maintenance repairs to the mortar.

37. Spalling, crumbling or broken material

**Task:** Repair

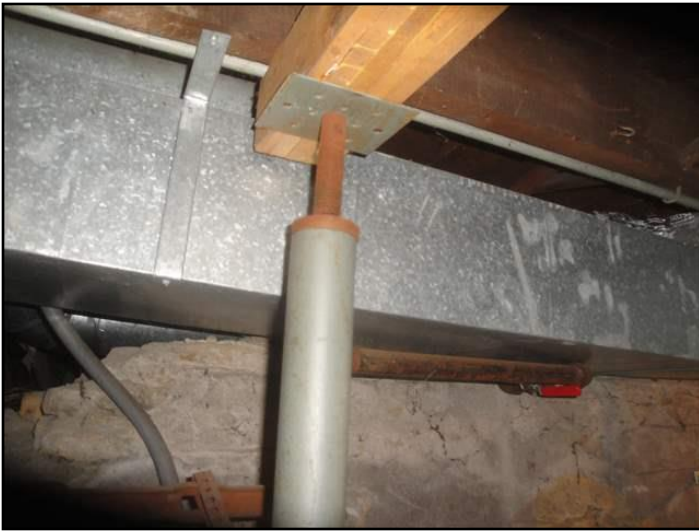
29. Condition: • Adjustable column.

39. Adjustable column.

Task: Below current standards - Repair

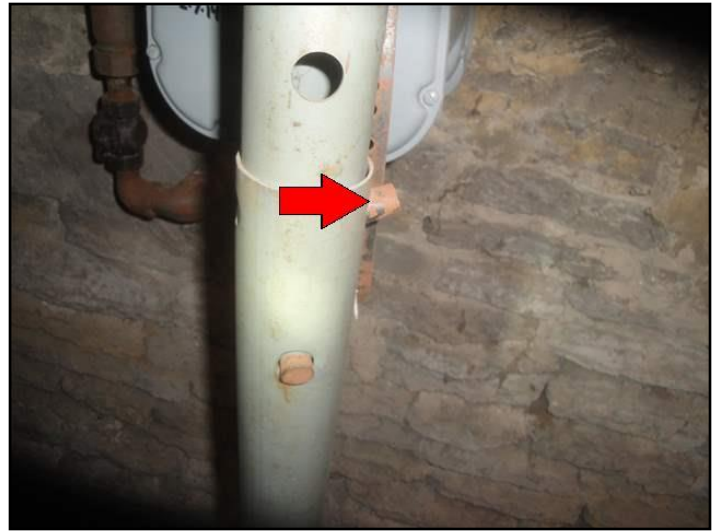
40. Adjustable column.

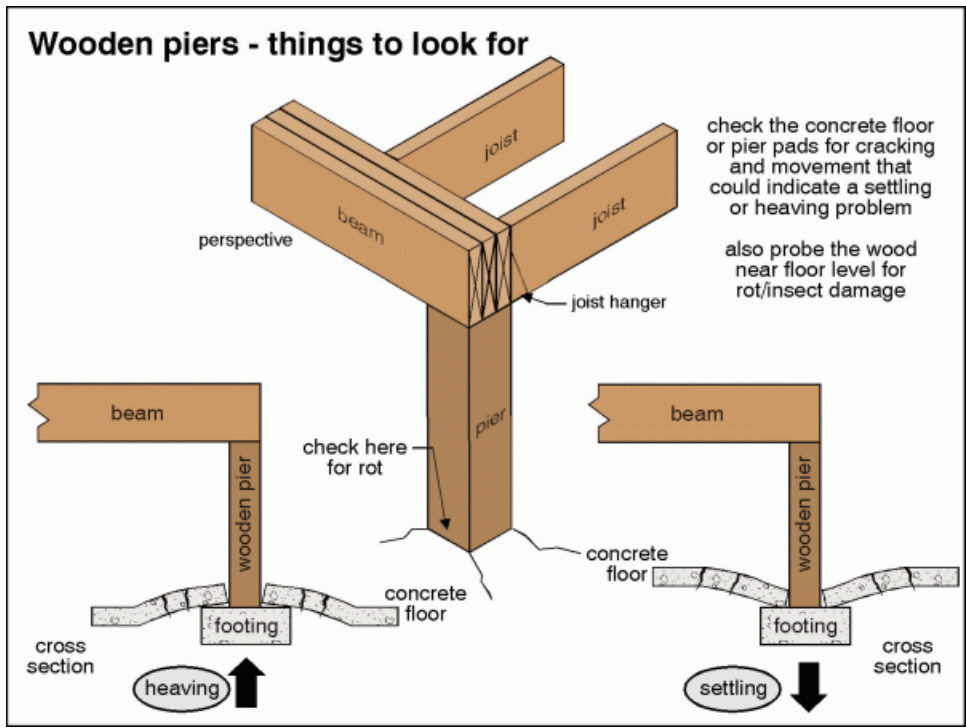
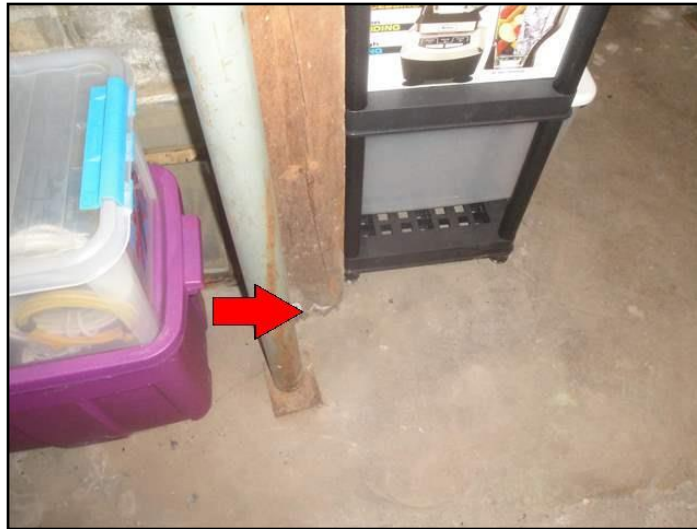
**30. Condition:** • [Rot](#)

Minor rot was observed suggesting previous moisture intrusion.

41. Rot

**Task:** Monitor

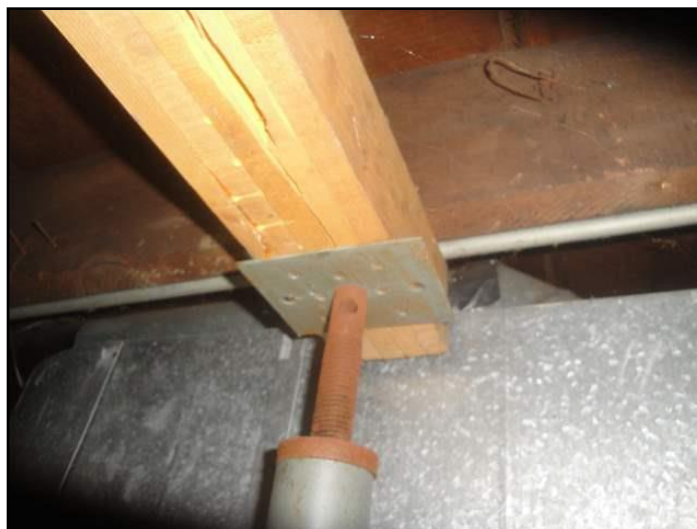
42.

**31. Condition:** • The additional beams supported by temporary adjustable steel columns are constructed of glued 1" x 4" material and are likely undersized for the application. Engineered or dimensional lumber should be selected according to the span and load.

**Task:** Replace

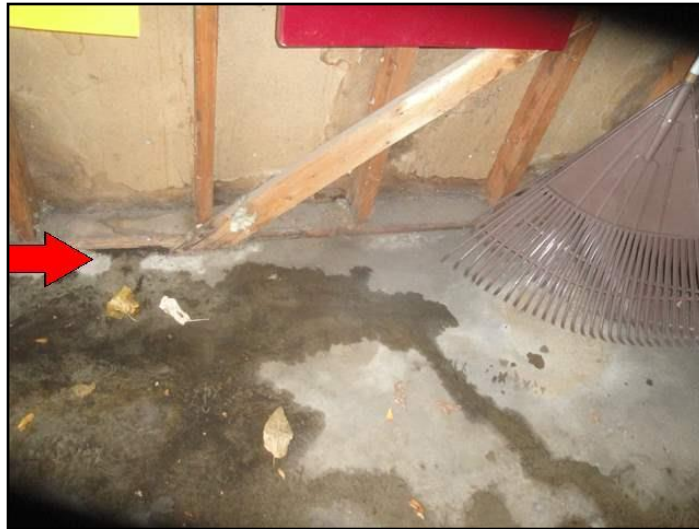
**32. Condition:** • [At or below grade level](#)

The bottom plate is at grade and water appears to be entering the garage from the exterior. This condition will eventually lead to rot. This defect will be difficult to correct without excavating the soil and installing proper drainage.

43. At or below grade level

**Task:** Below current standards - Repair

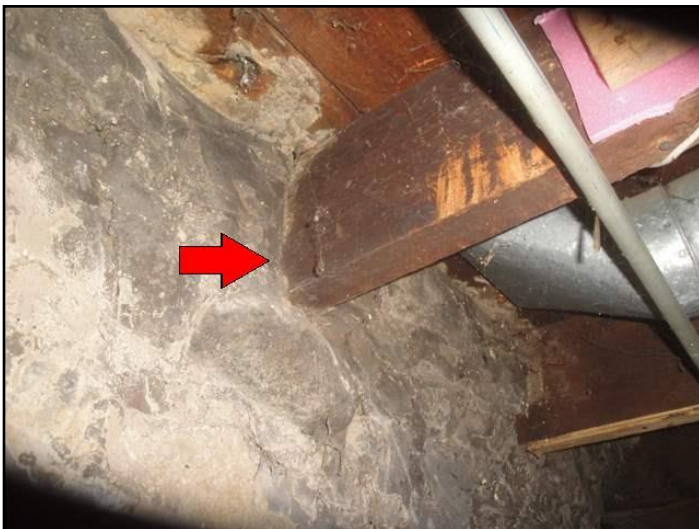
44.

**33. Condition:** • The joists and beams lack adequate clearance from the earth in some areas. The joists are encased in mortar and lack adequate air space at the ends of the joist. Monitor for moisture intrusion as these areas are vulnerable to rot.

**Task:** Below current standards - Monitor

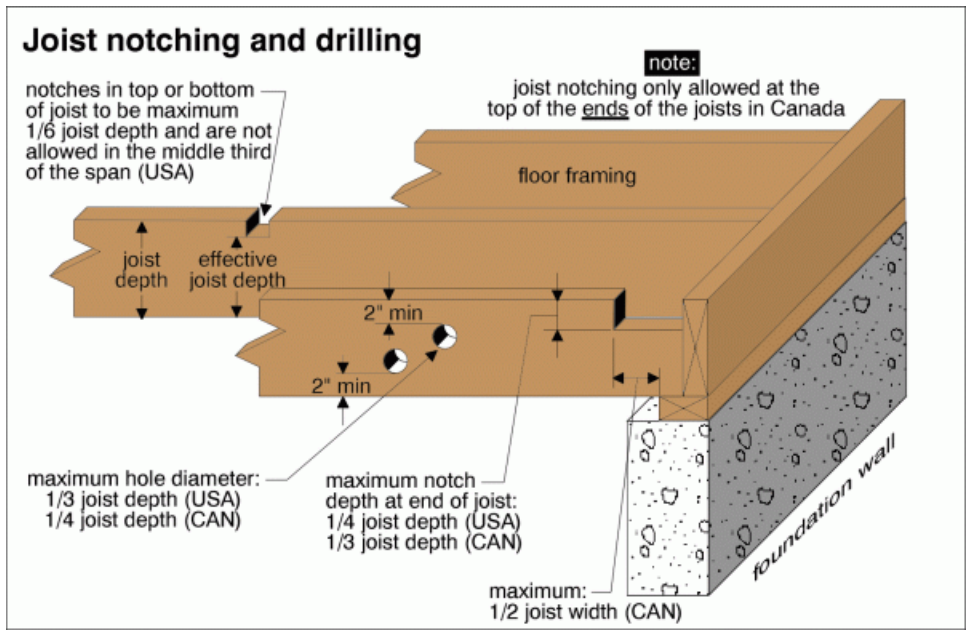
**34. Condition:** • [Notches or holes](#)

46. Notches or holes

**Task:** Monitor

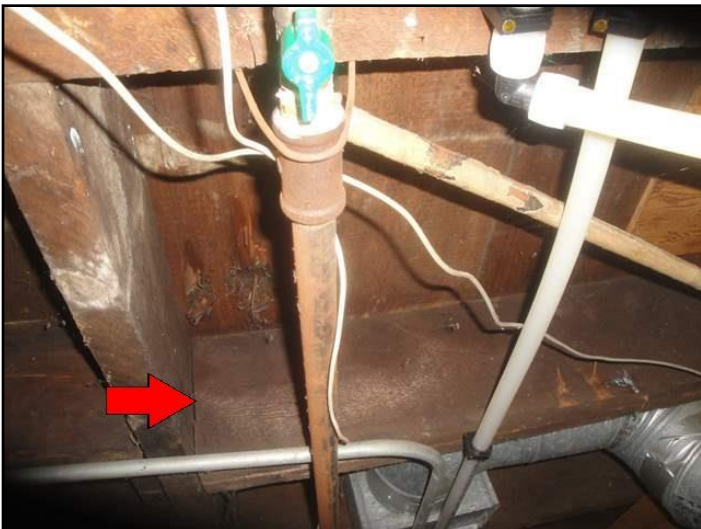
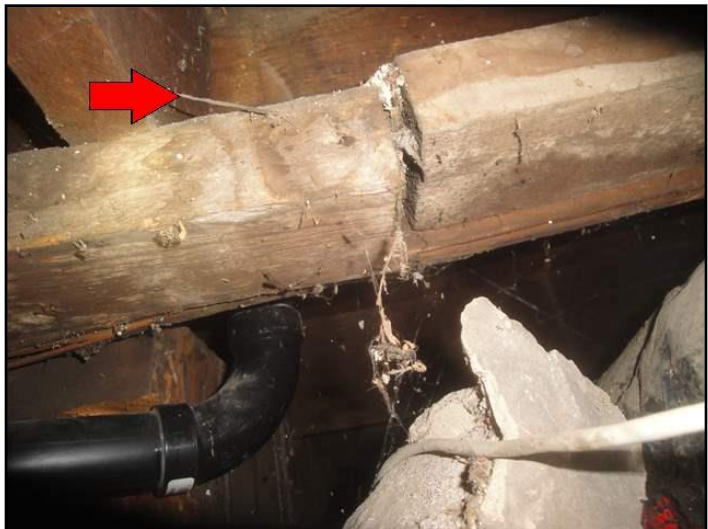
**35. Condition:** • [Poor end bearing, joist hanger connections](#)

Missing joist hangers. Common in older homes. Monitor for any movement or settling of joists and install metal joist hangers if necessary.

47. Poor end bearing, joist hanger connections

48. Poor end bearing, joist hanger connections

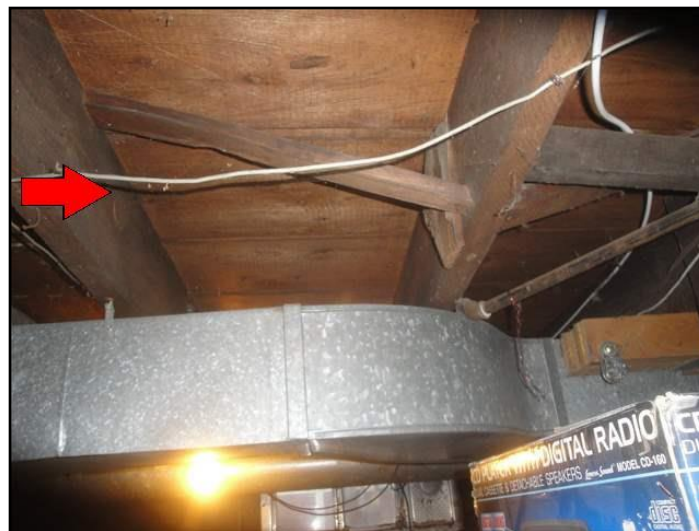
36. Condition: • [Ineffective blocking, bracing or bridging](#)

49. Ineffective blocking, bracing or bridging

Task: Repair

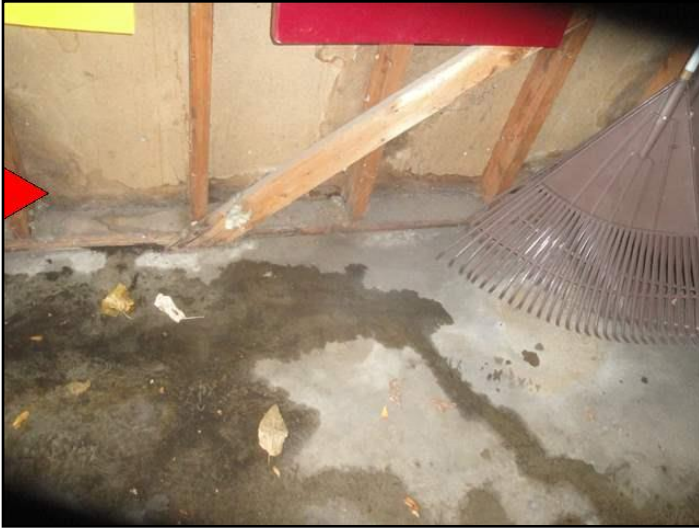
37. Condition: • [Rot](#)

Water damaged sheathing observed.

50. Rot

**Task:** Repair

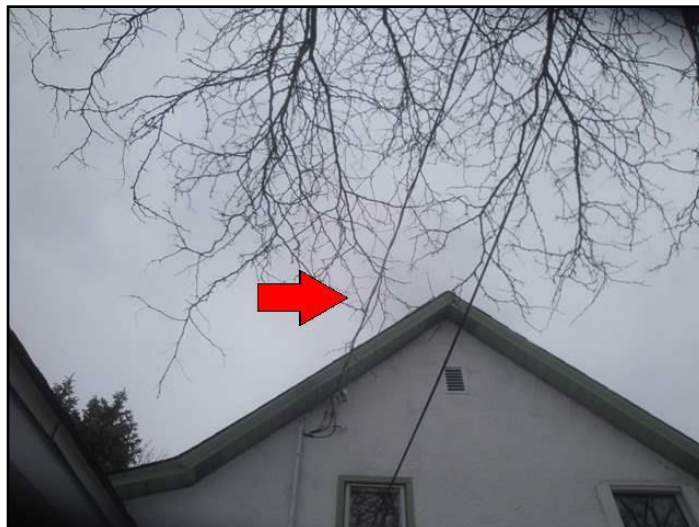
**38. Condition:** • [Branches, vines interfering with wires](#)

**Implication(s):** Damage to wire | Electric shock | Interruption of electrical service

52. Branches, vines interfering with wires

**Task:** Correct

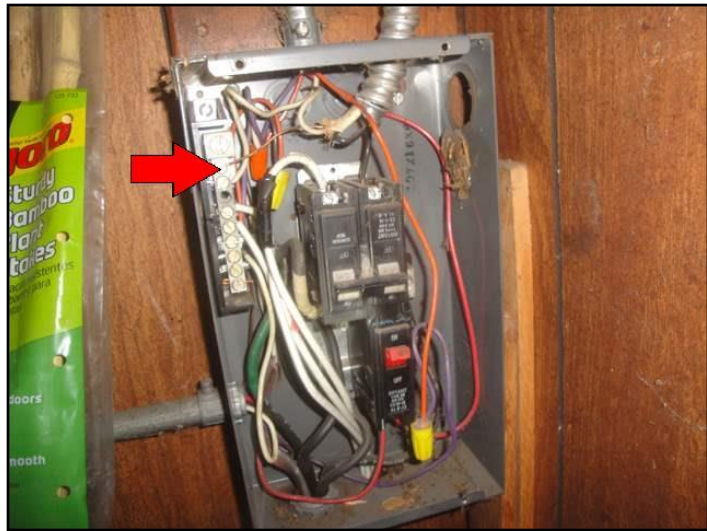
**39. Condition:** • [Neutral bonded to ground downstream of box](#)

53. Neutral bonded to ground downstream of box

**Task:** Repair

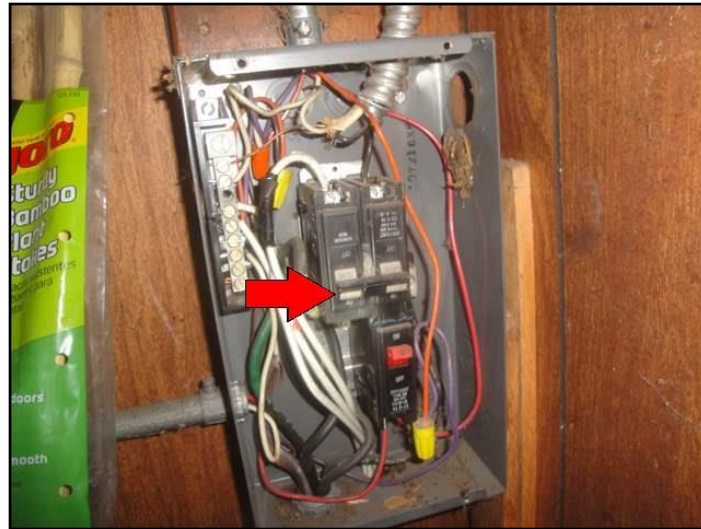
54.

**40. Condition:** • Individual breakers are tied together.

**Task:** Repair

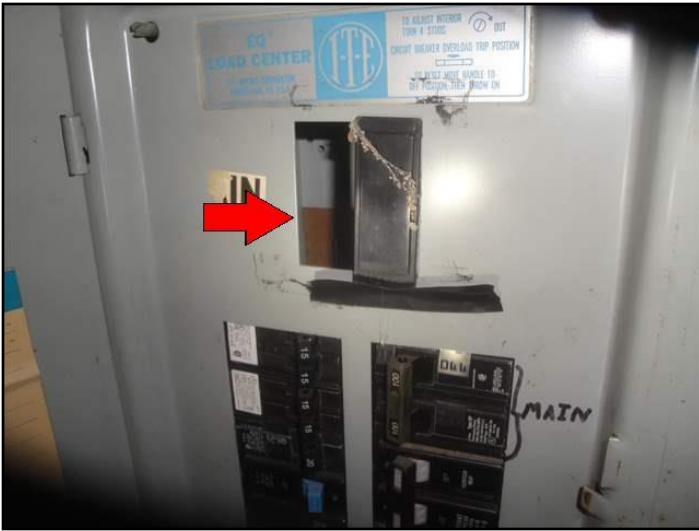
41. Condition: • [Openings in panel](#)

Implication(s): Electric shock | Fire hazard

55. Openings in panel

Task: Repair

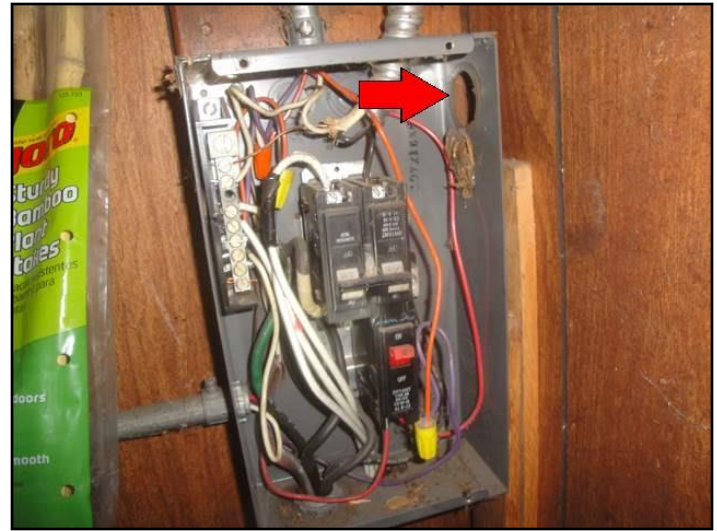
56. Openings in panel

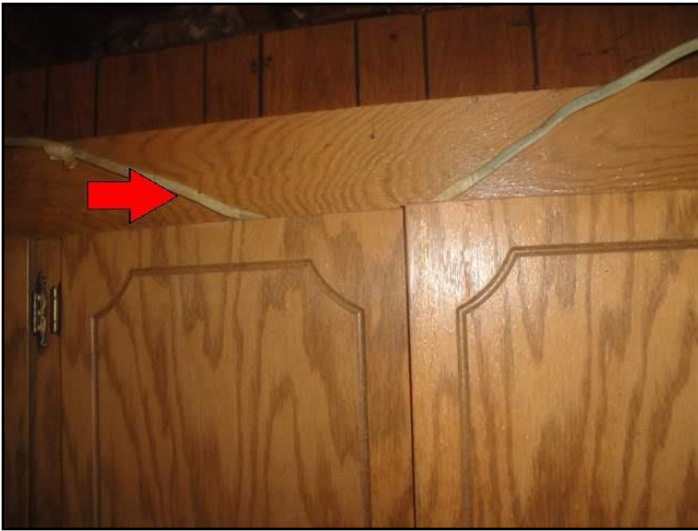
44. Condition: • [Exposed on walls or ceilings](#)

58. Exposed on walls or ceilings

Task: Improve

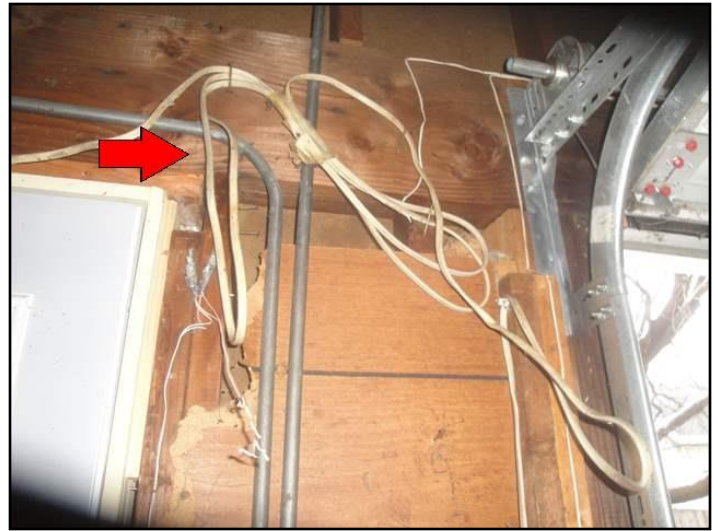
59. Exposed on walls or ceilings

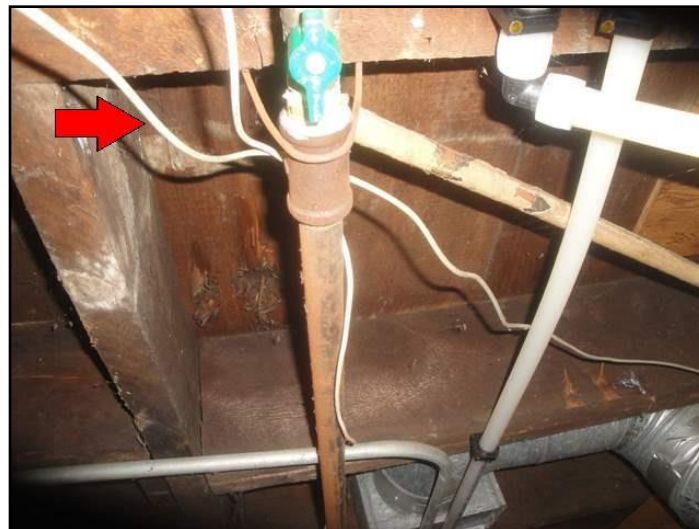
46. Condition: • [Not well secured](#)

**Implication(s):** Electric shock | Fire hazard

61. *Not well secured*

**Task:** Repair

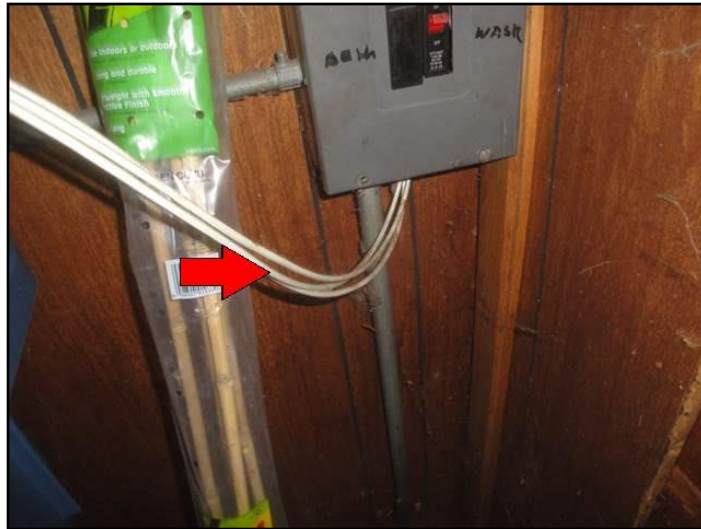
47. **Condition:** • [Flexible conduit needed](#)

62. Flexible conduit needed

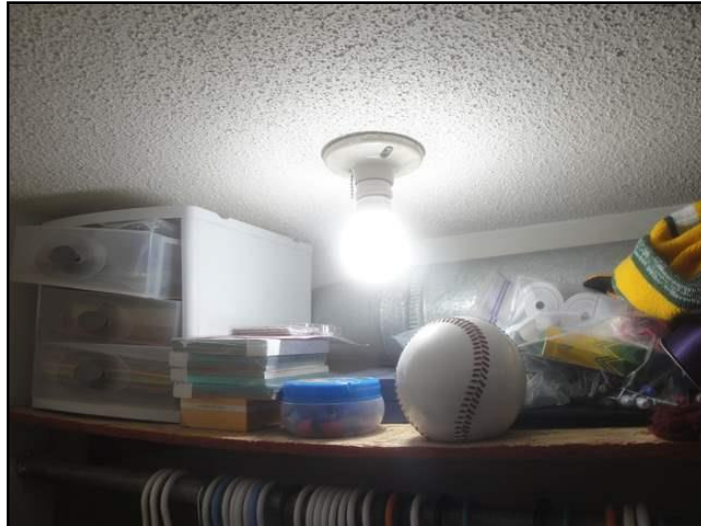
49. Condition: • [Improper closet lighting](#)

Implication(s): Fire hazard

63. Improper closet lighting

Add globe to reduce the risk of fire when items in the closet have the potential to come into contact with or have little clearance from hot exposed bulb.

**Task:** Repair or replace

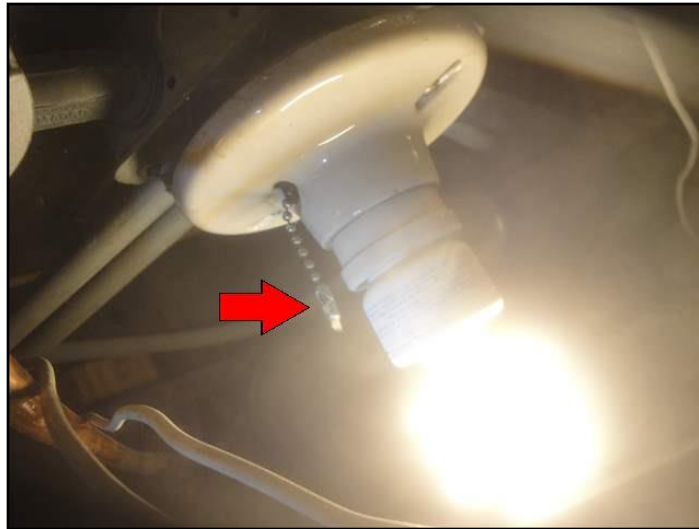
50. Condition: • [Isolating links needed on pull chains](#)

64. Isolating links needed on pull chains

Task: Provide

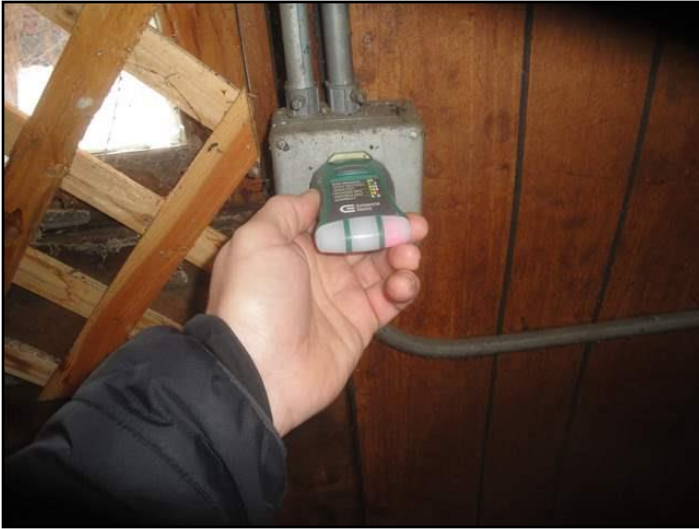
52. Condition: • [Ground needed for 3-slot outlet](#)

66. Ground needed for 3-slot outlet

Task: Repair

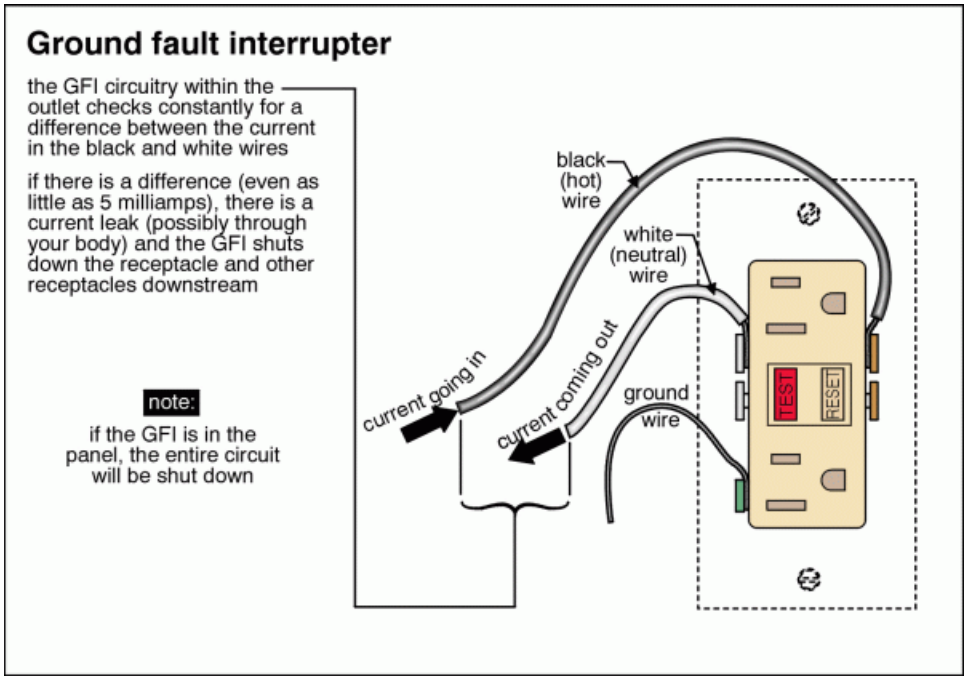
**55. Condition:** • [No AFCI \(Arc Fault Circuit Interrupter\)](#)

Current standards require AFCI protection for all 120v 15Amp & 20Amp branch circuits supplying power to outlets in the following areas: Family rooms, dining rooms, living rooms, parlors, libraries, dens, bedrooms, sun rooms, recreation rooms, closets, hallways & similar rooms. Also required for kitchen and laundry areas. Also required for devices (switches) in all areas above. Not required on individual circuit for central station alarm in RMC, IMC, EMT or steel-armored cable (type AC or MC) with metal junction boxes.

**Implication(s):** Fire hazard

Local building official may require upgrades to any wiring that is extended, modified or replaced.

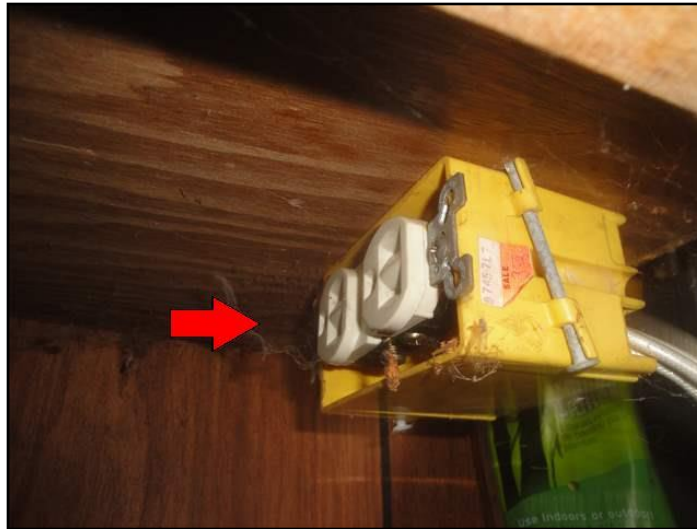
68. Missing

**56. Condition:** • [Missing](#)

**Task:** Replace

**Time:** Immediate

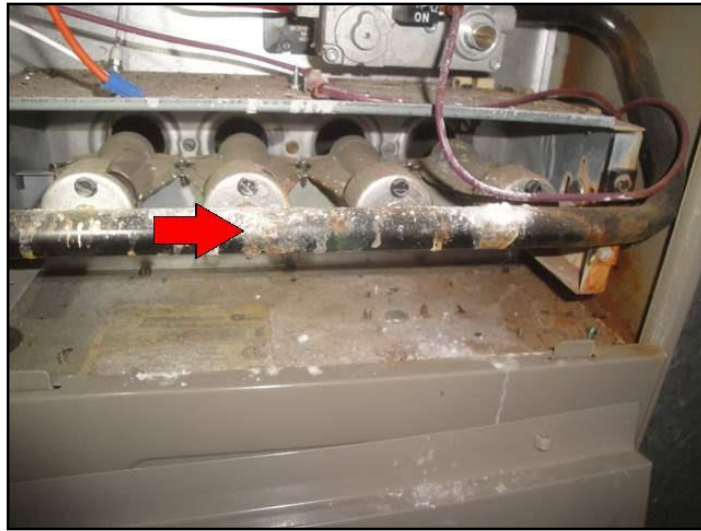
69. Scale

**61. Condition:** • Scale

**Implication(s):** Shortened life expectancy of material | Material deterioration

**Time:** Less than 1 year

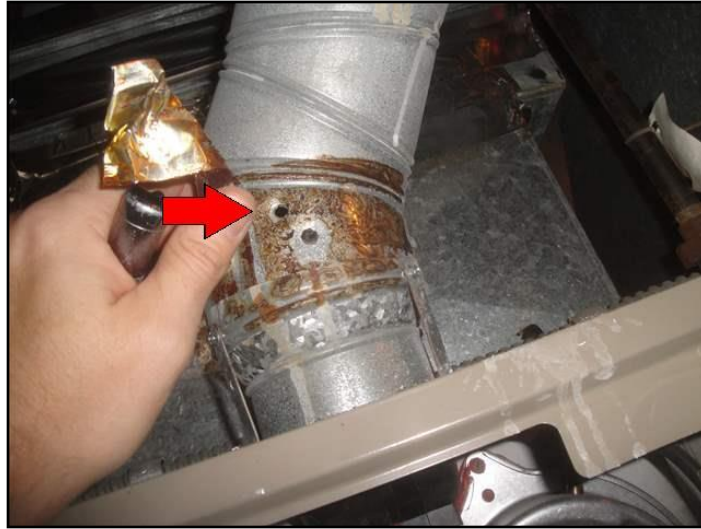
70. Poor connections

62. Condition: • [Poor connections](#)

Deteriorated foil tape at CO test hole.

**Implication(s):** Equipment not operating properly | Hazardous combustion products entering home

**Task:** Repair

**Time:** Immediate

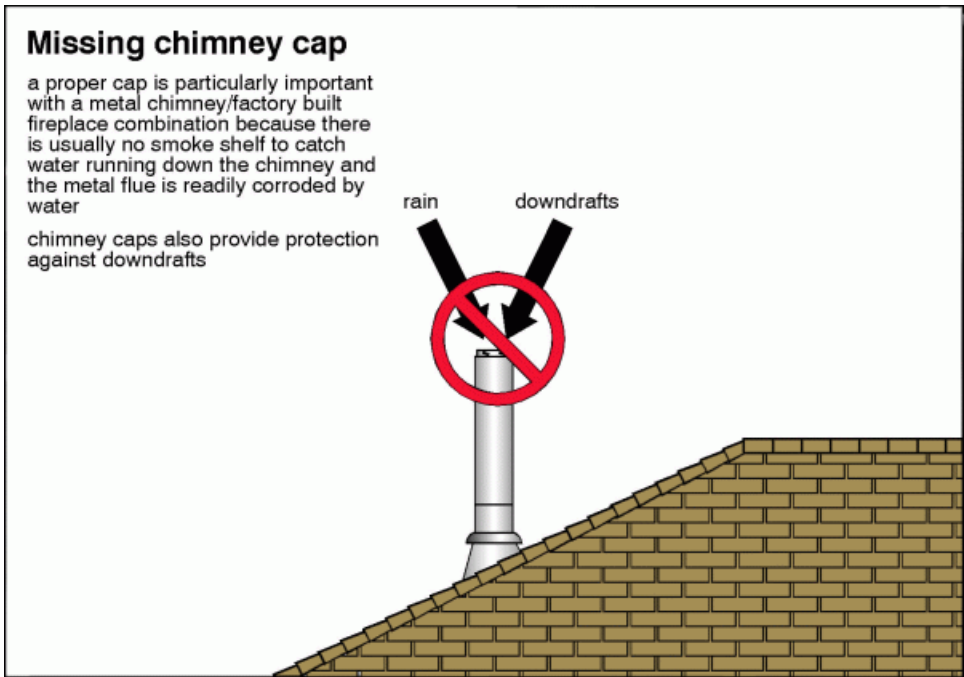
66. Condition: • [Cap missing, obstructed or wrong type](#)

Implication(s): Chance of water damage to contents, finishes and/or structure | Equipment not operating properly | Hazardous combustion products entering home

Task: Provide

Time: Less than 1 year
