# PROPERTY CONDITION ASSESSMENT REPORT

Sample Report  
Minneapolis, MN

Tuesday, December 1, 2015

RE: Report No. 1497  
Sample Report  
Minneapolis, MN

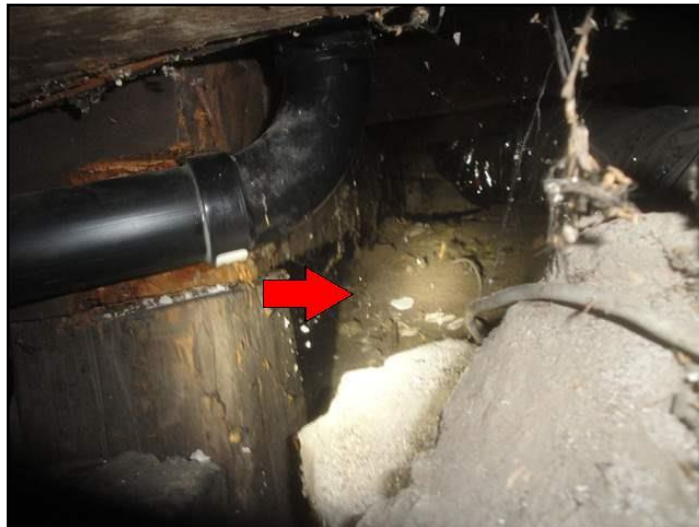
72. No vapor barrier

**69. Condition:** • [No vapor barrier](#)

**Implication(s):** Chance of condensation damage to finishes and/or structure

**Task:** Below current standards

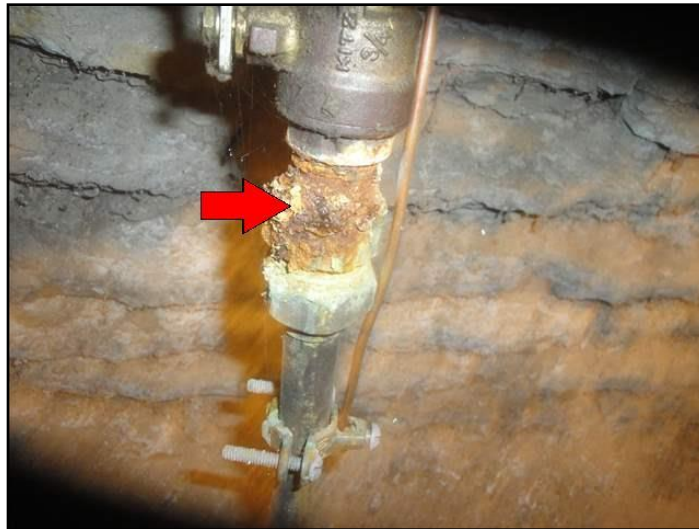
75.

71. Condition: • Rusted fitting

Task: Repair

Time: Less than 1 year

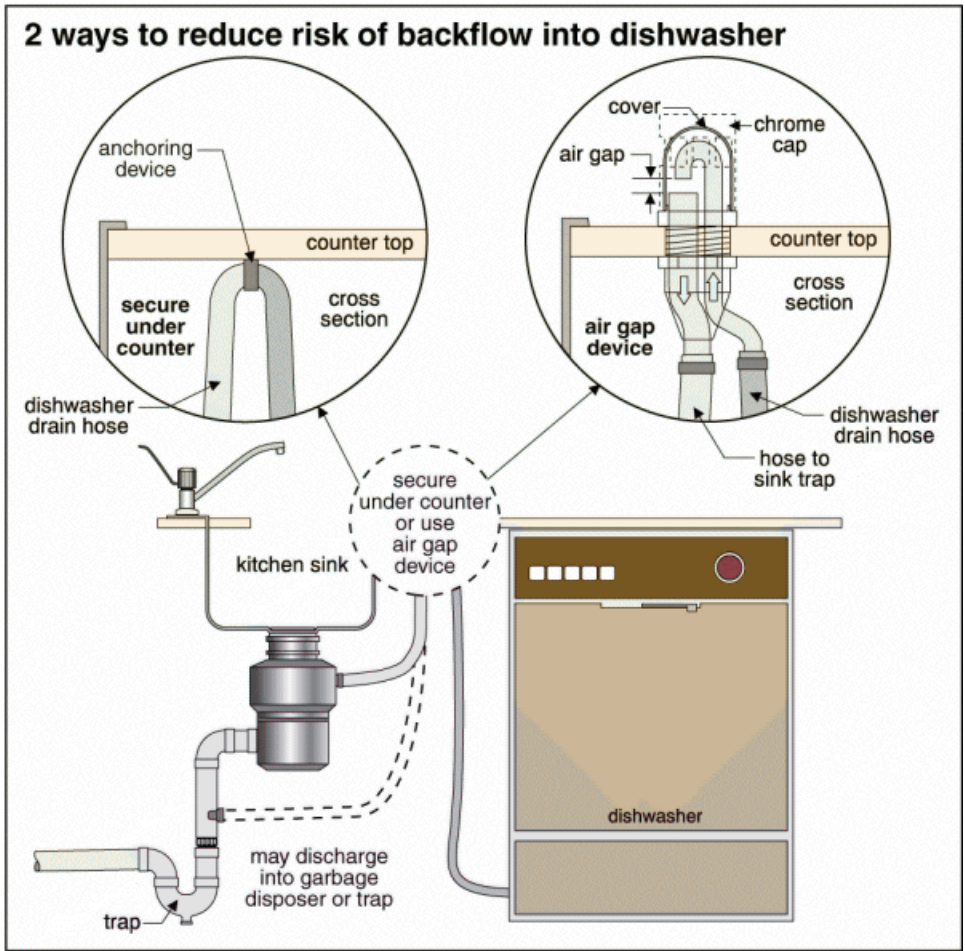
76. Dishwasher drain connections

72. Condition: • [Dishwasher drain connections](#)

Implication(s): Chance of water damage to contents, finishes and/or structure

Task: Below current standards

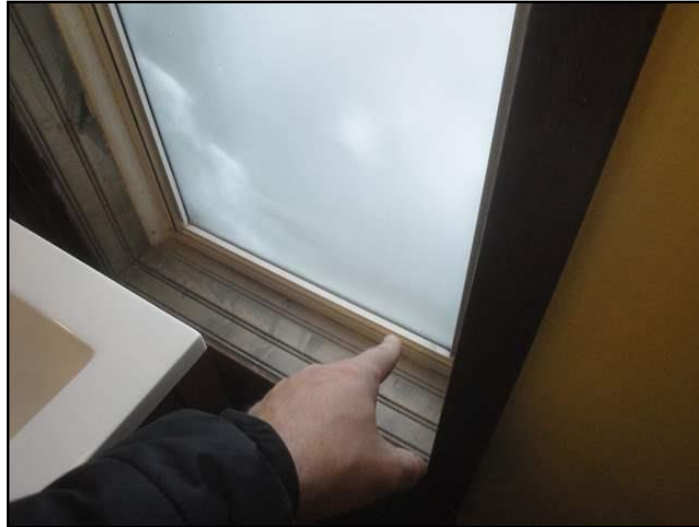
79. Safety glass not installed

77. Condition: • Safety glass not installed

**Location:** First Floor Bathroom

**Task:** Below current standards

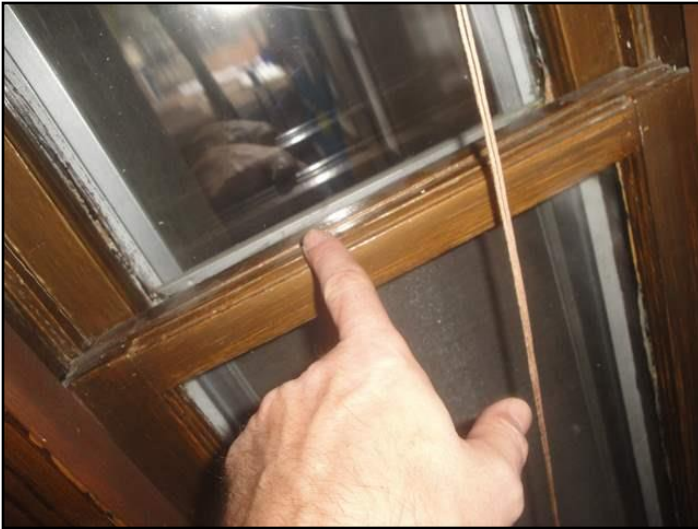
81. *Missing*

## 80. Condition: • [Missing](#)

Missing window locks.

**Task:** Provide

**Time:** Less than 1 year

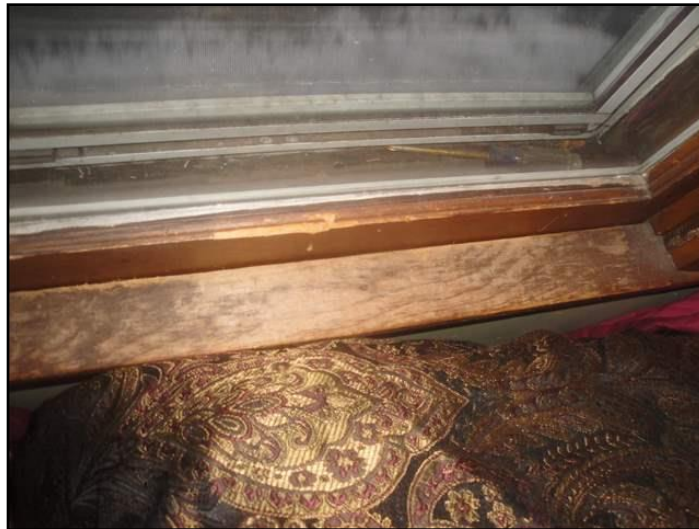
83. Stained

82. Condition: • [Stained](#)

Water stains and faded. Monitor for evidence of moisture when the window is closed.

Implication(s): Cosmetic defects

Task: Repair

Time: Discretionary

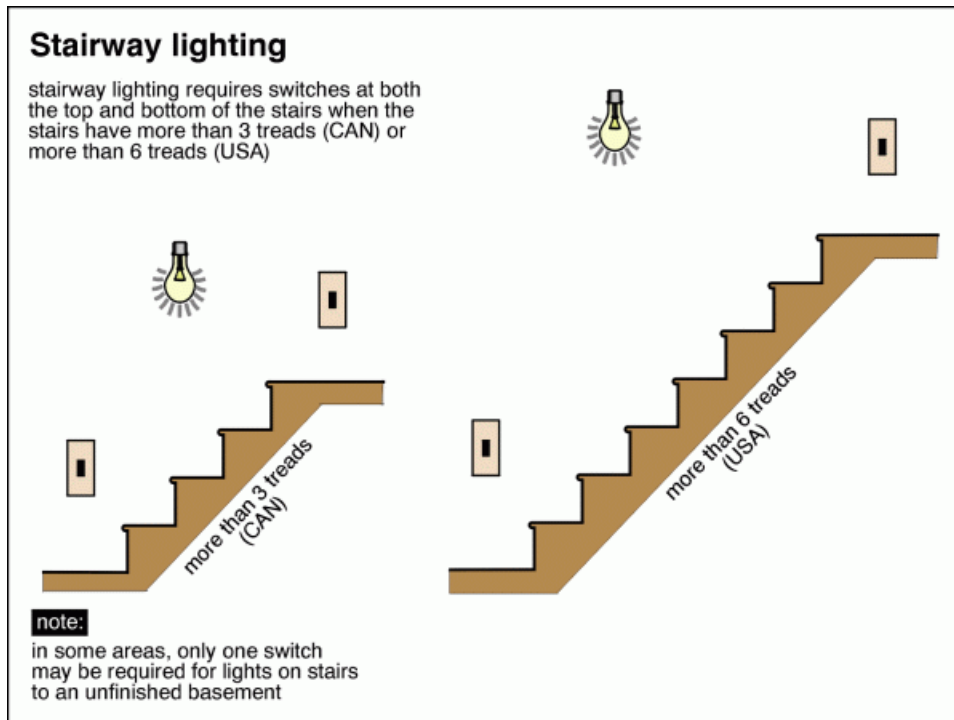
84. Condition: • [Not controlled by three way switch](#)

Implication(s): Trip or fall hazard

Task: Below current standards

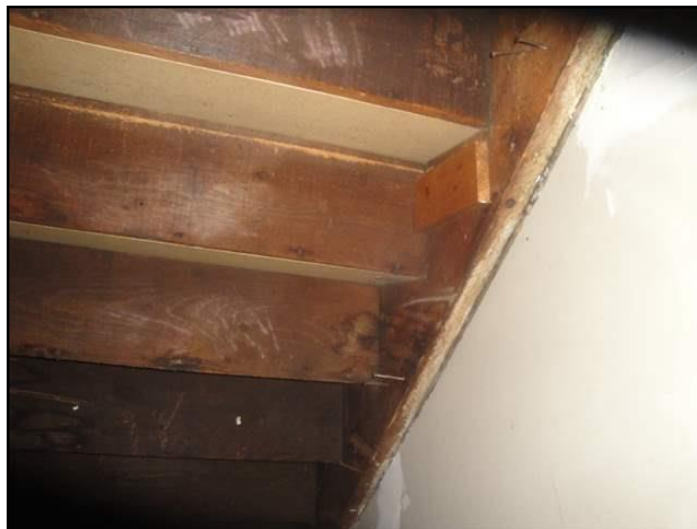
85. Drywall missing or incomplete on underside...

85. Condition: • [Drywall missing or incomplete on underside of stairs](#)

Implication(s): Increased fire hazard

**Task:** Below current standards

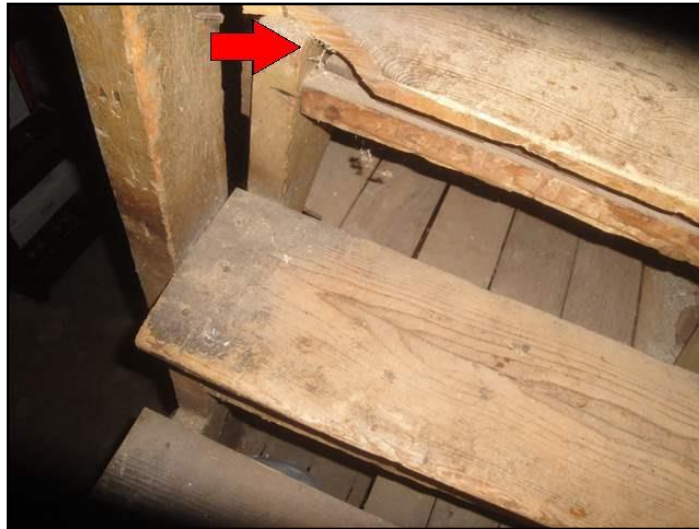
86. Worn or damaged

**92. Condition:** • [Worn or damaged](#)

**Implication(s):** Weakened structure | Trip or fall hazard

**Task:** Repair

**Time:** Immediate

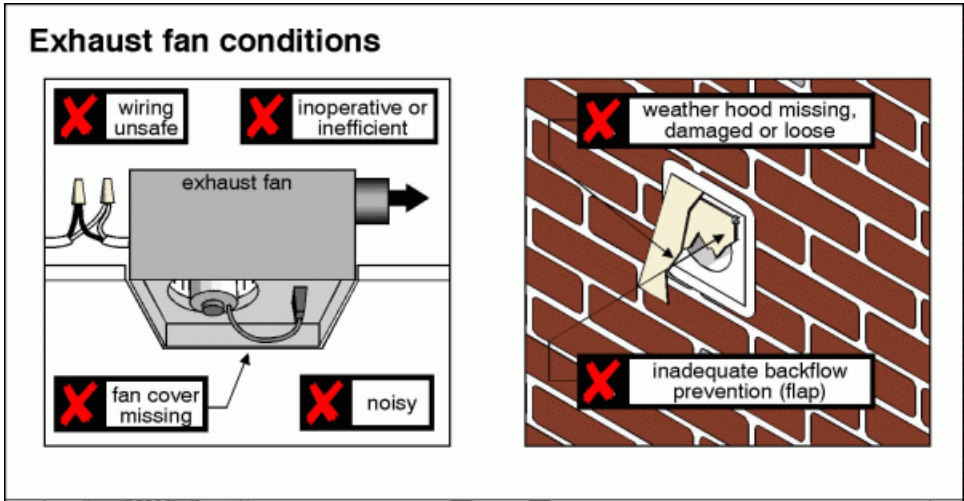
99. Condition: • [Inoperative](#)

Task: Repair or replace

Time: Less than 1 year

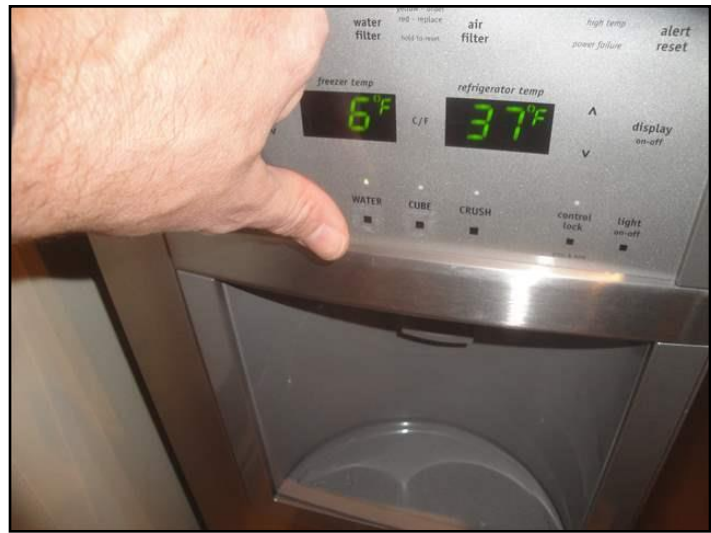
88.

100. Condition: • Water dispenser is inoperable.

Task: Repair

Time: Discretionary
