# Your Inspection Report

## Sample Report West St. Paul, MN

**INSPECTION DATE:**  
Monday, June 2, 2014

RE: Report No. 1205, v.8  
Sample Report  
West St. Paul, MN

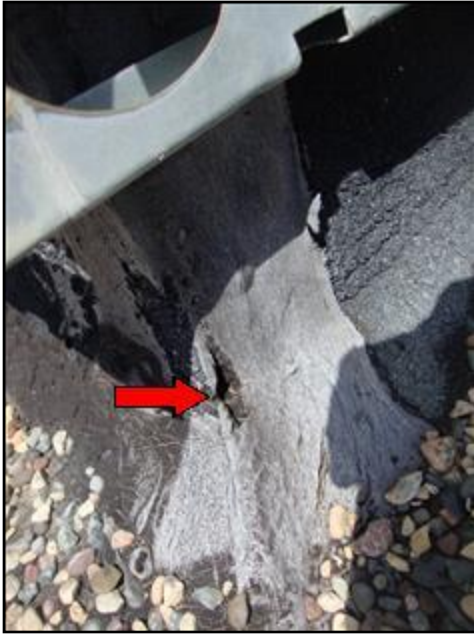
*Damaged membrane on the curb mount*

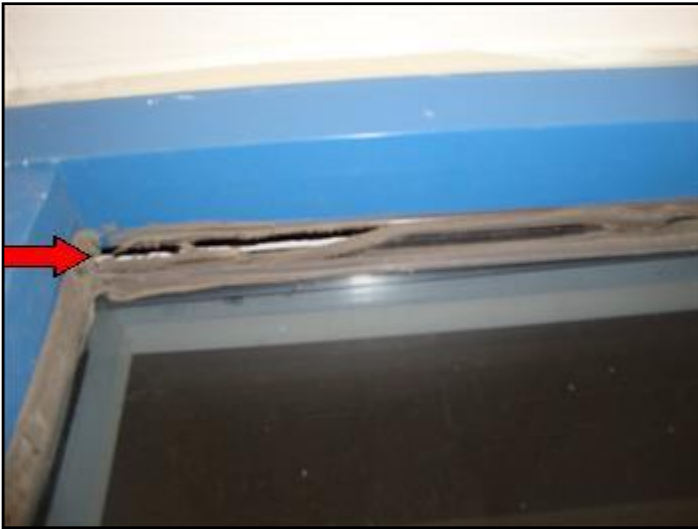
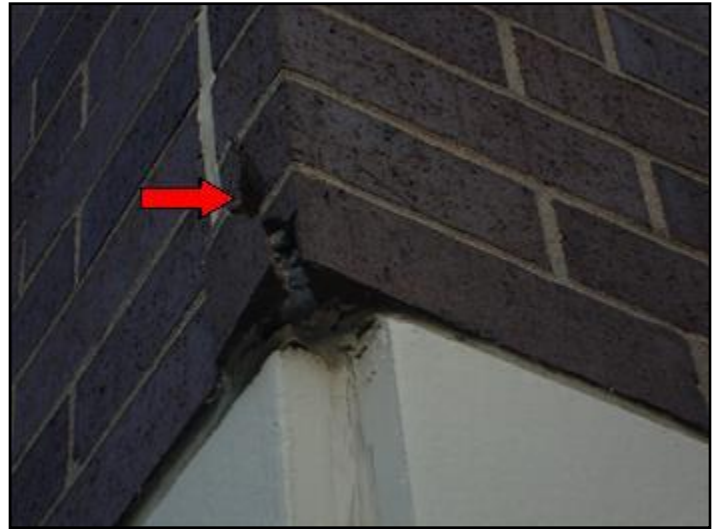
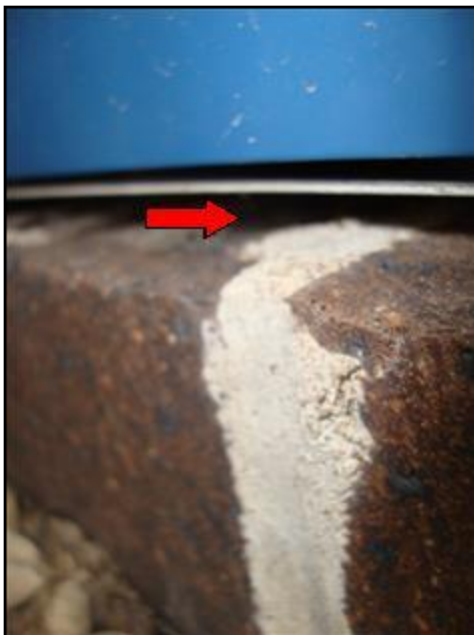
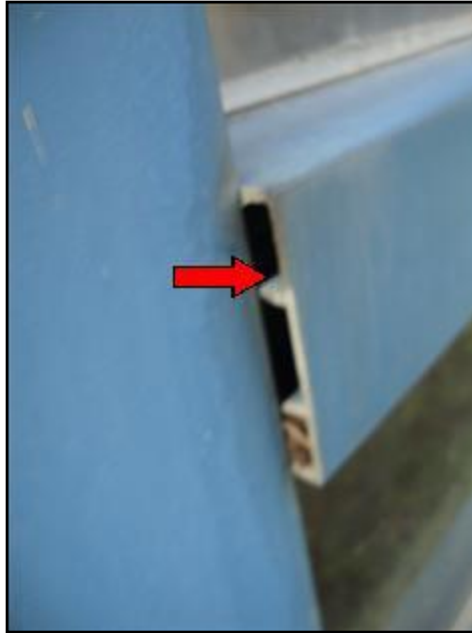
**74. Condition:** • Some settling has occurred, as can be expected in any building

The location of the windows near grade made assessment of the below grade foundation difficult. Gaps at the bottoms of the window frames and a broken window with settled glass in suite RS may indicate some minor to moderated settlement at the front glass wall. The rear block wall and front concrete column and beam structure exhibited very minor settlement.

*Some settling has occurred, as can be...*

**Task:** Monitor

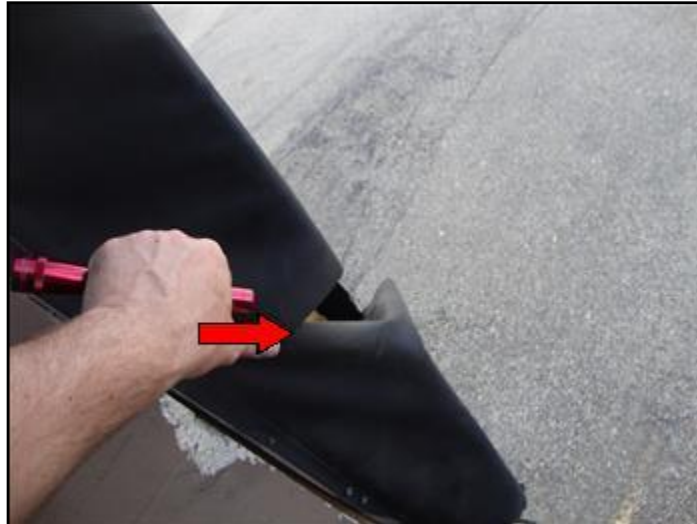
**95. Condition:** • Replace damaged / missing cushions

*Replace damaged / missing cushions*

**Task:** Repair

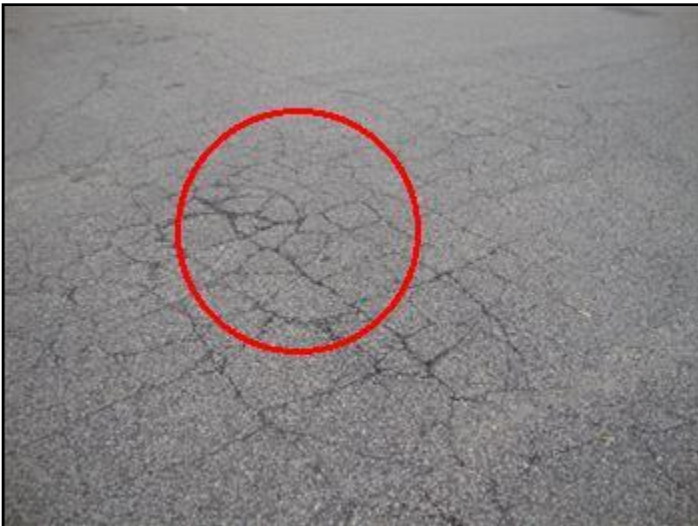
**109. Condition:** • Major repairs to the asphalt pavement should be expected  
Cracks should be repaired and badly checked areas patched to extend service life.

*Major repairs to the asphalt pavement...*

**Task:** Repair
