# Home Inspection Report

Property address: 1234 Center Ave.  
Charleston SC 29407

Inspected by: Stephen Houmard  
Solid Ground Home Inspections  
South Carolina License #2046  
*Certified ASHI® Home Inspector*  
*Infrared-Certified® Home Inspector*

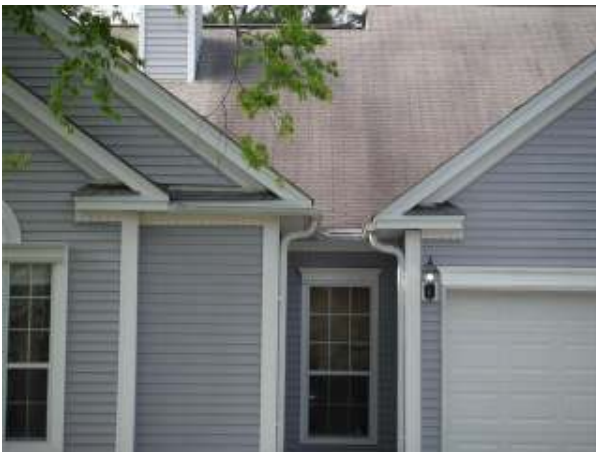
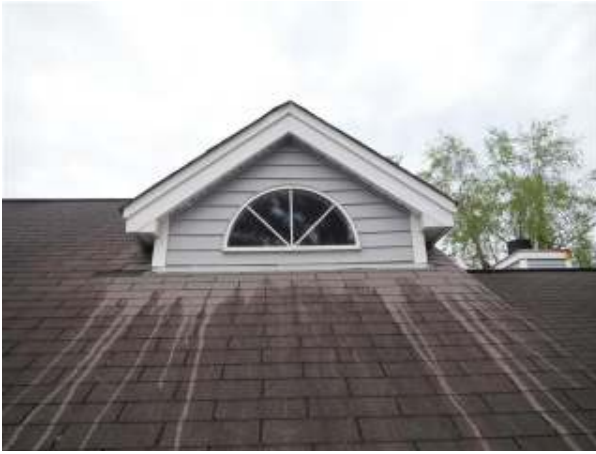
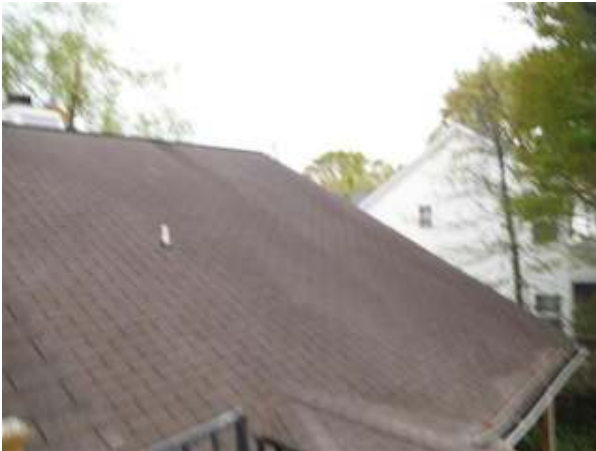
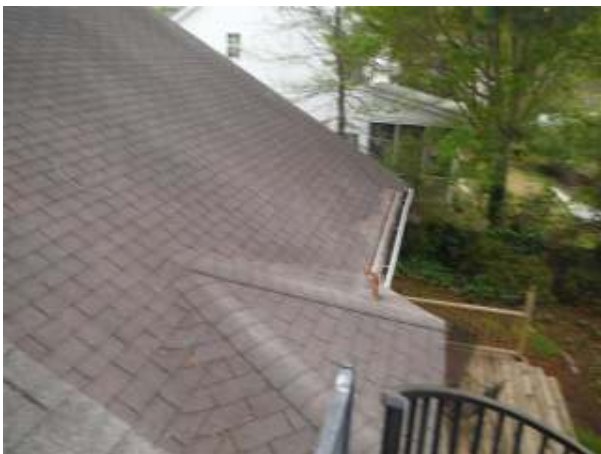
(1) Observed that this home has 3-tab fiberglass shingles which are estimated to be about 19 years old or so. Please note the shingles are showing signs of age and wear -- they are losing their granules (protecting them from the UV rays) which keep them from cracking. For your reference, the average roof with this type of shingles can last up to 18 years and possibly longer depending on the local climate and roof ventilation. Recommend monitoring the roof for possible problems or leaks and plan to replace the shingles in the in the next few years or so when you have a chance.. You may also want to check out the SC Safe Home Program on the web at [www.scsafehome.sc.gov](http://www.scsafehome.sc.gov) -- this organization provides grant dollars to those who qualify for the purpose of making homes more wind and hurricane resistant to include roof covering replacement.

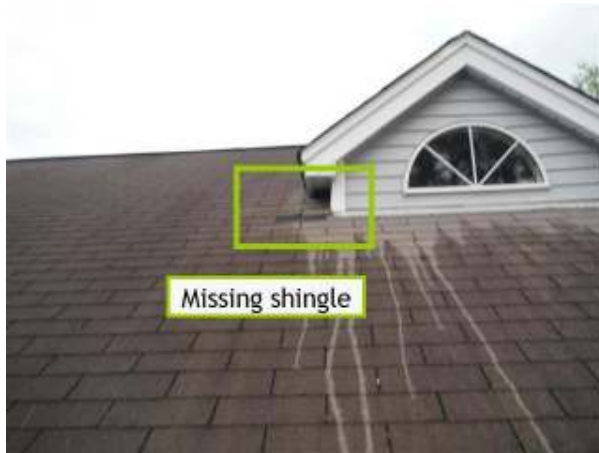
(3) Observed that there are one or more missing shingles on the back of the roof. Recommend having a roofing contractor make the needed repairs to ensure the roof remains water tight.

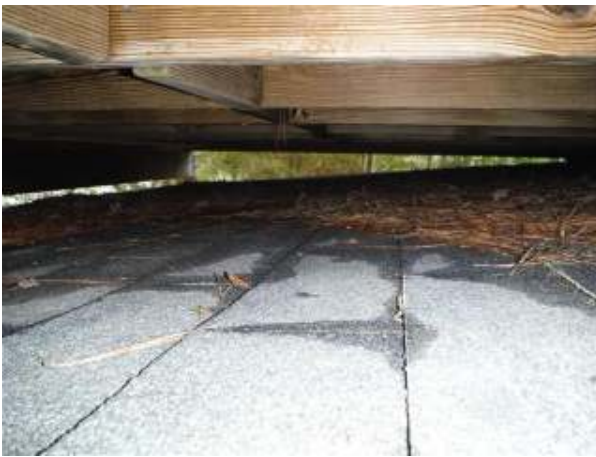
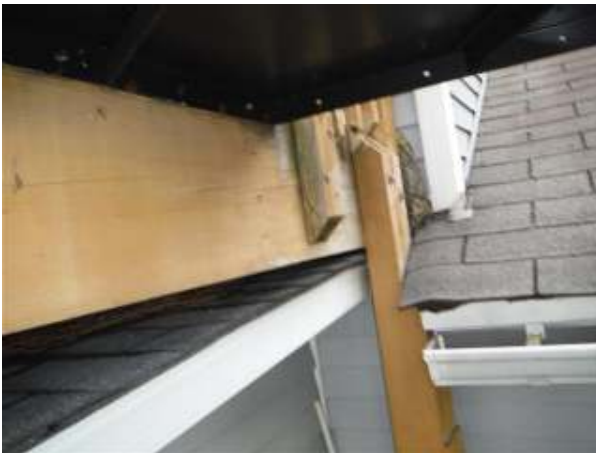
(4) Please note the roof over the sunroom and the area under the deck cannot be repaired without removing the deck. Debris on the shingles on this low slope roof may cause moisture to back up under the shingles. This is an FYI.

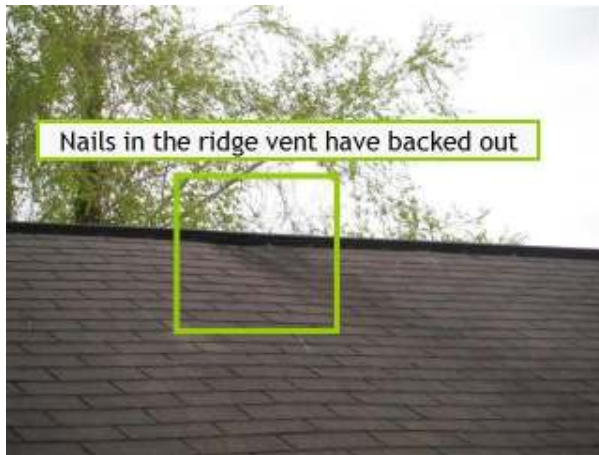
(2) Observed that one or more of the nails in the ridge vent (which runs along the roof peak) has pulled out slightly due to wind and heat -- this can lead to a roof leak. Recommend having a roofing contractor replace the nails (bang them back in) and apply roofing tar over the nail heads (as a seal) to ensure the roof remains water tight.

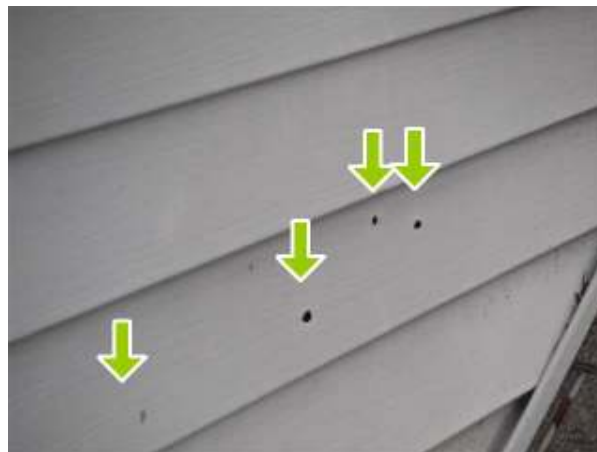
(2) Observed that there are several small holes in the siding along the second floor. Recommend having a contractor or handyman seal these holes to ensure the siding is water tight.

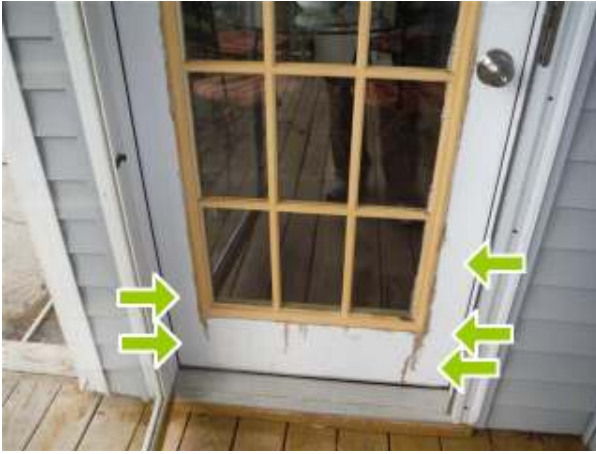
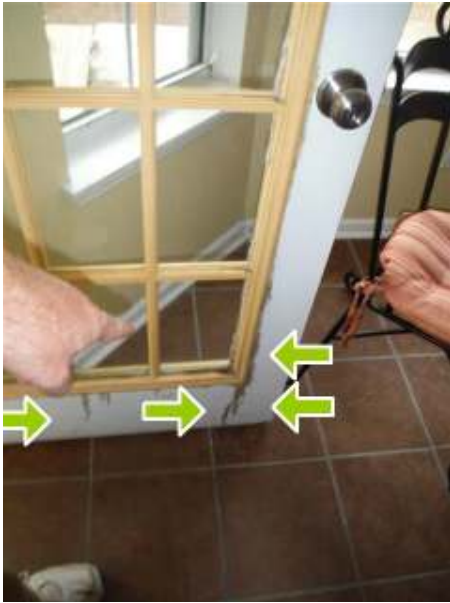
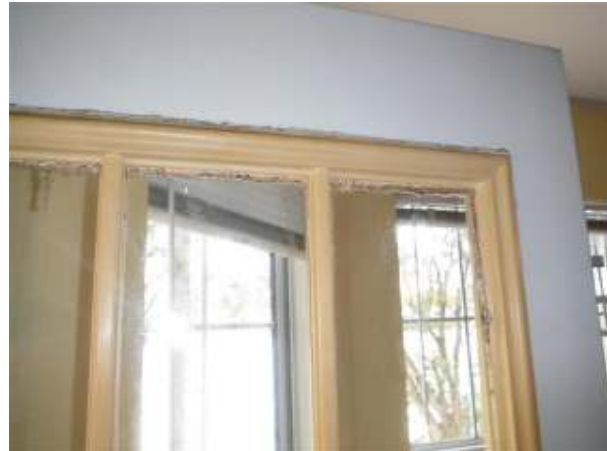
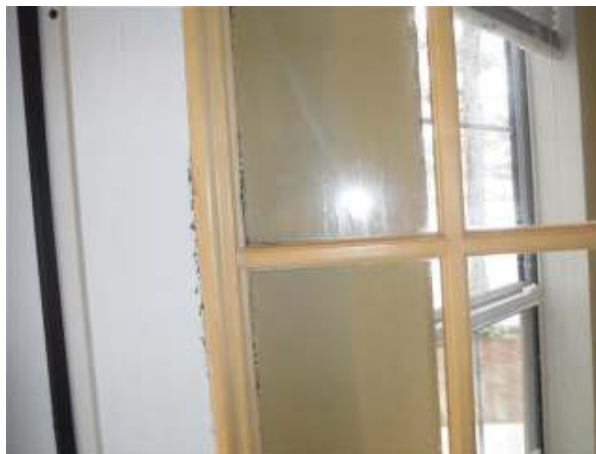
(1) Observed that the back exterior door has been caulked with glue. The bugs are now stuck in this glue and it is running down the door. Recommend having a contractor replace this door which has never been painted.

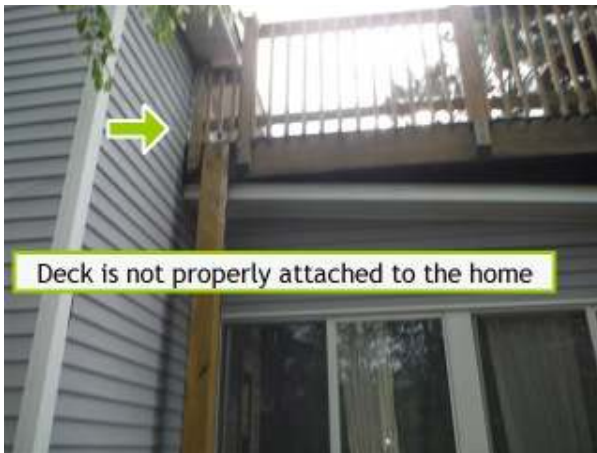
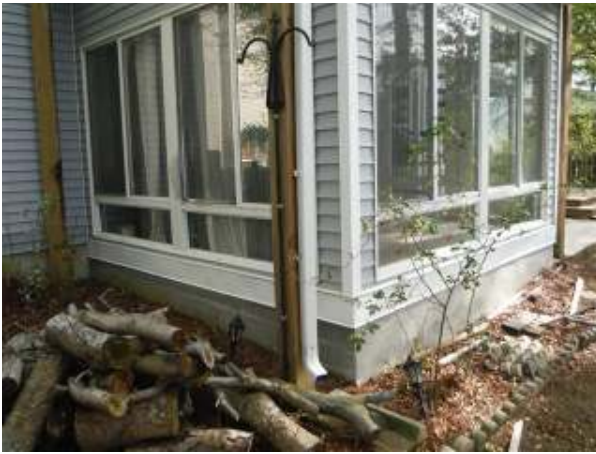
(1) Observed that the deck band is not attached securely to the home. Instead, the deck should be attached with 5/8" galvanized lag screws or carriage bolts about every 36". Recommend having a contractor properly secure the deck to the home, for safety. Please note this deck sits on four posts and there are no signs of bracing or anchoring into the home. Recommend having a contractor evaluate the deck further and make any repairs needed to ensure its structurally sound and properly attached to the home, for safety.

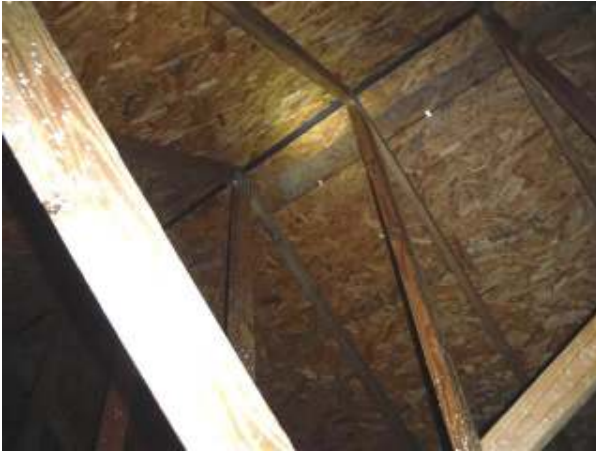
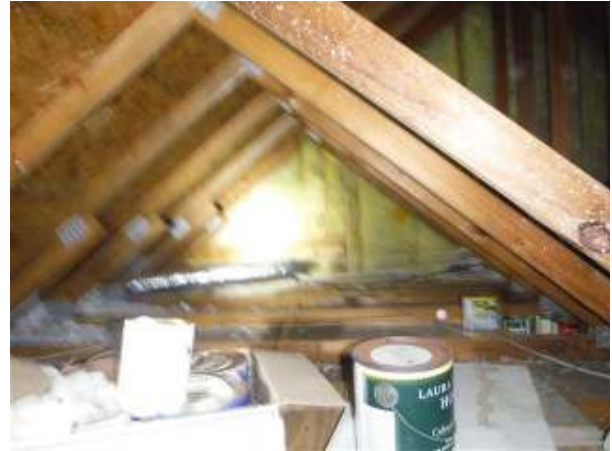
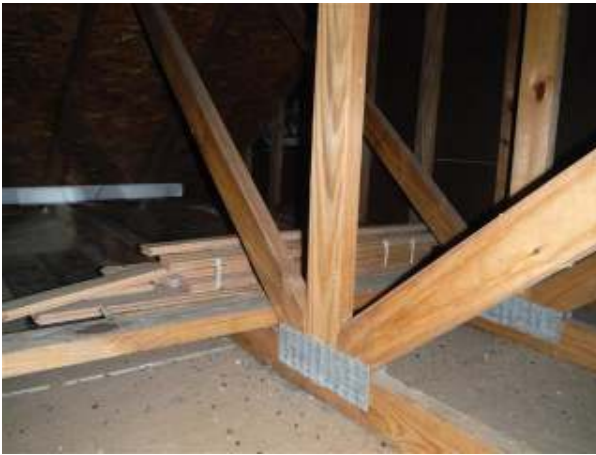
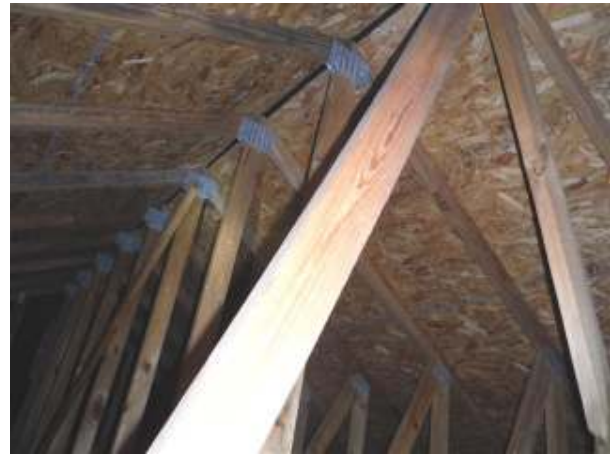
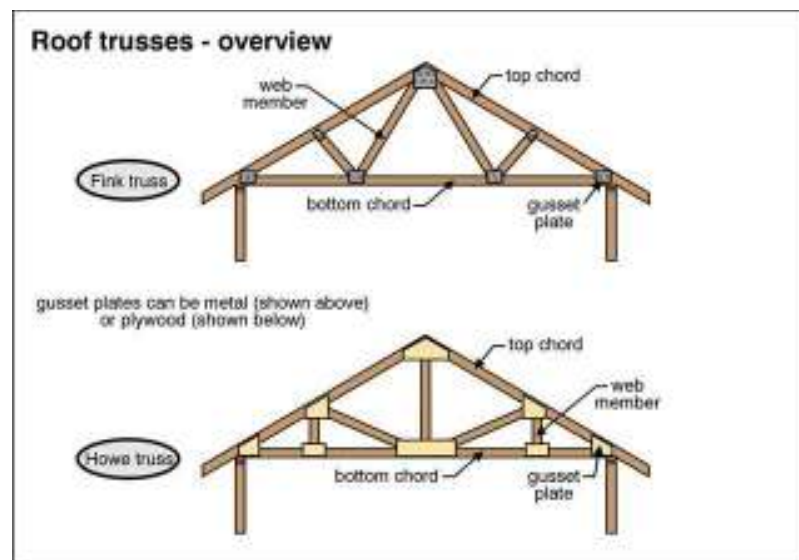
(1) Observed that this roof is well built and has an engineered roof truss system. For your reference, these trusses were designed by an engineer, built in a factory for this home, then shipped to the job site and lifted into place. Also, the trusses use 2x4's instead of 2x6's -- this is just a small difference vs. what you may be used to seeing in the attic.

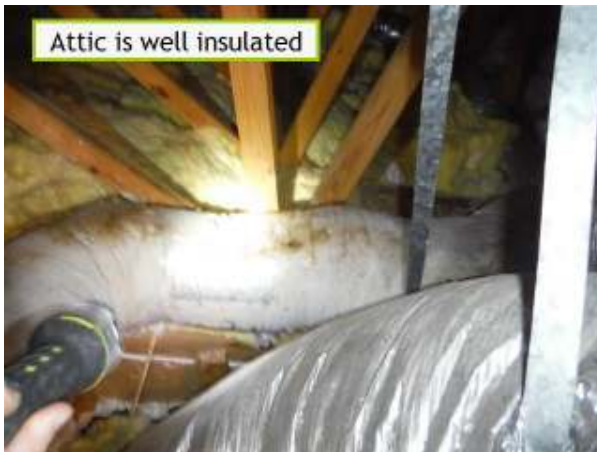
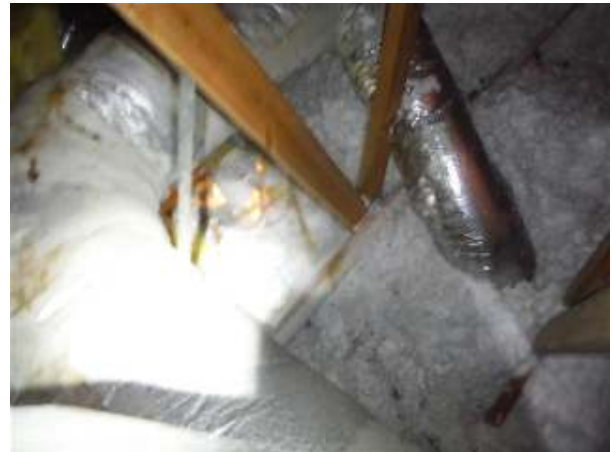
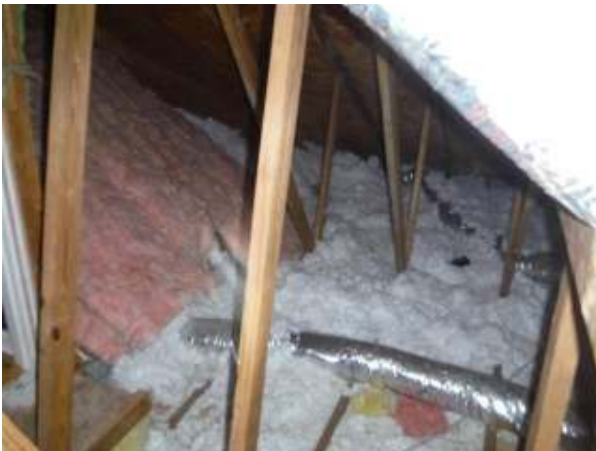
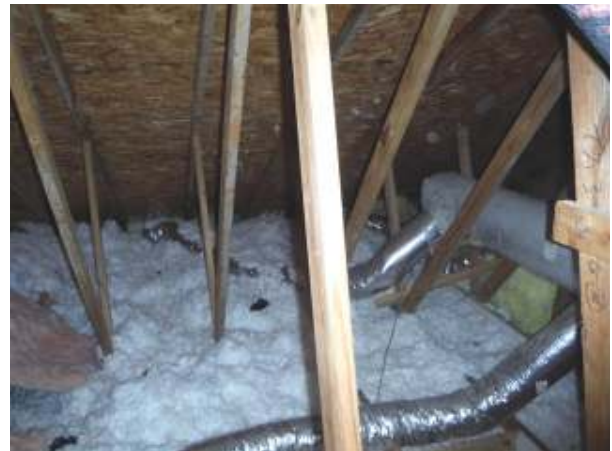
(1) Observed that this home has an amount insulation on the attic floor which equates to R-30 or better. *Good to know! The effectiveness of insulation is measured by its R-number which is its ability to resist the flow of heat. The higher the R-number, the greater the resistance to winter heat loss or summer heat gain. Today's standard for insulation in newer homes is R-30 or better.*

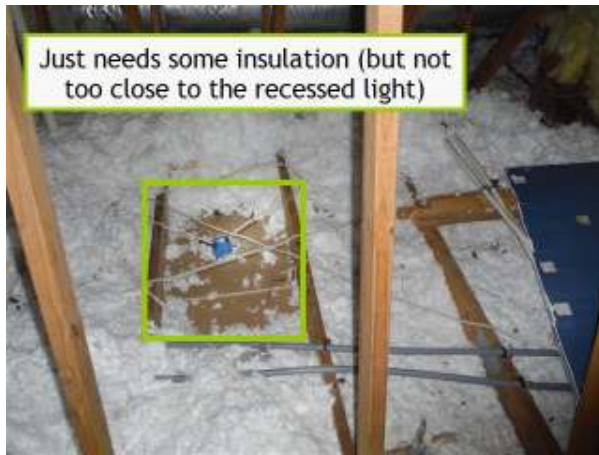
(2) Observed that one or more areas of the attic are missing insulation. Recommend having a contractor replace the missing insulation, where needed, for energy savings.

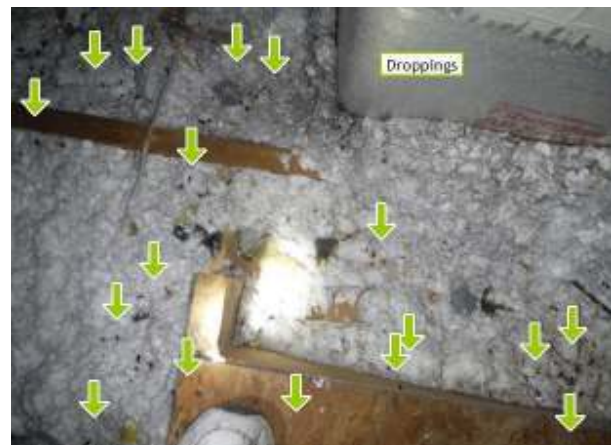
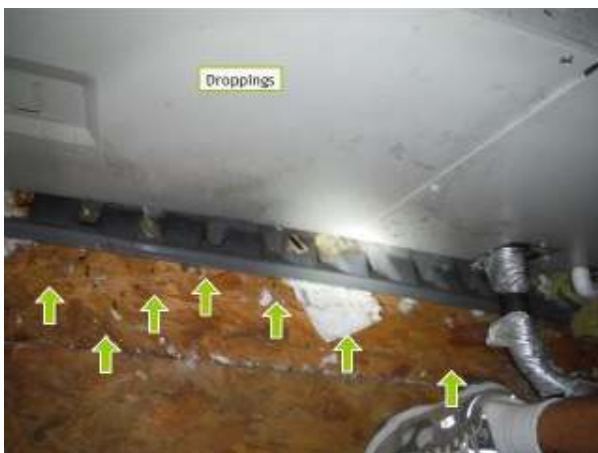
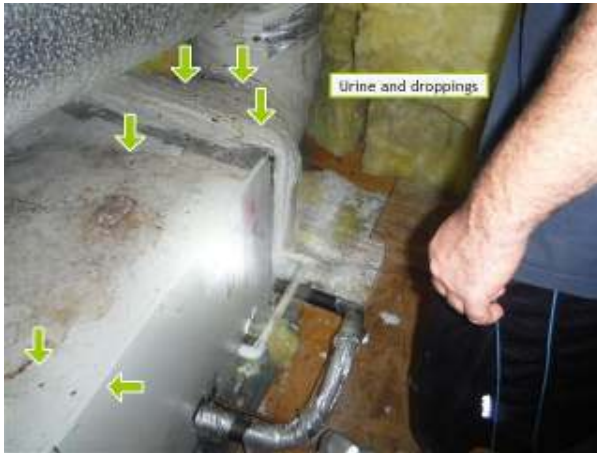
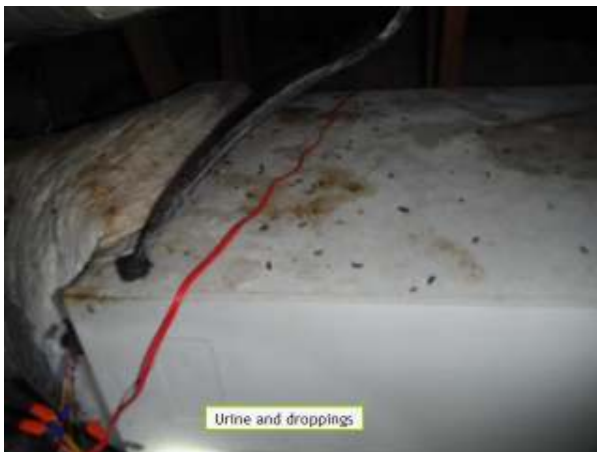
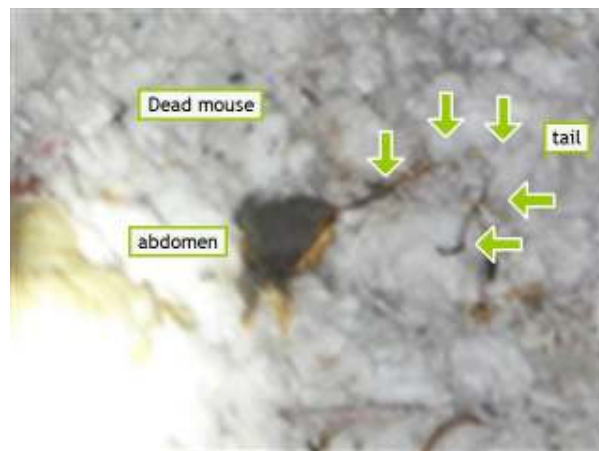
(3) Please note there are squirrel trails through the insulation in the attic and droppings around this space. It appears they're entering the attic through the various roof openings. Since pests can sometimes cause damage to the roof or the components inside the attic, recommend having a pest control company evaluate the attic and treat as needed to eliminate the pests and/or prevent their return.

(4) Observed that the attic has a strong smell of urine and animal droppings. Also, the insulation has rodent trails and rodent hole/nests throughout. The droppings are seen on top of the air handle, the air ducts and throughout the insulation. A small dead rodent was found in the insulation near the HVAC platform. There are signs of past attempts to keep rodents out of the attic with screens and mesh. Due to the amount of droppings and the smell of urine, recommend having an exterminator or contractor remove the insulation, clean the droppings and urine off the air ducts and HVAC unit, then seal the attic to prevent pests from re-entering and install new insulation where needed.

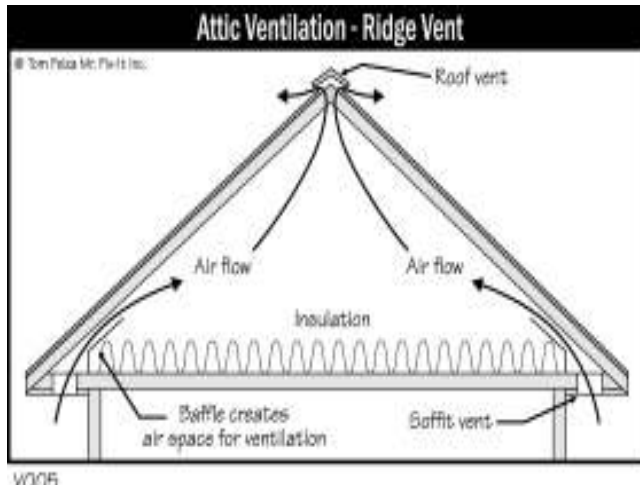
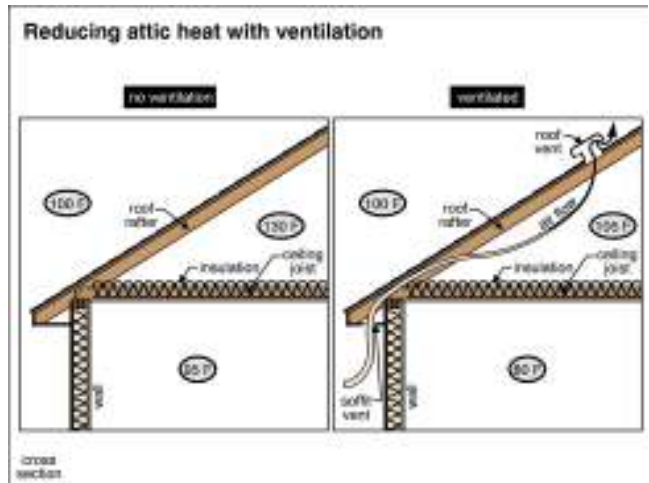
Observed that the attic is well ventilated via ridge and soffit vents (please see following diagram).

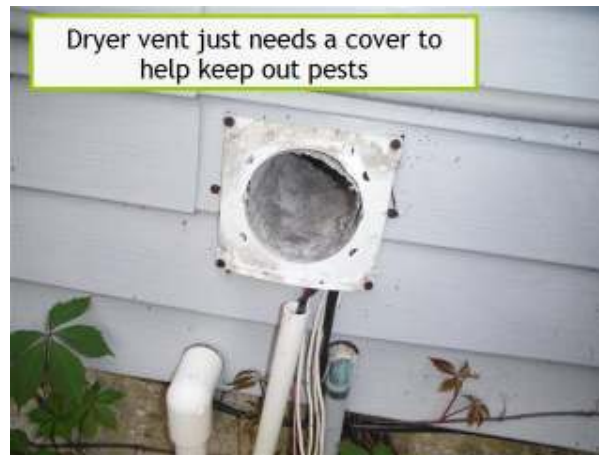
(1) Observed that the vent for the dryer is missing its cover on the exterior of the home. Recommend having a handyman install a cover to prevent pests from entering the home through this opening.

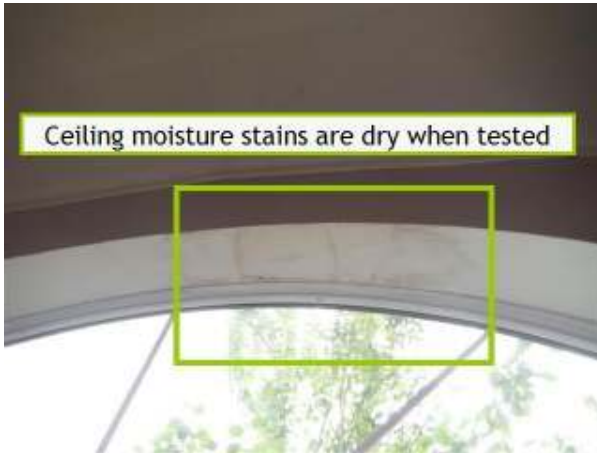
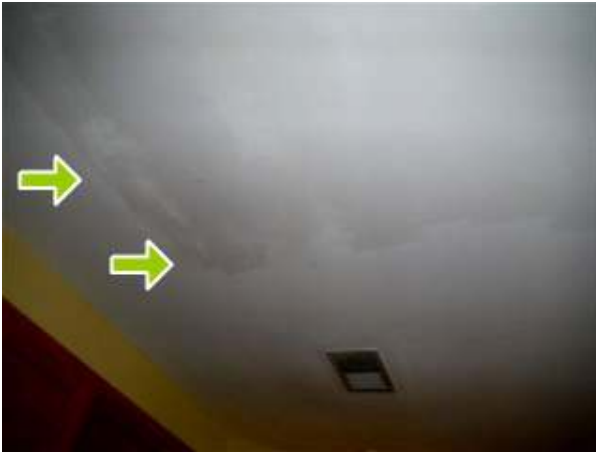
Observed that there are moisture stains on the ceiling in the living room, kitchen and master bedroom. Please note these areas are dry when tested with an infrared camera and moisture meter. Recommend painting the ceilings. You may want to consider KILZ® UPSHOT® ceiling paint for this job -- its an aerosol interior oil-based stain sealer with a unique vertical spray tip for overhead application. It's great for blocking most ceiling stains like water, smoke and grease.

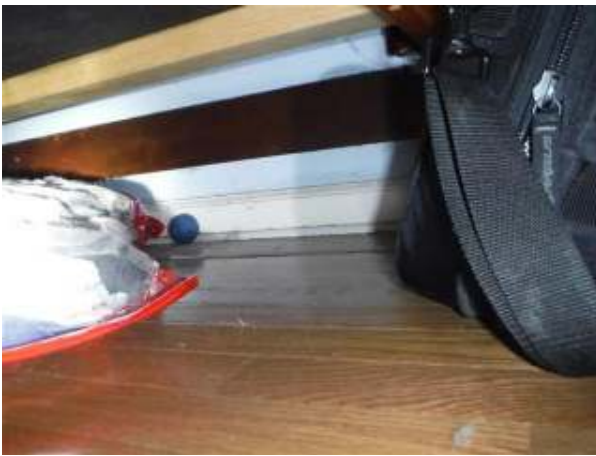
Observed that the part of the wood flooring in the master bedroom is damaged from a past water leak in the kitchen at the refrigerator connection. The floor is damaged and the wall has a large hole. Recommend having a contractor replace the damaged flooring and repair the wall.

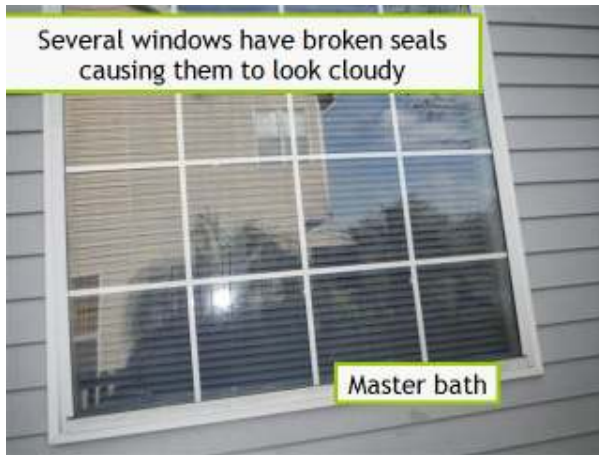
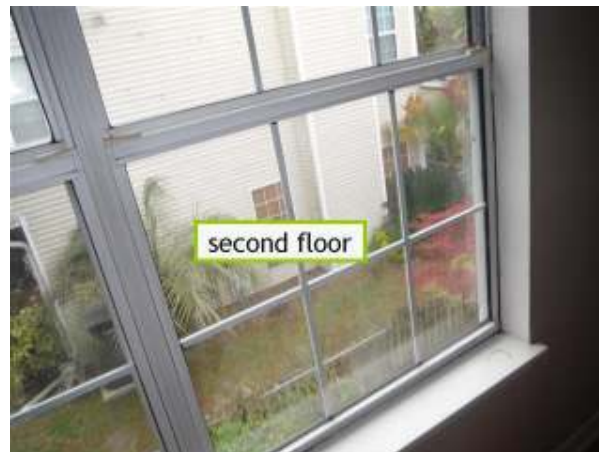
(1) Observed that there three windows which have broken seals causing them to have a cloudy appearance -- one in the master bath and two in upstairs bedroom(s) (see photos for location). When the seal is broken, moisture seeps in between the panes of glass and causes condensation. Additionally, the insulating properties of the window are significantly reduced so that it acts just like a regular piece of glass. Recommend having a window contractor repair or replace these windows, as needed, so that they again have a clear view to the outside and are insulated to help conserve energy. You want want to consult with [www.theglassguru.com](http://www.theglassguru.com) -- they have a moisture removal process which may repair the windows without having to replace them.

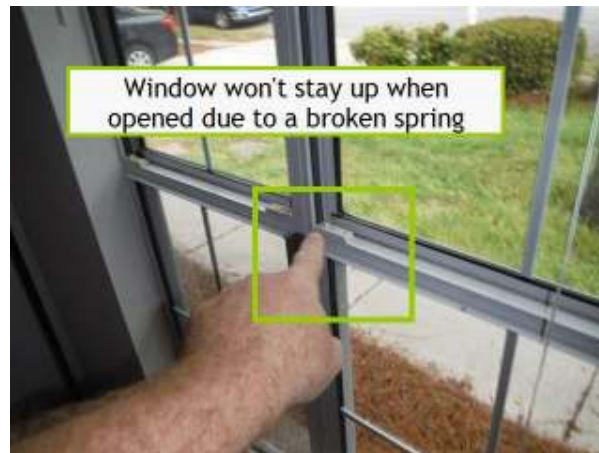
(2) Observed that the windows in the front bedroom will not stay up when opened because the spring is damaged. Recommend having a contractor replace the spring so that the window opens, stays open and closes as it should.

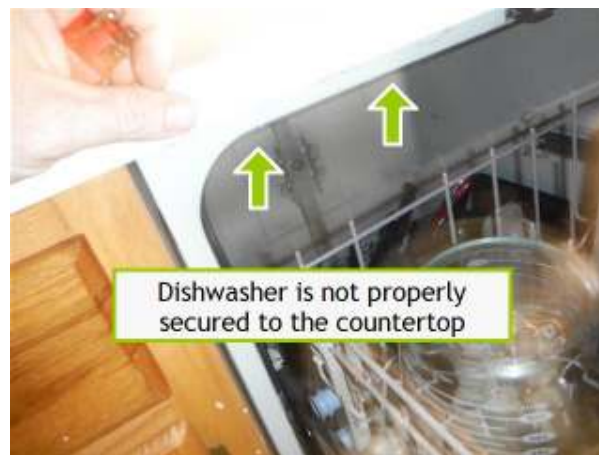
(2) Observed that the dishwasher is loose -- it is not properly secured to the underside of the countertop. Recommend having an appliance repairman secure the dishwasher as it should be using the right length screw.

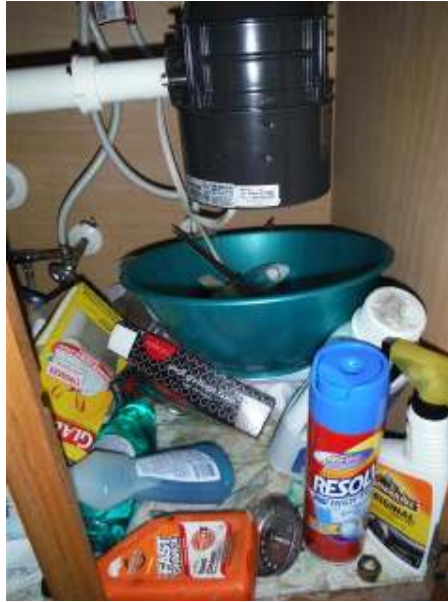
For your reference, the average garbage disposal lasts between 10 and 12 years. Please note its possible the garage disposal is an older model. Due to age, recommend monitoring the disposal for possible problems and plan to replace it, when needed. *Since this is an older appliance, also suggest purchasing a 1-year home warranty at closing -- the 90-day limited warranty provided with your inspection does not cover appliances over 10 years old.*

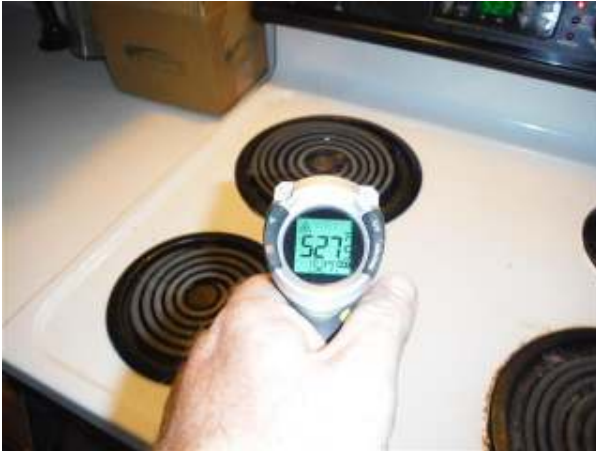
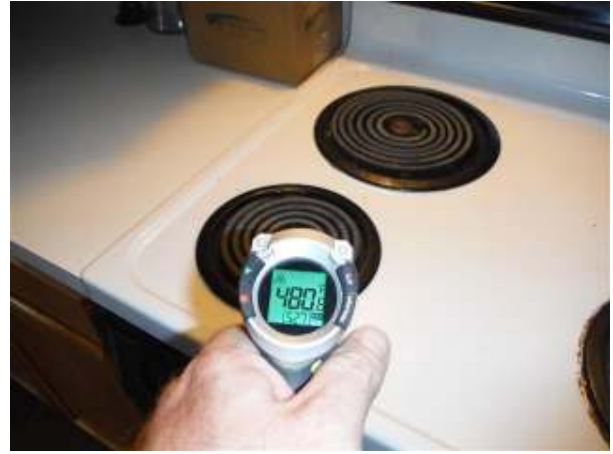
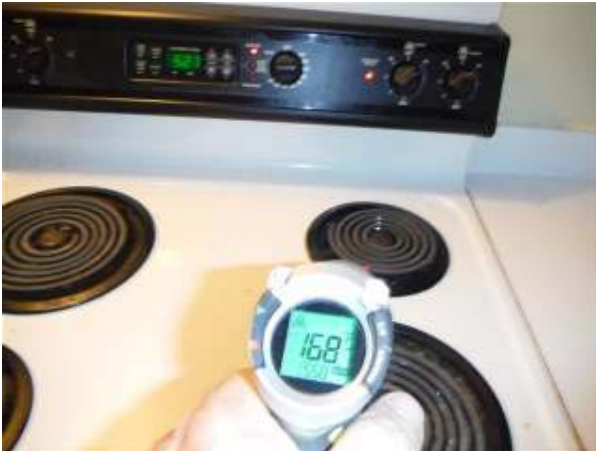
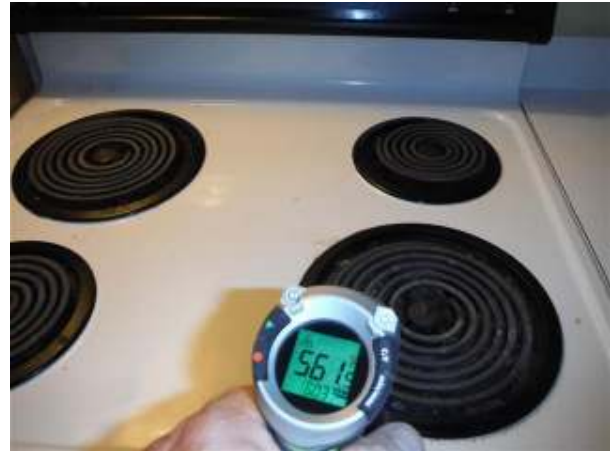
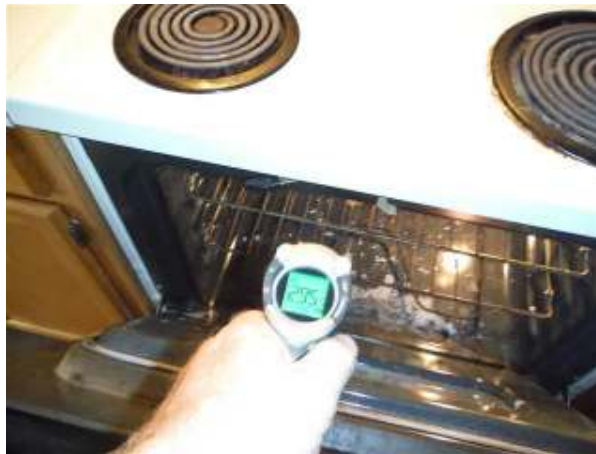
(1) Observed that the oven and cooktop work when tested -- they were tested with a infrared red thermometer to ensure they are heating as they should. Please note I did not test for maximum temperature. For your reference, the average electric range will last about 17 years (gas ranges last about 19 years) and the cooktop will last between 13 and 20 years. Due to age, recommend monitoring the stove for possible problems and plan to replace it when needed. *Since this is an older appliance, also suggest purchasing a 1-year home warranty at closing -- the 90-day limited warranty provided with your inspection does not cover appliances over 10 years old.*

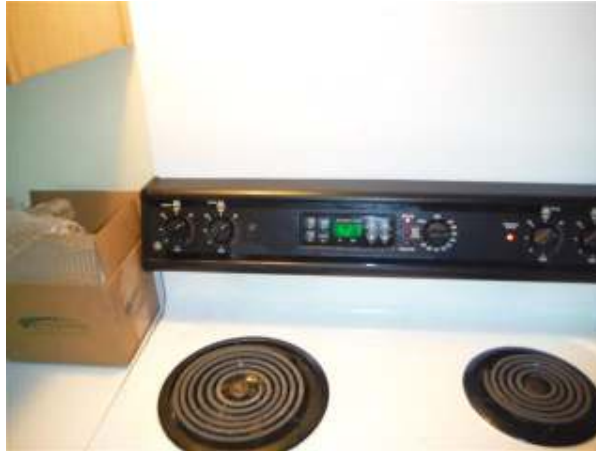
(2) Observed that the anti-tip bracket for the stove is not installed. For your reference, this bracket is secured to the floor then the stove slides into the bracket so it doesn't tip forward. Recommend having an appliance repairman install an anti-tip bracket, for safety.

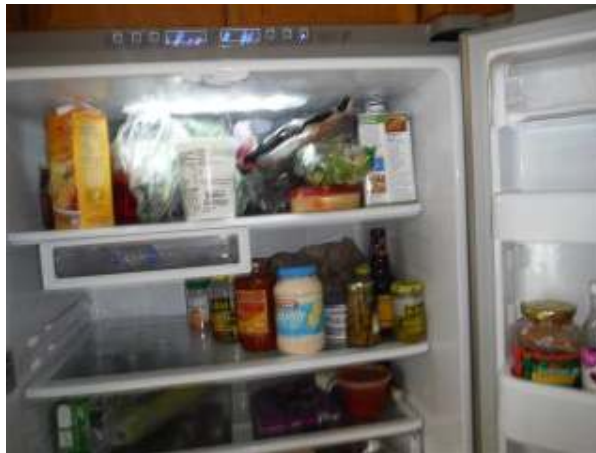
(1) For your reference, the average refrigerator will last between 14 and 19 years. Also, the temperature inside the refrigerator should be kept between 35 and 38 degrees F (and no more than 40 degrees) for food safety. The freezer should be set at 0 degrees F.

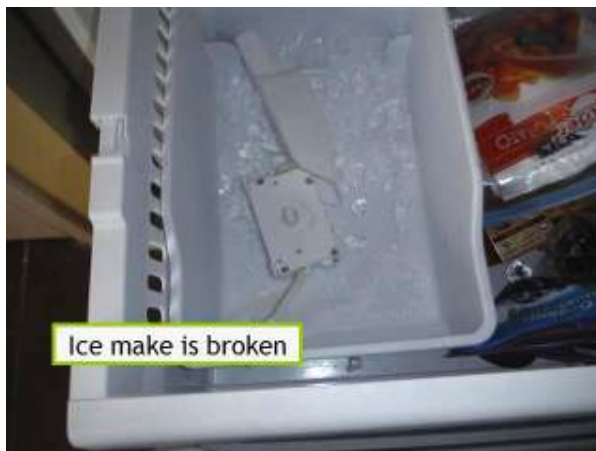
(2) Observed that the ice maker for the refrigerator is broken. Recommend replacement.

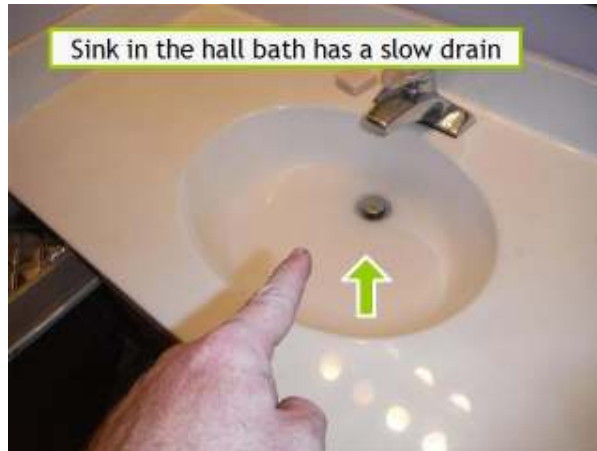
(1) Observed that the sink in the hall bath is slow to drain -- this is likely from a hair clog. Recommend using Drain-O to see if this will resolve the clog. If not, then recommend having a plumber evaluate further and make the needed repairs so this sink drains as it should.

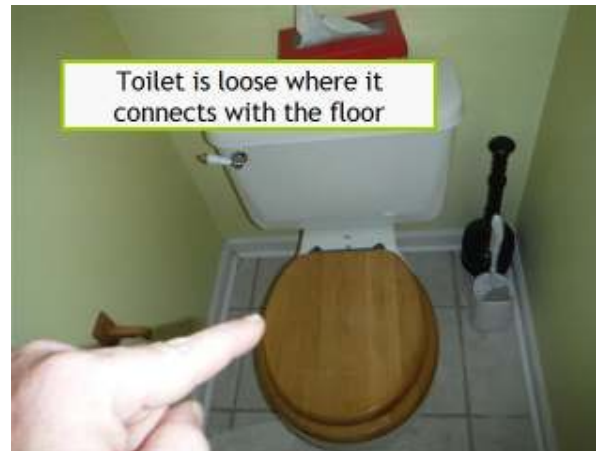
P027

(2) Observed that the toilet in the master bath is loose where it connects to the floor -- this is very common. For your reference, a loose toilet bowl may result in a leak at the wax ring and/or at the supply piping connection which can damage the floor and sub-floor below. Recommend having a handyman tighten the floor bolts so the toilet is properly secure.

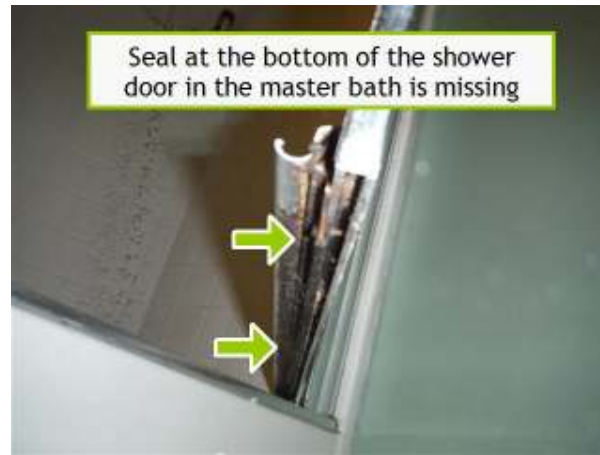
(3) Observed that the seal at the bottom of the shower door in the master bath is missing -- this can allow water to seep out of the shower onto the walls and floors which can cause damage over time. Recommend having a handyman install a seal at the bottom of the shower door to help keep the shower water tight.

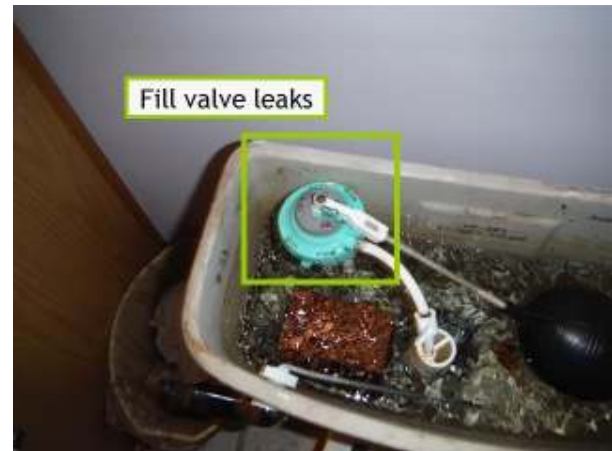
(1) Observed that the fill valve for the toilet in the hall bath leaks from the top instead of draining from the bottom. Recommend having a plumber repair or replace the fill valve, as needed, so the toilet works as it should.

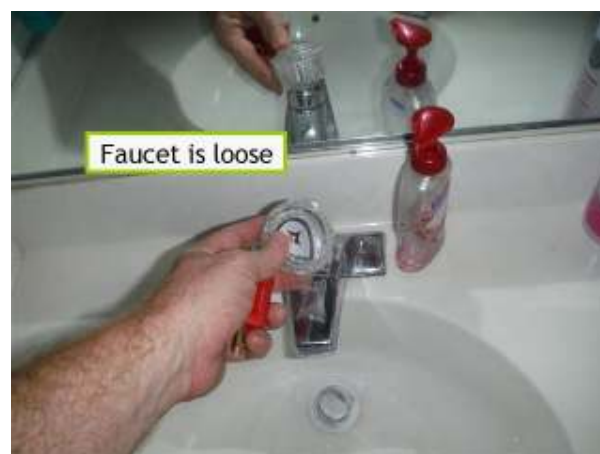
(2) Observed that the left faucet for the sink in the master bath is loose. Recommend having a contractor / handyman make the needed repairs.

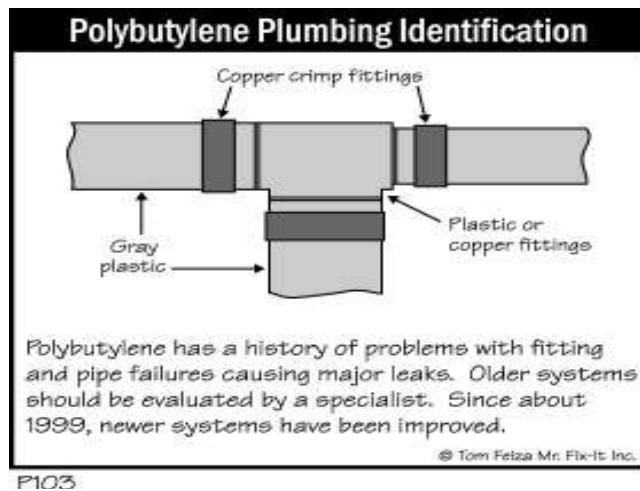
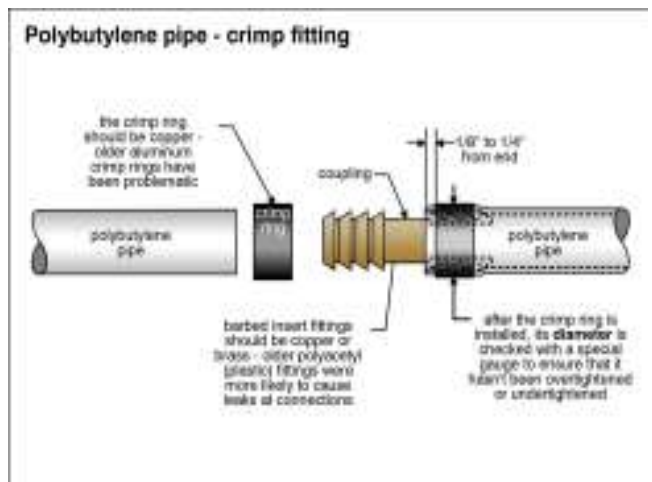
(3) Observed that this home has gray polybutylene plastic plumbing supply lines (PB). For your reference, polybutylene has been used in this area for many years, but has had a higher than normal failure rate and is no longer widely used. Over time, the pipe can react with chlorine in water and could leak or break. In this house, copper fittings are used with the PB piping which have been known to

improve its performance. For more information, please visit the web at [www.polybutylene.com/poly.html](http://www.polybutylene.com/poly.html) or [www.pbpipe.com](http://www.pbpipe.com). Recommend monitoring your plumbing for possible problems or leaks as you would any other house.

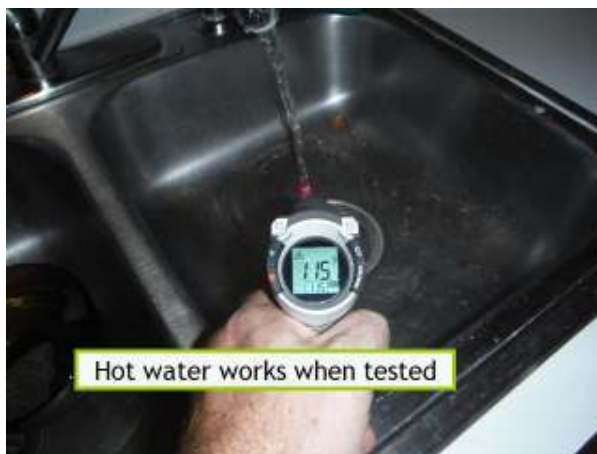
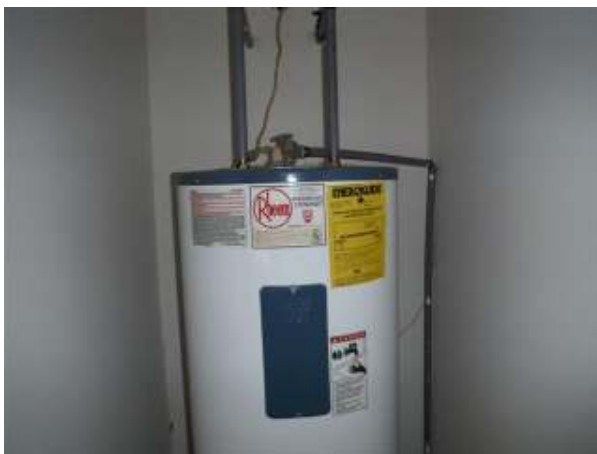
(1) Observed that the electric water heater is 19 years old. Please note the hot water works when tested. For your reference, the average hot water heater lasts about 12 years and sometimes longer. Due to age, recommend monitoring the hot water heater for possible problems or leaks and plan to replace this unit, when needed. *Since this is an older appliance, recommend purchasing a 1-year home warranty at closing -- the 90-day limited warranty provided with this inspection will not cover appliances over 10 years old.*

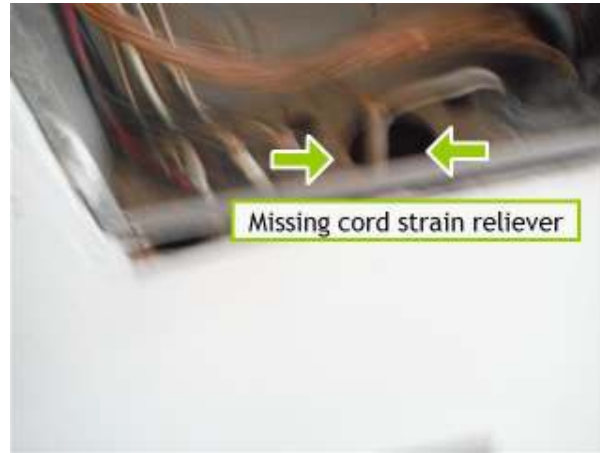
(2) Observed that one or more of the cord strain relievers in the electrical panel are missing. For your reference, the purpose of a cord strain reliever is to prevent electrical wires from being pulled out the bottom of the panel or becoming frayed and to keep pests from entering the panel. Recommend having an electrician install cord strain relievers, where needed, for safety.

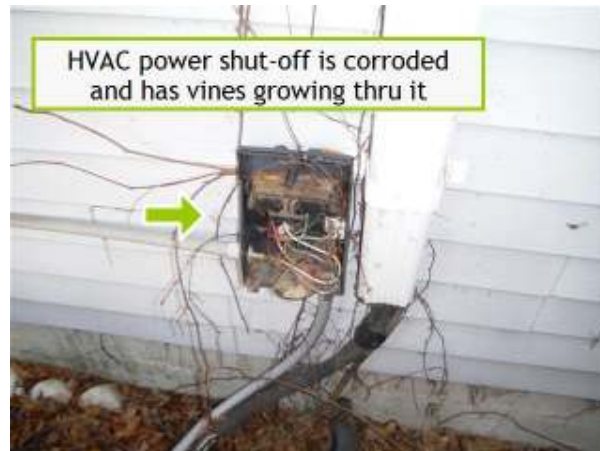
Observed that the power shut off for the outdoor HVAC unit (for the upstairs) is damaged and has vines growing in it. Also, the connections are corroded -- this is a fire hazard. Recommend having an electrician replace this shut-off.

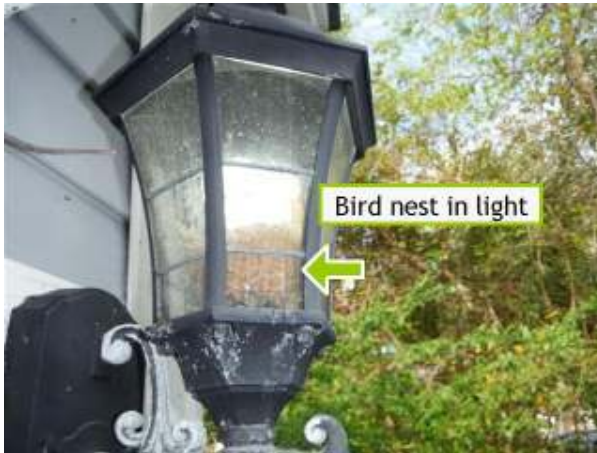
(1) Observed that one or more of the exterior lights have bird nests in them -- this is a fire hazard. Recommend removing the bird nests, for safety.

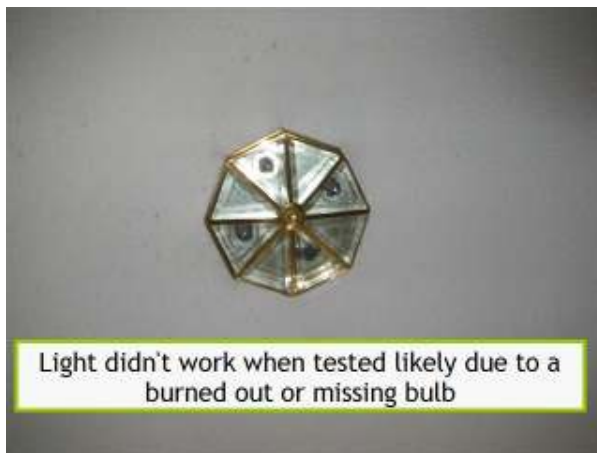
(2) Observed that one or more of the lights did not work likely due to burned out light bulbs. Recommend changing the light bulbs to see if the lights work then. If not, recommend having an electrician make the repairs needed so the lights work as they should.

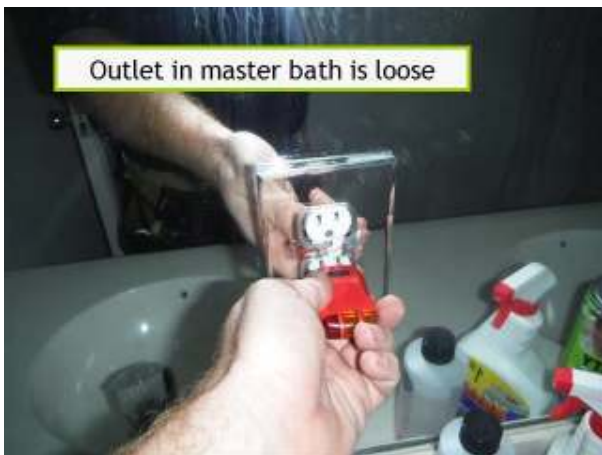
(4) Observed that the outlet in the upstairs master bathroom is loose. Recommend having an electrician properly secure this outlet, for safety.

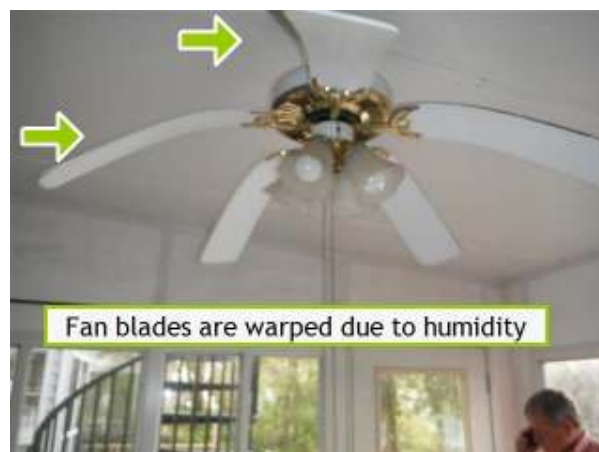
(5) Observed that the fan blades for the ceiling fan in the sunroom are warped due to humidity. Recommend replacing the fan blades.

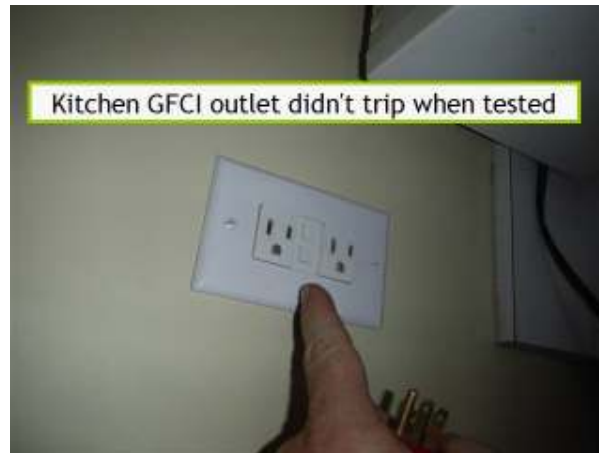
(1) Observed that the GFCI outlet in the kitchen didn't trip when tested. Recommend having an electrician make the needed repairs so this outlet works as it should, for safety.

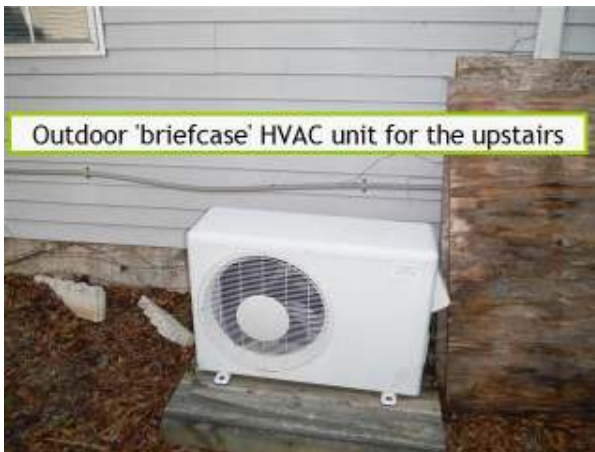
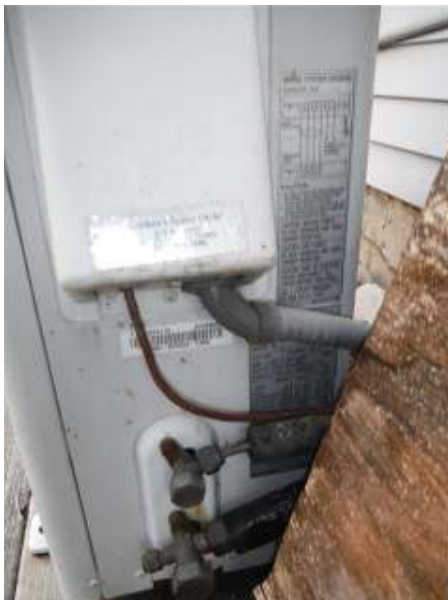
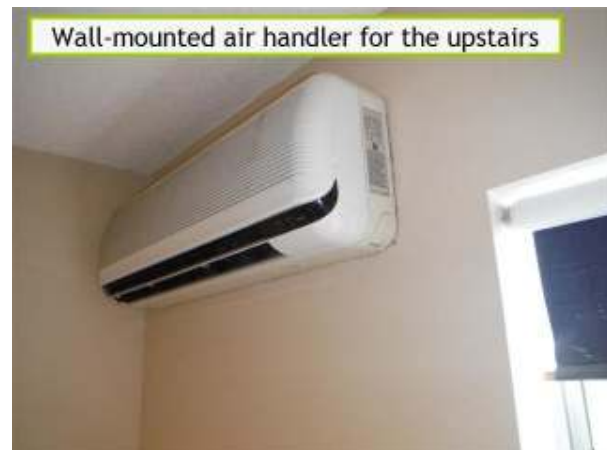
(3) Observed that there is a ductless system (an outdoor 'briefcase a/c unit and a wall-mount indoor air handler) to heat and cool the second floor. Please note this unit did not cool at all. The outdoor unit may not be charged and/or not working due to the damaged electrical connection. Recommend having a HVAC repairman evaluate further and make the needed repairs so the upstairs has good cooling capability.

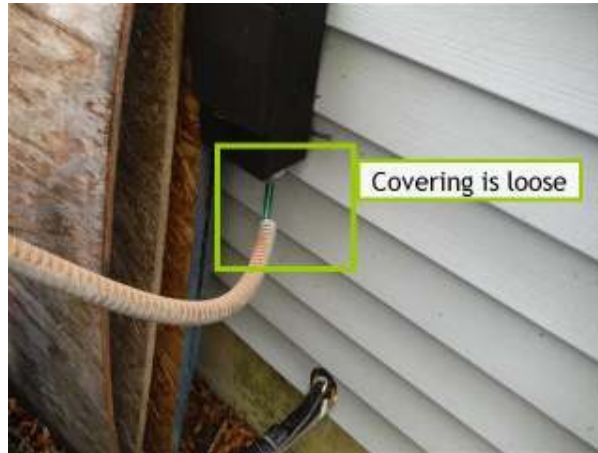
(4) Observed that the weather-proof covering for the outdoor HVAC unit's power cord is loose. Recommend repair.
