# Home Inspection Report

Property address: 1234 Center Ave.  
Charleston SC 29407

Inspected by: Stephen Houmard  
Solid Ground Home Inspections  
South Carolina License #2046  
*Certified ASHI® Home Inspector*  
*Infrared-Certified® Home Inspector*

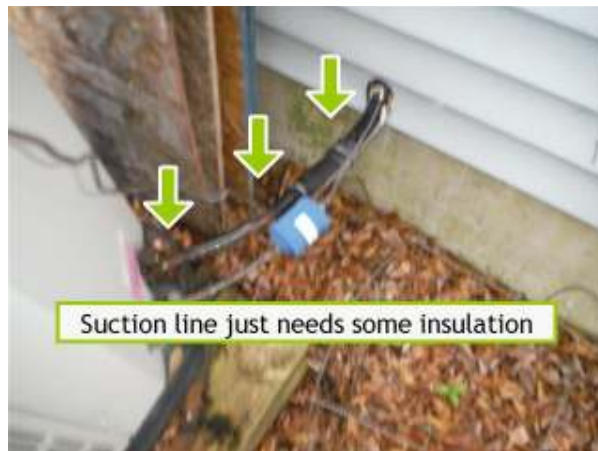
(6) At the outdoor a/c compressor, the suction line is not completely insulated with a foam sleeve -- on this unit, part of the foam sleeve is missing which can cause hinder the home's cooling ability and produce condensation. Recommend having an HVAC repairman insulate the suction line, where needed, for energy savings.

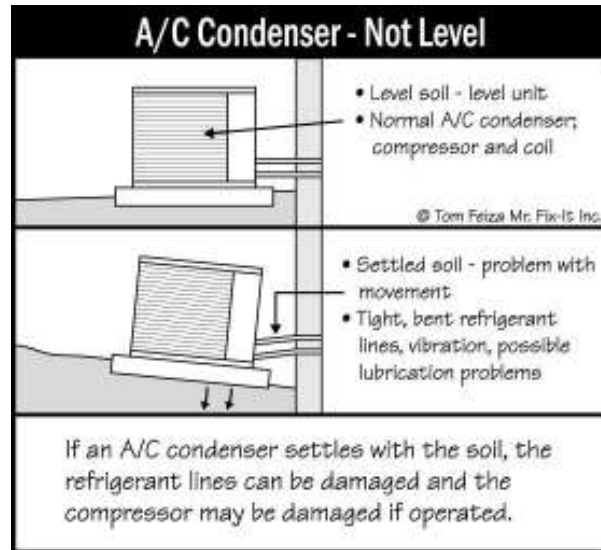
(7) Observed that the outdoor a/c compressor is not level. For your reference, the compressor should not be more than 10 degrees out of level to ensure it is properly lubricated (oil can become trapped if unit is out of level) and to prevent stress/breaking of the refrigerant lines. Recommend having an HVAC repairman level the unit so that it works as it should.

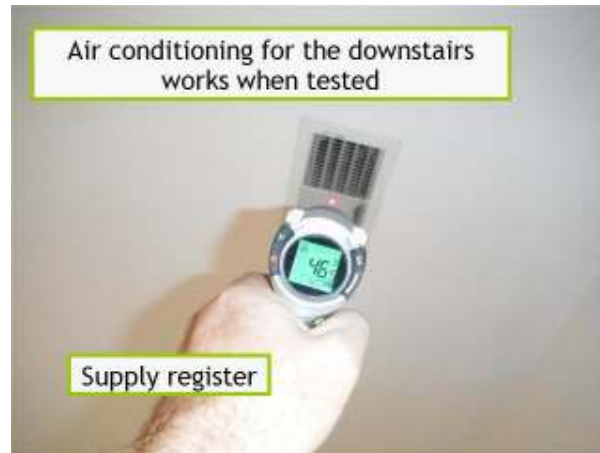
(1) When tested, it appears that the air conditioning for the downstairs is working well. For your reference, there should be at least a 14 degree difference between the air at the return register and where the cooled air enters the home at the supply register to indicate normal functioning. In this case, there was a 22 degree difference. Please note the heat was not tested since the outside temperature was over 65 degrees to prevent possible damage to the outdoor a/c compressor(s).

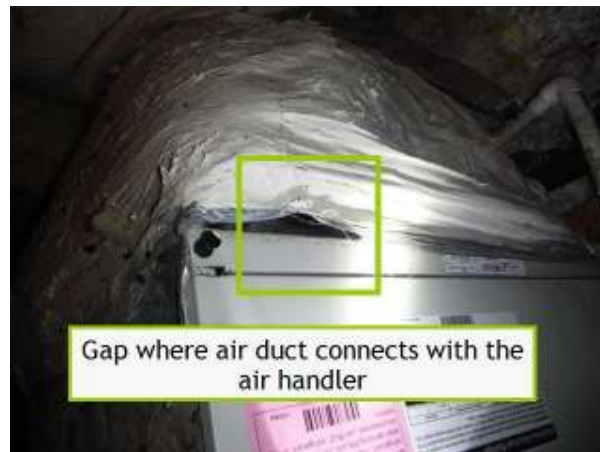
(1) Observed that there is a gap where an air duct attached to the air handler in the attic -- this is allowing conditioned air to escape into the attic. Recommend having an HVAC repairman evaluate the air ducts and seal openings, where needed.

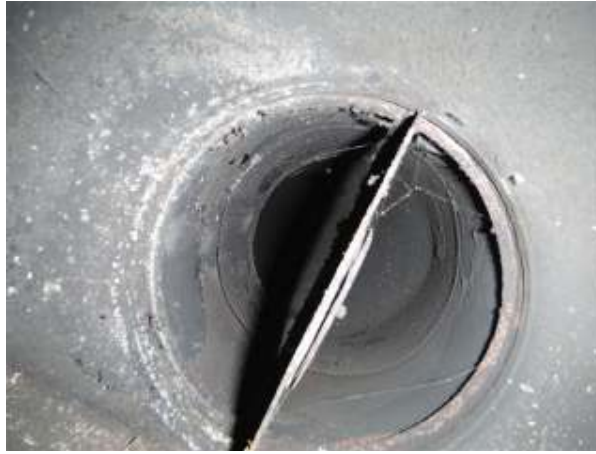
(1) Observed that the chimney liner appears to be in good condition. Please note there is some, but not a lot, of creosote build-up which can be a fire hazard and may also conceal hairline cracks in the liner. As a safety precaution, we generally suggest having a chimney sweep clean the liner to remove the build-up. Build-up which is 1/8" deep or more should be cleaned. With the build-up removed, the liner can be properly inspected to ensure it is in good condition (ideally) before a fire is made in the fireplace.

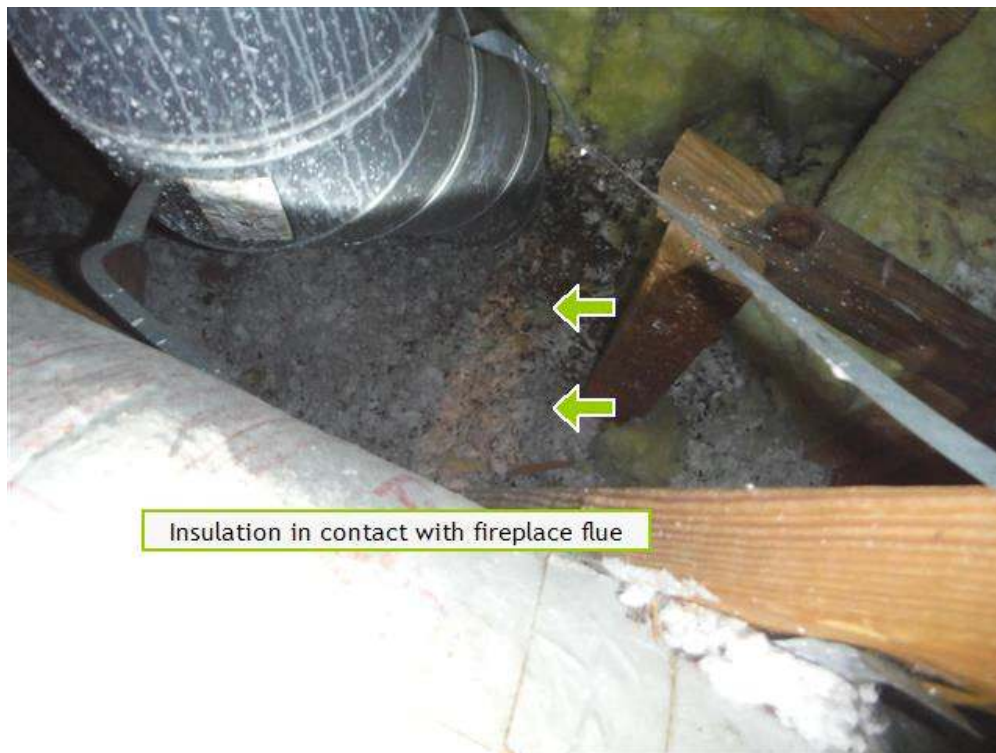
(2) Observed that the flue pipe for the fireplace is in contact with the insulation as it travels through the attic -- a fire hazard. Please note the flue pipe can get very hot when in use. Recommend having a contractor or handyman move the insulation away from the flue pipe so its no longer in direct contact and so there is sufficient clear space all the way around for this type of flue, for safety.

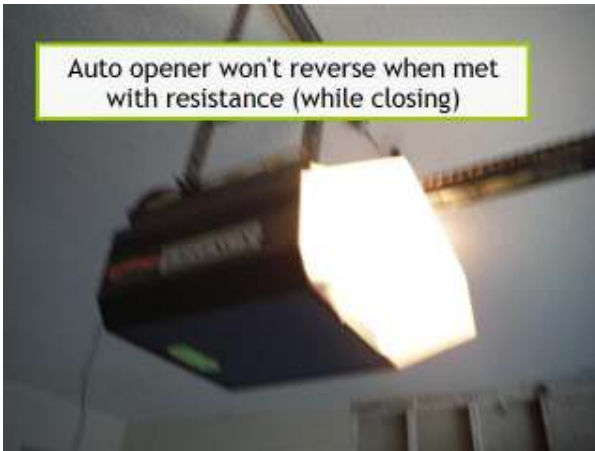
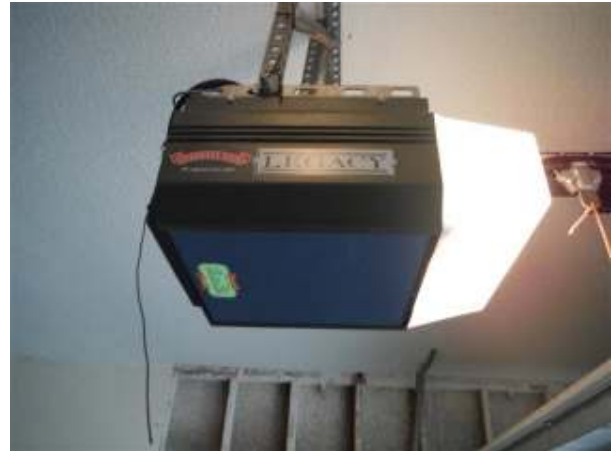
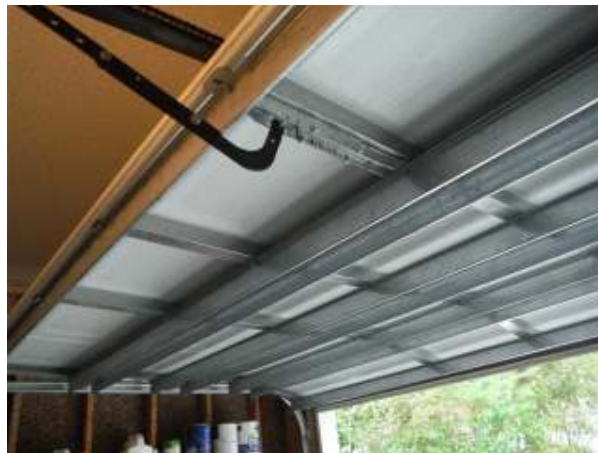
(1) Observed that this home has an automatic garage door opener in good working order. Please note that when tested, the garage door will not reverse when met with resistance. Recommend having a handyman adjust the settings for the garage door opener so that the door will reverse when needed -- when someone or something is in its way. All other safety features are in good working condition.
