INSPECTION REPORT

For the Property at:
123 RUE ABCD
QC A0B 0C0

Prepared for: Jim Smith
Inspection Date: Wednesday, December 1, 2021
Prepared by: Hamed Khani, NACHI20082410

Report No. 1001, v.3

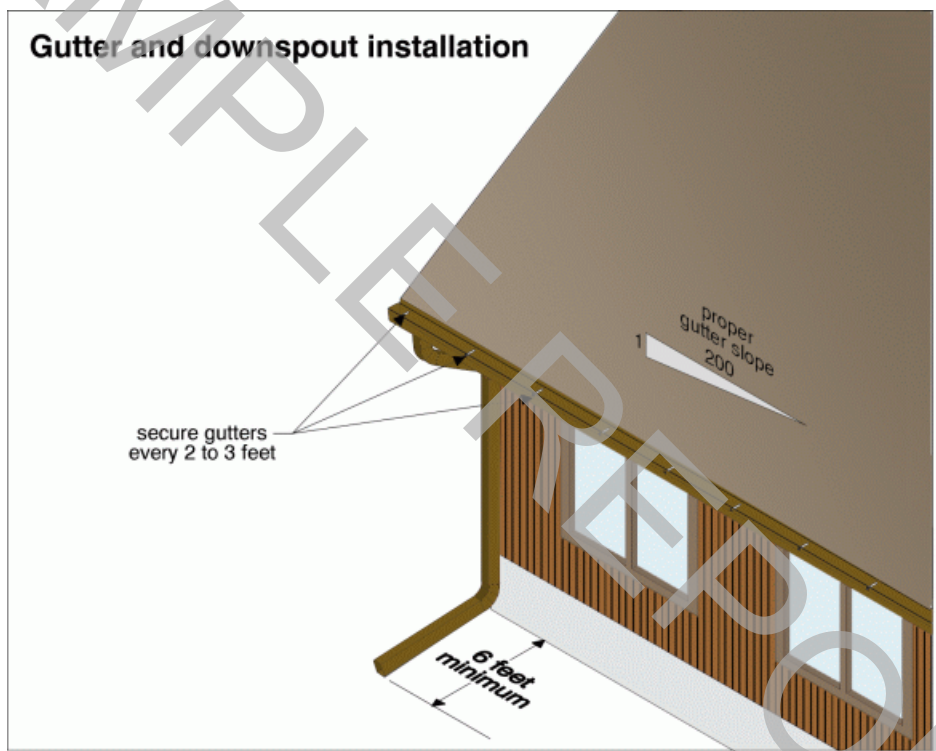
14. Condition: • [Missing](#)

Task: Provide

Time: As soon as possible

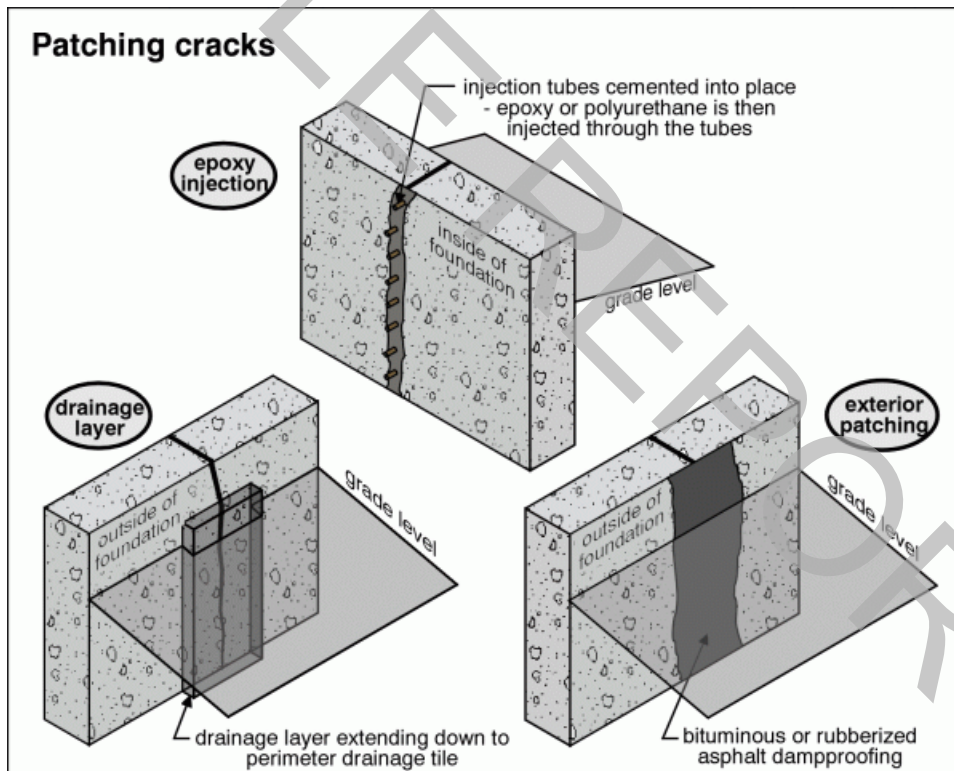
- 28. Condition:** • Typical minor cracks
Repair if needed
- Implication(s):** Chance of water entering building
- Location:** Various Exterior
- Task:** Further evaluation Monitor
- Time:** Regular maintenance

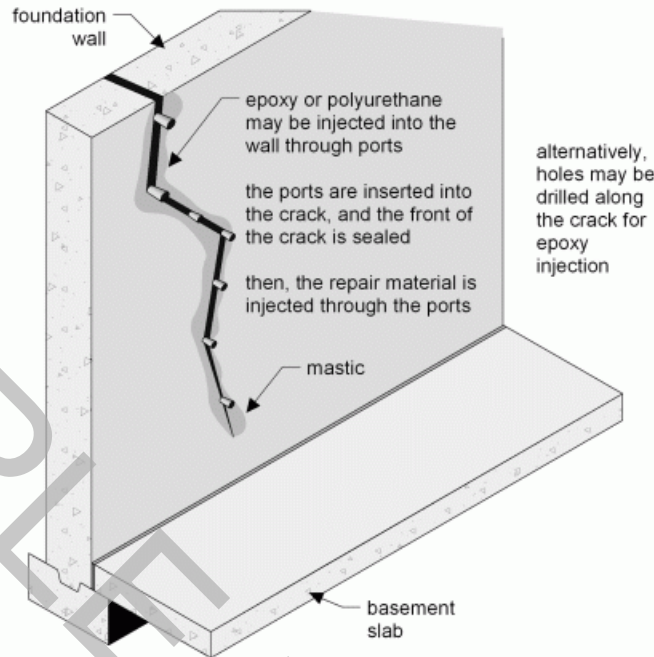
Crack repair - epoxy and polyurethane injection

epoxy is as strong as concrete and forms a structural seal

however, it hardens slowly, and if there is space at the back of the crack, it may leak out

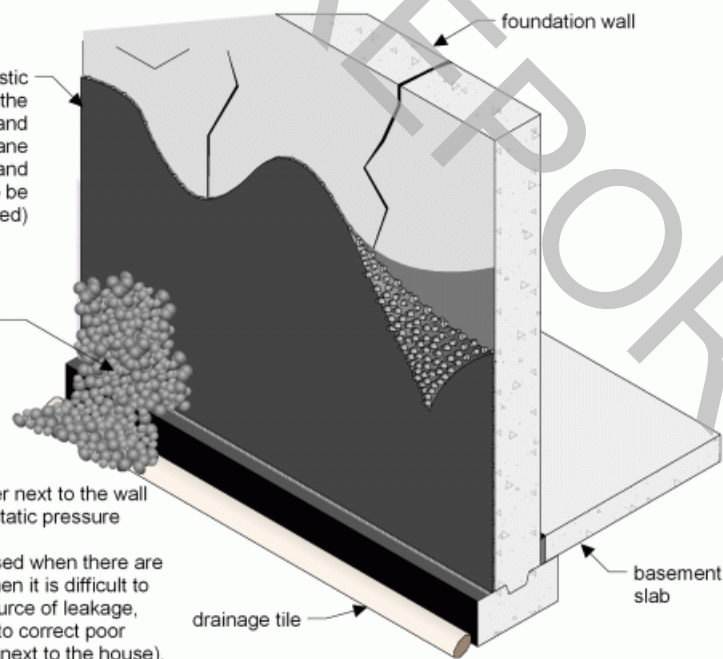
Crack repair - drainage layer

dimpled plastic membrane protects the wall from moisture and provides drainage plane (other membranes and methods may also be used)

adding a drainage layer next to the wall helps to relieve hydrostatic pressure

this method may be used when there are many small cracks, when it is difficult to identify the specific source of leakage, and when it is difficult to correct poor grading (such as a hill next to the house).

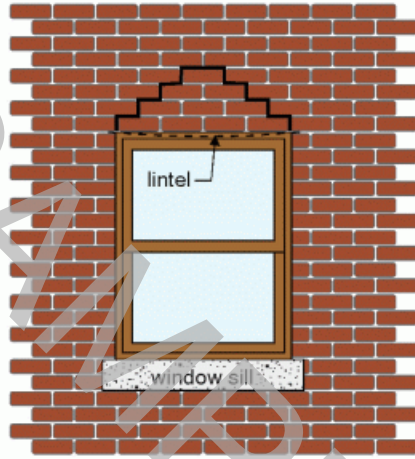
Lintel related wall cracks

crack pattern commonly associated with sagging lintels due to undersizing or deterioration

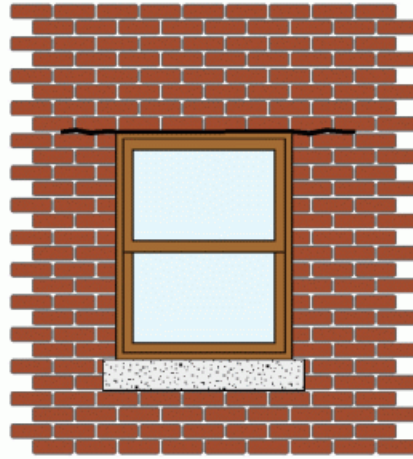
horizontal crack often caused by rusting steel lintels expanding
