Home Inspection Report

Prepared for: Tommy Condo
Date: 9/8/2010

Property address: 789 Palmetto Blvd. Unit 36
Charleston SC 29412

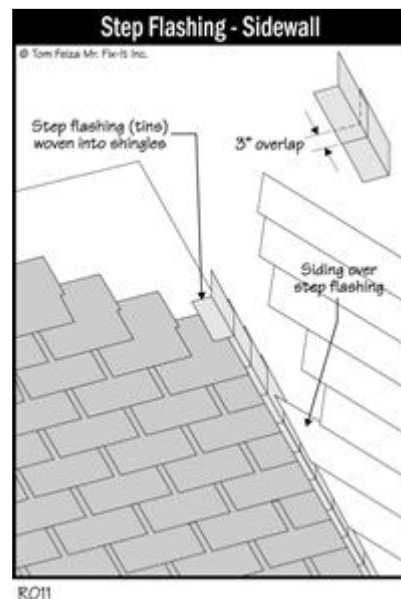
Observed that the flashings are in good condition. For your reference, flashing is a sheet of metal or Neoprene which is installed around pipes and chimneys traveling through the roof to ensure these areas are water tight. Also, flashing is applied along the sidewalls where different parts of the roof come together as well.

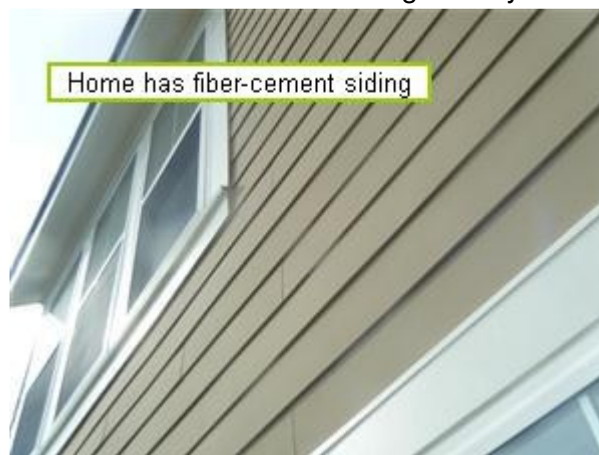
Observed that this home has fiber-cement siding. For your reference, fiber cement siding is a low-maintenance, impact-resistant and durable alternative to wood siding. In essence, it combines the look of natural wood with the durability of cement. For example, HardiPlank, a name you may be familiar with, is a brand name fiber cement product. Also, it is non-combustible and designed to resist wind and hail damage and is naturally resistant to fungus, mildew, termites and deterioration from salt and uv rays. Although fiber cement siding is available in a wide array of colors, it can also be painted any color you choose, should you ever feel in the mood for change and it will hold the paint color. Most cement fiber siding comes with incredible warranties—some run as long as 50 years.

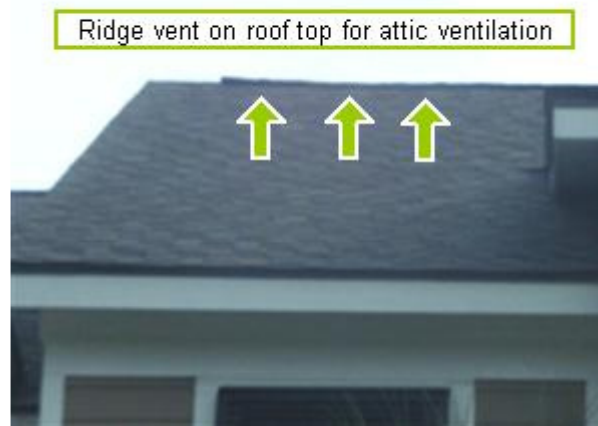
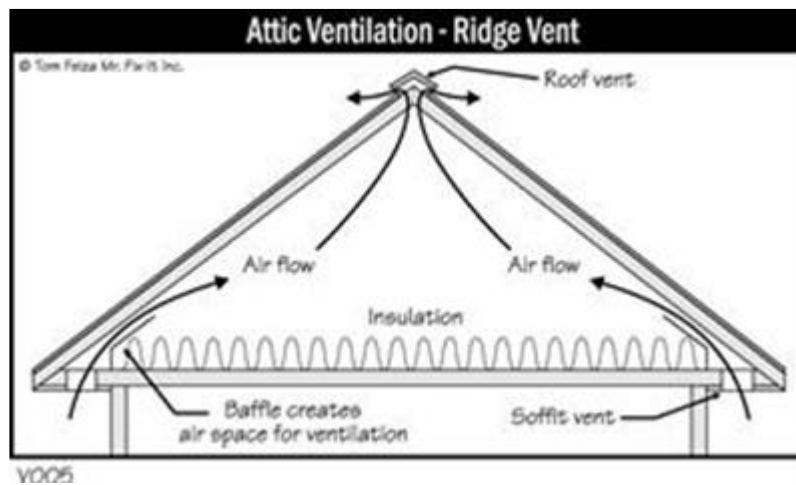
Observed that this home has good ventilation in the attic -- the included illustration describes how the attic is ventilated in your home.

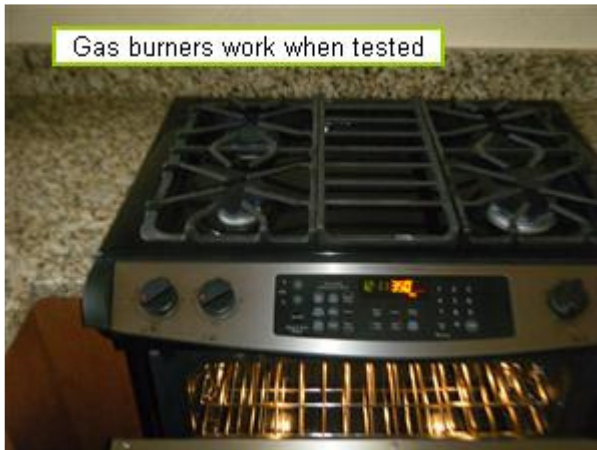
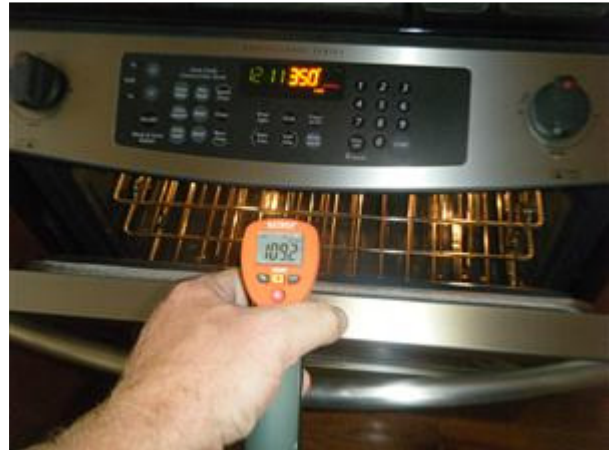
Observed that the oven and cooktop appear to be working well --Please note I did not test for maximum temperature.

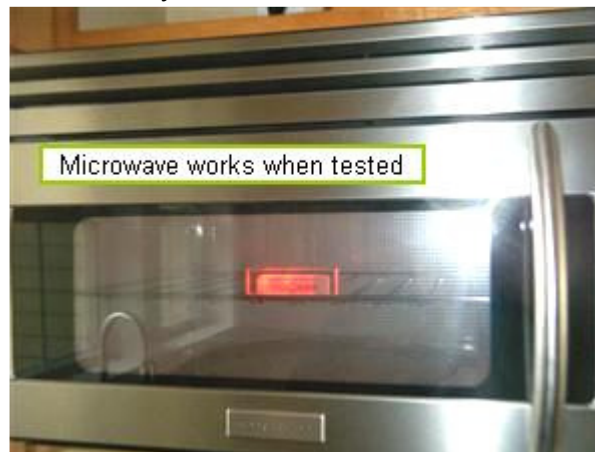
Observed that the microwave appears to be working well -- it was tested with a microwave tester to ensure it is operating properly and that there are no door leaks. For your reference, the average microwave lasts 10 years.

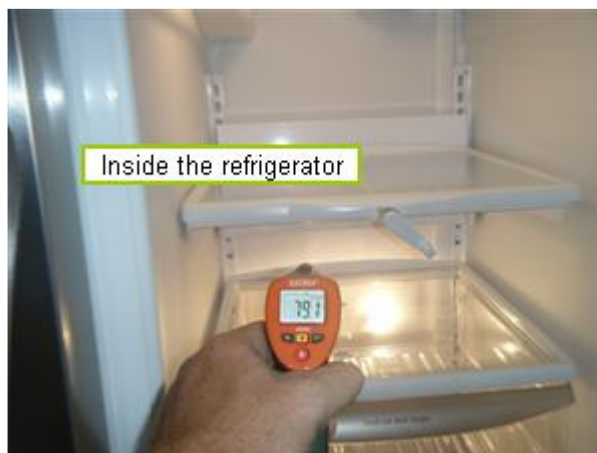
(1) Please note the refrigerator was turned on at the time of the inspection. As a result, it did not have enough time to cool down. However, it did start to cool. When I return to complete the plumbing inspection, I will check the refrigerator temps again if it's been left on such that it's had a chance to cool sufficiently.

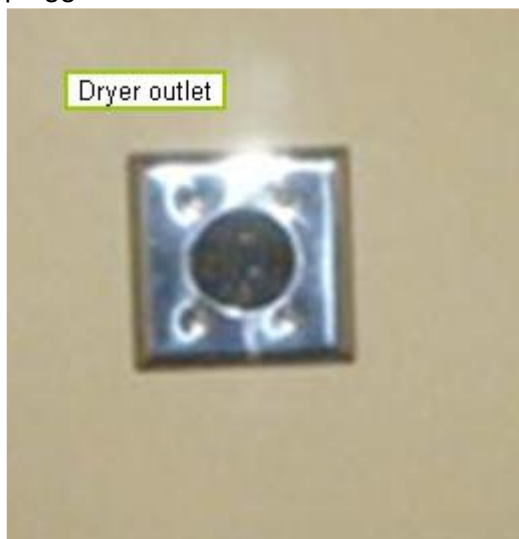
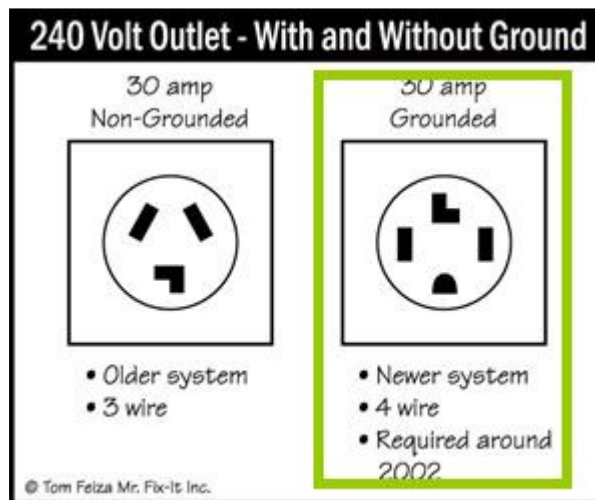
If the plug for your dryer doesn't fit into the dryer outlet, then take this photo to your local home or hardware store and ask for a four prong dryer "pig tail" so that the dryer can be plugged in.

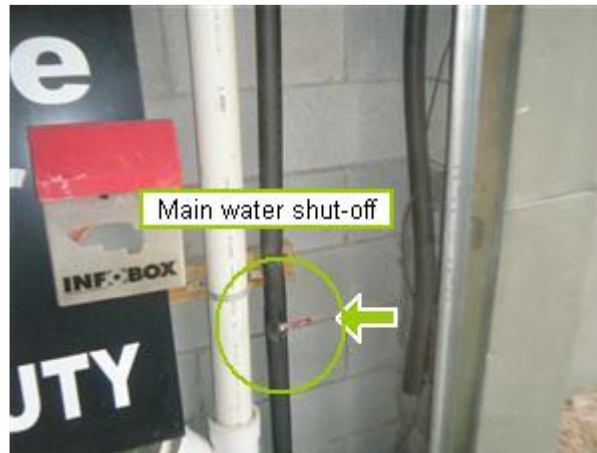
Observed that the main water shut-off is located in the garage. If you need to do any plumbing work in the house, or if one of your pipes breaks, you'll need to know where to shut-off the water so repairs can be made.

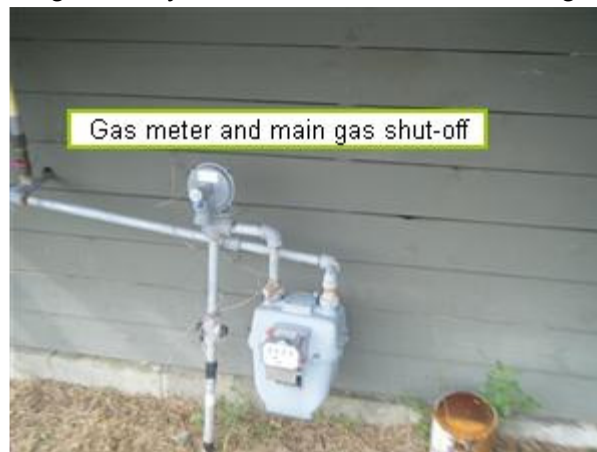
(1) The main fuel/gas shut-off is located at the gas meter outside. In the event that repairs need to be made to the gas line, you'll need to know where the gas shut-off is located.

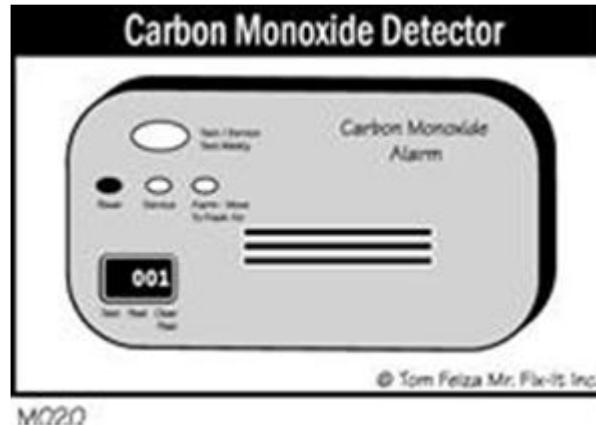
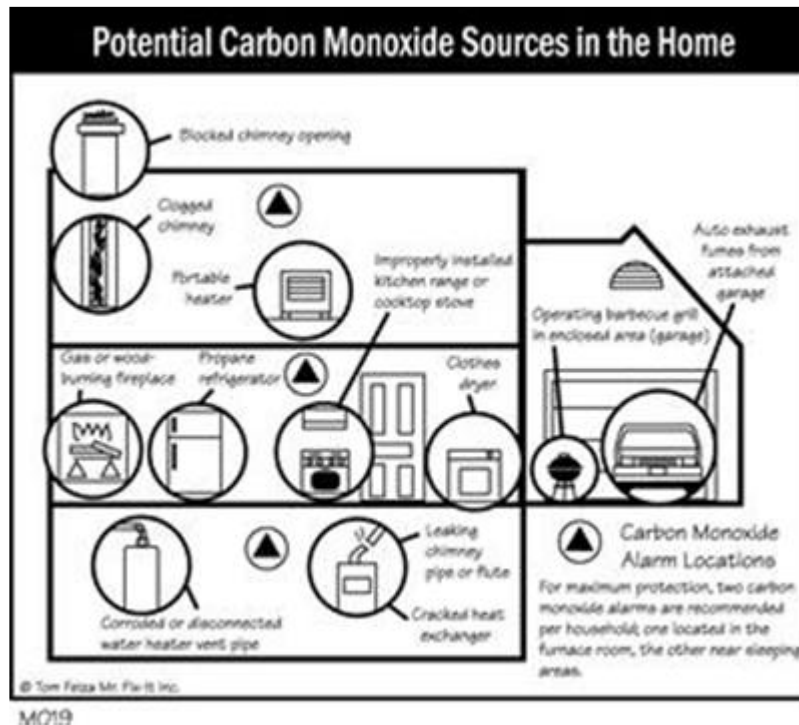
(2) With the presence of any gas-powered appliances in the home, recommend installation of at least two carbon monoxide detectors with loud alarms -- one or more near (but not on top or in front of) the gas appliances and hot water heater and one in the sleeping areas 5 feet from the floor for safety. Recommend testing and changing the batteries in your carbon monoxide detectors when you test and change the batteries in the smoke detectors.

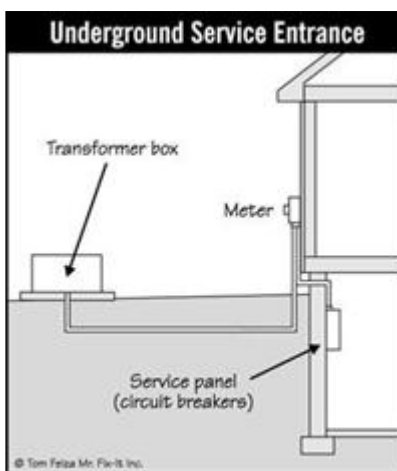
Observed that the underground service entrance conductor (where the power enters the home from the street), electrical meter and grounding rod are located on the side of the home and are in good working condition

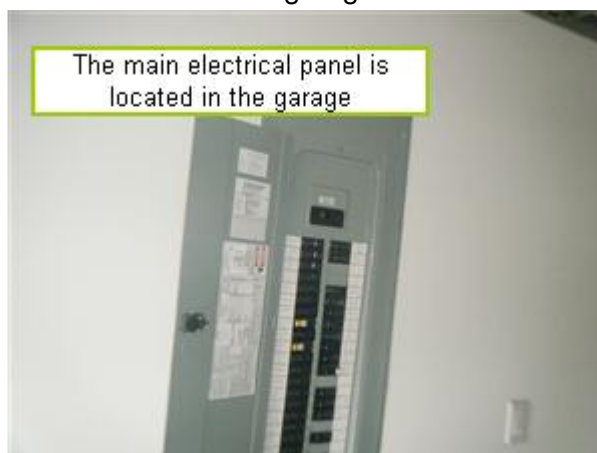
The main electrical panel is located in the garage.

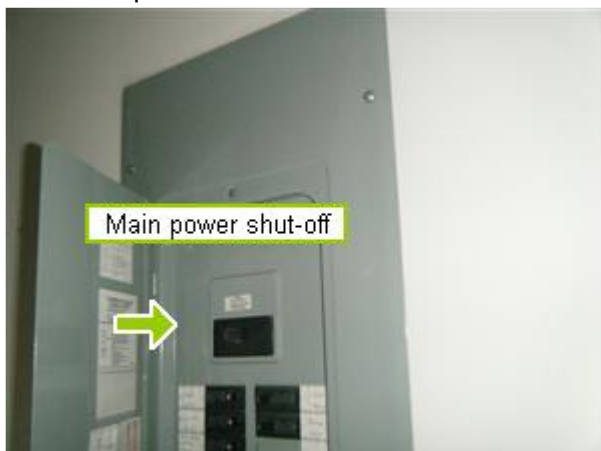
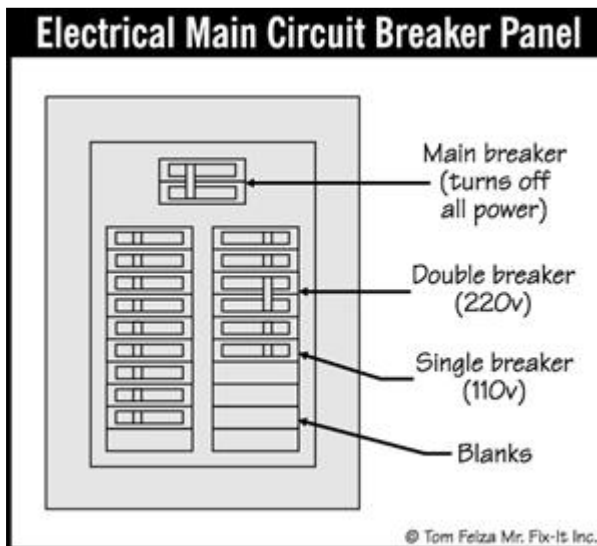
E002

(1) Observed the main electrical disconnect (also called a main breaker) is on located on the main electrical panel. It is helpful to know where the main breaker is in case you need to turn off the power for the whole home.

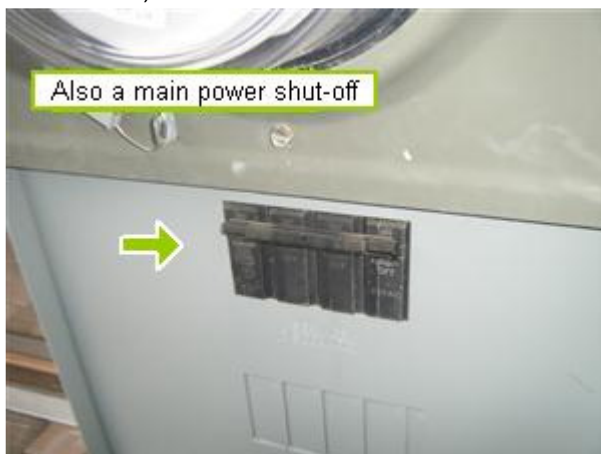
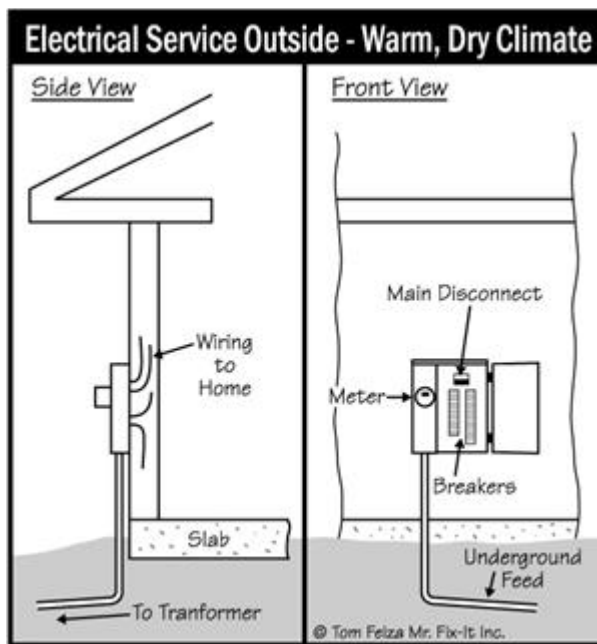
E019

(2) Please note there is a second main electrical disconnect (also called a main breaker) located next to the electrical meter outside.

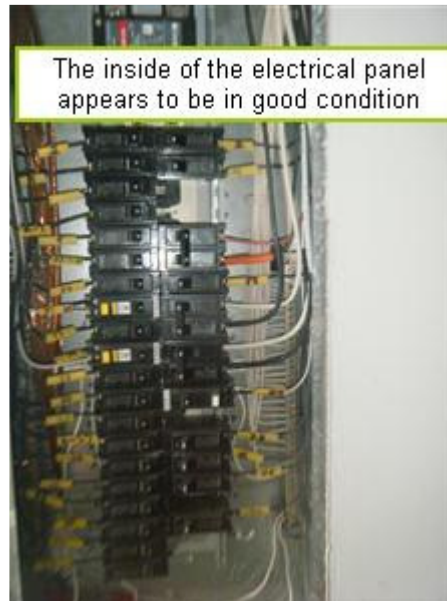
Observed that the inside of the electrical panel is in good condition.

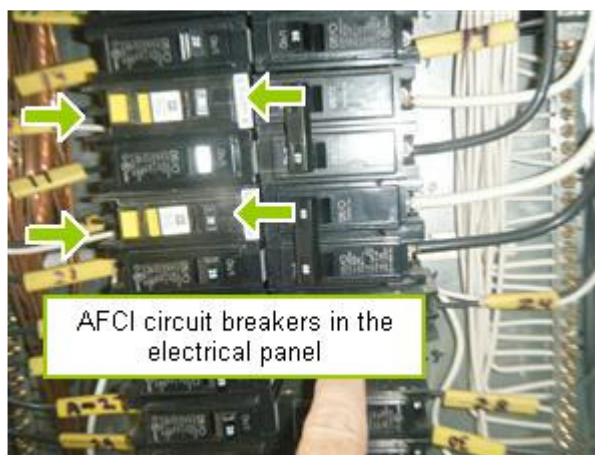
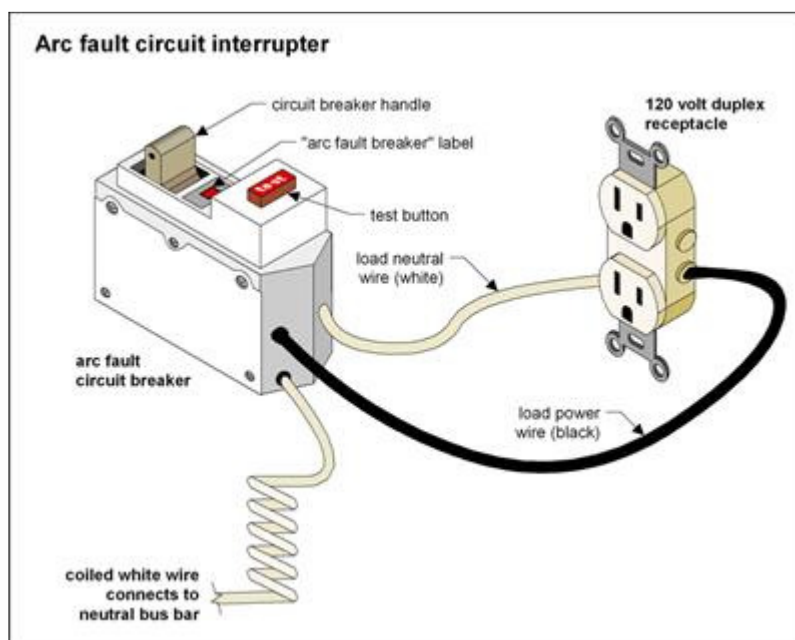
Observed that this home has Arc Fault Circuit Interrupters (AFCI's) -- a new safety device designed to prevent fire hazards. In contrast, GFCIs are designed to prevent electric shock hazards.

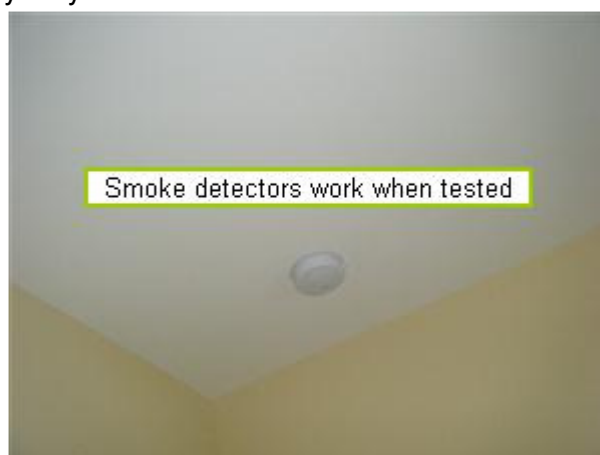
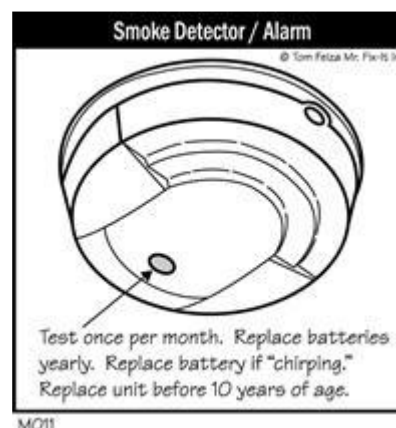
Observed that this home has smoke detectors which activated when tested. Recommend replacing the batteries in your smoke detectors every six months. Also, suggest testing the detectors every 30 days by pushing the test button. Smoke detectors should be replaced every 10 years.

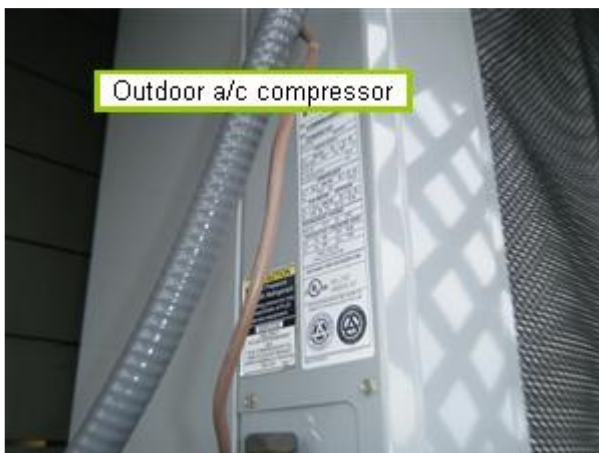
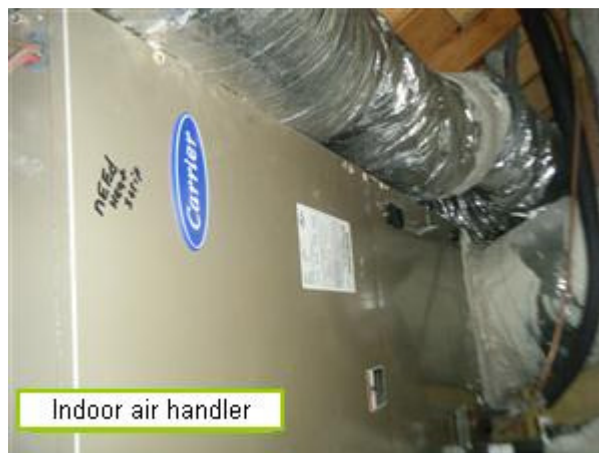
(1) Observed that this home has a heat pump system consisting of an outdoor a/c compressor and an indoor air handler which work together to heat and cool the home. Both pieces of equipment are 3 years old. For your reference, outdoor a/c compressors generally last up to 15 years and air handlers up to 20 years and both often longer with good maintenance.

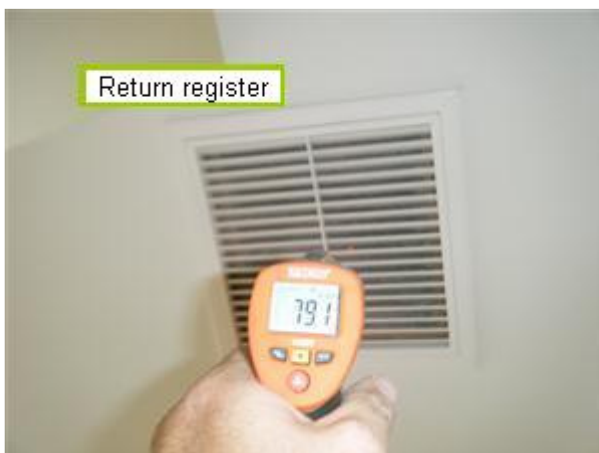
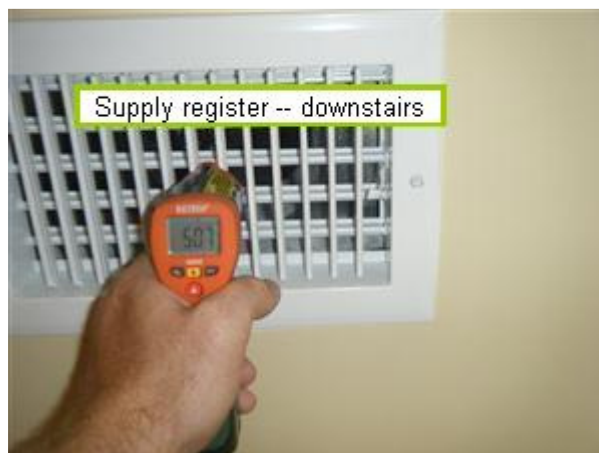
(1) When tested, it appears that the air conditioning for the home is working well. For your reference, there should be at least a 14 degree difference between the air at the return air register and where the cooled air enters the home from the supply air register to indicate normal functioning. In this case, there was a 29 degree difference.

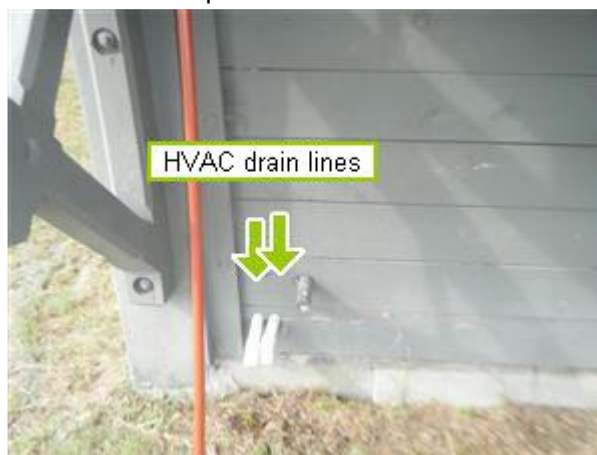
During the hot summer months in Charleston, the air conditioner can produce up to a gallon of water an hour in condensation. This unwanted water is drained through the primary condensation drain line which extends to the exterior of the home (usually near the outdoor a/c compressor). If this line becomes clogged, or the air filter is dirty and needs to be changed (this causes excess condensation), the condensation from the air handler will drip into the pan under unit and will drain through the secondary drain line. Therefore, if there is water coming from the secondary drain line, change the air filter. If this doesn't stop the drip from the secondary drain line, then take a look at your air handler to see what's going on and/or have an HVAC repairman investigate. Changing your air filter every 30 days will help reduce the amount of condensation produced.

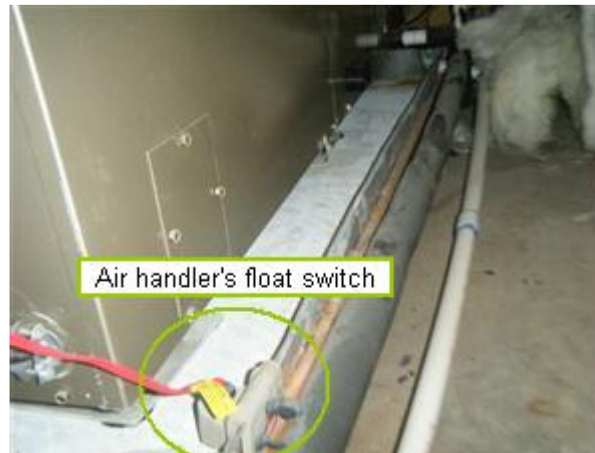
Please note the air handler has a 'float switch' which will turn off the outdoor compressor when the condensation pan (for the air handler) fills up to prevent the water from spilling over onto the floor below.

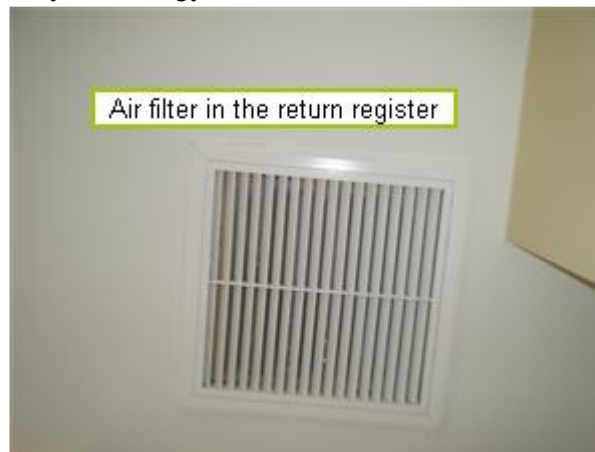
Observed that the size of the air filters are 14 x 14 and 14 x 30. Recommend using an inexpensive air filter and changing it frequently - ideally once a month. An easy way to remember to change the air filter is to change it when you pay the power bill each month. For your reference, the purpose of the air filter is to keep your furnace/air handler clean. A dirty, clogged filter blocks air flow and reduces the system's efficiency. If dirty air filters aren't changed regularly, the system can produce excess condensation which you may then see as a moisture stain on your ceiling. Please note the higher end filters make it more difficult for your furnace/air handler to draw and push air throughout your home, putting strain on your furnace/air handler and your energy bills.
