INVESTIGATION REPORT

FIM nr.: 1903957

REFINERY SHUTDOWN AFTER POWER FAILURE IN 25 KV STATION 4

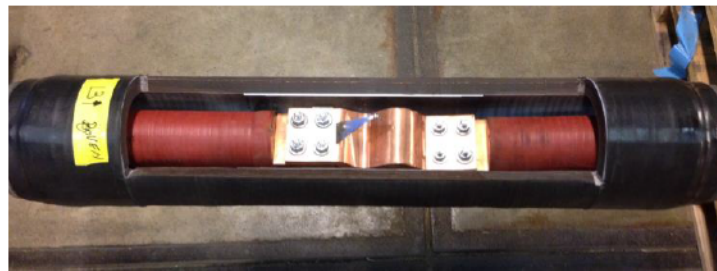
Fig.13: 90-degree cut out of connection tube with flexible connection

- 5) **Dissection of the non-failed bus ducts.** From one of the undamaged connection tubes a 90-degree cut out in lengthwise direction was made to understand the (electrical) stress control in these connection tubes (see Figure 13). Furthermore, a part of the bus bar, its flexible connection as well as a connection tube have been cut in half in lengthwise direction to understand the (electrical) stress control between the connection tube and the (electrical) stress control at the end of the bus bar (see Figure 14).

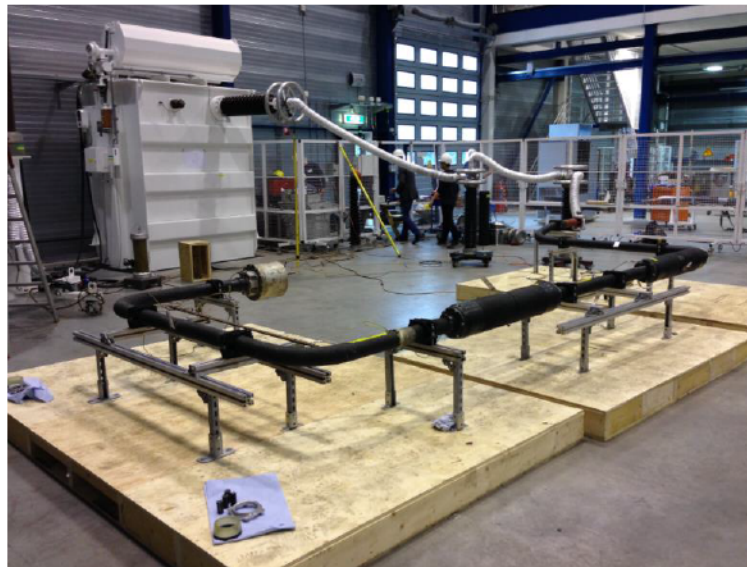
Fig.15: Test setup of at the High Voltage Laboratory of DNV GL at Arnhem.

For the PD measurement, a horizontal test setup of the bus duct was made (see Figure 15) because from an electrical point of view it does not result in any difference in comparison to a vertical setup and from a safety point of view this is much better (no working at heights).

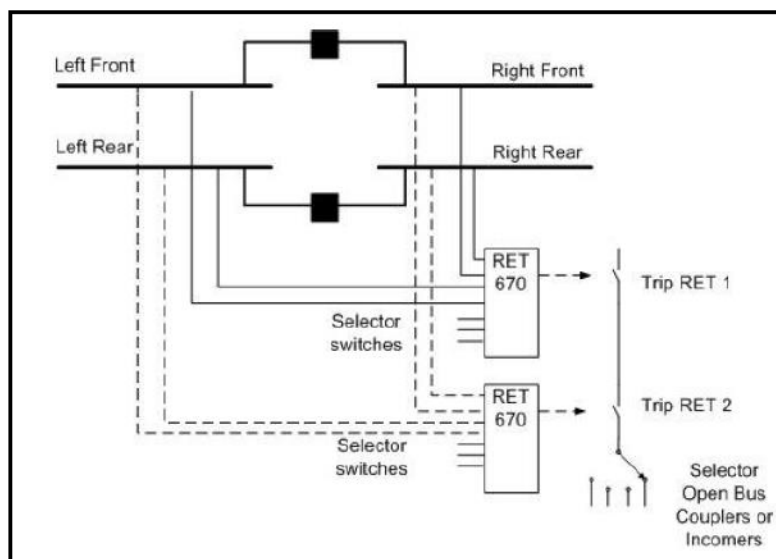
Fig.16: Frequency load shedding

Conclusion is that the frequency load shedding system did not work correctly and that [REDACTED] should not have been shed. The malfunctioning of the frequency load shedding could be caused by incorrect settings or alternatively that the wrong bus bar measurement is used. The relays and hence the settings are regularly tested. During testing immediately after the incident, the relays worked as intended. Therefore, a setting problem is not likely.
