YOUR INSPECTION REPORT

505 Pemberton Place
Picayune, MS 39466

Friday, December 9, 2016

Lochard Home Inspection
118 Dogwood Valley
Picayune, MS 39466

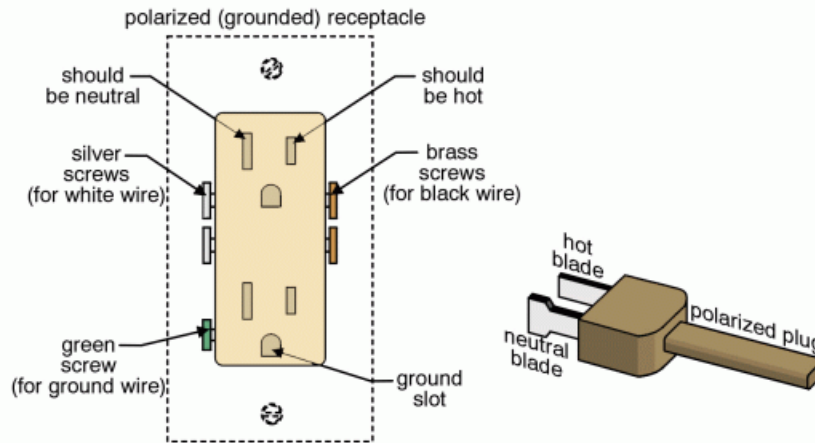
Reversed polarity

Condition: • [Reversed polarity](#)

when the polarity is reversed, the wide receptacle slot is (incorrectly) hot and the narrow slot is neutral - this is not uncommon when people forget that the black wire should be attached to the receptacle's brass screws

Task: Repair
