# Home Inspection Report

Prepared for: Janie Johnson  
Date: 7/6/2010

Property address: 350 Summer Lane  
North Charleston SC 29420

Inspected by: Stephen Houmard  
South Carolina License #2046  
Solid Ground Home Inspections, LLC  
Professional Member:  
-American Society of Home Inspectors  
(ASHI)

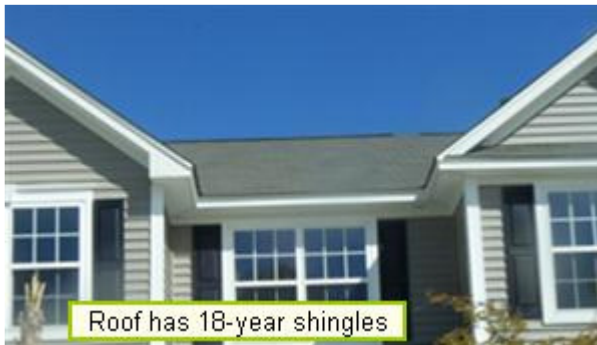
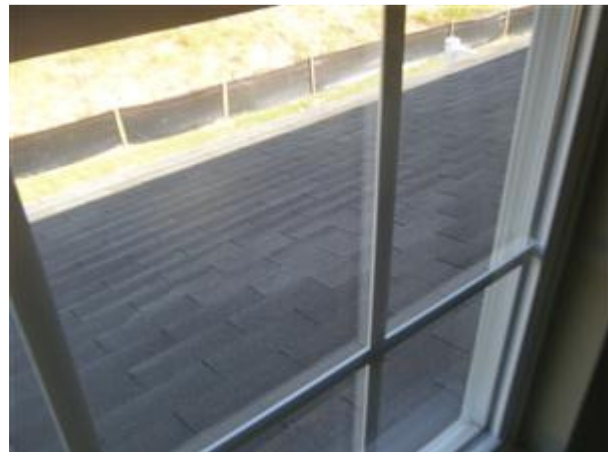
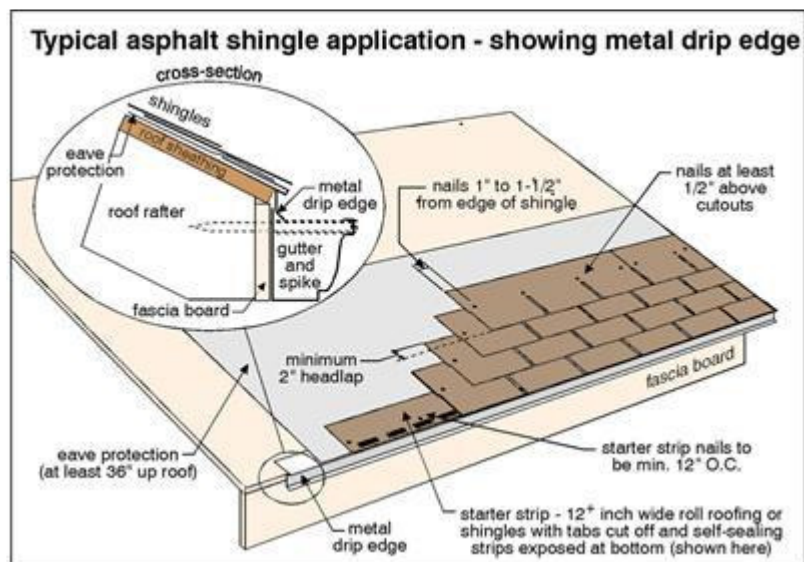
Observed that the roof has 3-tab fiberglass shingles which are estimated to be new. For your reference, the average roof with this type of shingles can last up to 18 years and possibly longer depending on the local climate and roof ventilation.

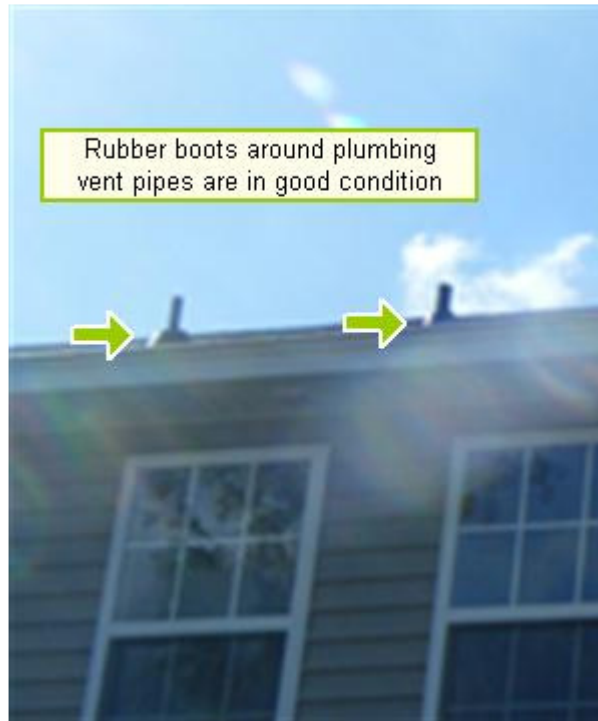
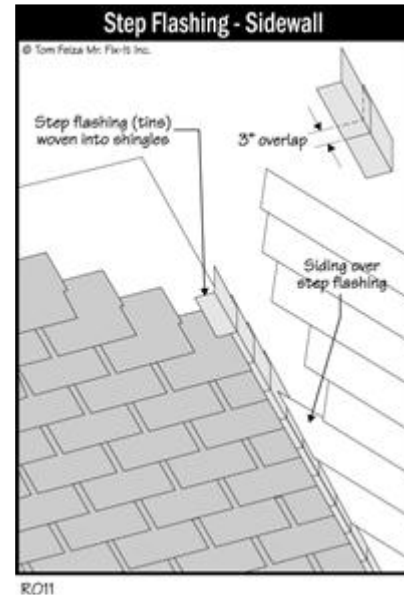
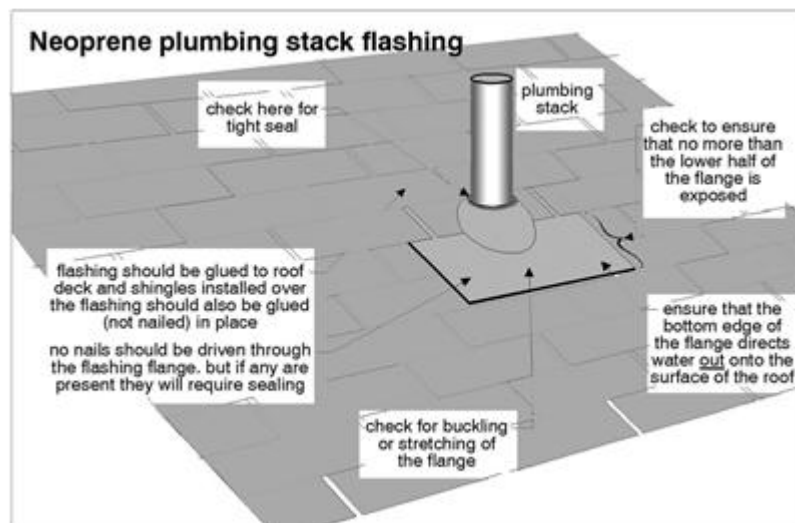
Observed that the flashings are in good condition. For your reference, flashing is a sheet of metal or Neoprene which is installed around pipes and chimneys traveling through the roof to

ensure these areas are water tight. Also, flashing is applied along the sidewalls where different parts of the roof come together as well.

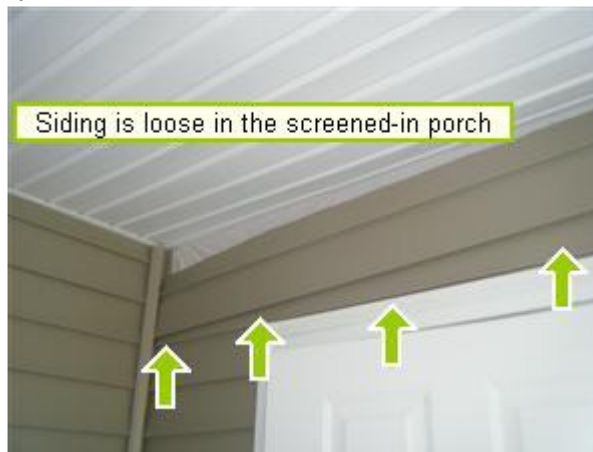
(2) Observed that a section of siding on the screen porch is loose. Recommend notifying the builder so it can be repaired.

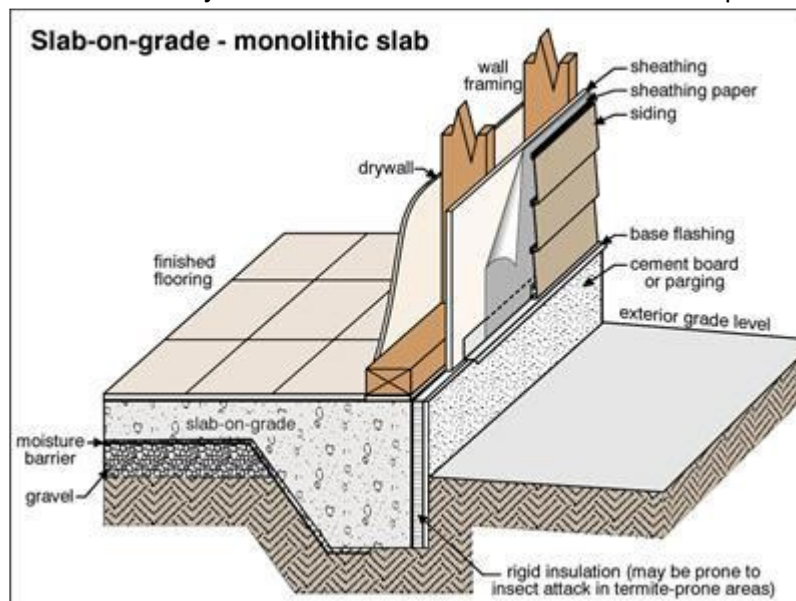
Observed that this home has a cement slab foundation. For your reference, this means that the foundation is built directly on the soil and does not have a crawlspace.

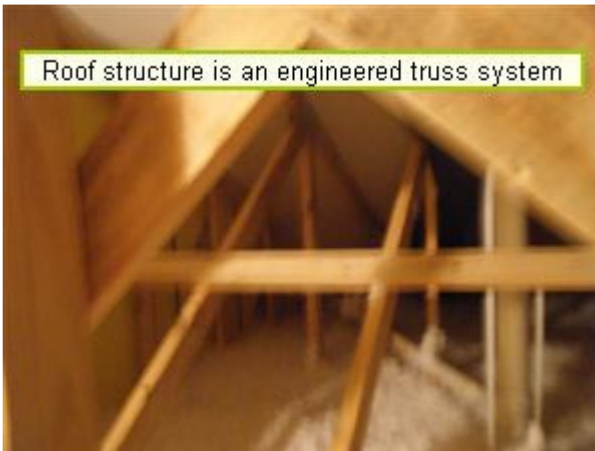
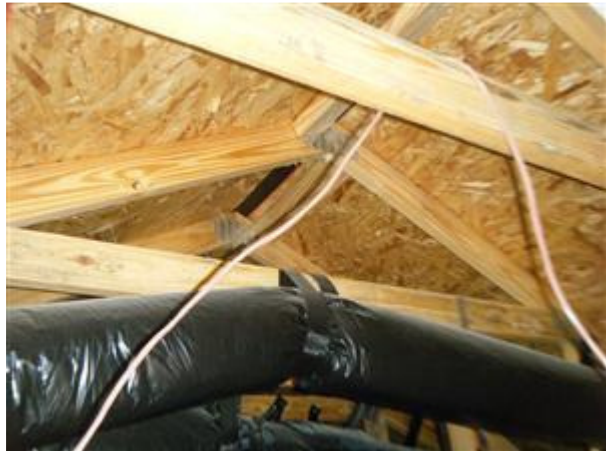
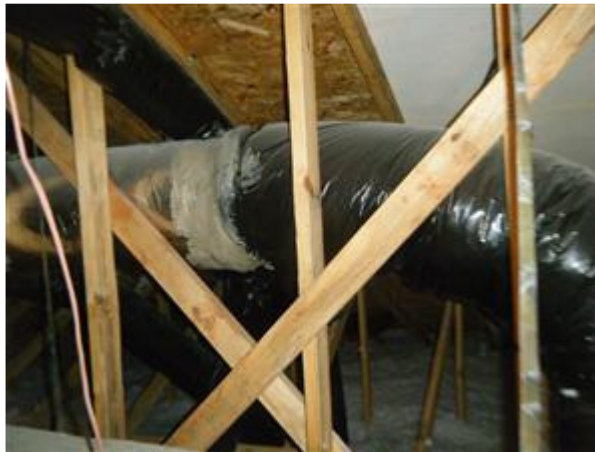
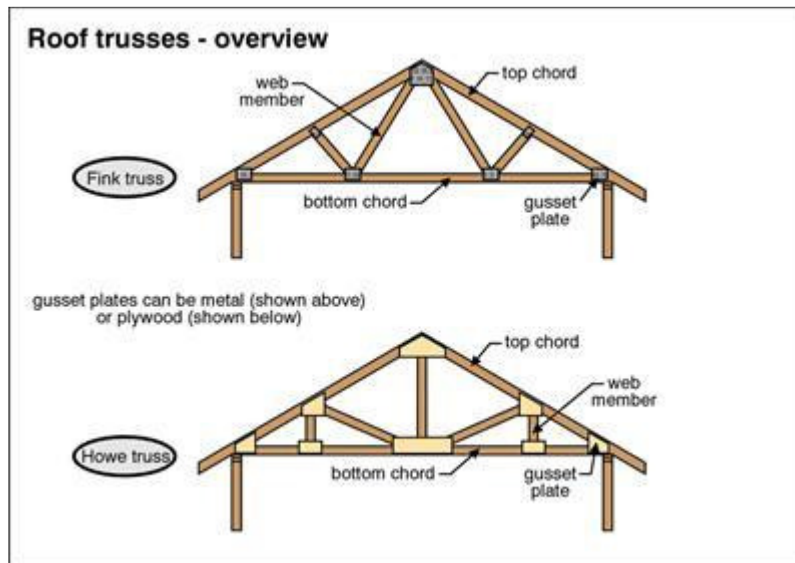
(1) Observed that this roof is well built and has an engineered roof truss system. For your reference, these trusses were designed by an engineer, built in a factory for this home, then shipped to the job site and lifted into place. Also, the trusses use 2x4's instead of 2x6's -- this is just a small difference vs. what you may be used to seeing in the attic.

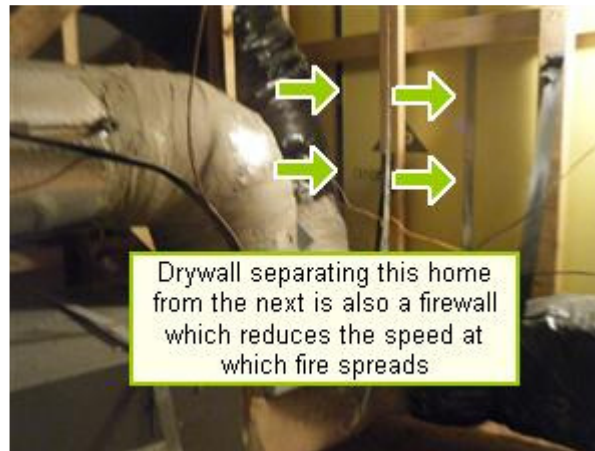
(2) Observed that there is drywall in the attic which separates this home from the next -- a positive. For your reference, drywall will help reduce the speed at which fire spreads from one home to the next.

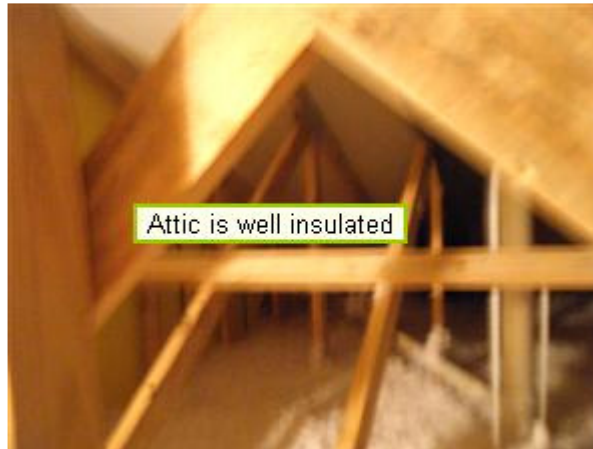
Observed that this home has an amount insulation on the attic floor which equates to R-30 or better. For your reference, the effectiveness of insulation is measured by its R-number which is its ability to resist the flow of heat. The higher the R-number, the greater the resistance to winter heat loss or summer heat gain. Today's standard for insulation in newer homes is R-30 or better.

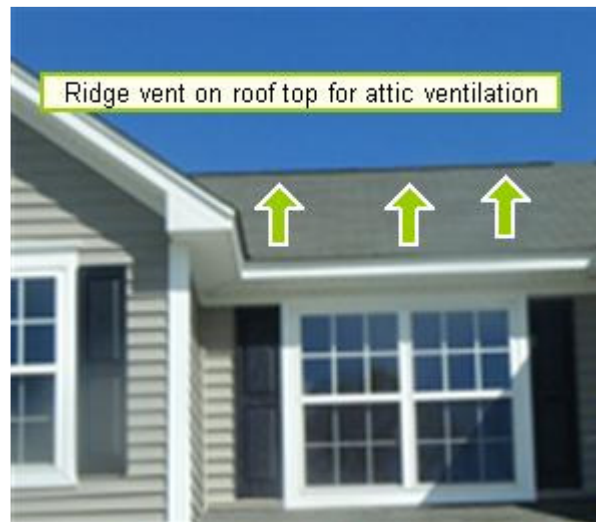
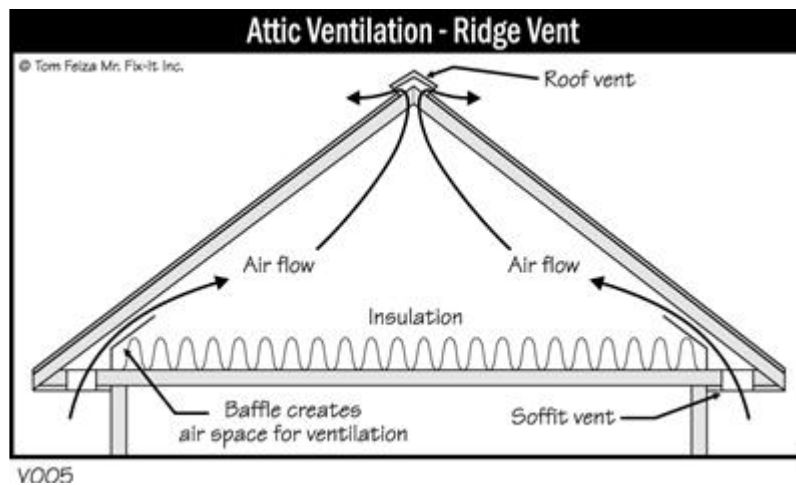
Observed that this home has good ventilation in the attic -- the included illustration describes how the attic is ventilated in your home.

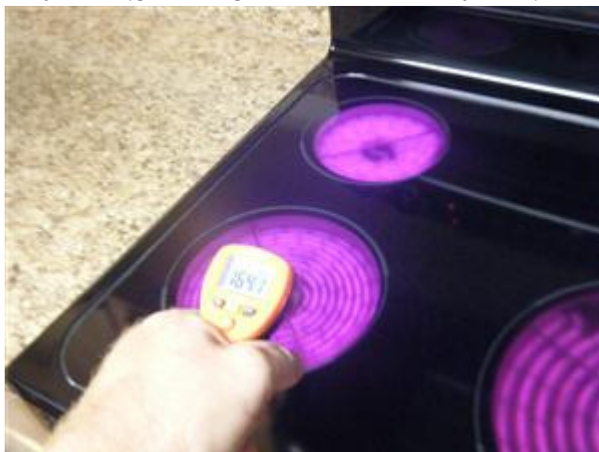
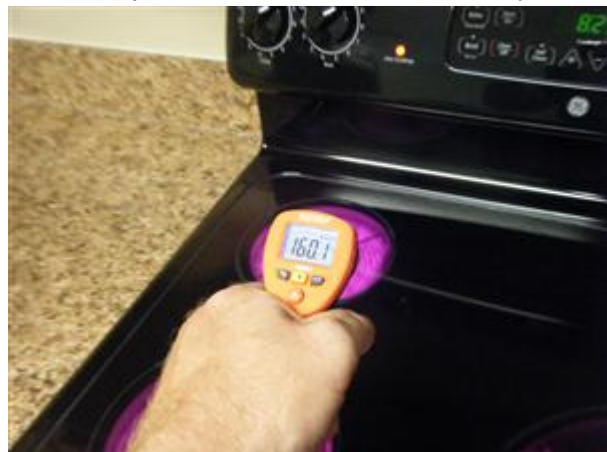
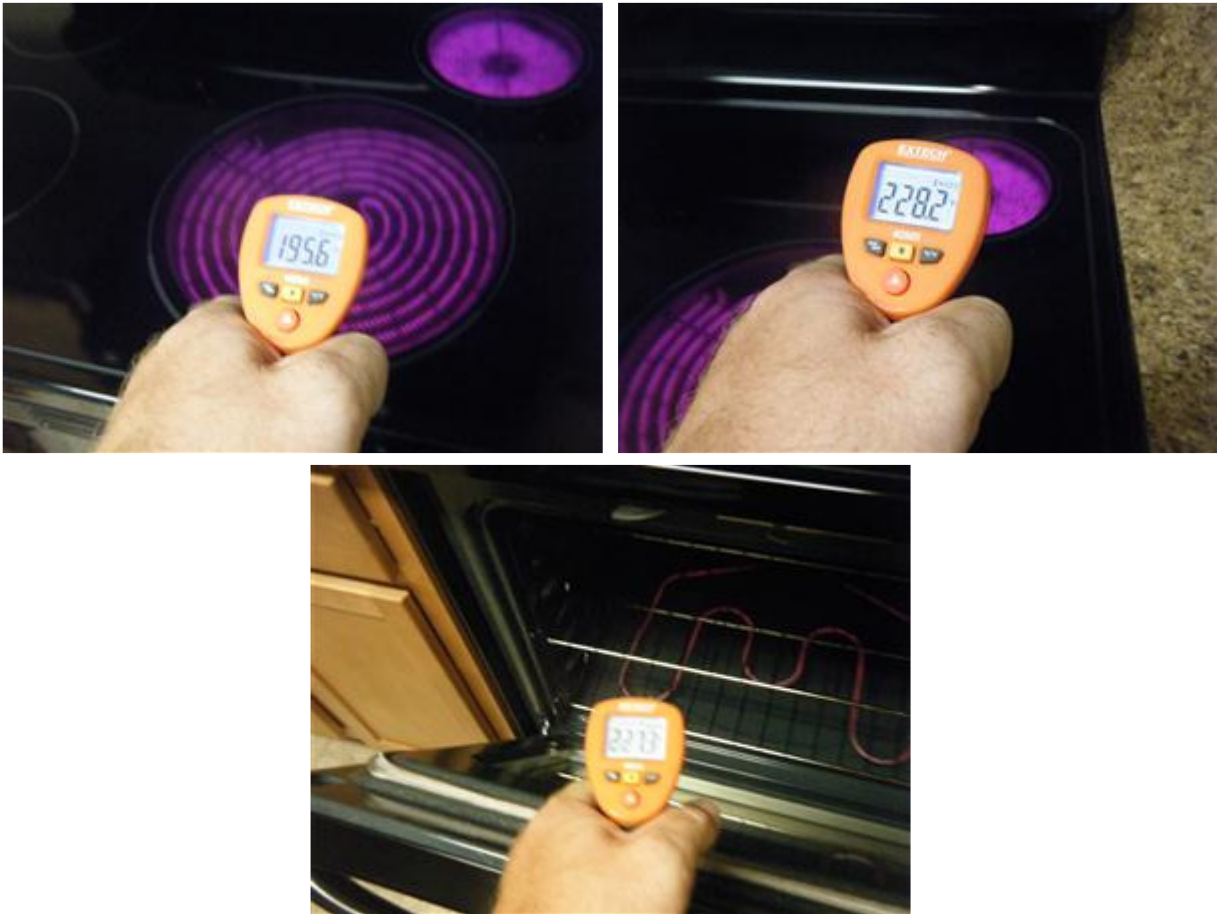
Observed that the oven and cooktop appear to be working well -- they were tested with a infrared red thermometer to ensure they are heating as they should. Please note I did not test for maximum temperature. For your reference, the average electric range will last about 17 years (gas ranges last about 19 years) and the cooktop will last between 13 and 20 years.

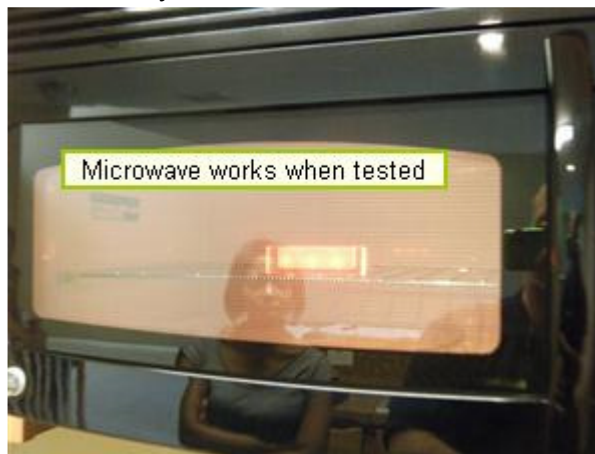
Observed that the microwave appears to be working well -- it was tested with a microwave tester to ensure it is operating properly and that there are no door leaks. For your reference, the average microwave lasts 10 years.

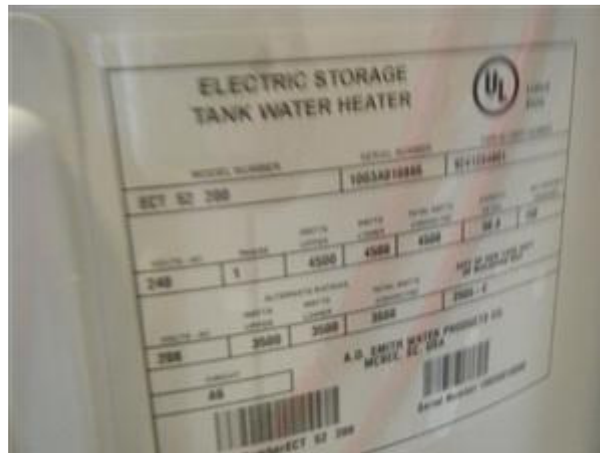
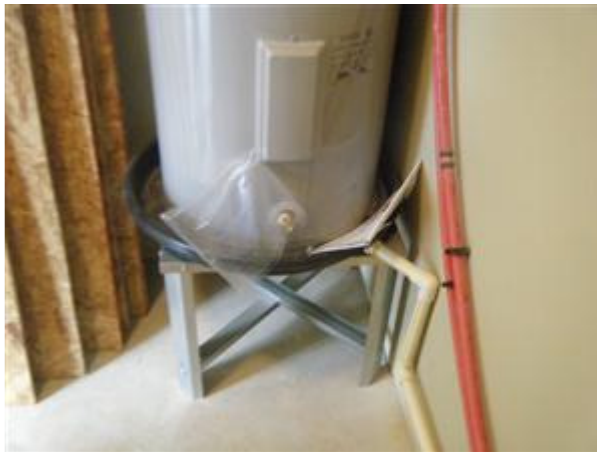
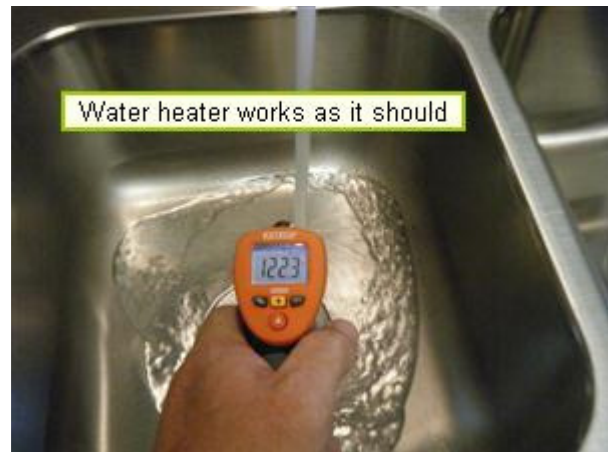
Water heater works as it should

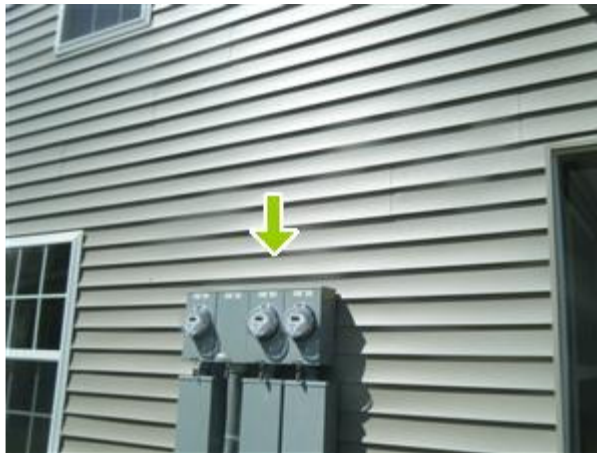
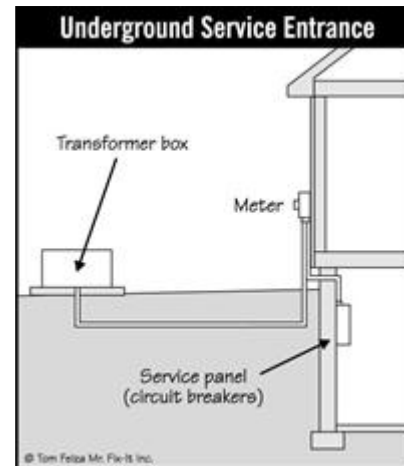
Observed that the underground service entrance conductor (where the power enters the home from the street), electrical meter and grounding rod are located on the side of the home and are in good working condition

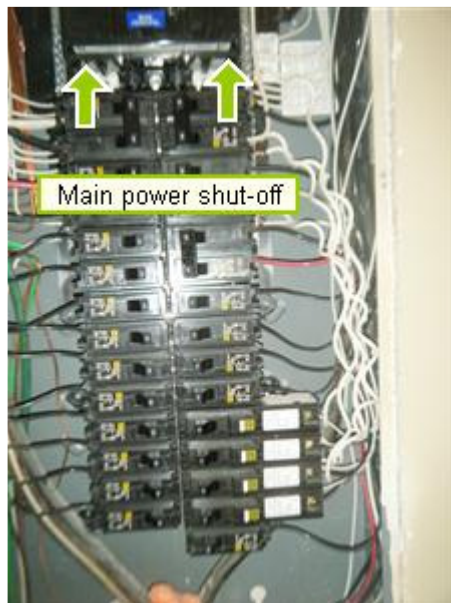
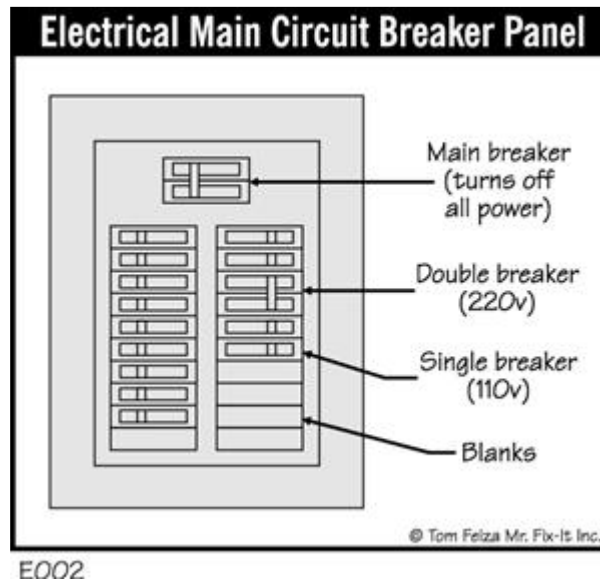
(1) Observed the main electrical disconnect (also called a main breaker) is on located on the main electrical panel. It is helpful to know where the main breaker is in case you need to turn off the power for the whole home.

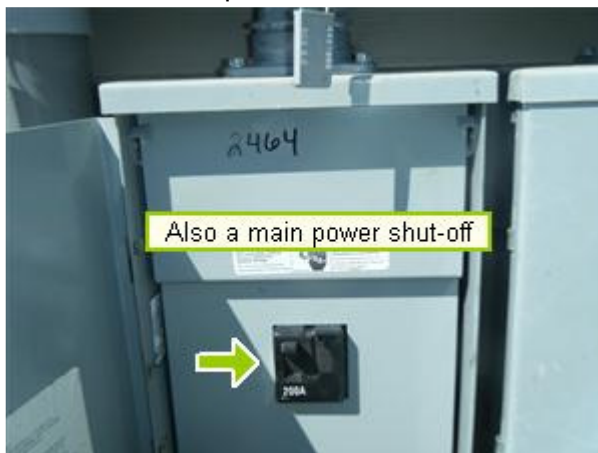
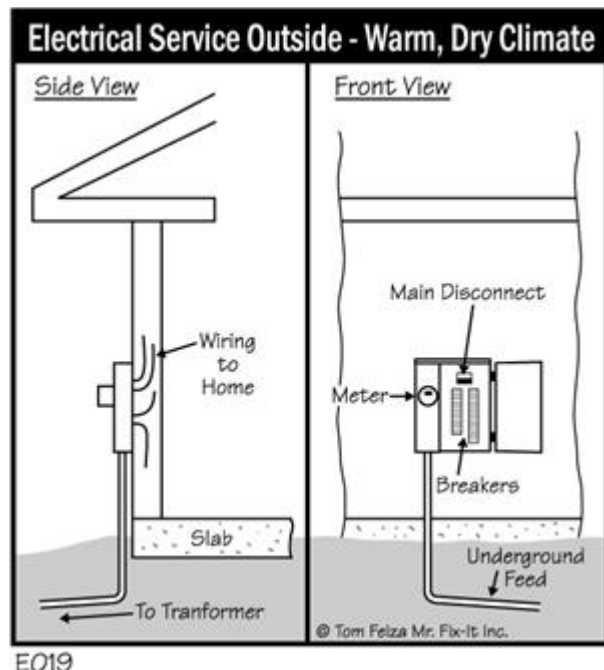
(2) Observed the main electrical disconnect (also called a main breaker) is on located next to the electrical meter outside. It is helpful to know where the main breaker is in case you need to turn off the power for the whole home.

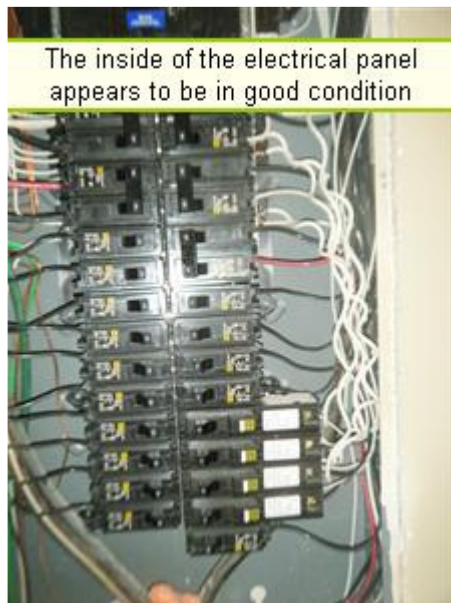
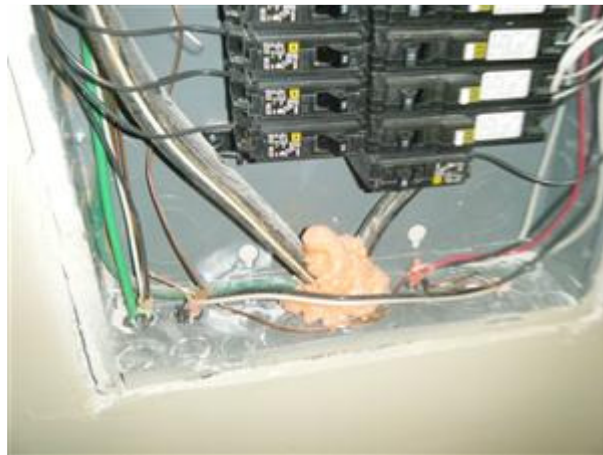
Observed that the inside of the electrical panel is in good condition.

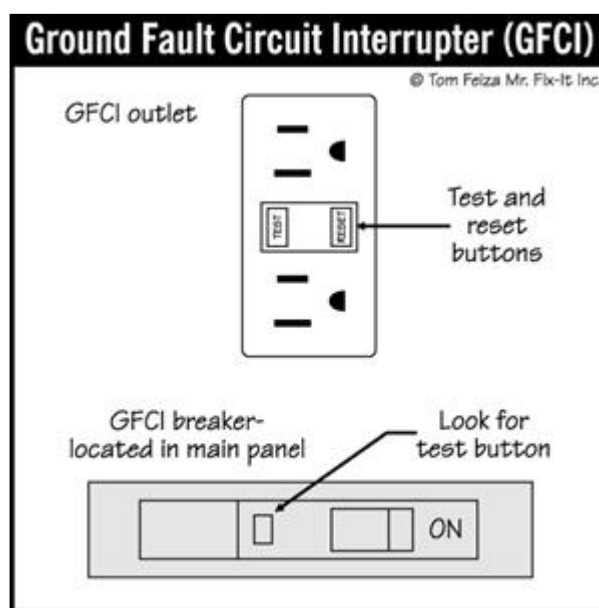
Observed that this home has GFCI (Ground Fault Circuit Interrupters) outlets in the proper locations -- within 6 feet of water for safety -- and are in good working condition when tested. For your reference, GFCI's are electrical outlets which have a modern 'circuit breaker' safety feature built-in.

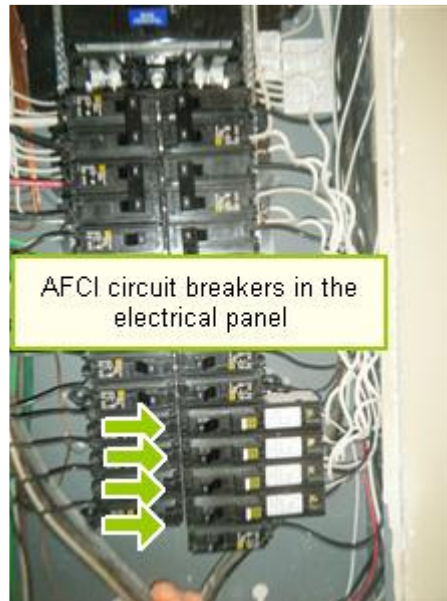
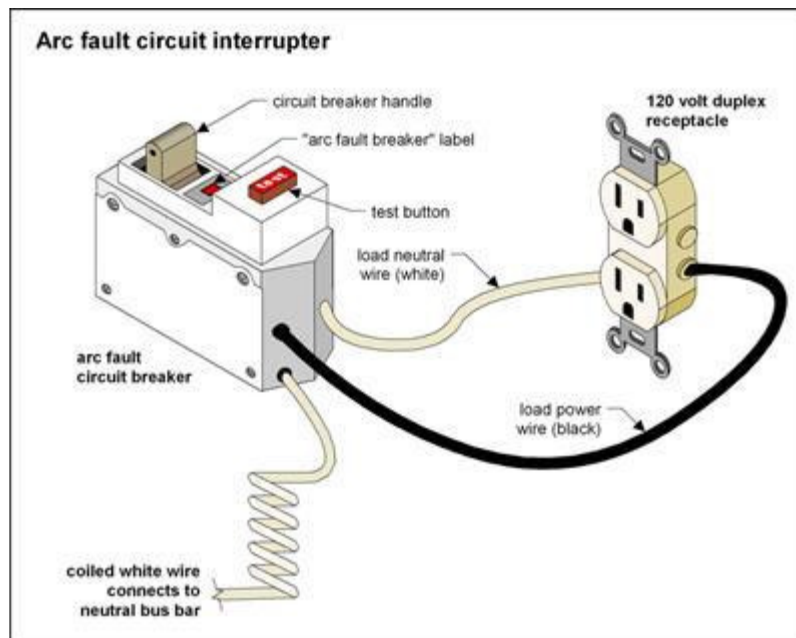
Observed that this home has Arc Fault Circuit Interrupters (AFCI's) -- a new safety device designed to prevent fire hazards. In contrast, GFCIs are designed to prevent electric shock hazards.

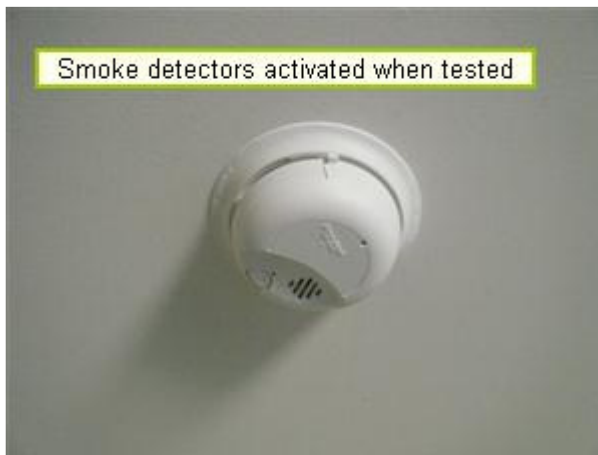
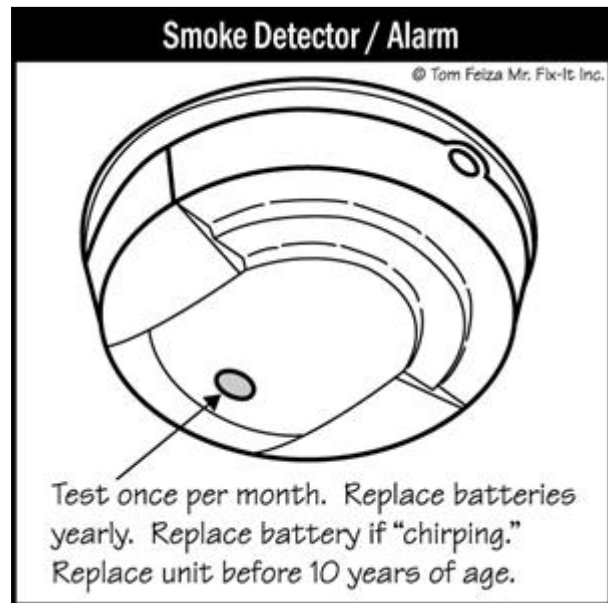
Observed that this home has smoke detectors which activated when tested. Recommend replacing the batteries in your smoke detectors every six months. Also, suggest testing the detectors every 30 days by pushing the test button. Smoke detectors should be replaced every 10 years.

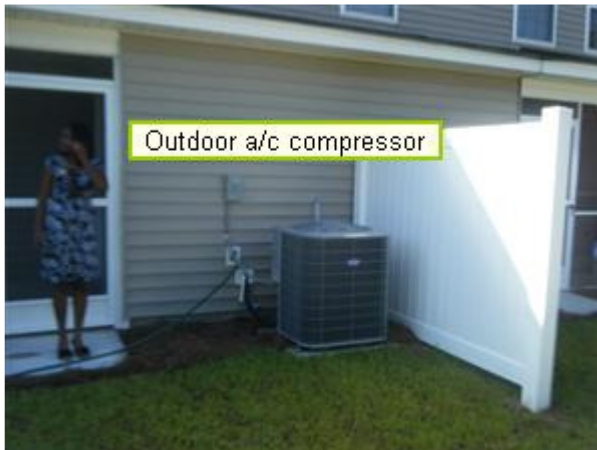
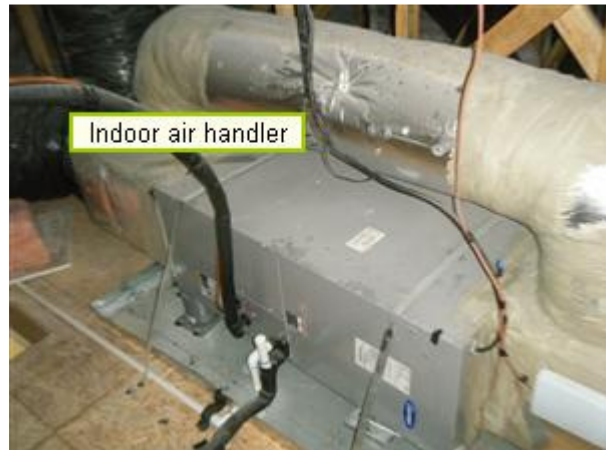
(1) Observed that this home has a heat pump system consisting of an outdoor compressor and an indoor air handler which work together to heat and cool the home. Both pieces of equipment are new. For your reference, outdoor a/c compressors generally last up to 15 years and air handlers up to 20 years and both often longer with good maintenance.

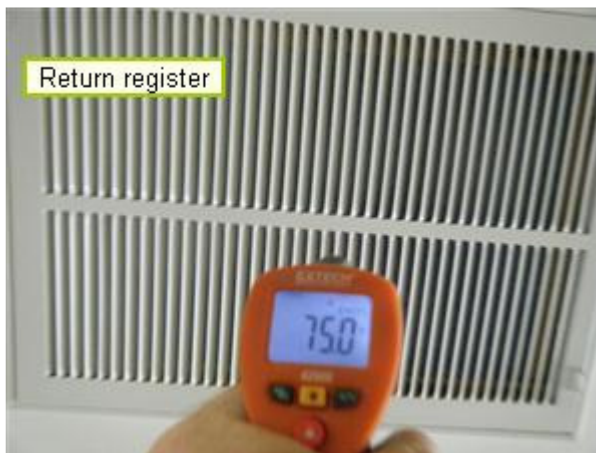
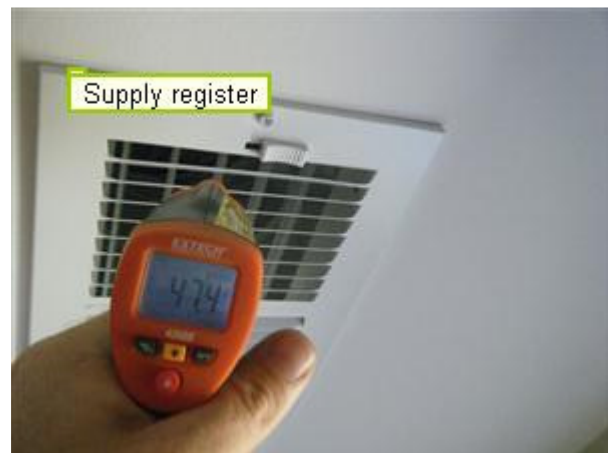
(1) When tested, it appears that the air conditioning is working well. For your reference, there should be at least a 14 degree difference between the air at the return air register and where the cooled air enters the home from the supply air register to indicate normal functioning. In this case, there was a 28 degree difference.

Please note the heat was not tested since the outside temperature was above 65 degrees to prevent possible damage to the compressor. It is likely that the heat is also working well.

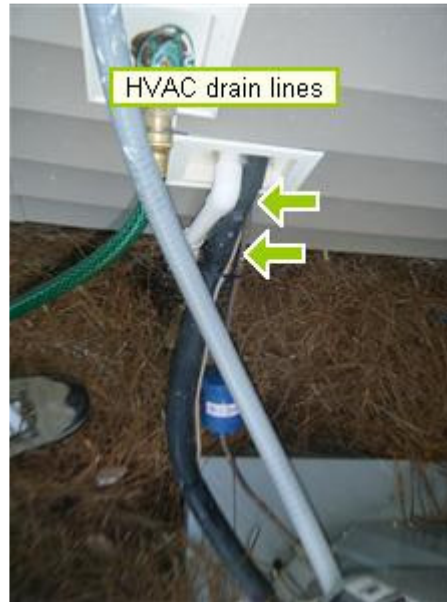
During the hot summer months in Charleston, the air conditioner can produce up to a gallon of water an hour in condensation. This unwanted water is drained through the primary condensation drain line which extends to the exterior of the home (usually near the outdoor a/c compressor). If this line becomes clogged, or the air filter is dirty and needs to be

changed (this causes excess condensation), the condensation from the air handler will drip into the pan under unit and will drain through the secondary drain line. Therefore, if there is water coming from the secondary drain line, change the air filter. If this doesn't stop the drip from the secondary drain line, then take a look at your air handler to see what's going on and/or have an HVAC repairman investigate. Changing your air filter every 30 days will help reduce the amount of condensation produced.

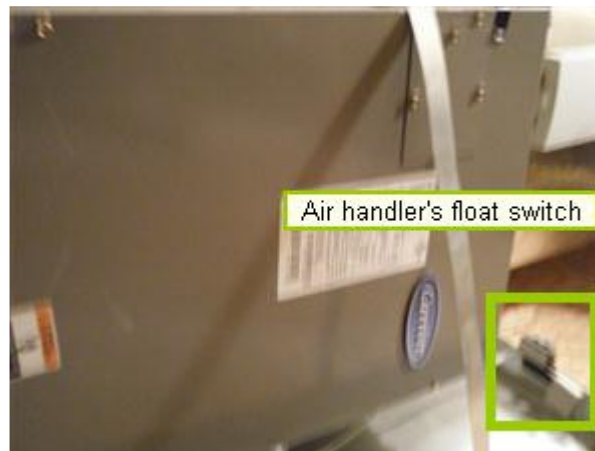
Please note the air handler has a 'float switch' which will turn off the outdoor compressor when the condensation pan (for the air handler) fills up to prevent the water from spilling over onto the floor below.

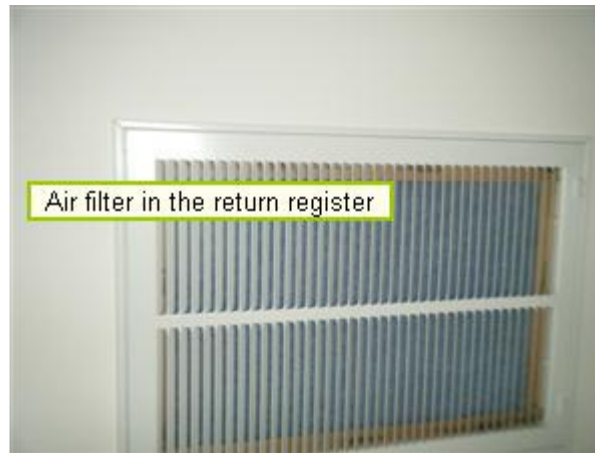
Observed that the size of the air filters are 16 x 20. Recommend using an inexpensive air filter and changing it frequently - ideally once a month. An easy way to remember to change the air filter is to change it when you pay the power bill each month. For your reference, the purpose of the air filter is to keep your furnace/air handler clean. A dirty, clogged filter blocks air flow and reduces the system's efficiency. If dirty air filters aren't changed regularly, the
