Property Address: 1804 South Broad Street
Hamilton NJ 08610
Municipality: Hamilton
County: Mercer
Purpose: Evaluation of Collapse

Structural Evaluation
For
Cause Of Collapse
Of Single-Family House
July 23, 2018

1804 South Broad Street
Hamilton NJ

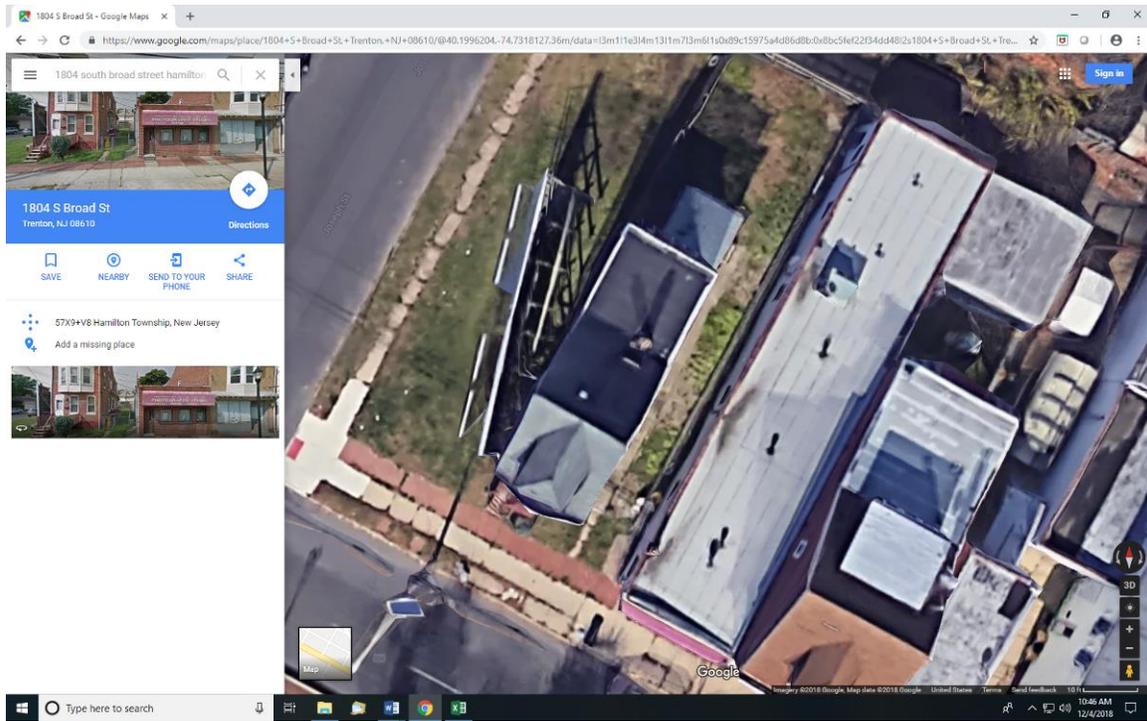
Photo 1 – Google Maps

Aerial view looking down at roof for house (1804 South Broad Street) on corner property.

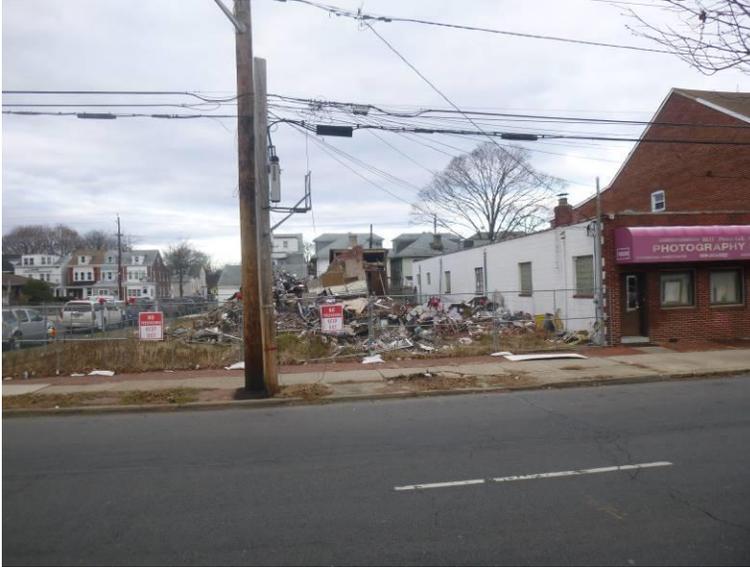
Photo 201

Much rubble from collapse of house remains on site, essentially as it was after rescue operations (Photo 201). However, large segments of former roof and floors have been removed.

Looking towards site of collapsed house from far side of South Broad Street.
