Contaneous Breakage Performance

Spontaneous Breakage of Toughened Glass

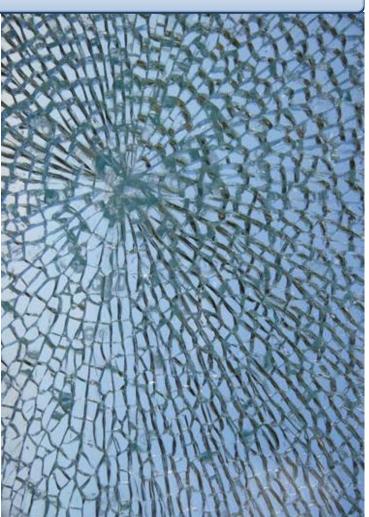
Spontaneous breakage of toughened (tempered) glass is immediately noticeable because an initial crack exceeding a critical size (depending on its location within the thickness of the glass). It causes complete fracture of the plate, typically into very small particles approximately cube shaped. Clumps of these small particles tend to stay together, much like a jig-saw puzzle, after breakage unless additional forces are applied. In annealed glass an initial crack may not have a sufficiently large applied load or stress to propagate it completely, and so even a relatively large crack may go unnoticed for some time. Some of the possible causes of initial cracking in toughened glass can include: hard body impacts; glass-to-glass contact, especially where edges can bump during installation; weld splatter; deep scratches, just into the tensile stress zone, which slowly grow (static fatigue) under the lockedin tempering stress; building movement - concrete floor creep etc, which takes up the edge clearance in a frame and causes localized bearing pressure and crushing, especially if the glass and frame sizes were not correct; differential expansion/contraction stresses from stiff adhesives (epoxies) used to glue items to toughened glass; and Nickel Sulphide (NiS) inclusions in the central half of the glass thickness.

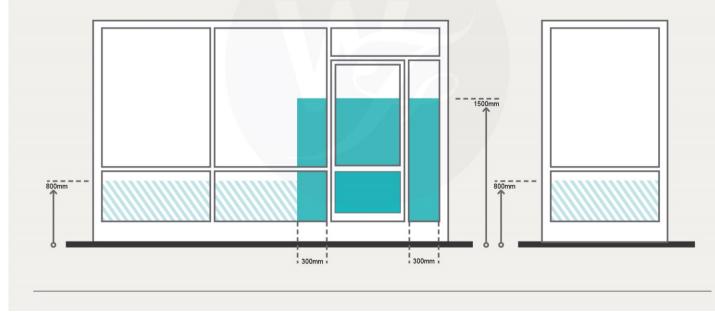
Critical locations

Between floor level and 1500mm above that level in doors and in side panels within 300mm of door. Between floor level and 800mm in the case of walls, partitions and windows. Any part of a glass pane affected must meet the requirements in its entirety and not just in the relevant section

Certain areas of internal and external walls are considered 'critical locations' in terms of glazing safety, and require the installation of glass that meets various minimum safety standards. These critical glazing locations are:
