EXECUTIVE SUMMARY EXTERIOR WALL CLADDING PERFORMANCE STUDY

Results of key building performance goals for energy efficiency, temperature control and moisture control in mixed, coastal, hot, humid, Zone 3 climates

EIFS INDUSTRY MEMBERS ASSOCIATION Conducted during period of January 2005 through June 2007 by researchers at Oak Ridge National Laboratory, US Department of Energy, through the Office of Energy Efficiency and Renewable Energy's Building Technologies Program and the EIFS Industry Members Association. August 15, 2008

EIFS Performs: Excellent Choice in Mixed, Coastal, Hot, Humid Climate for Energy Efficiency, Temperature and Moisture Control

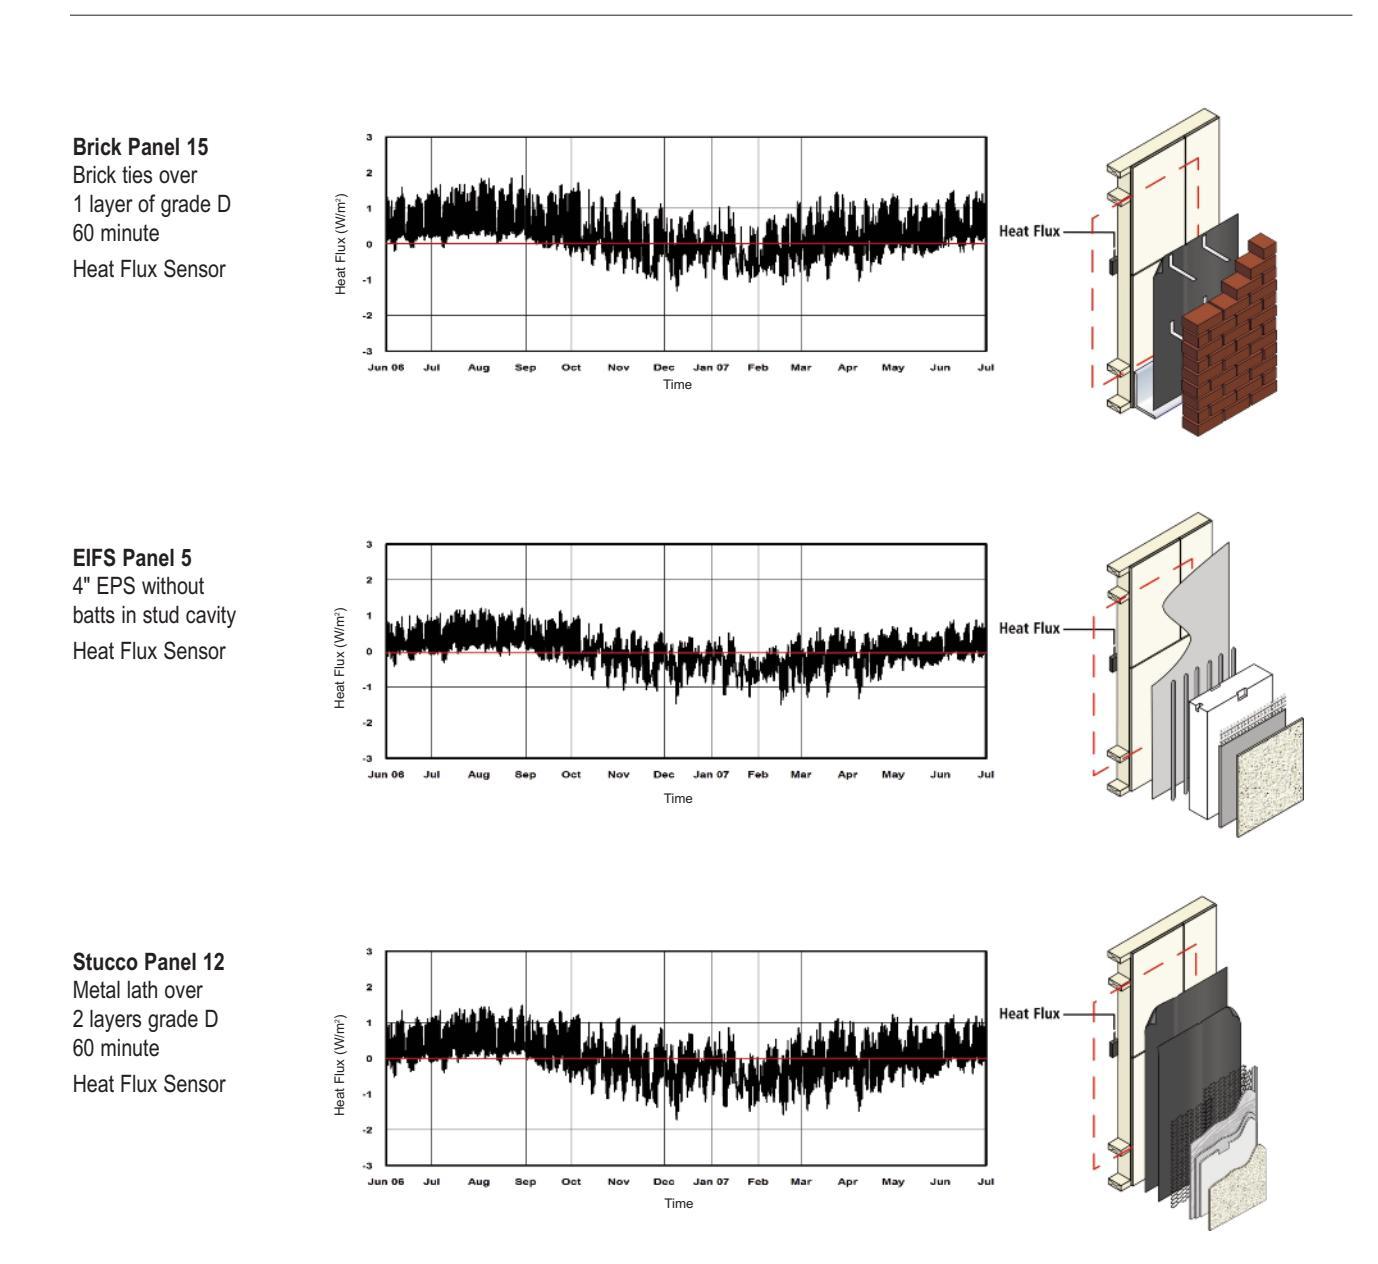
FIG 1 Comparison of Heat Flux Sensor on inside face of interior gypsum wall board in Brick, EIFS and Stucco assemblies

- In Phase II, one of the best performing wall system configurations was comprised of EIFS that included a liquid applied water-resistive barrier coating and four (4) inches of expanded polystyrene insulation board. In addition, all of the thermal insulation was placed outbound of the sheathing (no stud cavity insulation). This EIFS wall configuration performed better than brick. Brick had the lowest thermal and moisture performance among the claddings and wall configurations studied, followed by stucco (both 3-coat and 1-coat) (Fig. 1).

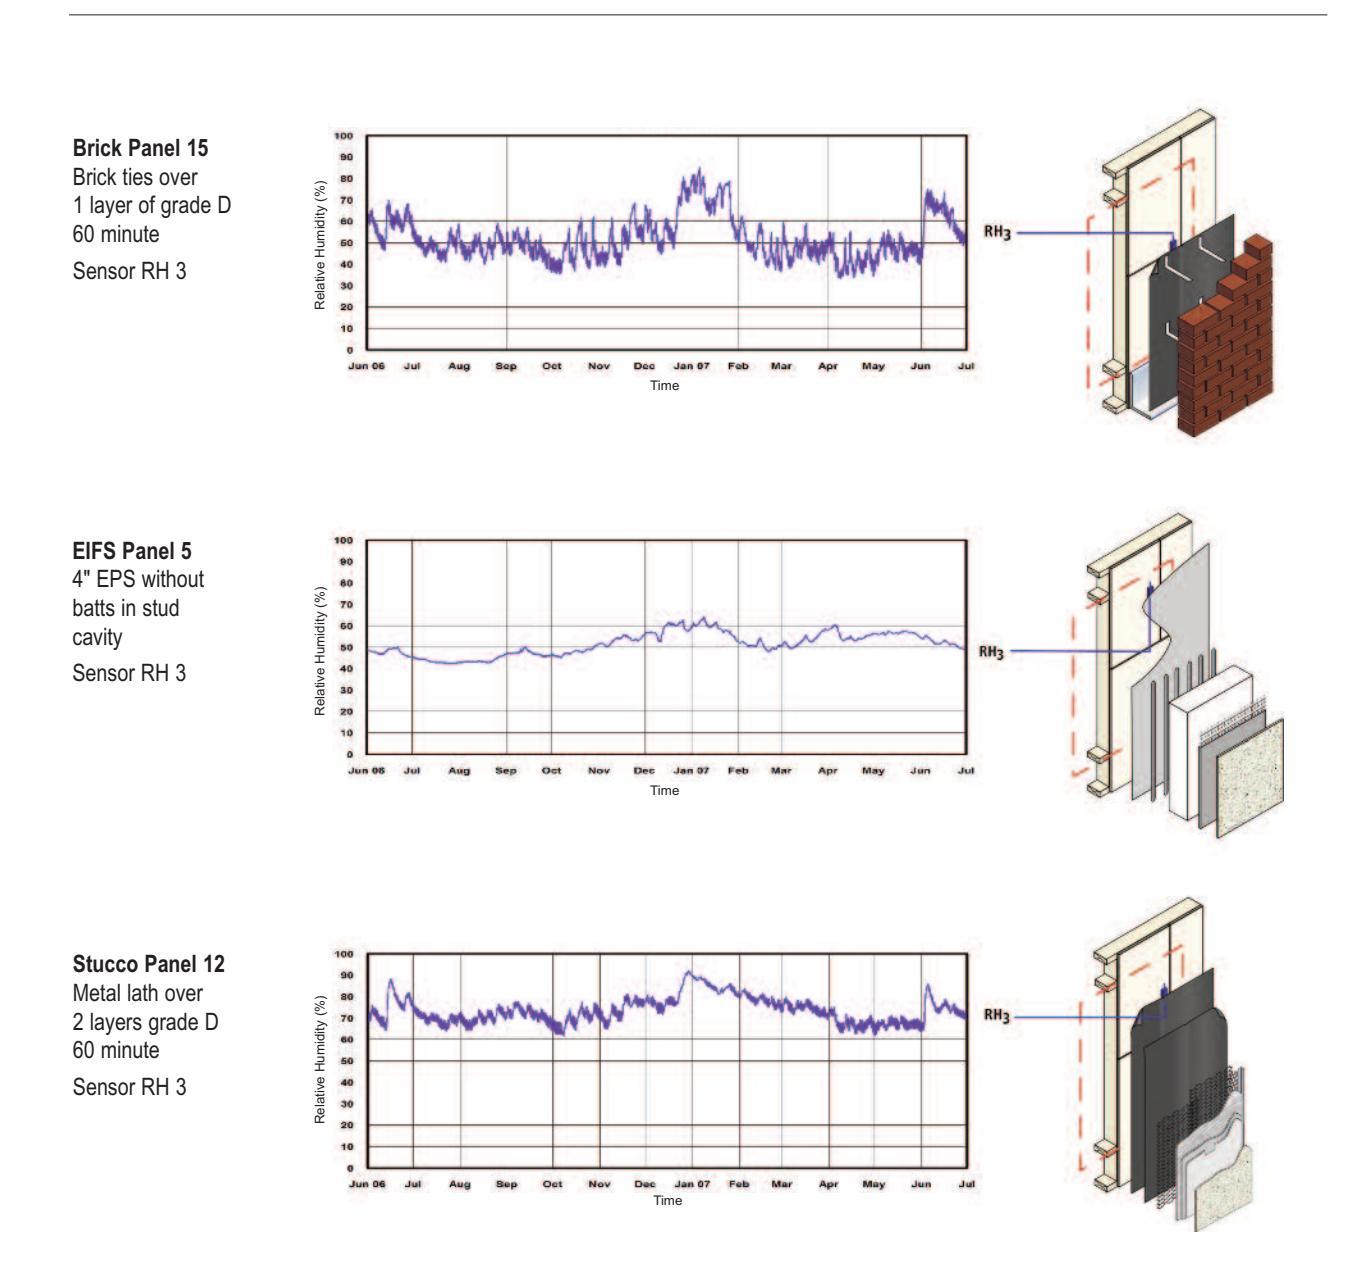
FIG 2 Comparison of Relative Humidity Sensor 3 (RH3) behind Water Resistive Barrier in Brick, EIFS and Stucco Assemblies

- EIFS walls maintained a consistent, acceptable level of moisture (average monthly relative humidity below 80 percent, as defined by ASHRAE SPC 160P, *Design Criteria for Moisture Control in Buildings*), within the cladding despite varying outdoor conditions when appropriate interior vapor retarders were used. Brick and stucco tended to accumulate slightly more moisture during both Phase I and Phase II of the project and retained moisture longer than EIFS (see Fig. 2 which represents the measured relative humidity on the face of the exterior sheathing).

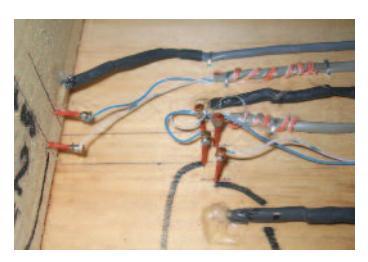
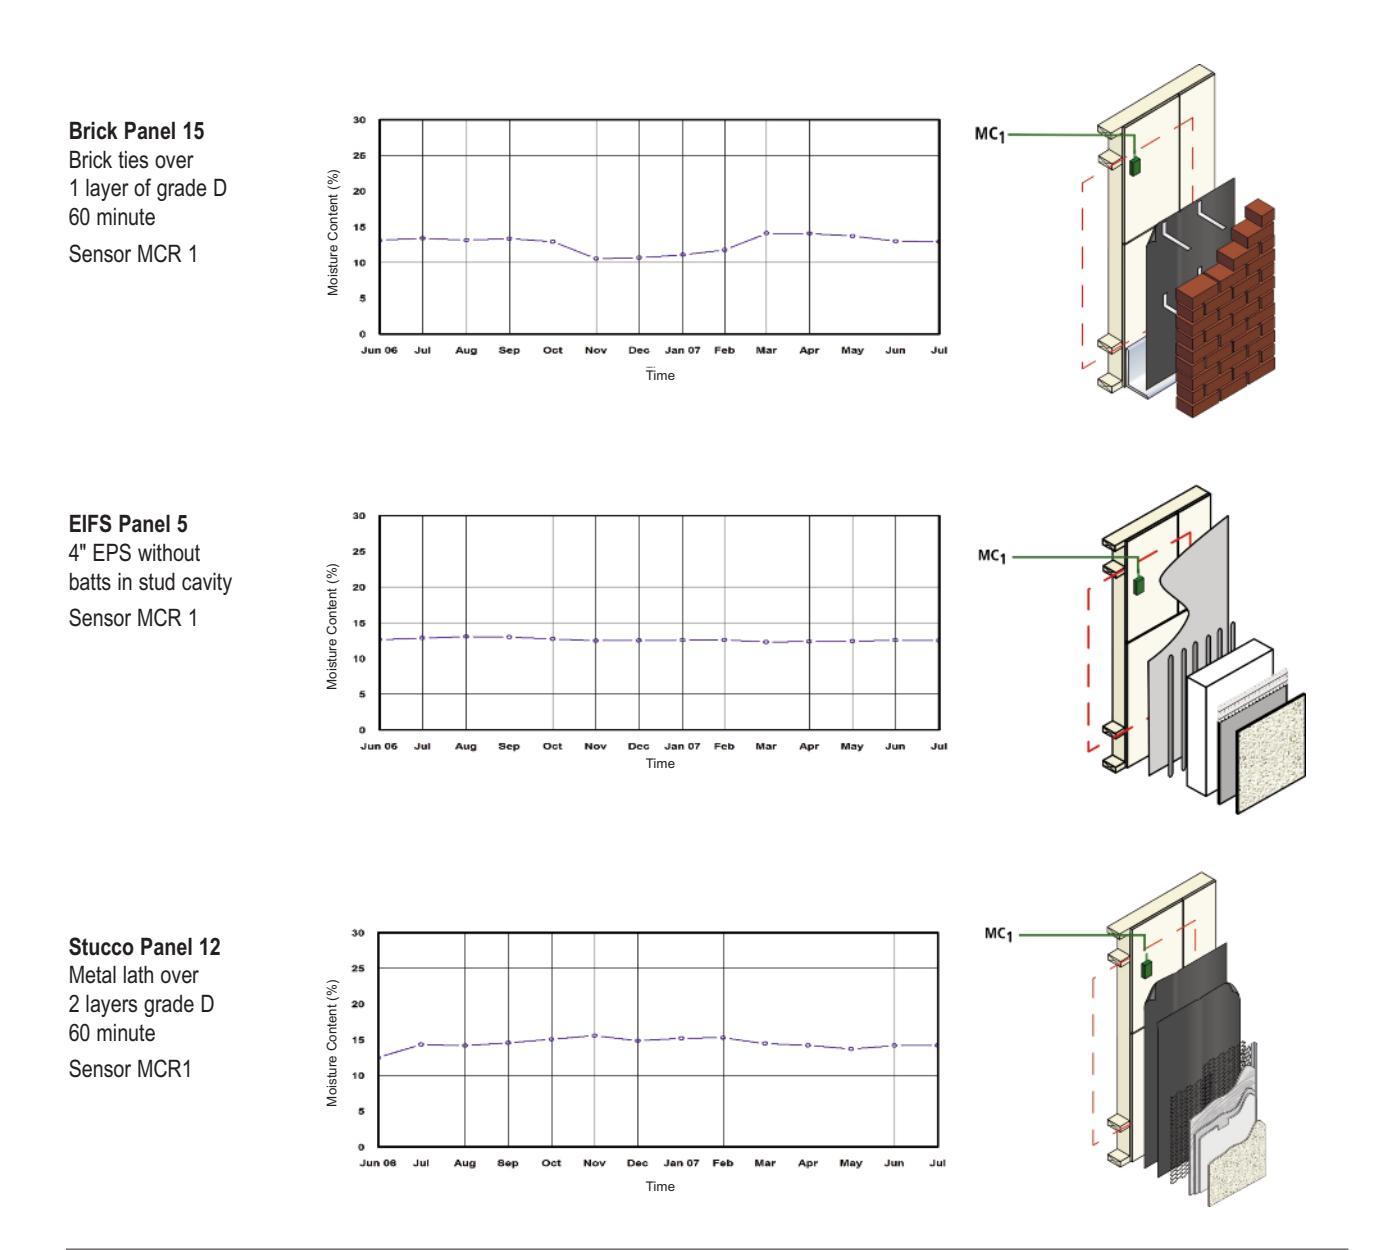
MC Sensor

Comparison of Moisture Content Sensor 1 (MCR1) of wood sheathing behind Water-Resistive Barrier in Brick, EIFS and Stucco Assemblies

- EIFS and a liquid applied water-resistive barrier coating readily dispersed moisture introduced by flaws (installed in Phase II) in the building envelope, as compared with brick, which retained more water (see Fig. 3 which represents the measured moisture content on the face of the exterior sheathing).

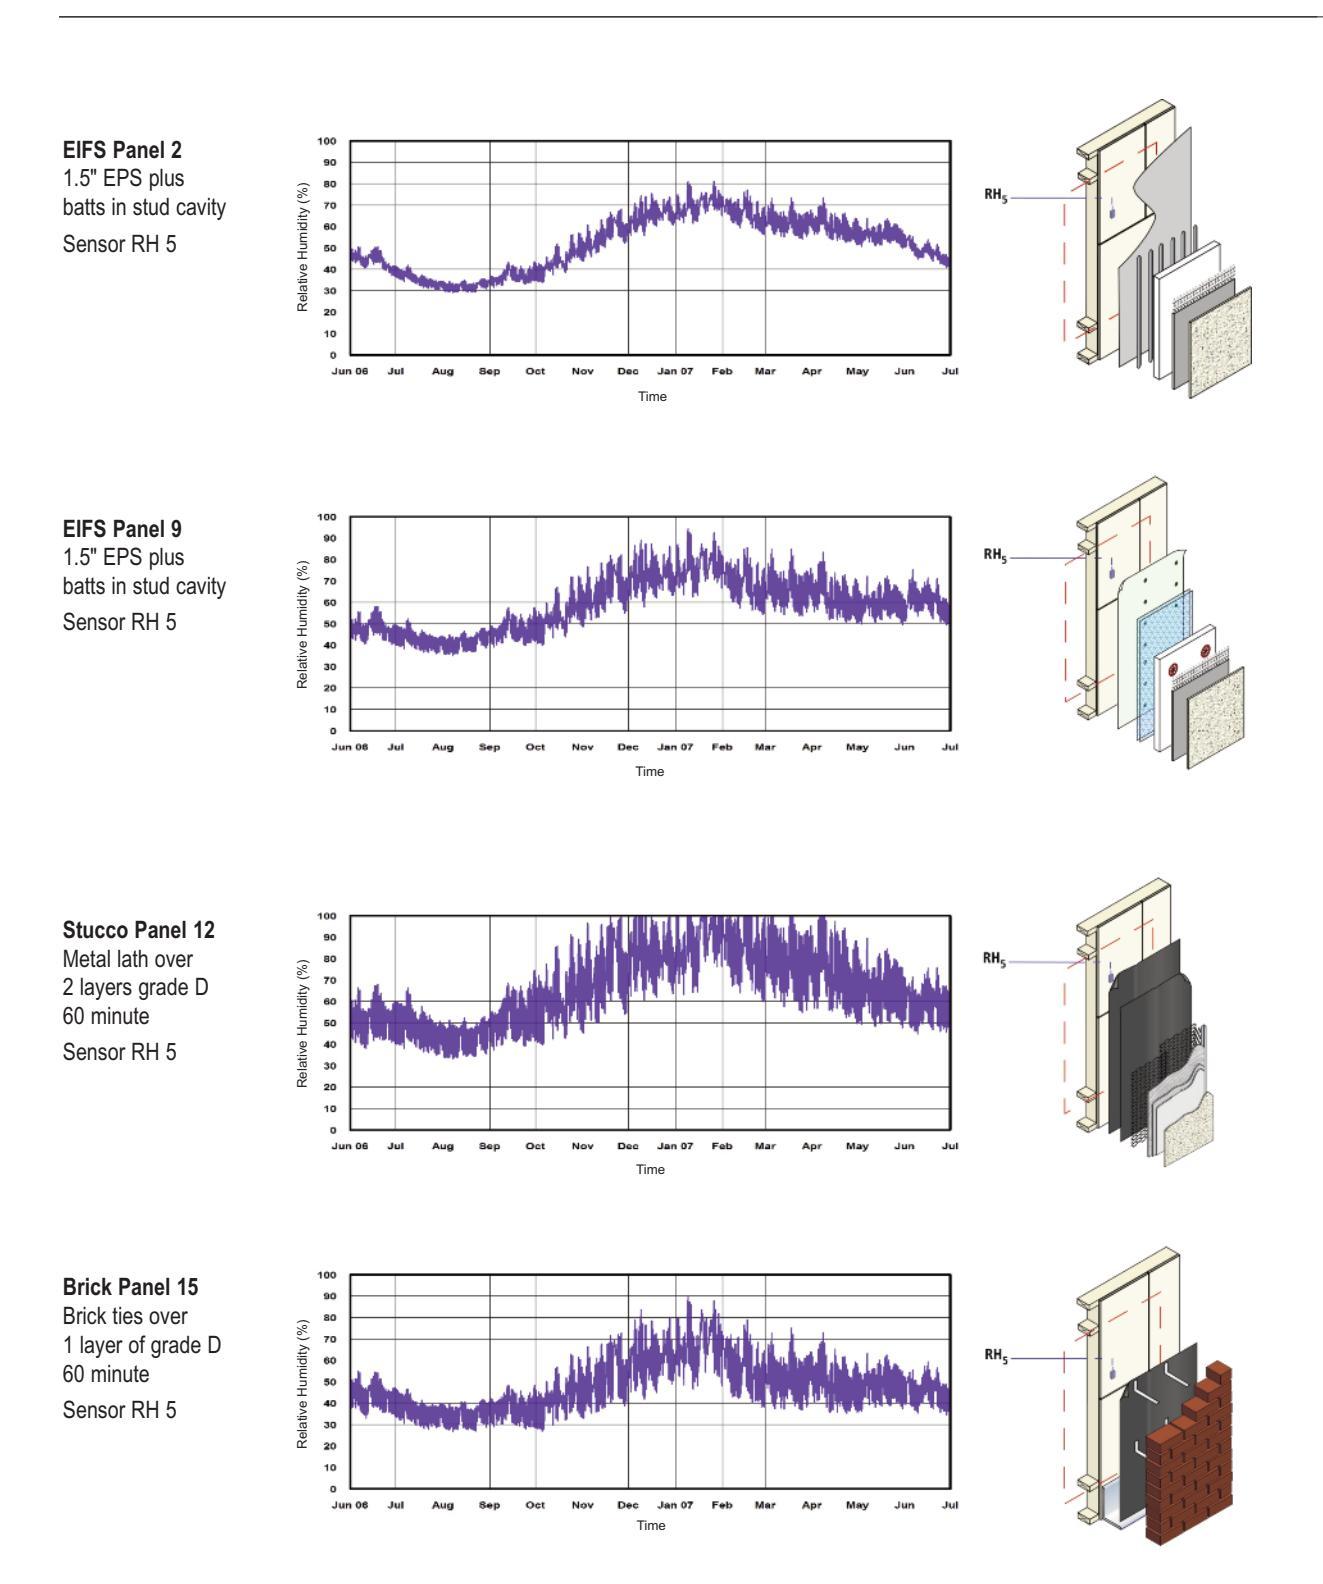
FIG 4 Comparison of Relative Humidity Sensor 5 (RH5) at inside face of sheathing in EIFS, Stucco and Brick Assemblies

- Liquid applied water-resistive barrier coatings, in certain instances as described later on in this report, outperformed other water-resistive barriers in this study. In addition, EIFS with water-resistive barrier coatings performed significantly better than other EIFS claddings that used building paper or spun-bonded polyolefin membranes. The results also indicated that building wraps permit greater vapor transport inward in mixed climates (see Fig. 4 which provides recorded relative humidity on the inside face [stud cavity side] of the exterior sheathing).

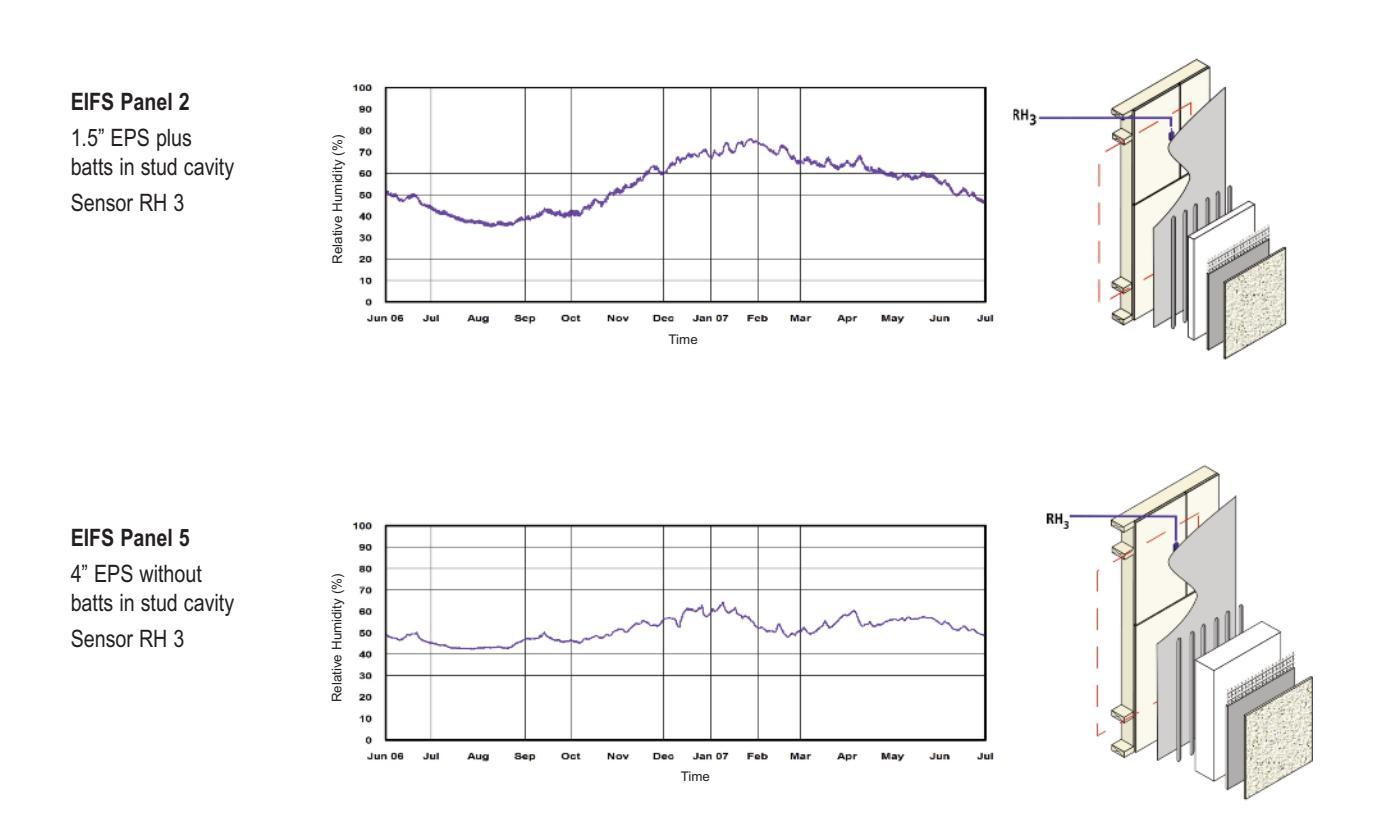
FIG 5 Comparison of Relative Humidity Sensor 3 (RH3) at inside face of sheathing behind Water-Resistive Barrier in 1.5" and 4" EIFS Assemblies

- Insulation located on the exterior (outside of the stud cavity) is more effective since it maintains the sheathing and insulation at drier levels. This has important implications for preventing material degradation (see Fig. 5 which provides the measured relative humidity on the face of the exterior sheathing).

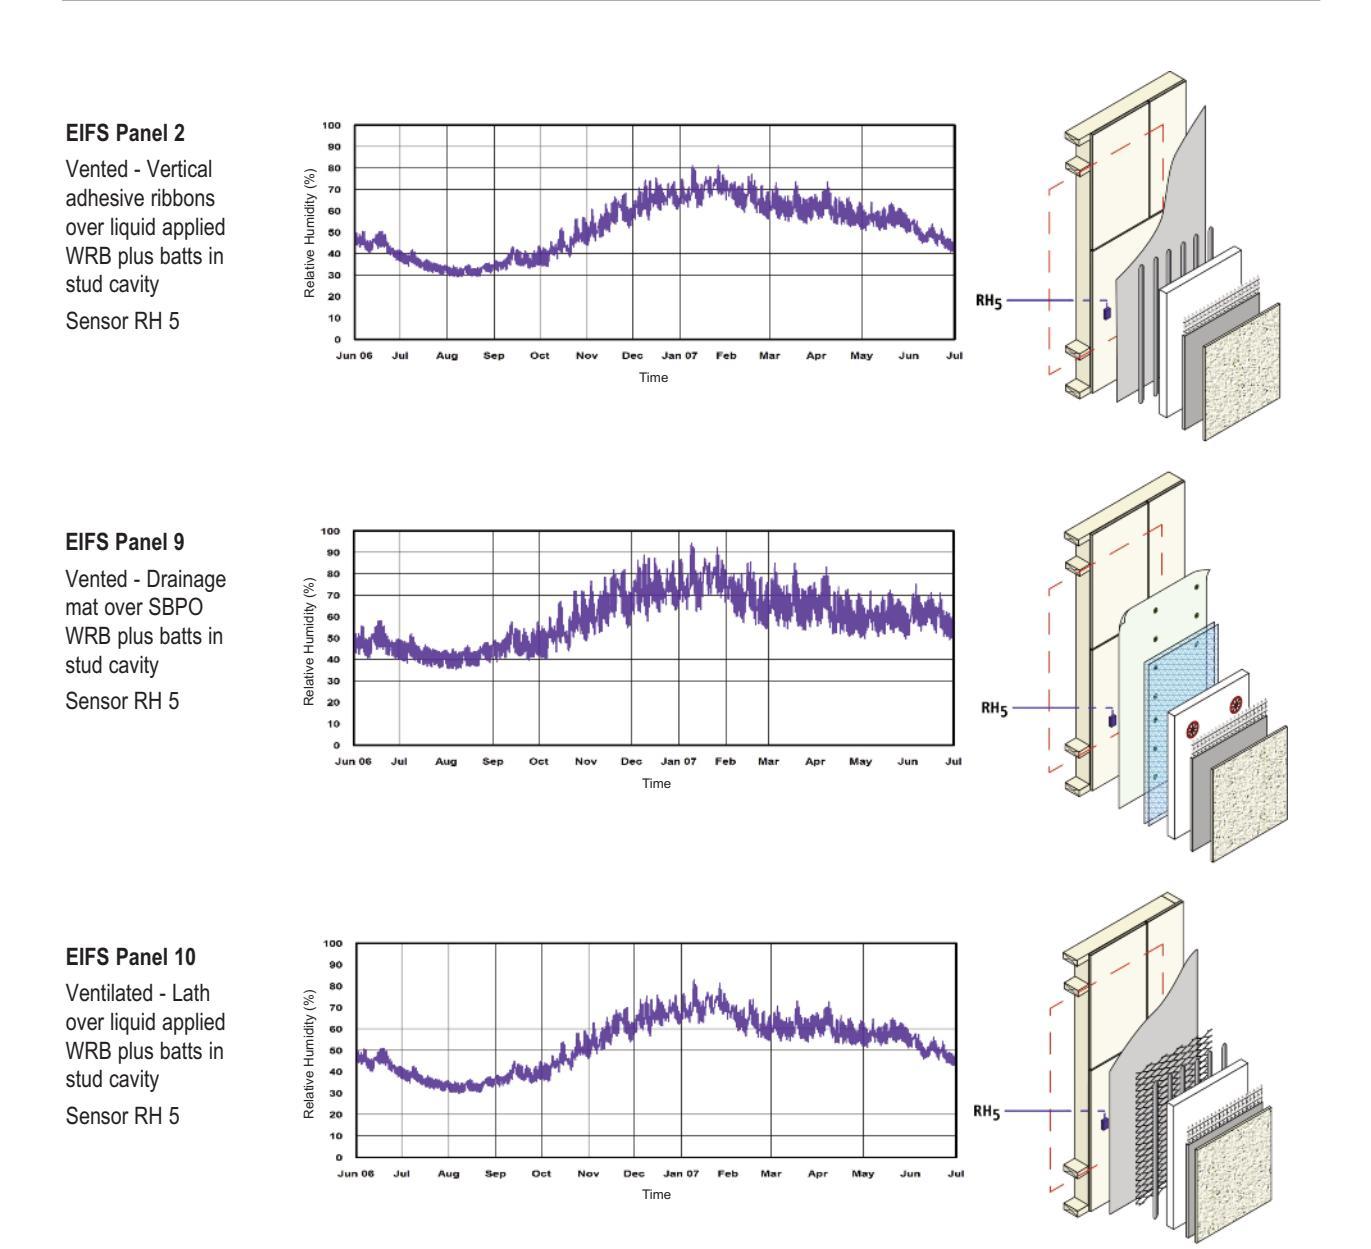
FIG 6 Comparison of Relative Humidity Sensor 5 (RH5) at inside face of sheathing in EIFS and Stucco Assemblies

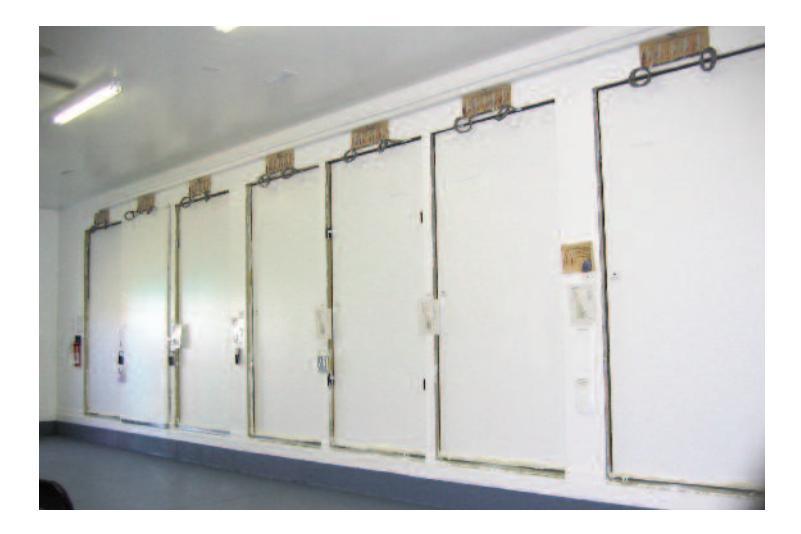
FIG 7 Interior of NET Facility

The researchers in consultation with the EIFS Industry Members Association (EIMA) designed and built a test facility in Hollywood, South Carolina near Charleston, a location that is typical of a mixed, coastal, Zone 3 climate, as prescribed in the 2006 International Energy Conservation Building Code. The building's flexible design allowed researchers to change the wall panels with ease and to control conditions inside the building by creating two zones within the building's interior (Figure 7). Interior temperature and relative humidity conditions were selected based on the proposed ASHRAE SPC 160P standard. Building orientation and placement of the wall panels were determined based on a comprehensive study of historical weather patterns, including prevailing wind and precipitation direction.

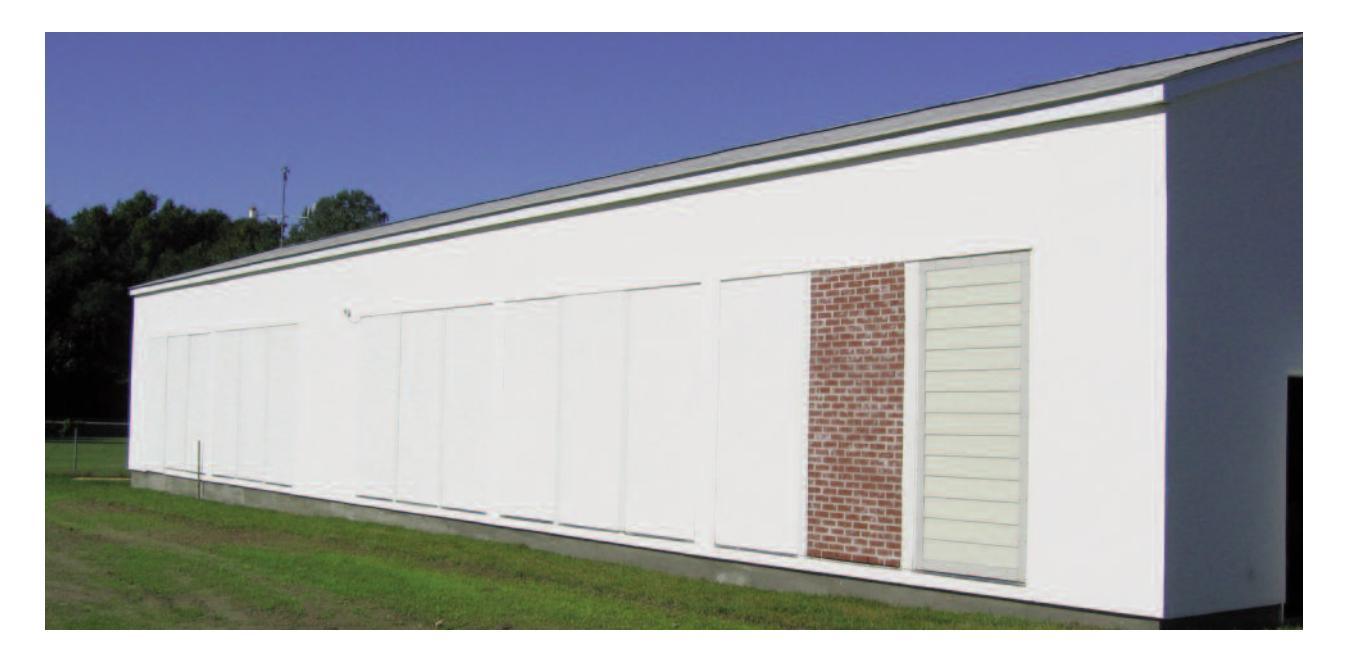
FIG 8 Exterior of Southeast Wall NET Facility (Phase 1)

In Phase I, 15 exterior cladding configurations were integrated into one side of the building (southeastern exposure), with the goal of having all the claddings exposed to similar weather conditions for a full weather year (15 months from January 2005 through May 2006) (Figure 8). In addition, the hygrothermal performance of three innovative EIFS features (liquid applied water-resistive barrier coatings, smart vapor retarder systems, and exterior cladding ventilation) were evaluated. Table 1 lists the configurations of these 15 wall panels.

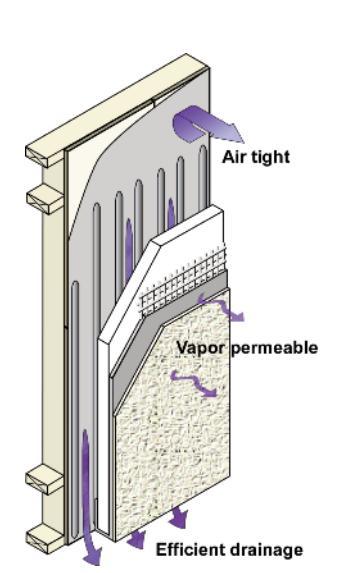
FIG 9

Vertical Ribbons of Adhesive Drain Efficiently

- The results of this study validate that vertical ribbons of adhesive provide an effective means of drainage within an EIFS clad wall assembly (see Fig. 9).

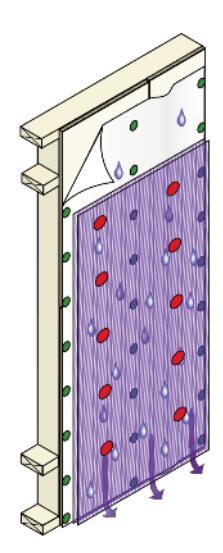
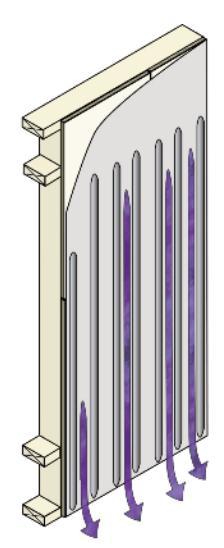
FIG 10

Different Strategies for Drainage

Drainage mats set cavity dimensions. Liquid applied water-resistive barrier coating with drainage cavity defined by vertical ribbons of adhesive.

liquid applied membranes have low surface tension.

or subset of an envelope, that optimize the thermal and moisture transport, which results in high drying potential of the walls (Figure 10).

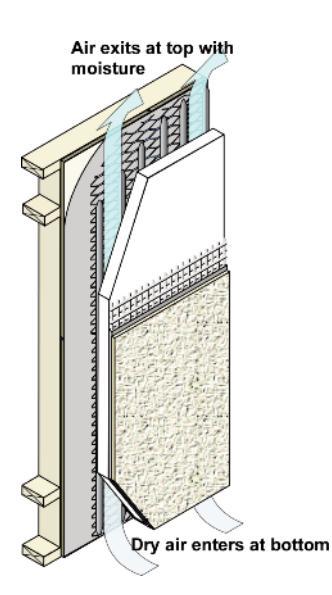
FIG 11

Drying Effect of Ventilation

Ventilated exterior claddings. In these systems, the exterior cladding is intentionally ventilated (open at top and bottom) and drained using one of two options: directly using integrated systems or channeled foam systems, or indirectly using adhesive channels, such as notched trowel, vertical ribbons. A variation of these systems was included in this study to assess unvented, vented (open at the bottom only) and ventilated systems (open at the top and bottom), (not commercially available). Vented systems moderate the air pressure across the exterior cladding, reducing the pressure difference across the cladding, which can reduce exterior air and water from entering the wall system. Ventilation allows air to move freely behind the cladding, which increases the drying potential of walls (Figure 11).

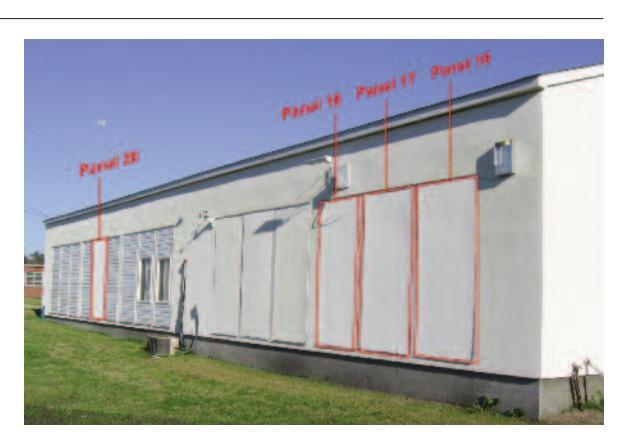
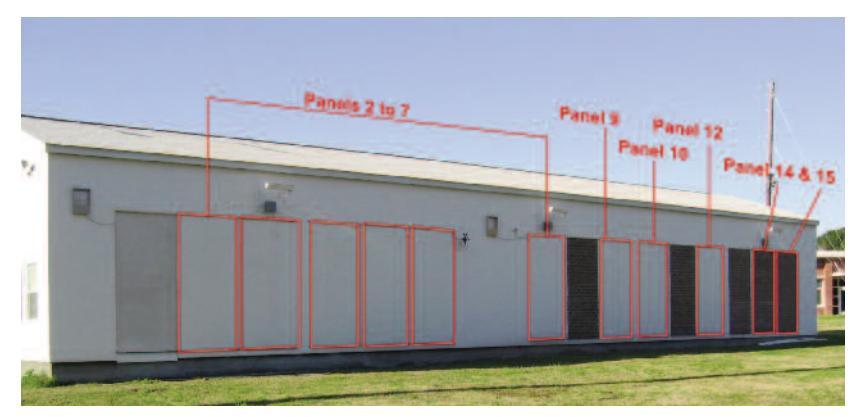
FIG 12 Phase II Panel Locations

Northwest Wall Panel Location

Southeast Wall Panel Location

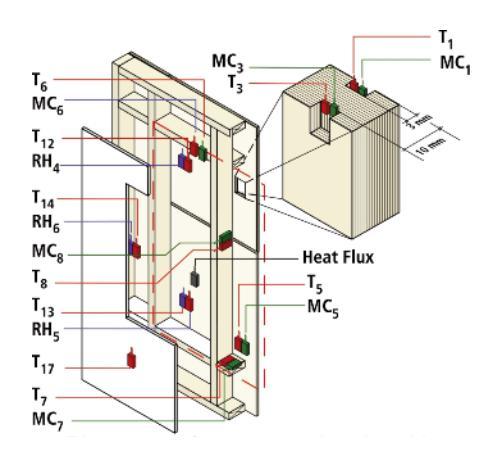
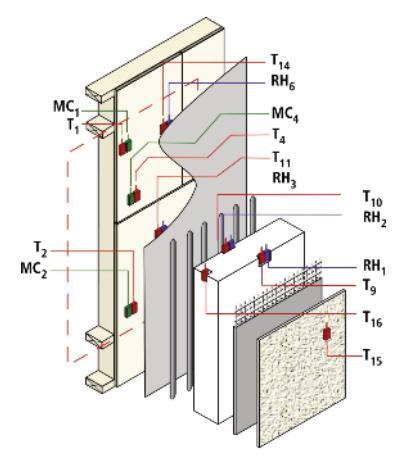
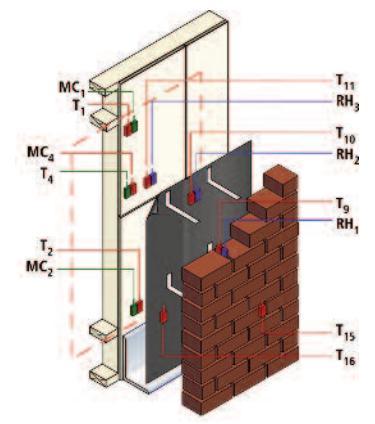
FIG 13 Placement of Sensors in Panels

Placement of sensors on exterior side of EIFS wall assemblies

Placement of sensors on exterior side of brick and stucco wall assemblies

side for all wall assemblies

Placement of sensors on interior

The sensor placements were identical for all the wall panels (Figure 13), except for relative humidity sensors on panels with absorptive cladding systems (brick and stucco) and non-absorptive cladding systems (EIFS), which were embedded into the exterior cladding on those panels with non-absorptive claddings (Figure 14).

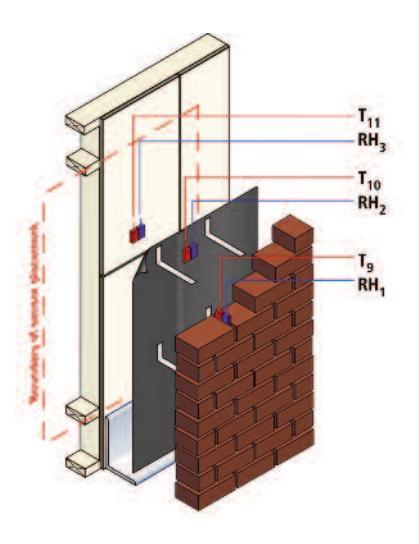
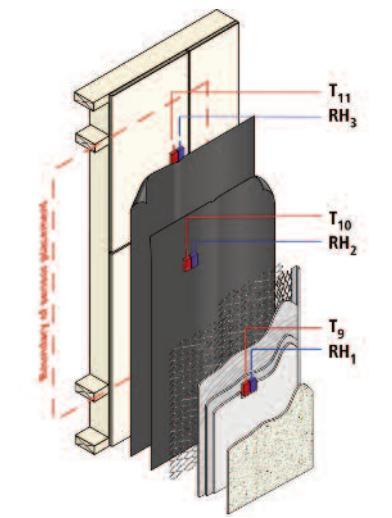
FIG 14 Placement of Relative Humidity Sensors in Brick and Stucco Panels

Placement of RH sensors on the exterior side of brick wall assembly

Placement of RH sensors on exterior side of stucco wall assembly

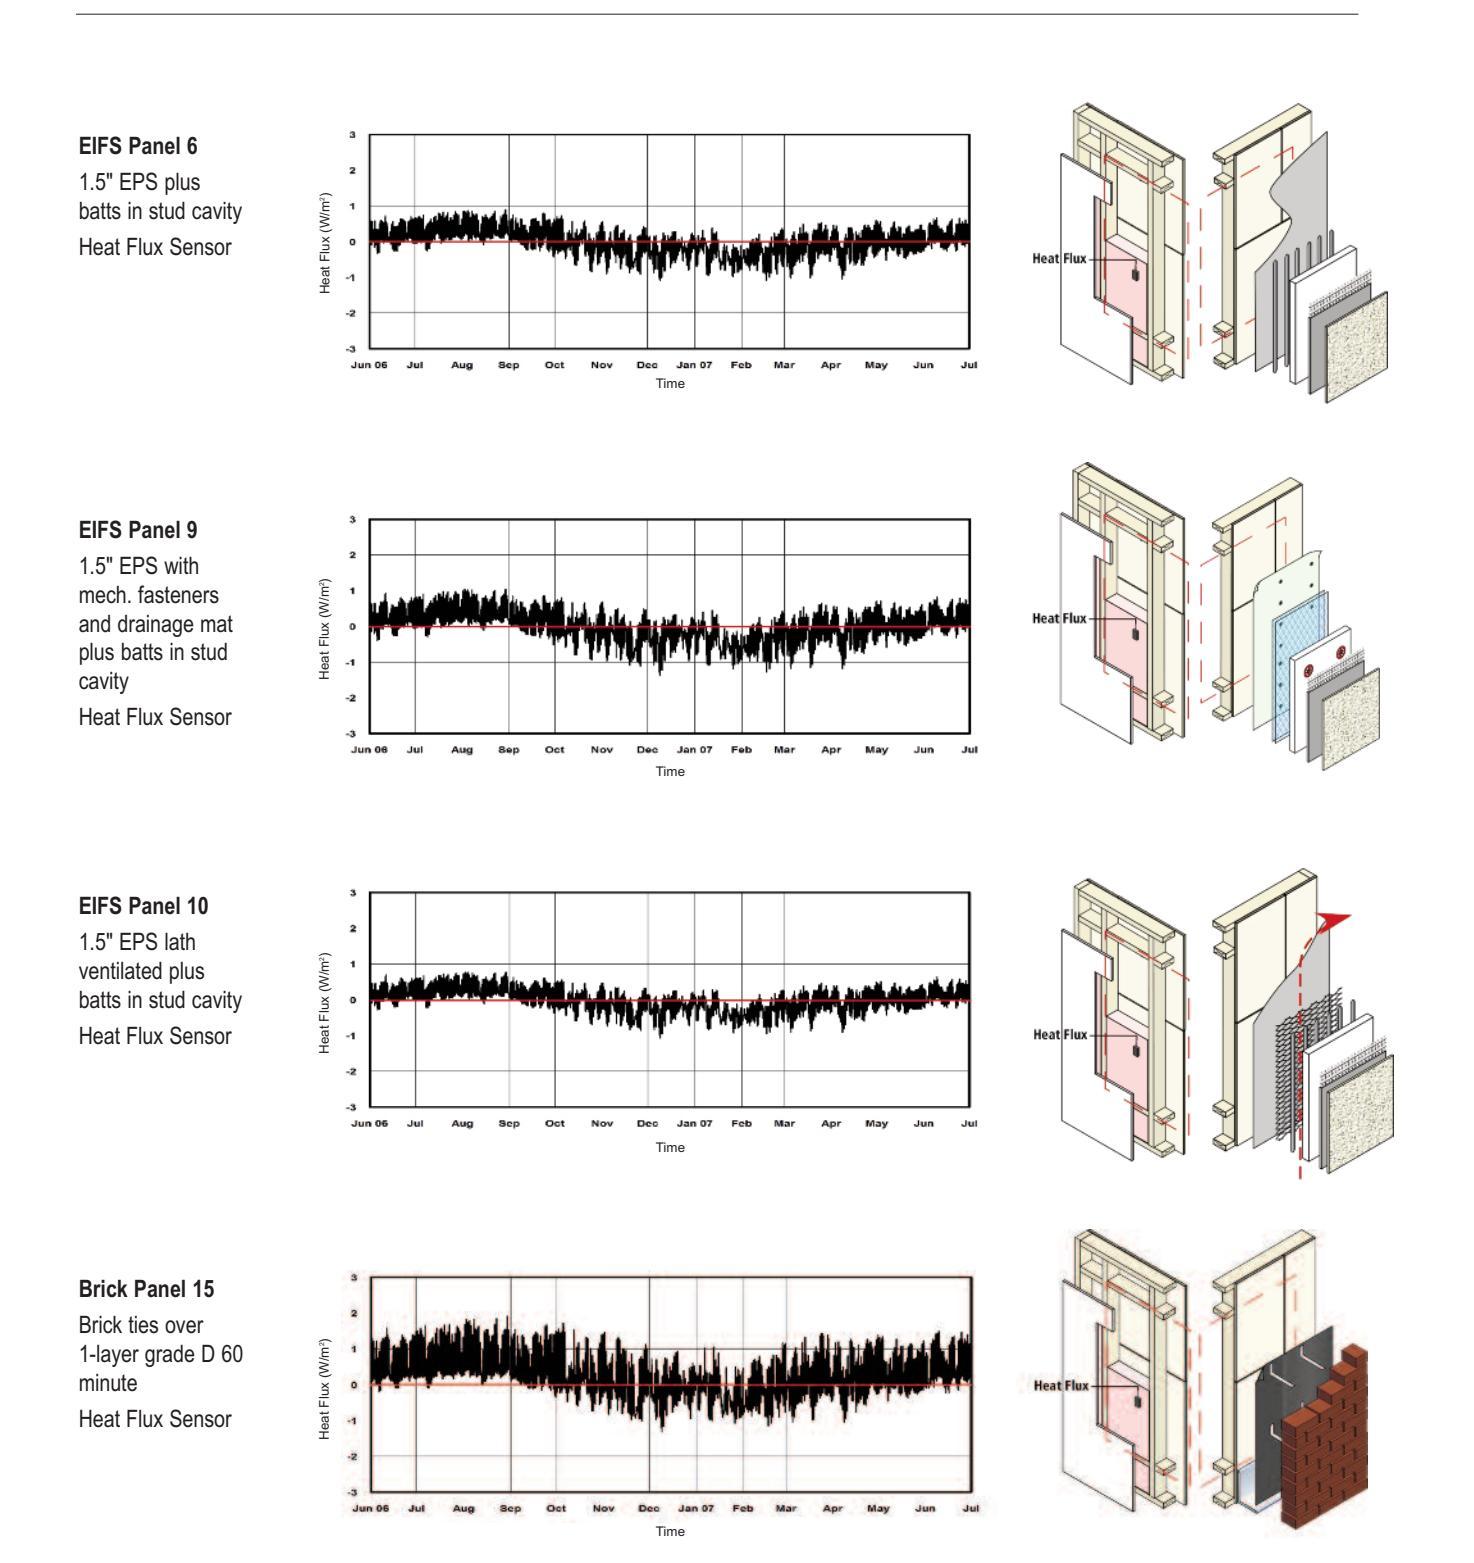
FIG 15 Comparison of Heat Flux Sensor at inside face of interior gypsum wall board in EIFS and Brick Assemblies

The heat flux data collected in this study showed a beneficial thermal performance of the exterior foam insulation for walls facing both southeast and northwest during the cooling season. Reductions of not only the total heat flow, but also substantial peak reduction was also noted. These findings demonstrate that walls with exterior foam insulation, regardless of the type of exterior cladding, can offer a significant energy cost savings. Specifically, the best performing wall configuration with respect to positive heat flux during the cooling months (keeping heat out) was EIFS with a liquid applied water-resistive barrier coating applied behind the EIFS ventilated wall (Panel 10). The second best performing wall configuration was EIFS with a liquid applied water-resistive barrier coating applied behind the EIFS (Panel 6). Panel 9, the mechanically fastened EIFS applied over the spun-bonded, polyolefin water-resistive barrier, ranked third. During the cooling season, the wall configurations with the greater heat flux were those constructed of brick (Panels 14 and 15) (Figure 15, page 16). As might be expected, the brick wall panels performed better in winter with respect to negative heat flux (keeping heat in), as brick mass tends to hold heat gain from solar radiation. The implication for energy efficiency is that mass walls like brick may have limited advantages in a mixed, coastal, Zone 3 climate, as the heating season is typically short and mild. In addition, during the cooling season, the HVAC system would likely have to work harder and use more energy to balance the positive heat flux.

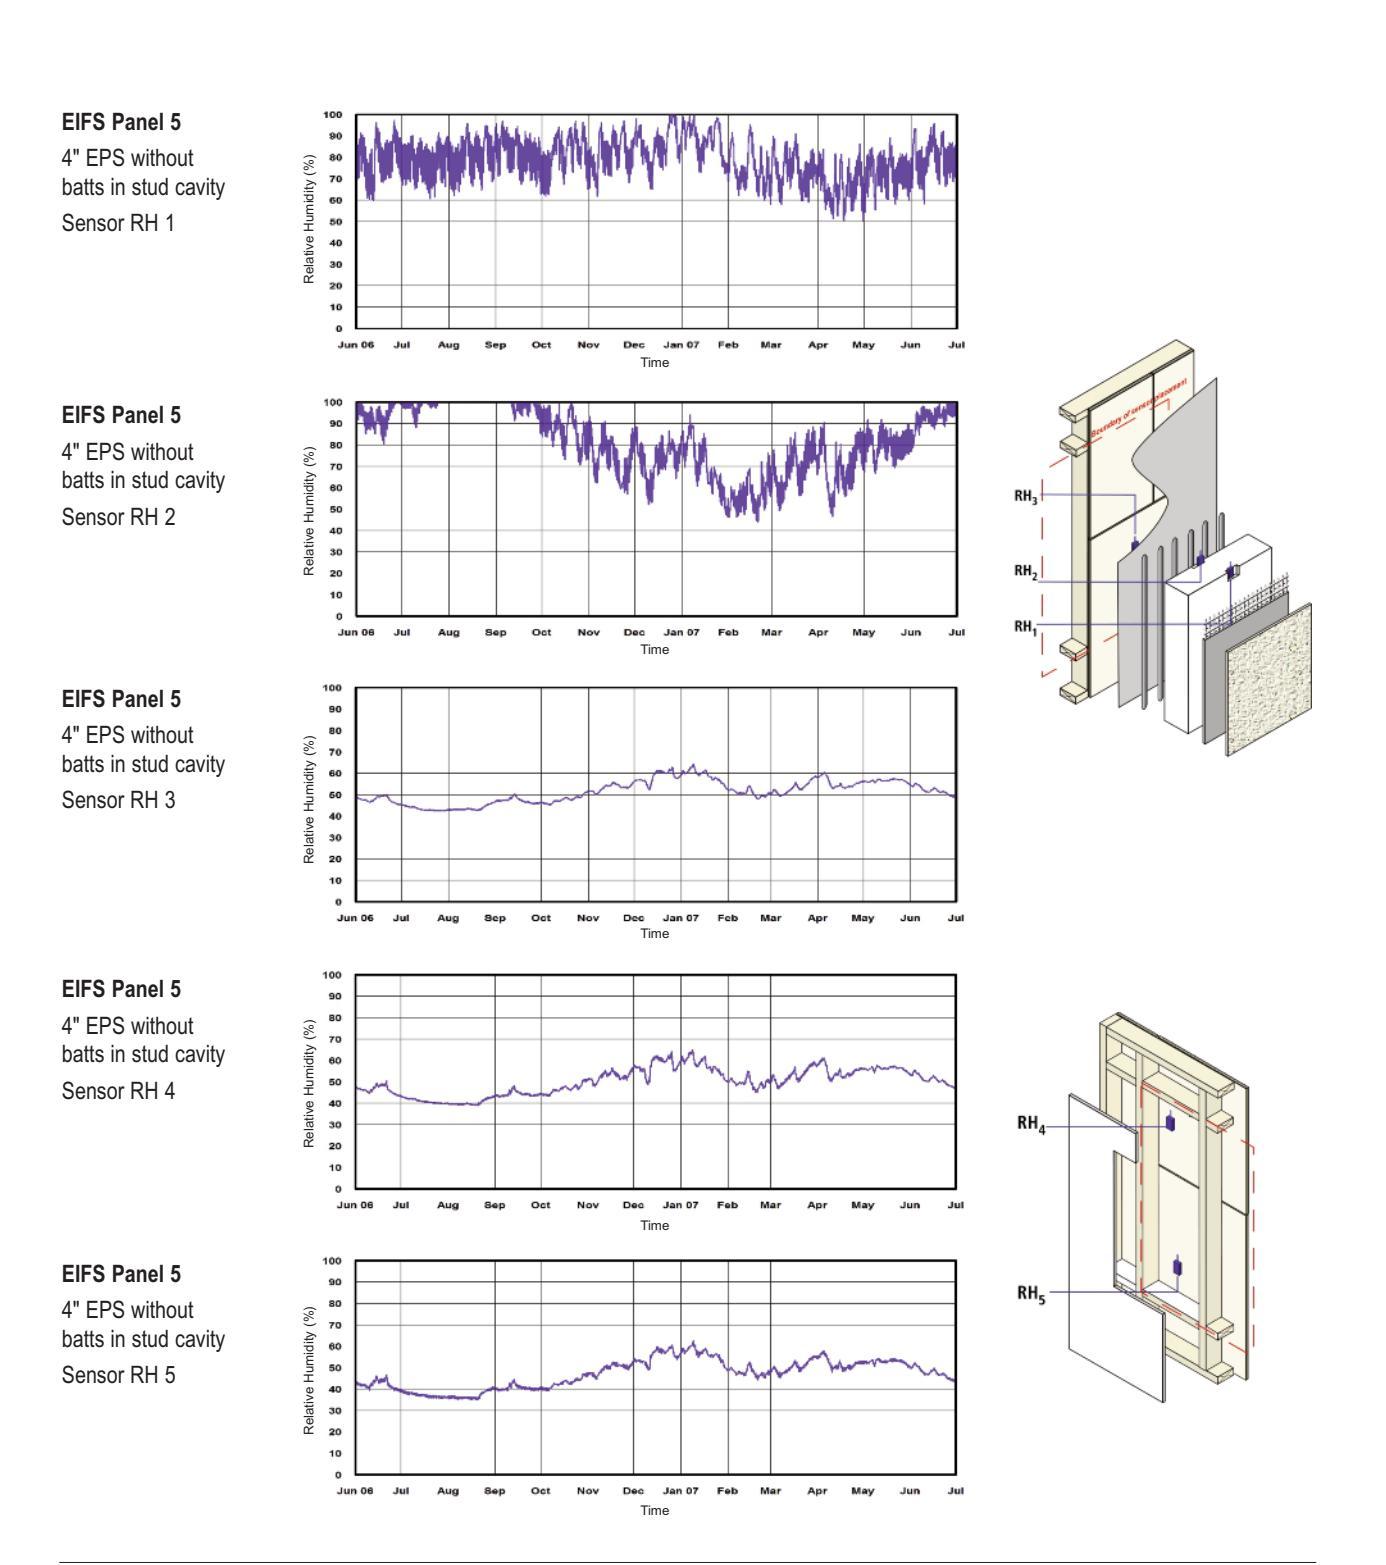
FIG 16 Relative Humidity through the wall in Panel 5

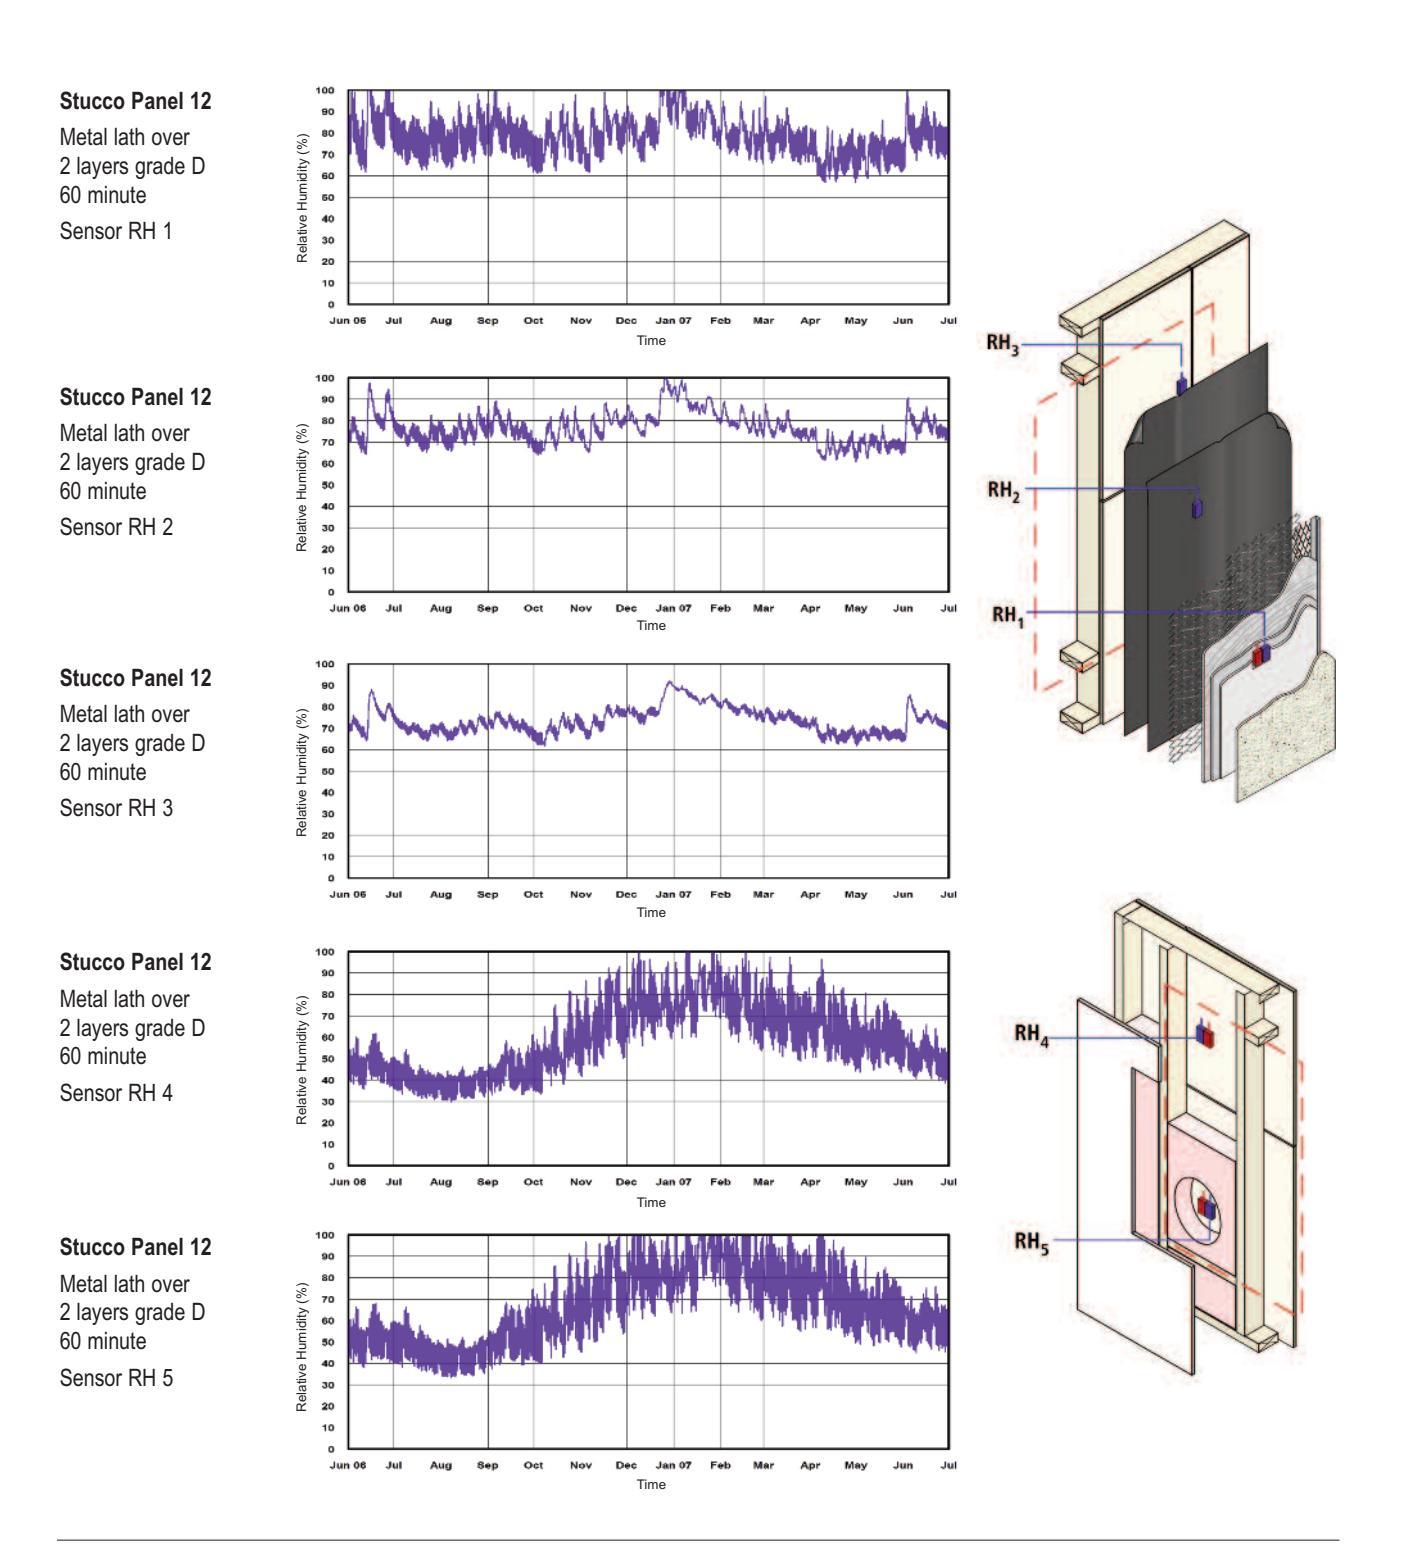
FIG 17 Relative Humidity through the wall in Panel 12
