EXECUTIVE SUMMARY EXTERIOR WALL CLADDING PERFORMANCE STUDY

Results of key building performance goals for energy efficiency, temperature control and moisture control in mixed, coastal, hot, humid, Zone 3 climates

EIFS INDUSTRY MEMBERS ASSOCIATION Conducted during period of January 2005 through June 2007 by researchers at Oak Ridge National Laboratory, US Department of Energy, through the Office of Energy Efficiency and Renewable Energy's Building Technologies Program and the EIFS Industry Members Association. August 15, 2008

EIFS Performs: Excellent Choice in Mixed, Coastal, Hot, Humid Climate for Energy Efficiency, Temperature and Moisture Control

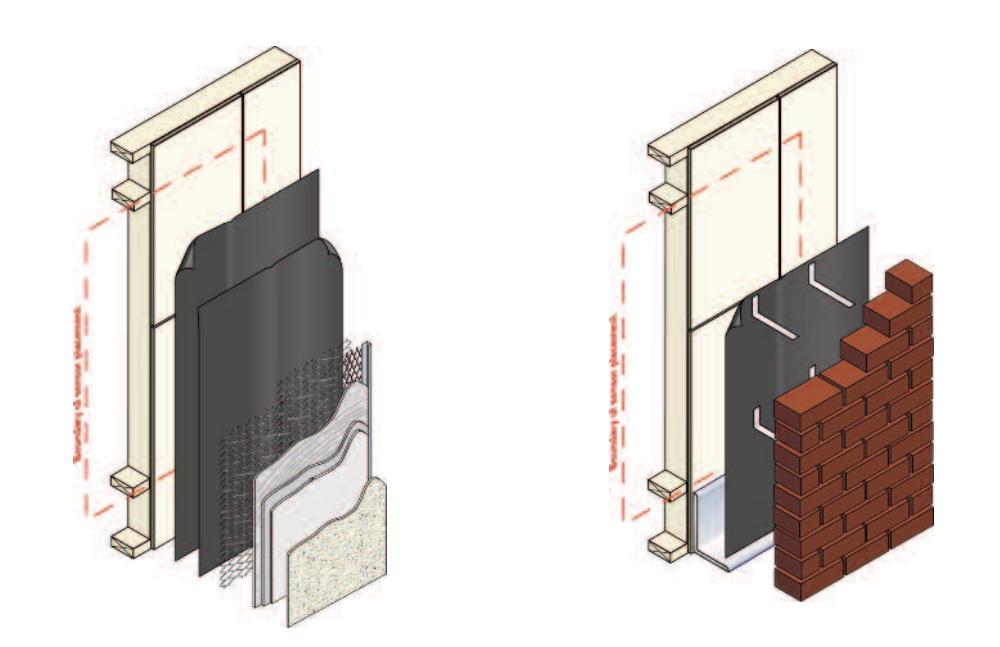
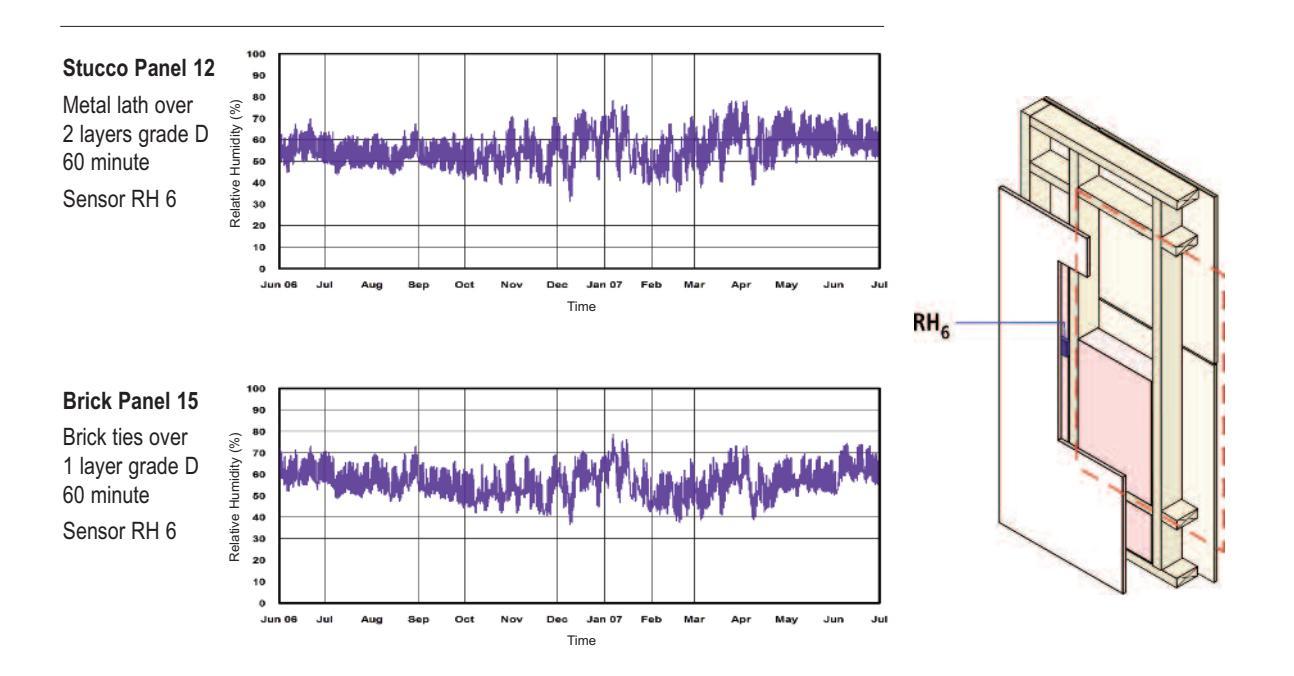
FIG 18 Relative Humidity at interface of interior gypsum wall board and insulation in Stucco and Brick

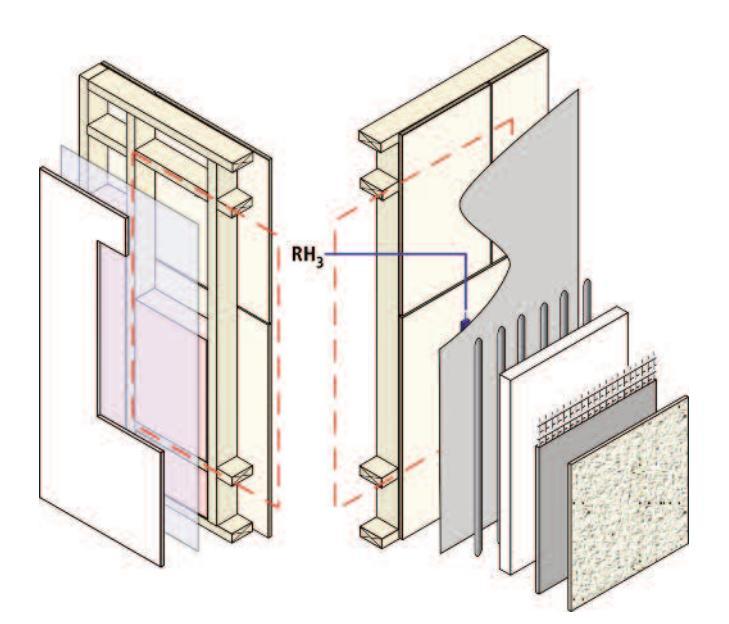
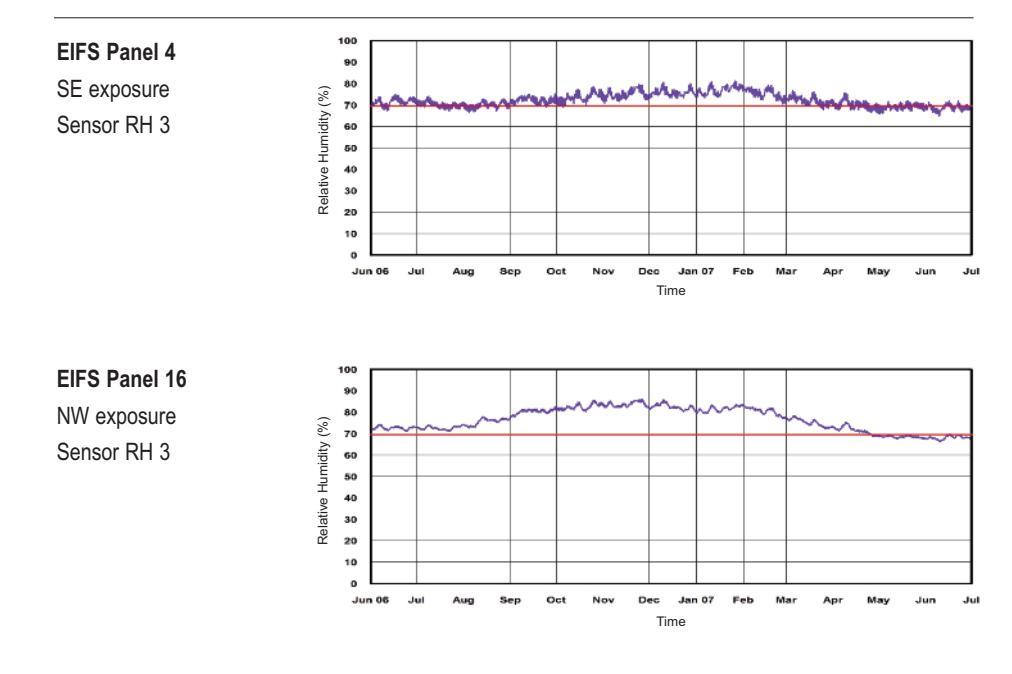
Comparison of Relative Humidity Sensor 3 for EIFS Panels 4 and 16 from the NW and SE sides of the facility. Panels constructed with a vapor barrier.

The results indicated that the highest relative humidities occurred near the exterior sheathing and wood framing during the winter months. This result was not unexpected, as insulation in the wall cavity will result in cooler temperatures at the exterior sheathing. In addition, relative humidity tends to increase as the temperature cools. The best performing wall configuration with respect to controlling relative humidity within the wall assembly was the EIFS panel with four inches of insulation (Panel 5) outbound of the sheathing. The wall stud cavity was not insulated and no vapor barrier was installed on the interior (see Figure 16, page 17). Panel 12, the wall configuration with 3-Coat Portland Cement Plaster (stucco), had the highest relative humidity in both summer and winter (Figure 17, page 18). The walls with stucco and brick showed high relative humidities at the insulation/gypsum interface during the winter months (Figure 18, page 19). Interestingly, the EIFS wall panel that faced northwest (Panel 16) had up to 17 percent higher relative humidity at the exterior sheathing as compared with EIFS wall panels that faced southeast (Figure 19, page 20).

The results also showed that using polyethylene vapor retarders increased the relative humidity by as much as 23 percent on the EIFS wall facing northwest (Panel 17) as compared with the EIFS wall panels facing southeast (Panel 7).

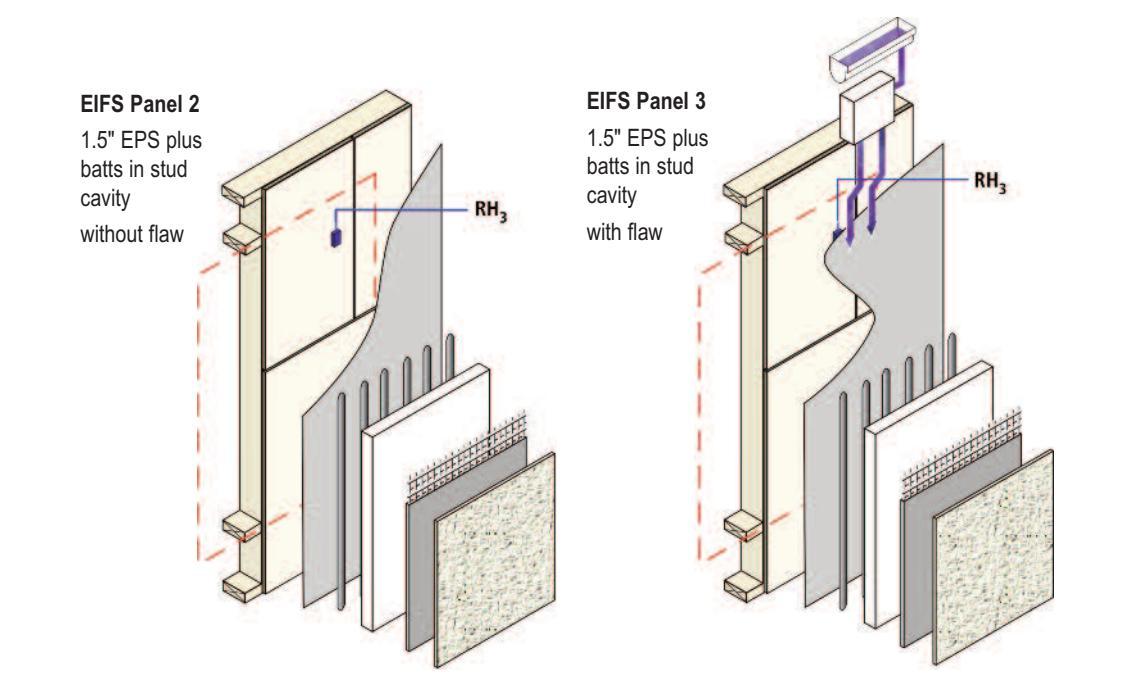
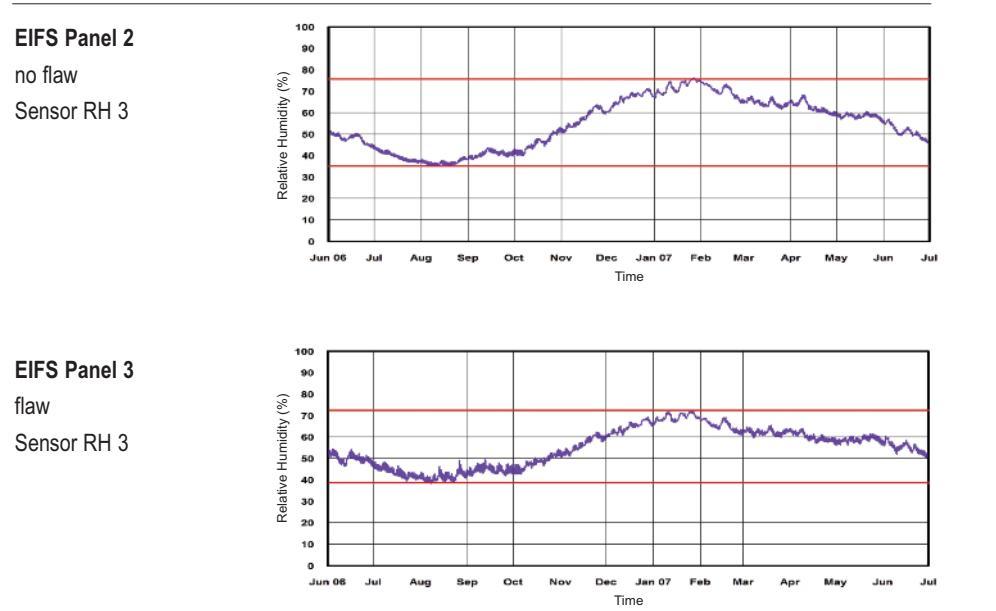
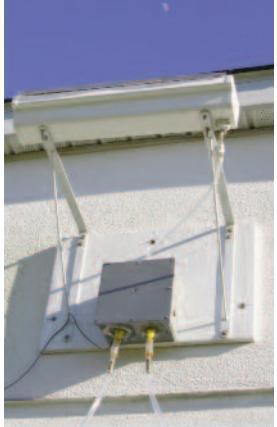
Comparison of Relative Humidity sensors (RH3) installed behind the liquid applied water-resistive barrier coating on EIFS panel 2 (without flaw) and EIFS panel 3 (with flaw)

"Flaw" - 2' gutter catches rain water and drains, via a tip-bucket measuring device, onto the WRB

- Panel 3 (Corresponding Panel 2): EIFS with notched trowel, vertical adhesive ribbons, a liquid applied water-resistive barrier coating, no interior vapor barrier, southeast orientation (Figure 20, page 21, which represents the measured relative humidity on the face of the exterior sheathing).
- **Panel 7** (Corresponding Panel 4): EIFS with notched trowel, vertical ribbon, a liquid applied water-resistive barrier coating, and a 6-mil Poly vapor barrier, southeast orientation (Figure 21, page 22).
- Panel 14 (Corresponding Panel 15): Brick, vented, southeast orientation (Figure 22, page 23, which represents the measured relative humidity on the face of the exterior sheathing).
- Panel 18 (Corresponding Panel 17): EIFS with notched trowel, vertical adhesive ribbons, a liquid applied water-resistive barrier coating, no interior vapor barrier, northwest orientation (Figure 23, page 24).

The results showed that introducing the simulated flaw in the EIFS in the southeast and northwest orientations had a small effect on the sheathing relative humidity. Conversely, introducing the flaw in the brick vented system in the southeast orientation had a much larger effect on sheathing relative humidity. The implication is that EIFS layers comprised of vertical ribbons of adhesive and a liquid applied water-resistive barrier coating provided the most effective method for managing bulk water intrusion into the cladding cavity.

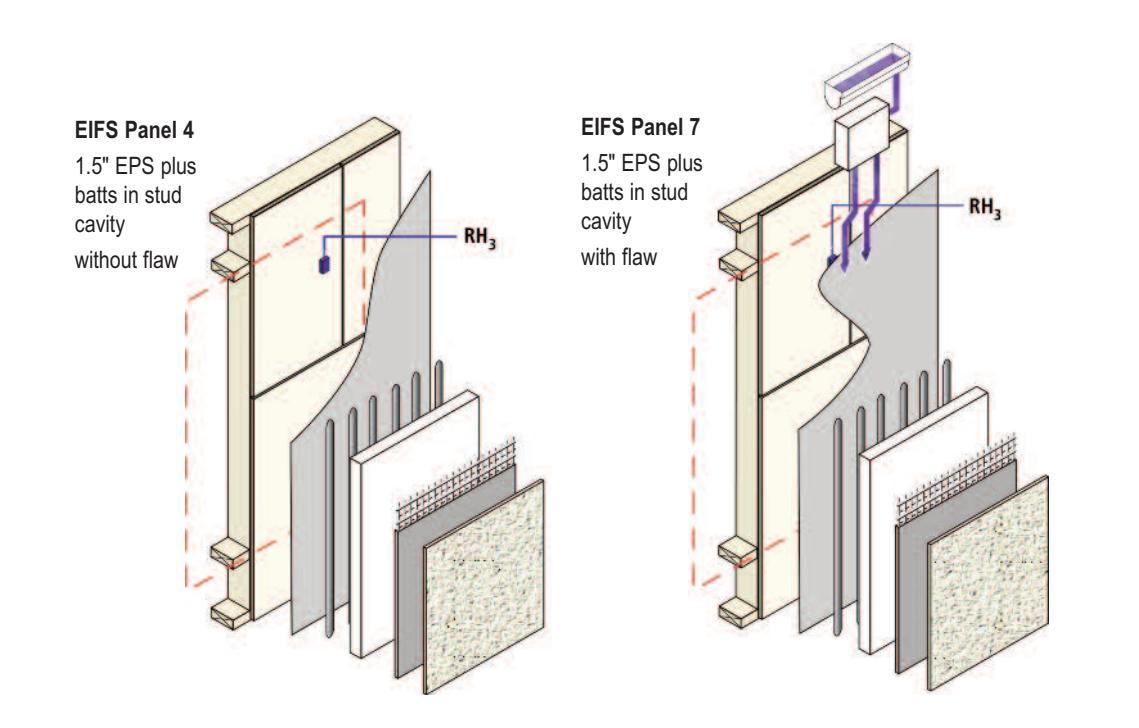
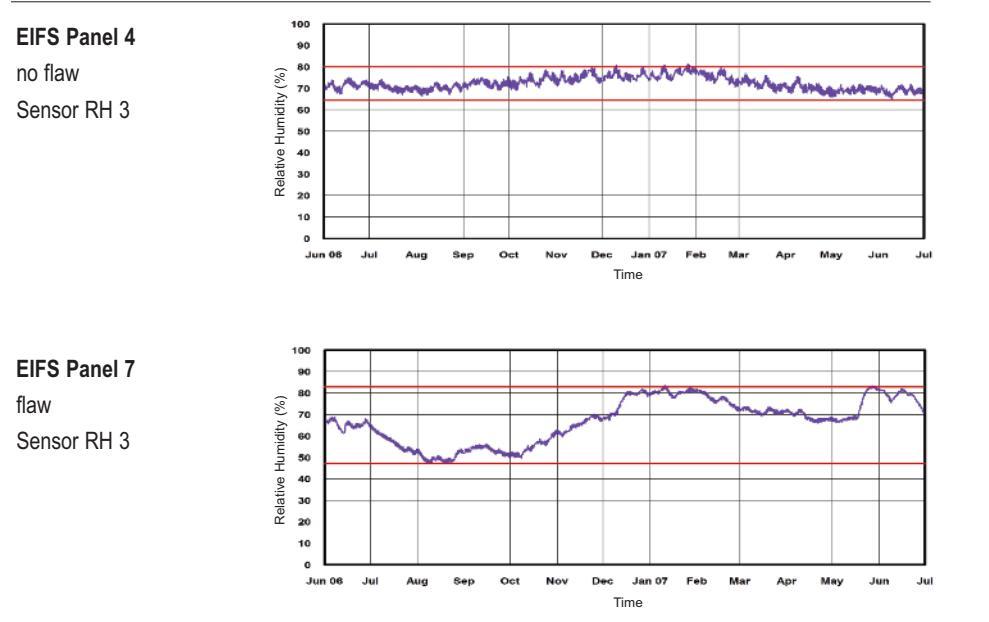
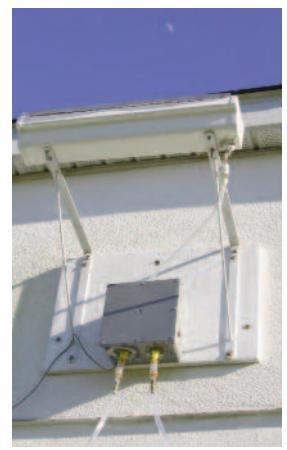
Comparison of Relative Humidity sensors (RH3) installed behind the liquidapplied water-resistive-barrier coating on EIFS panel 4 (without flaw) and EIFS panel 7 (with flaw). A 6-mil poly-vapor barrier is used on the interior.

"Flaw" - 2' gutter catches rain water and drains, via a tip-bucket measuring device, onto the WRB

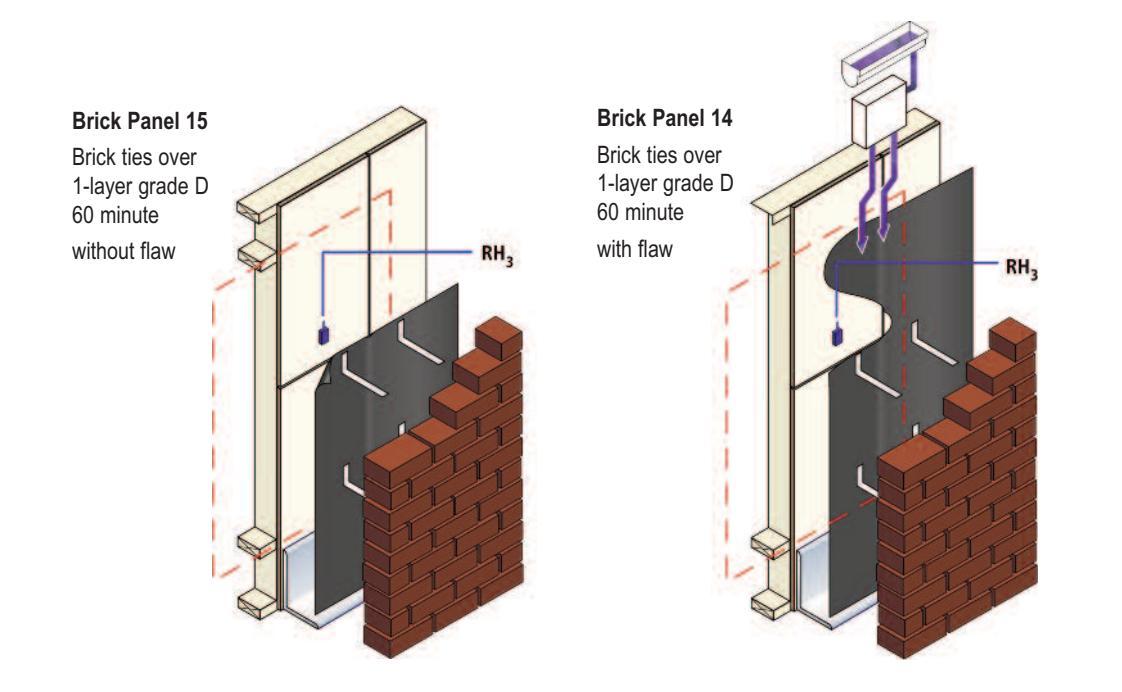
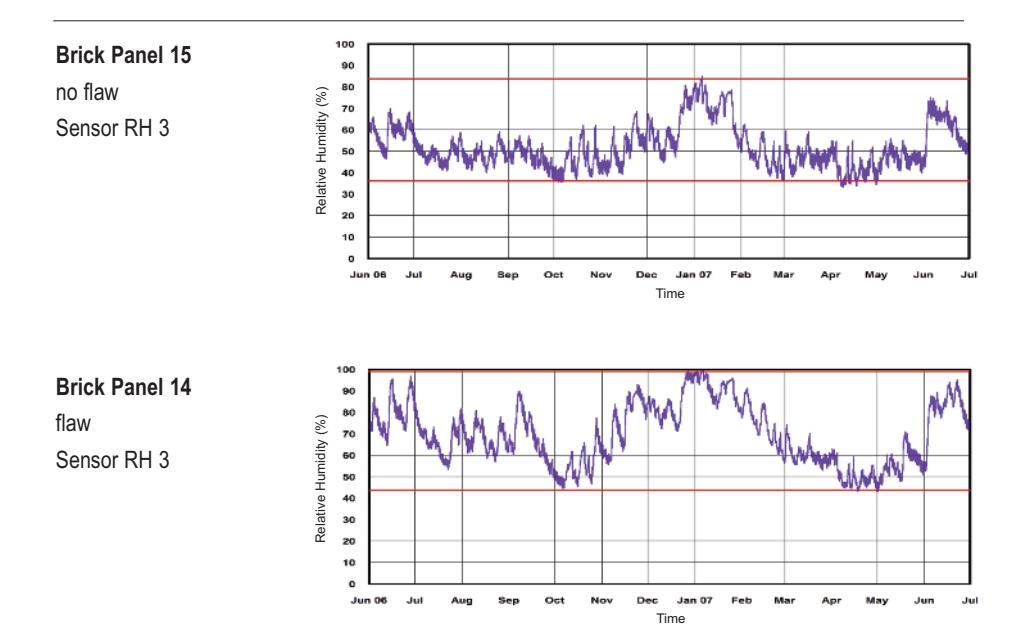
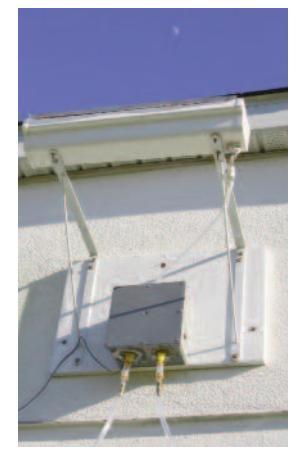
FIG 22 Comparison of Relative Humidity sensors (RH3) installed behind 1 layer grade D, 60-minute water-resistive barrier on Brick panel 15 (without flaw) and Brick panel 14 (with flaw)

"Flaw" - 2' gutter catches rain water and drains, via a tip-bucket measuring device, onto the WRB

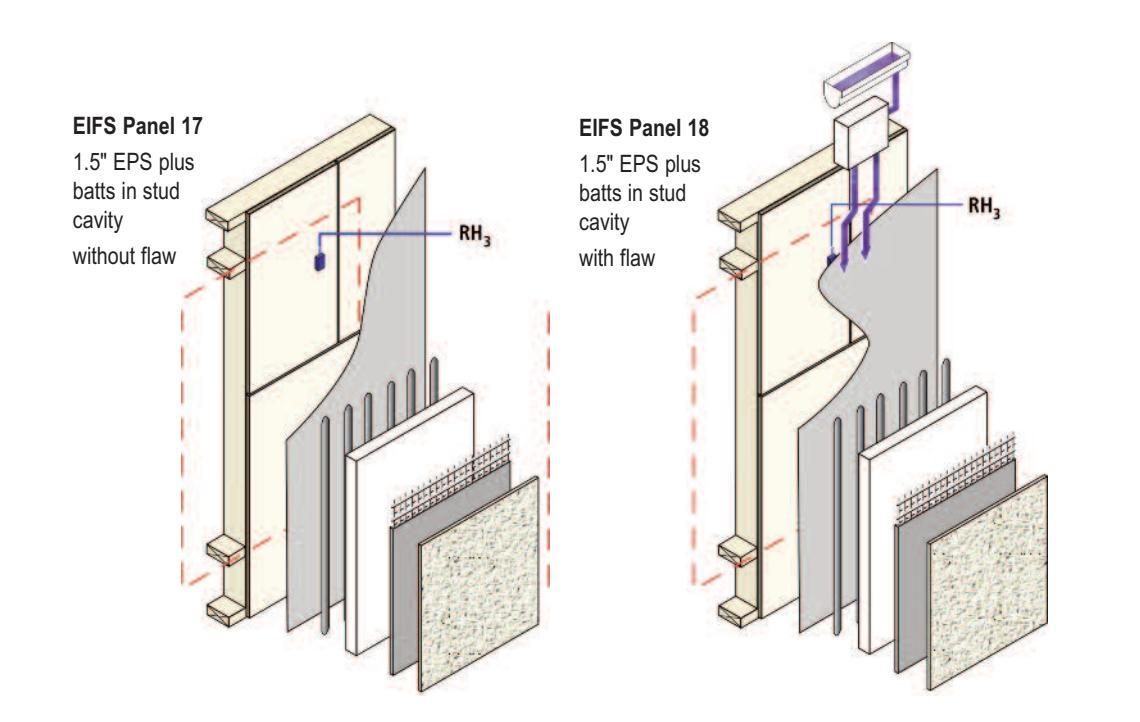
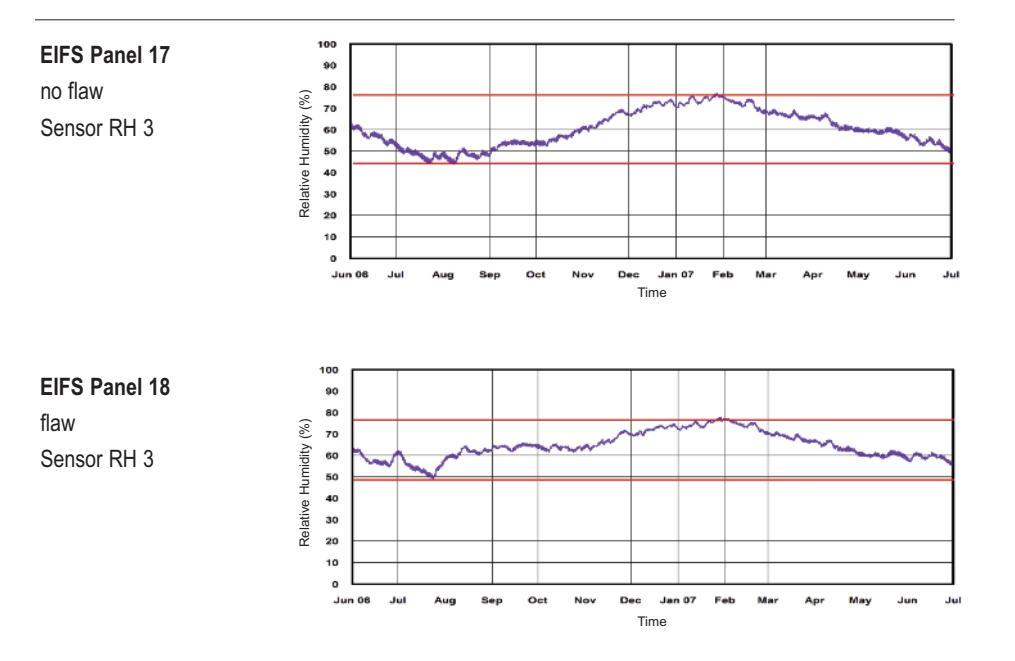
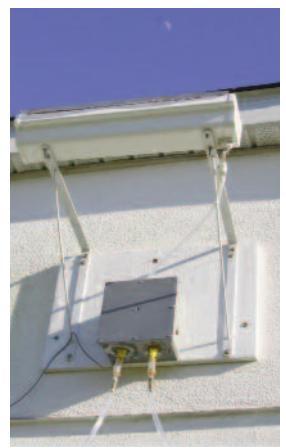
Comparison of Relative Humidity sensors (RH3) installed behind the liquid applied water-resistive barrier coating on EIFS panel 17 (without flaw) and EIFS panel 18 (with flaw)

"Flaw" - 2' gutter catches rain water and drains, via a tip-bucket measuring device, onto the WRB
