2015 Pleasant Lake Aquatic Vegetation Survey

Prepared for: Pleasant Lake Association

Annandale, Minnesota

WENCK Associates, Inc. 1800 Pioneer Creek Center Maple Plain, MN 55359 Phone: 763-479-4200 Fax: 763-479-4242

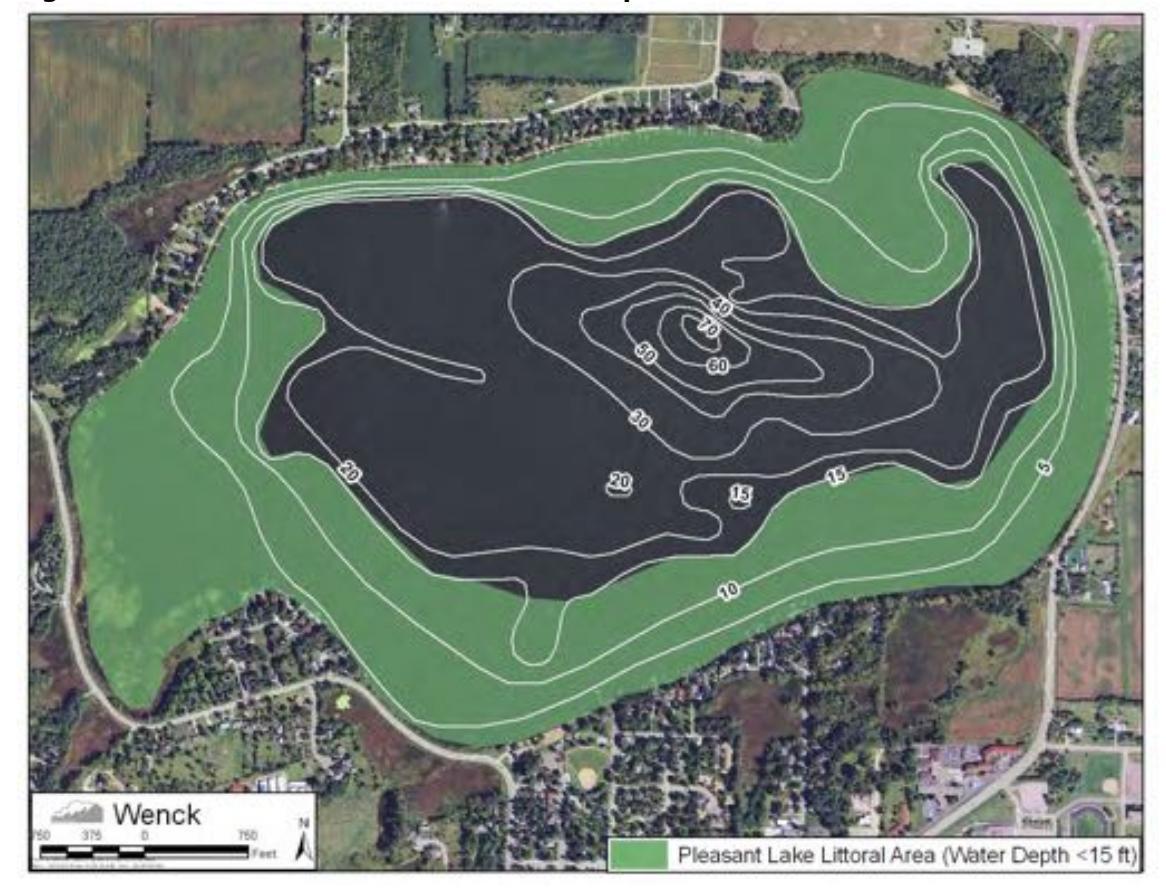
Figure 2: Pleasant Lake Littoral Area and Depth Contours

Wenck Associates, Inc. was contracted by the Pleasant Lake Association to conduct a survey of the aquatic vegetation in Pleasant Lake in 2015. Pleasant Lake is located in the City of Annandale in Wright County (See Figure 1). The lake is in the Clearwater River Watershed District and flows northeast to Clearwater Lake through an outlet channel in the northeast corner of the lake. Pleasant Lake has an approximate surface area of 571 acres, with a maximum depth of 71 feet. About 55% (312 acres) of the lake is littoral, or less than 15 feet deep (See Figure 2).

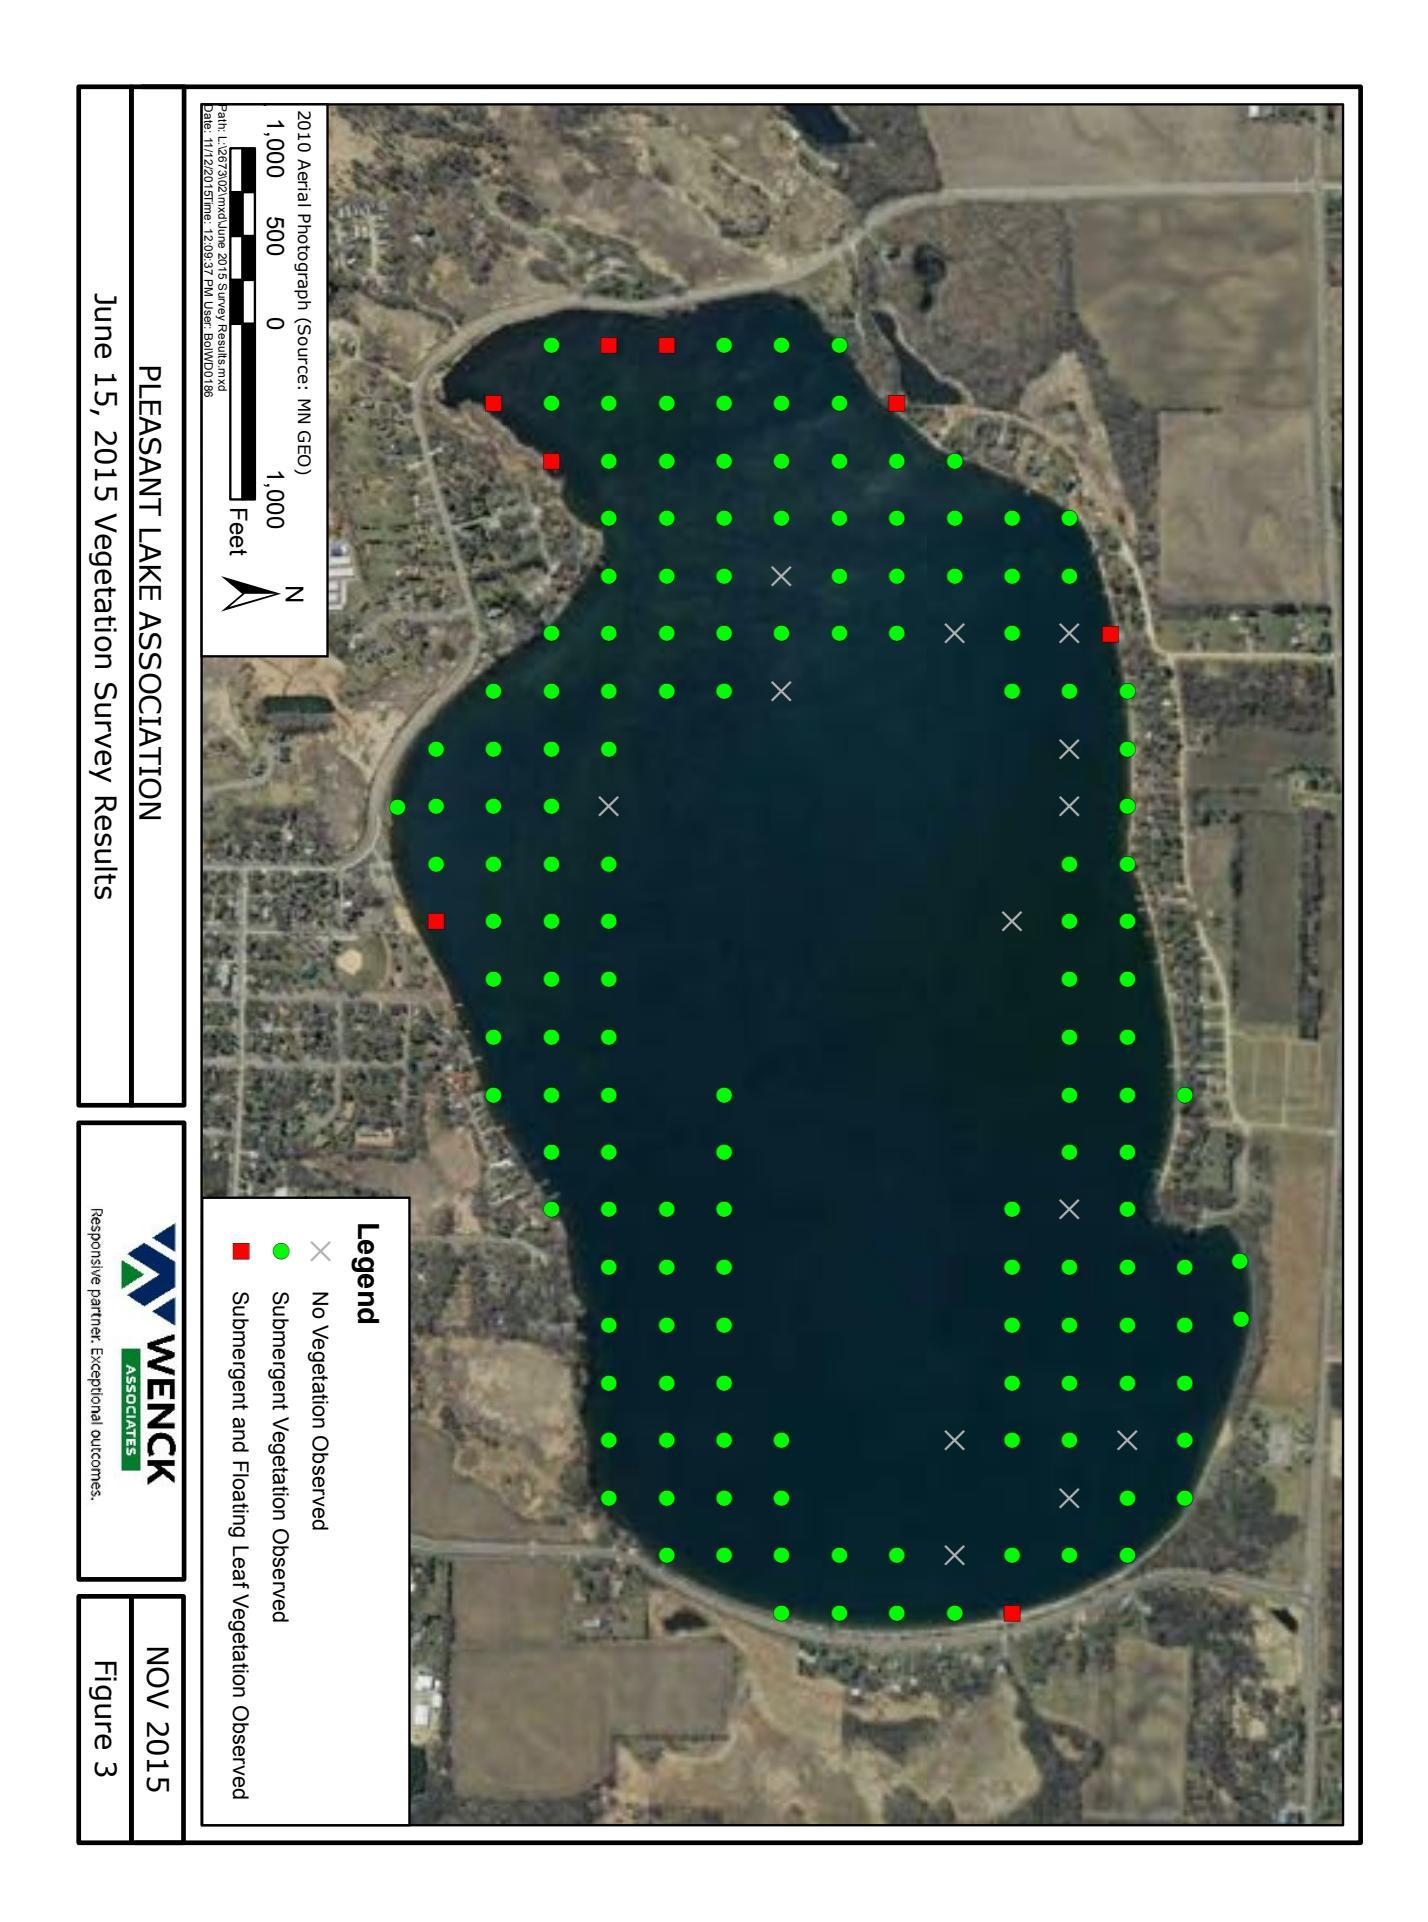
Vegetation was found at 94% of sampling sites during the June 15, 2015 survey (See Figure 3). Vegetation was observed at every sample point in the littoral area of the lake less than 15 feet deep. 21 species of aquatic vegetation were documented at sample stations during this survey. The maximum depth at which vegetation was found during this survey was 19.5 feet. In general, vegetation diversity and density decreased with depth.

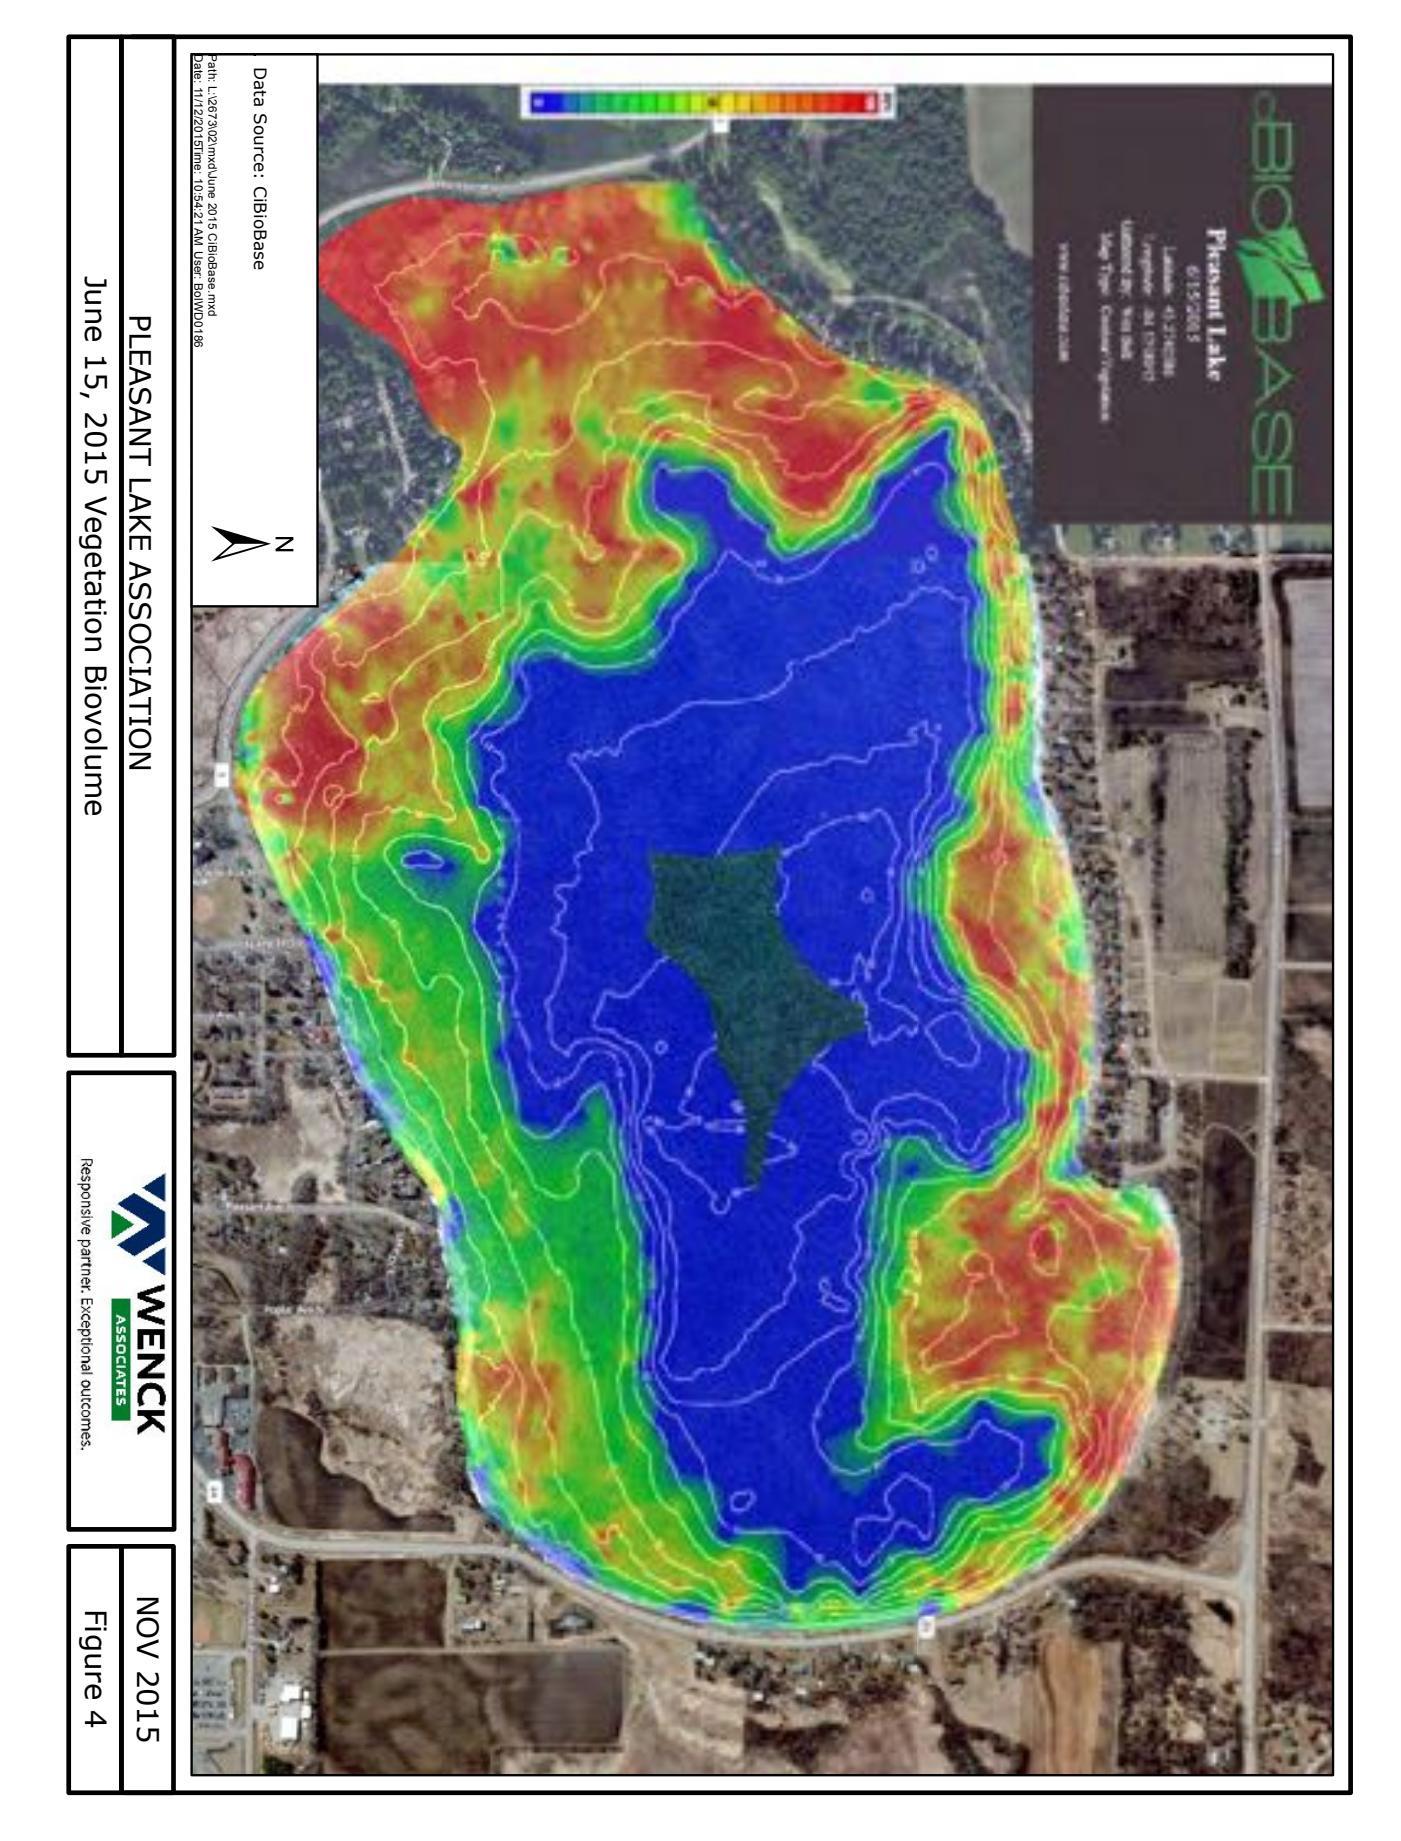
Figure 4 shows the vegetation biovolume analysis from CiBioBase ranging from 0% (colored in blue) to 100% (colored in red). Biovolume is a measurement of vegetation density that is the amount of the water column that is taken up by vegetation with 0% being no vegetation and a measurement of 100% meaning that vegetation growth is present throughout the entire water column. This analysis accurately shows the area of the lake that was vegetated at the time of the survey. This analysis also shows the dense vegetation observed in the western bay of the lake, nearshore areas, and areas dominated by curly leaf pondweed. Note that areas with biovolume near 100% from 6 to 12 feet of depth are generally representative of areas that had dense curly leaf pondweed growing near the surface at the time of this survey.

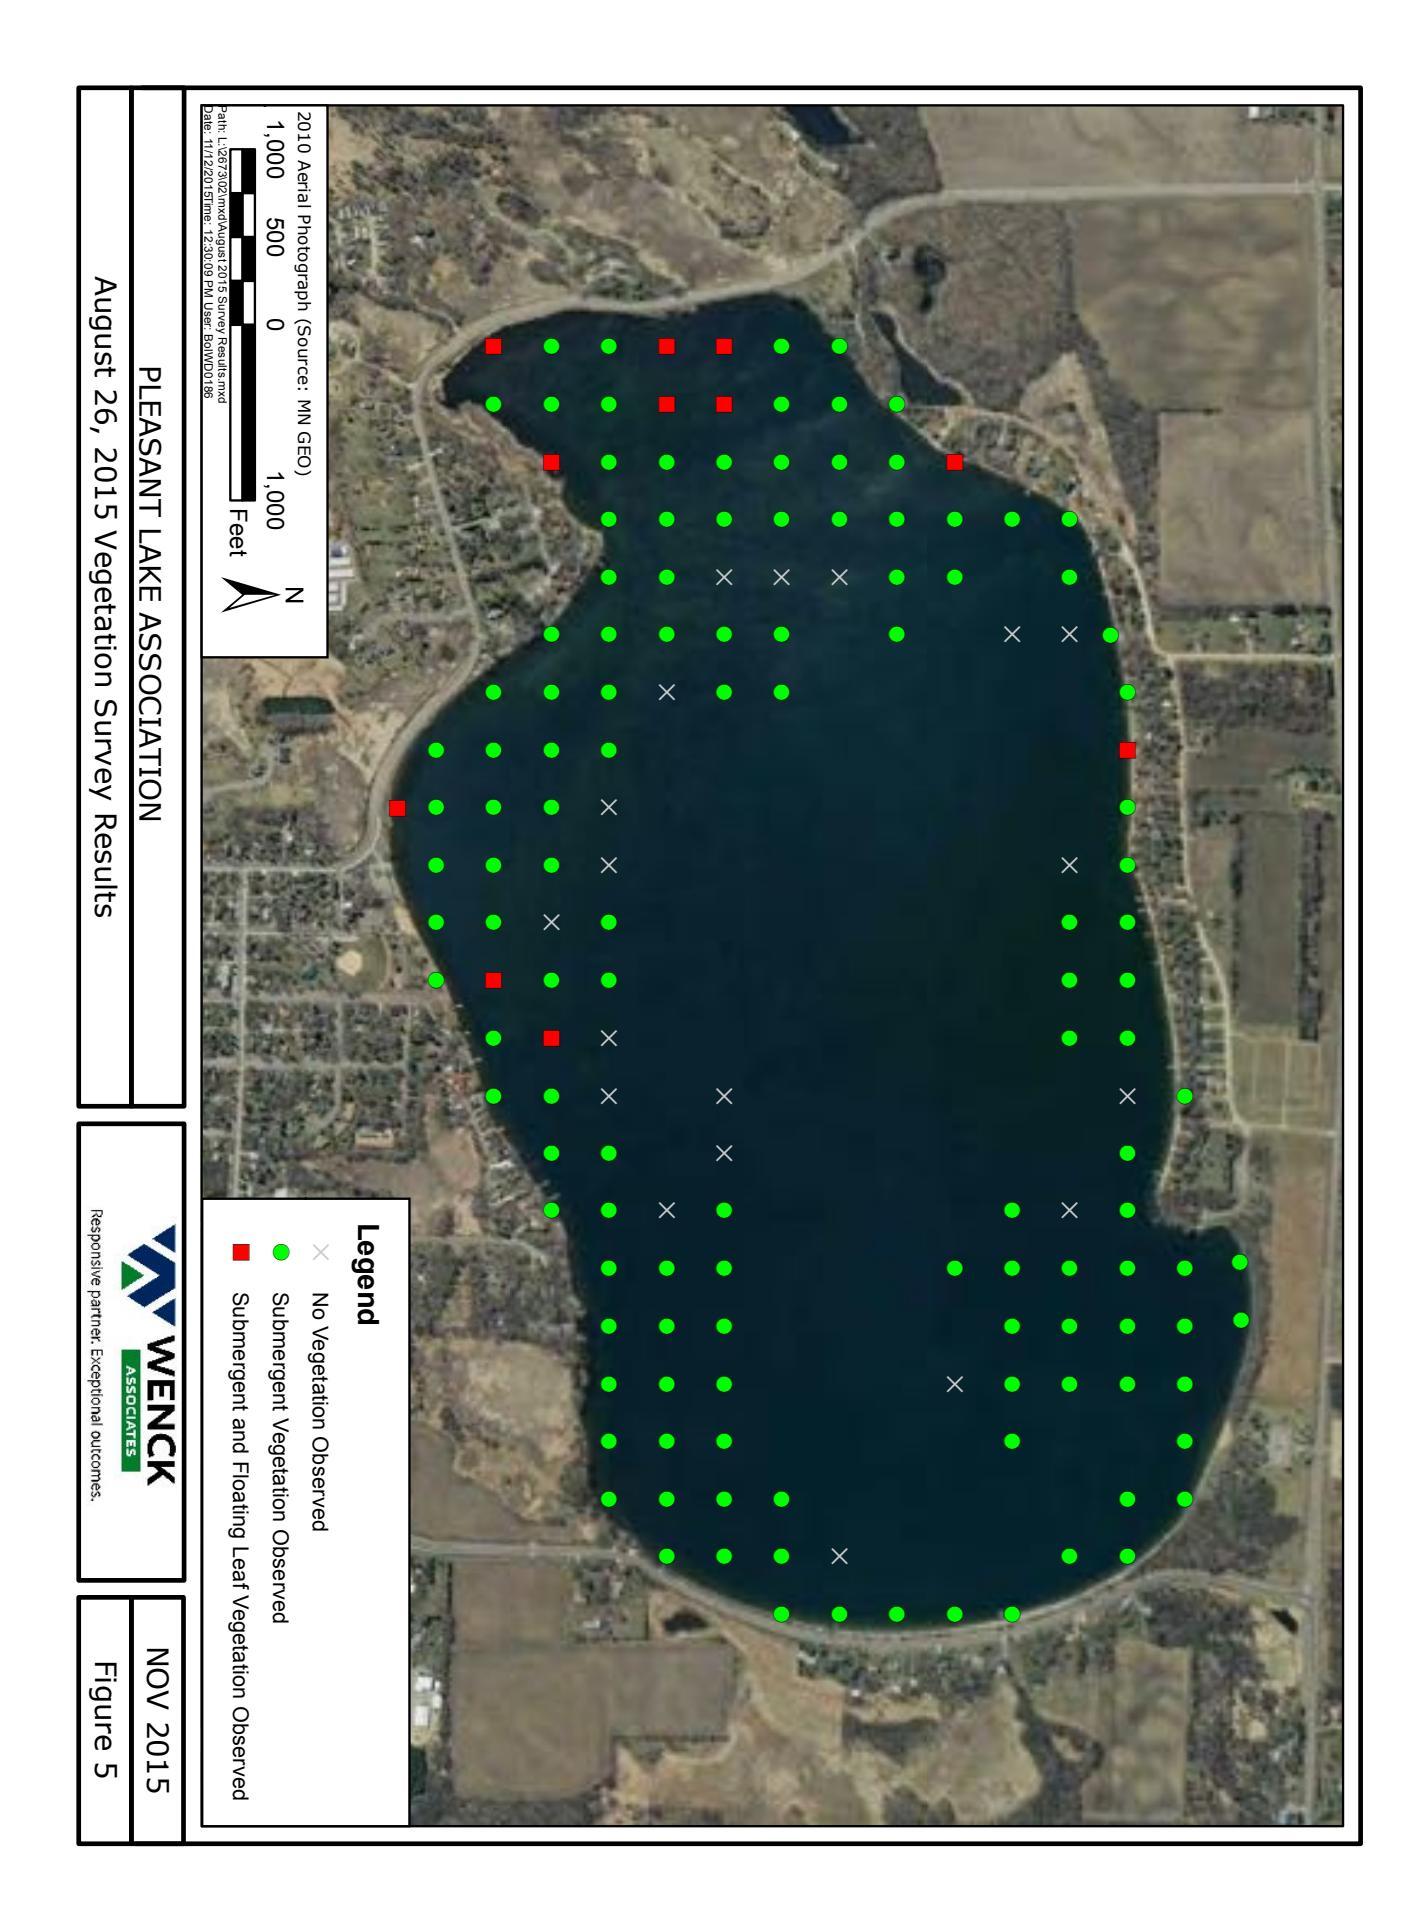
Vegetation was found at 88% of sampling sites during the August 26, 2015 survey (See Figure 5). Vegetation was found at 97% of sites in the littoral zone less than 15 feet deep. Twenty species of aquatic vegetation were documented at sample stations during the survey. The maximum depth at which vegetation was found was 18.5 feet, with frequency of occurrence and diversity generally decreasing with depth.

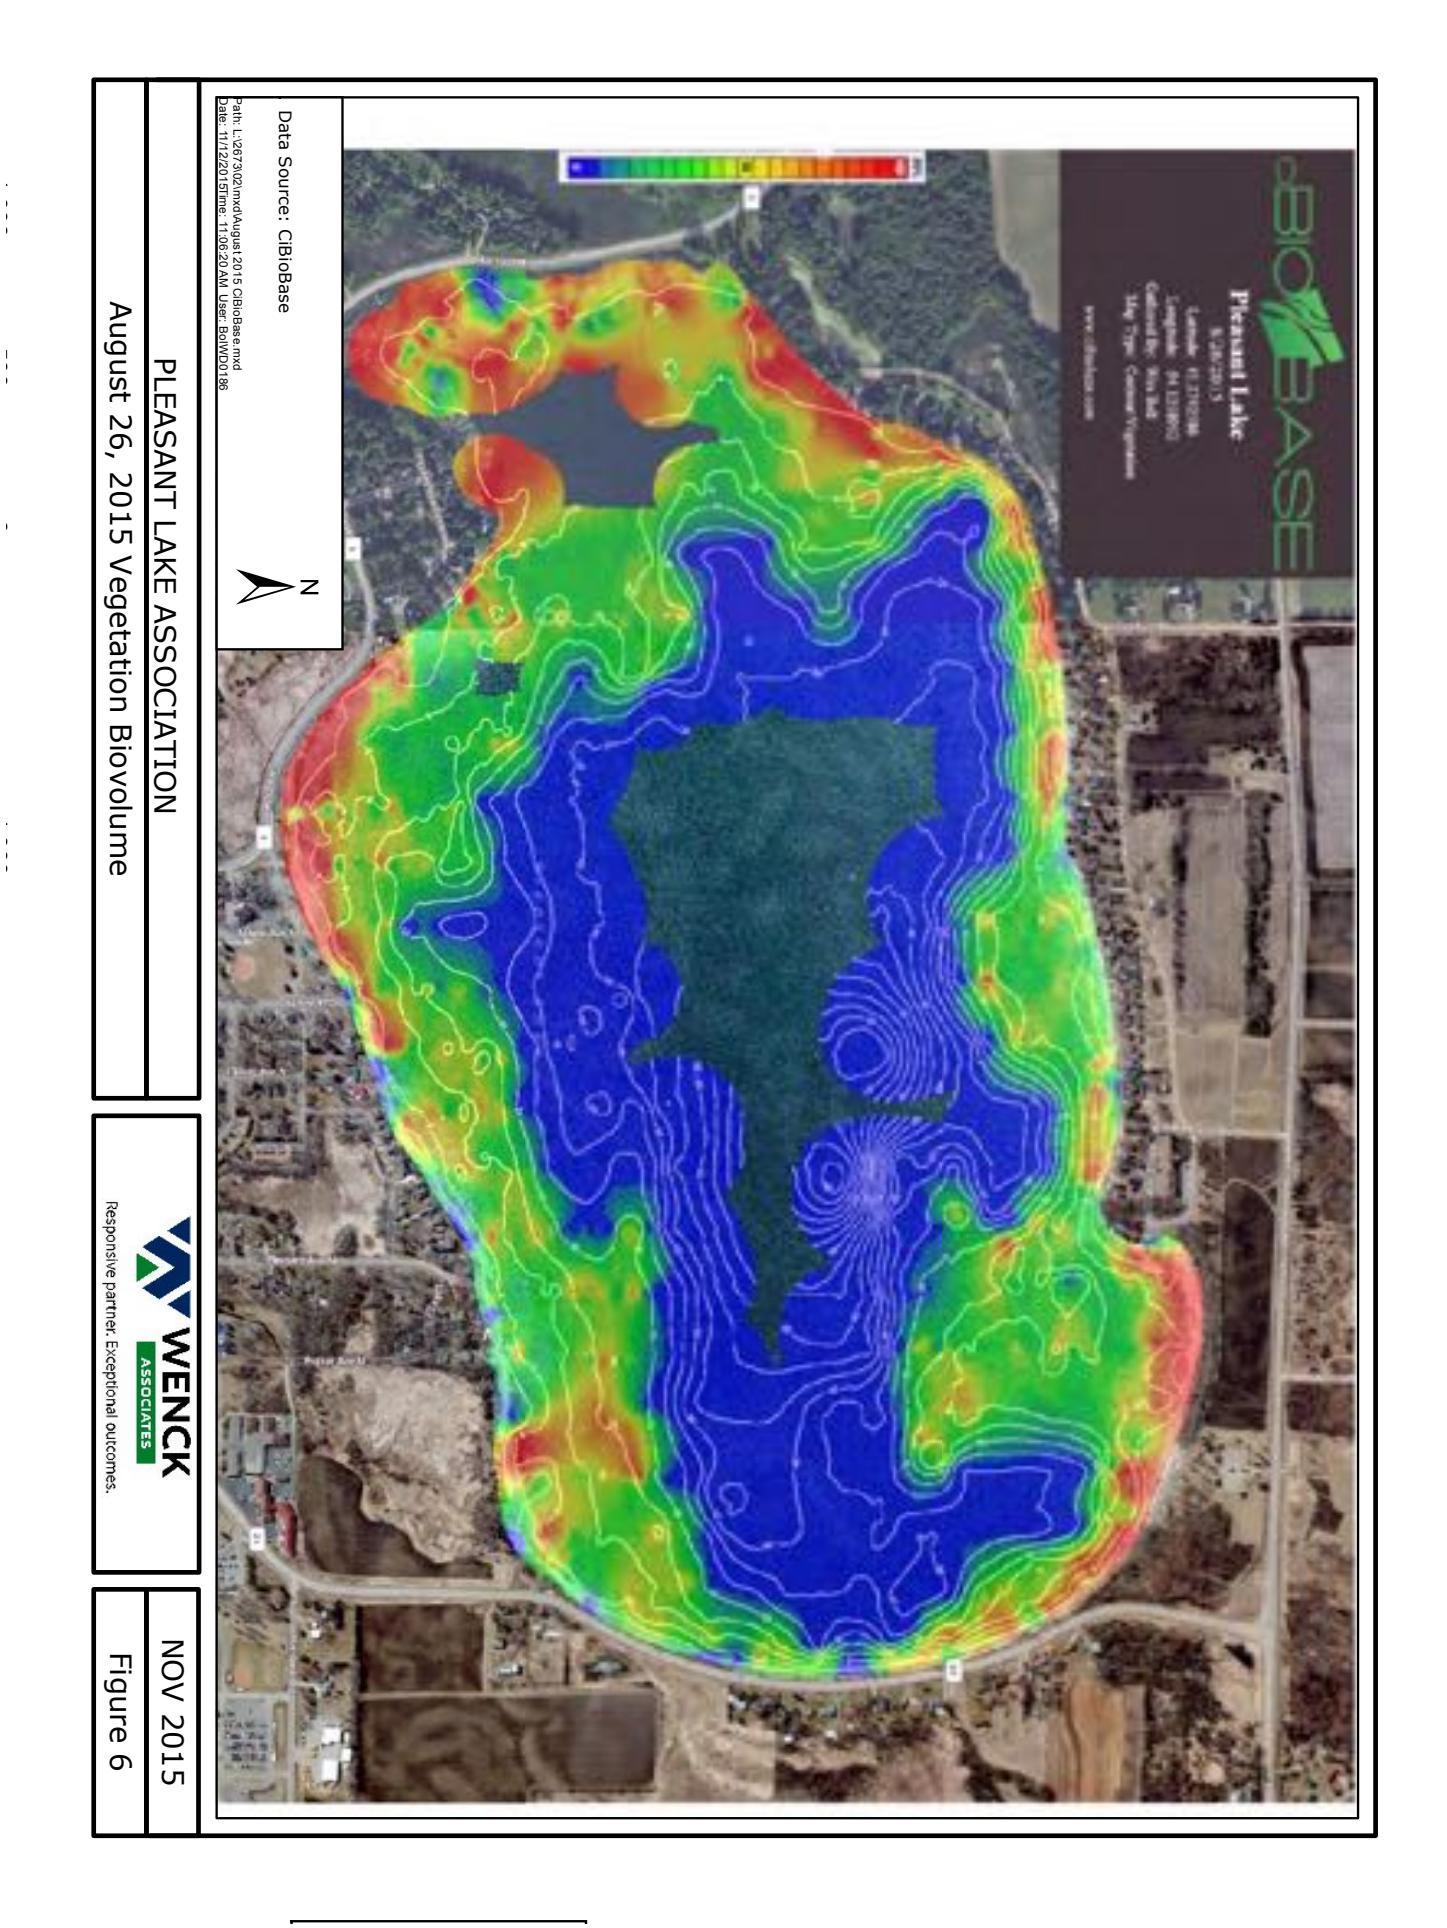
Figure 6 shows the vegetation biovolume from CiBioBase analysis that was observed during the August 2015 survey. This analysis demonstrates that the area of greatest vegetation density occurred in areas near shore and in the western bay of the lake. Note that areas with biovolumes near 100% in depths ranging from 6 to 12 feet around the lake during the June survey had biovolumes closer to 50% during the August 2015 survey. This demonstrates the change in vegetation species composition from a dominance of curly leaf pondweed in June to a dominance of coontail and northern milfoil in August.

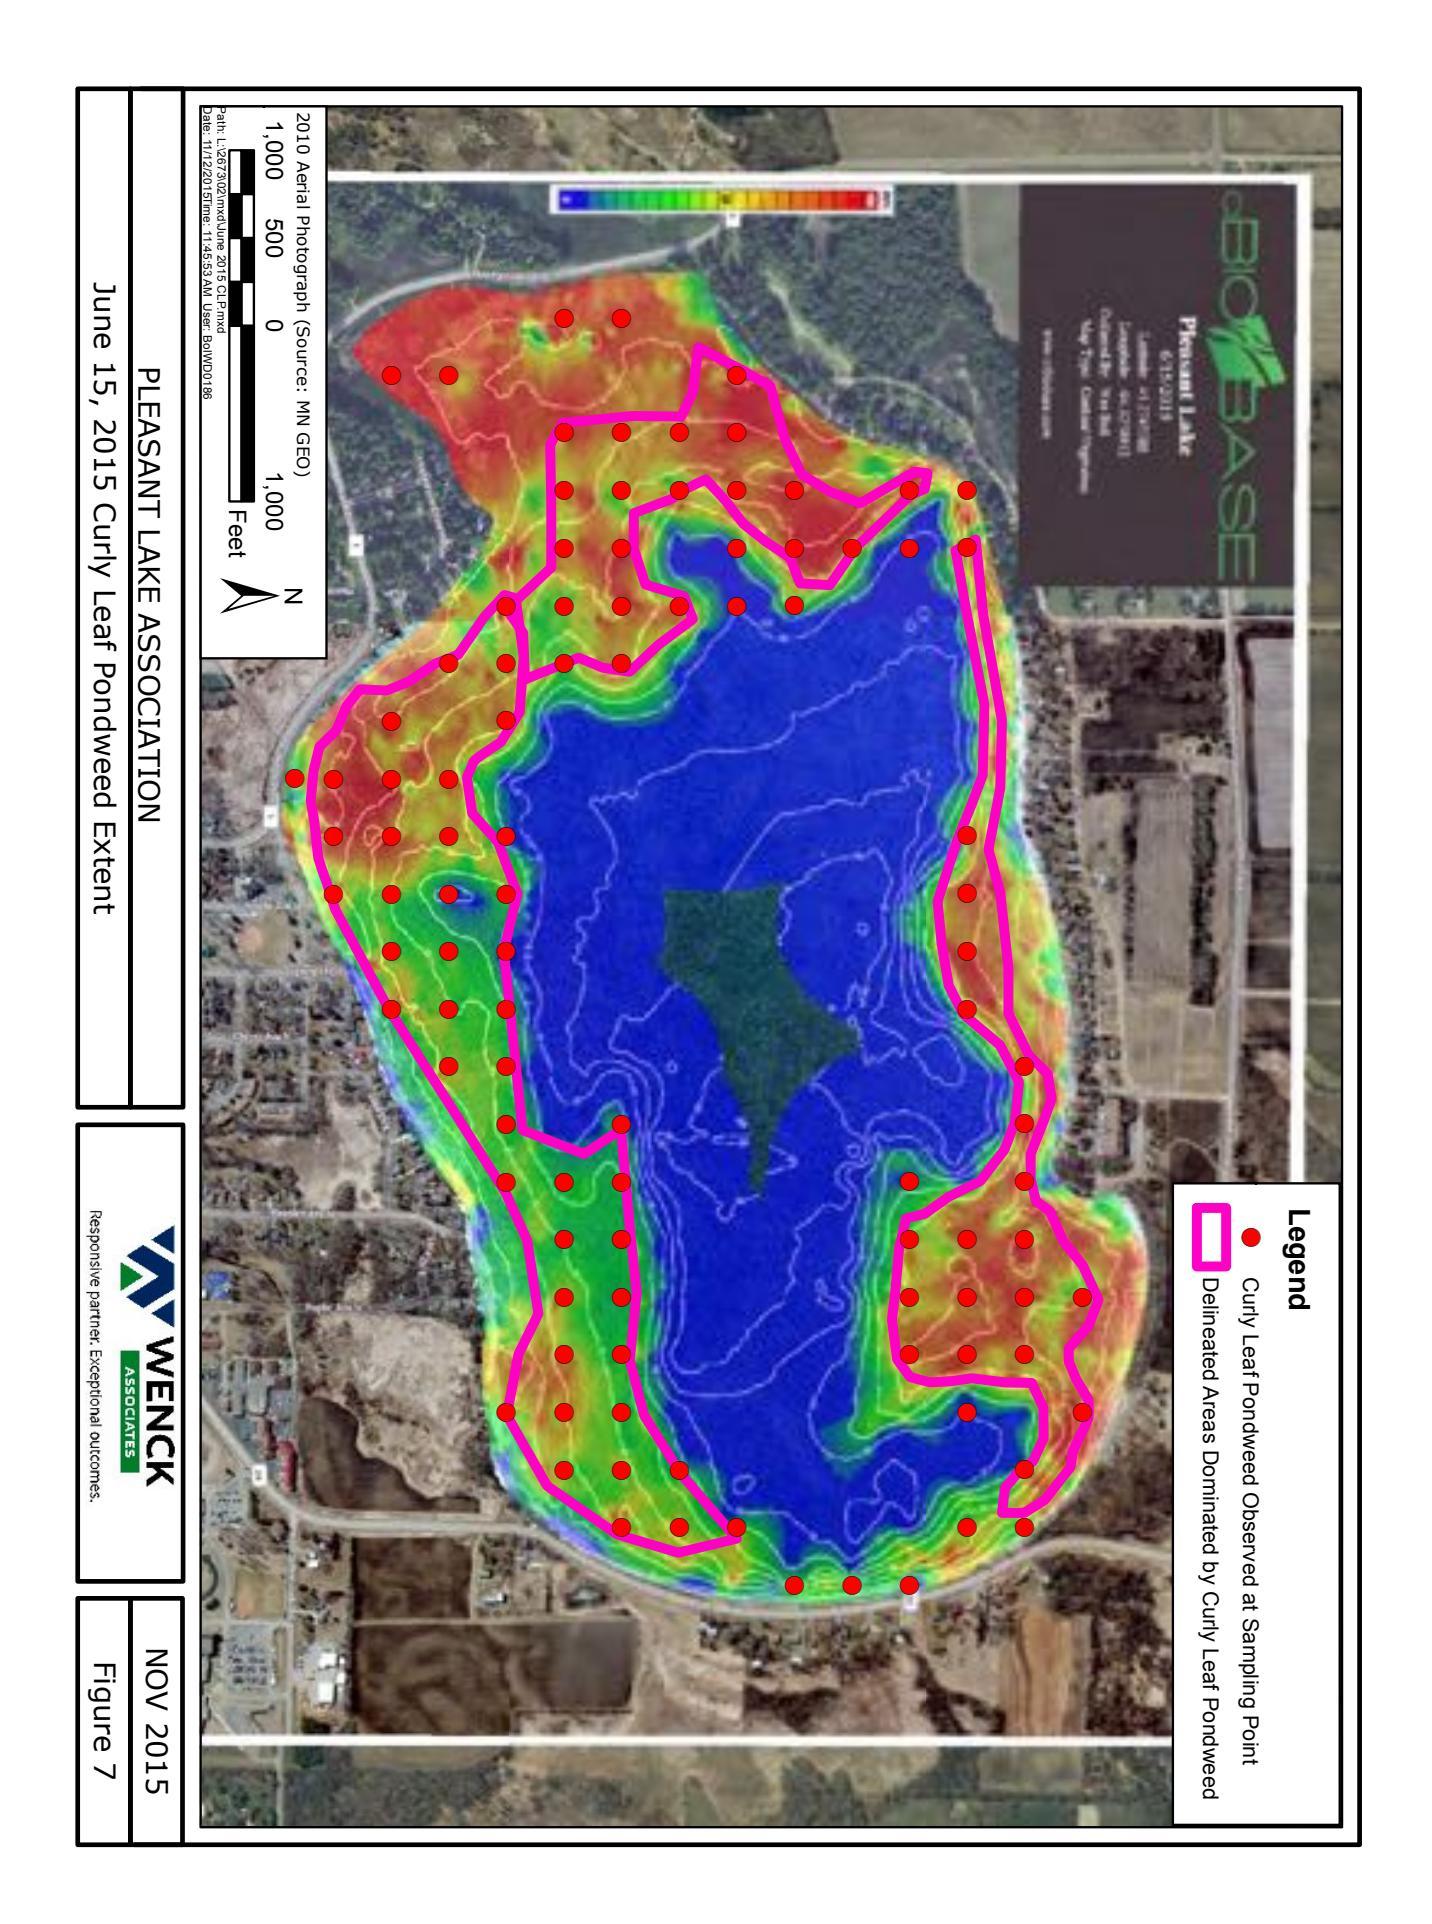
Sample points where curly leaf pondweed was observed during the June 2015 survey are overlaid on the biovolume data on Figure 7. Overall, curly leaf pondweed was observed at 64.3% of sampled points during this survey. Curly leaf pondweed was near peak growth at the time of the survey, as it was observed in dense mats growing to or near the surface in several locations. While it was observed from depths of 3 to 18 feet, curly leaf pondweed was observed was observed to be most prevalent in depths ranging from 6 to 12 feet.

The areas that were dominated by curly leaf pondweed were delineated as shown on Figure 7. While curly leaf pondweed was identified in other points outside of these delineated areas, it was interspersed with native species in these areas and did not completely dominate the vegetation community.

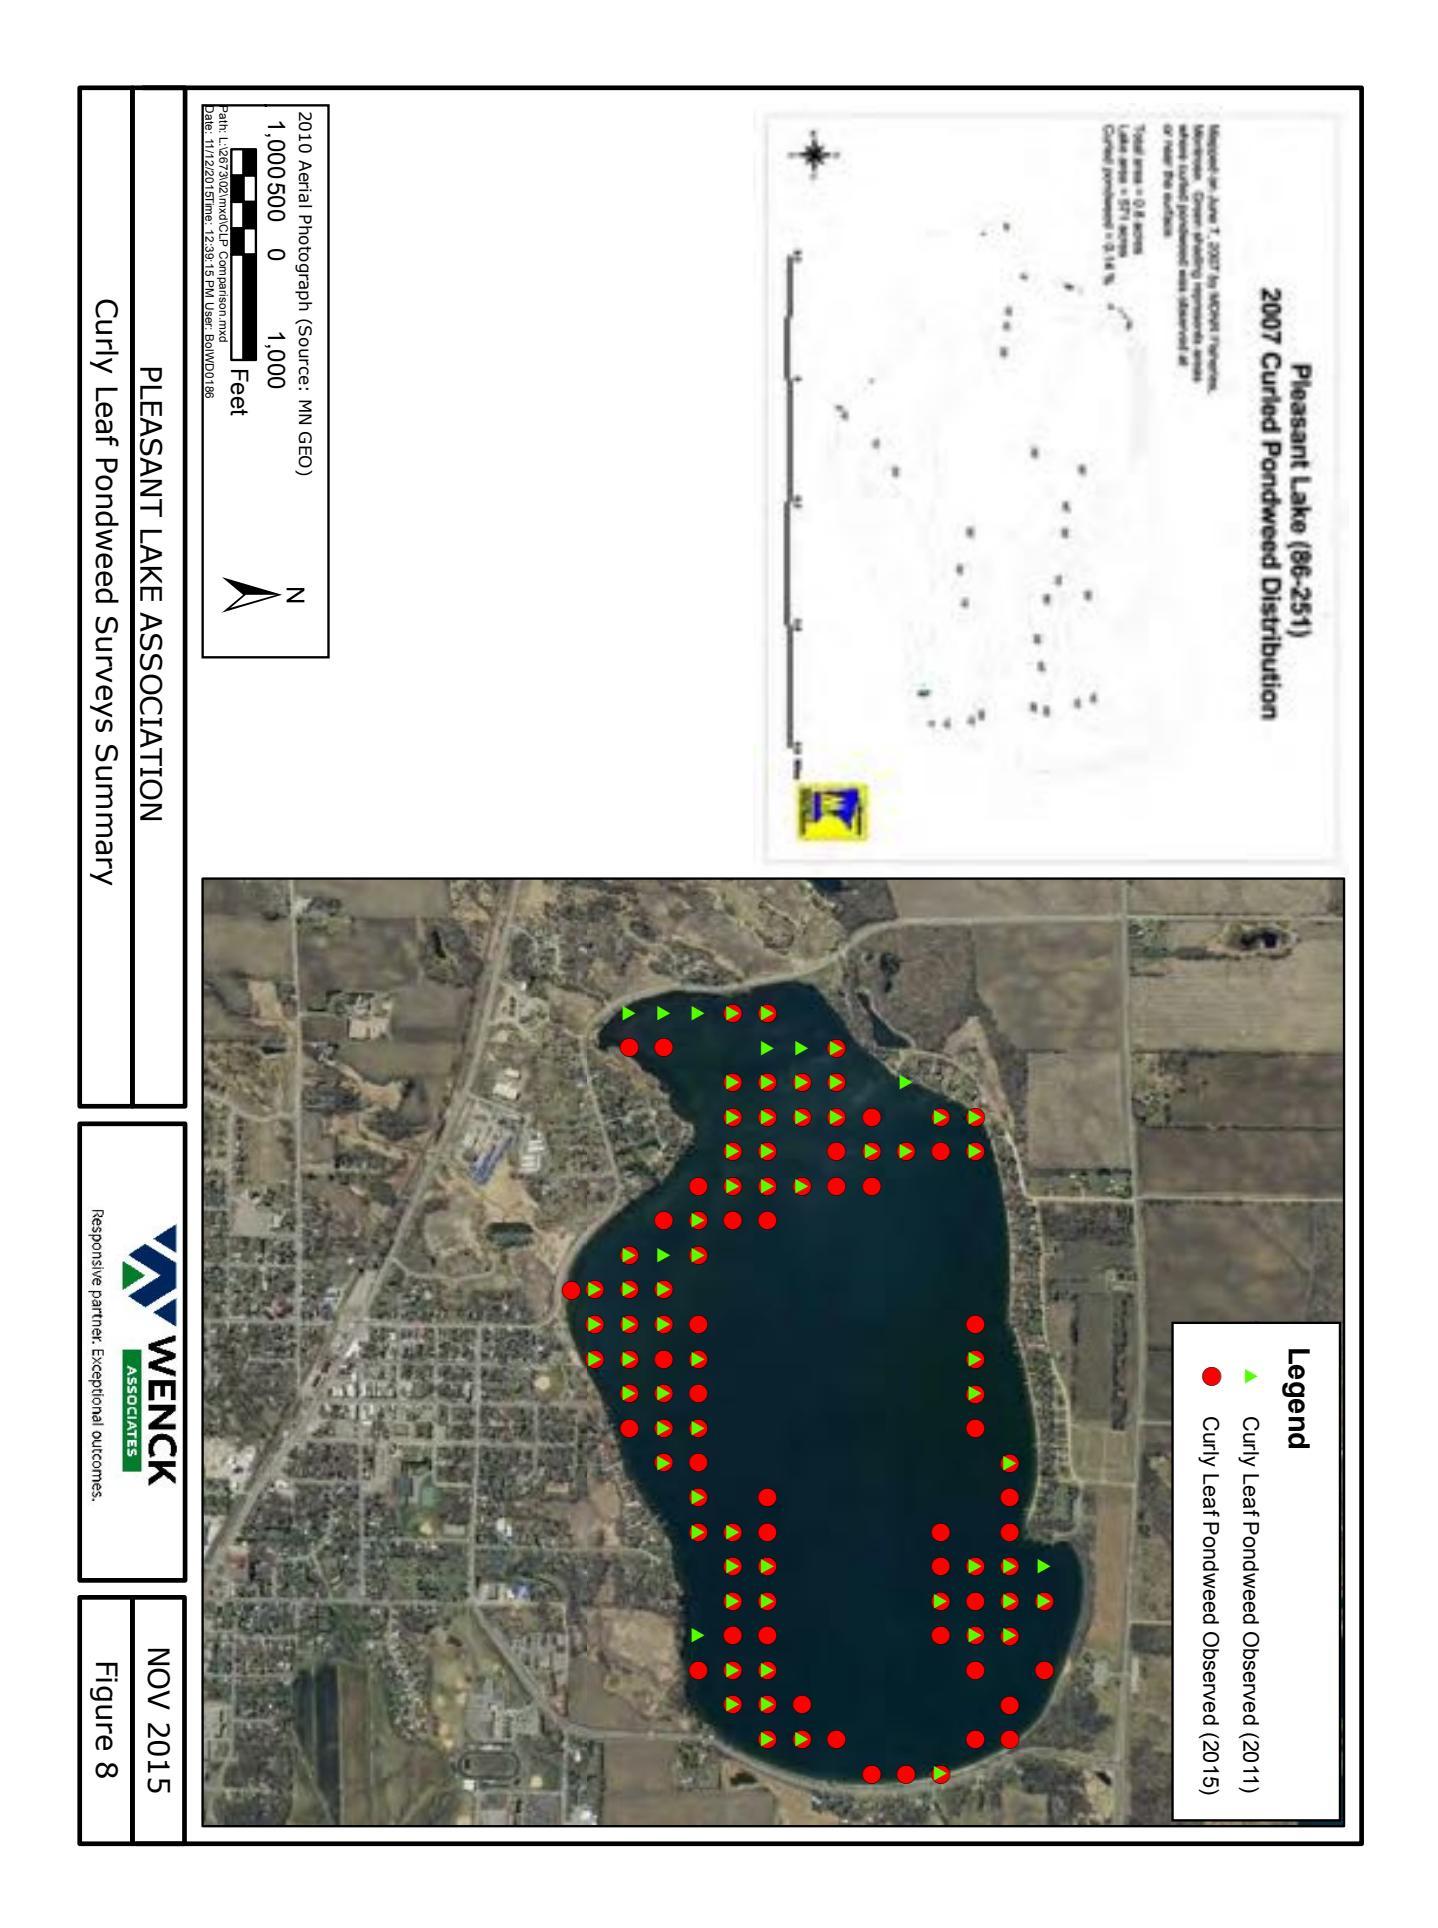
Previous vegetation surveys conducted on the lake in 2007 and 2011 estimated the extent of curly leaf pondweed in the lake. Figure 8 compares the extent of curly leaf pondweed in **VENCK**

previous surveys to the 2015 survey. A June 2007 survey conducted by the MN DNR found curly leaf pondweed limited to a few small stands totaling approximately 0.8 acres in the lake. A 2011 survey conducted by Wenck found that curly leaf pondweed was generally distributed across the lake in a similar extent to what was observed in 2015. The plant occurred slightly more frequently and in several new locations in 2015.
