CASE STUDY – REFURBISHMENT

BUSCOT MANOR HOUSE, BUSCOT, WILTSHIRE

Case Study for:
Buscot Manor House – Refurbishment

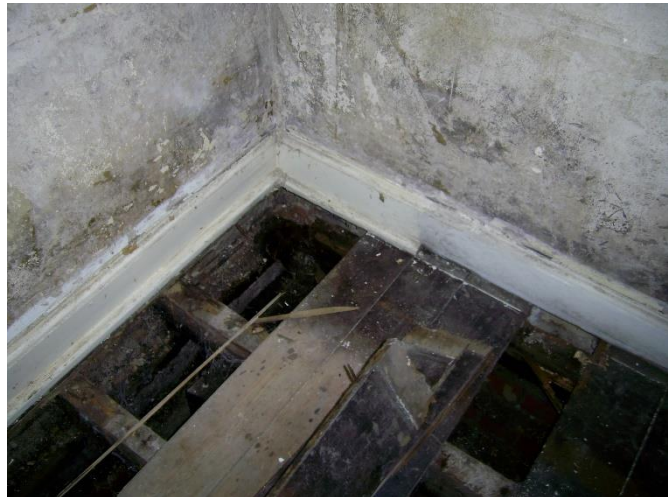
2 Bouncy floor boards indicated a defect - the embedded timber joists had suffered from wet rot and death watch beetle attack

The house was let on a long-term lease, but when the property became empty, the Trust took the opportunity to undertake maintenance works. The works developed from small remedial works to dealing with beetle infestation to the ground floor, historical research, new services and plastering to most of the walls.
