Putting cladding to the test

Peter Kaczmar reports on a test to find out what can be done

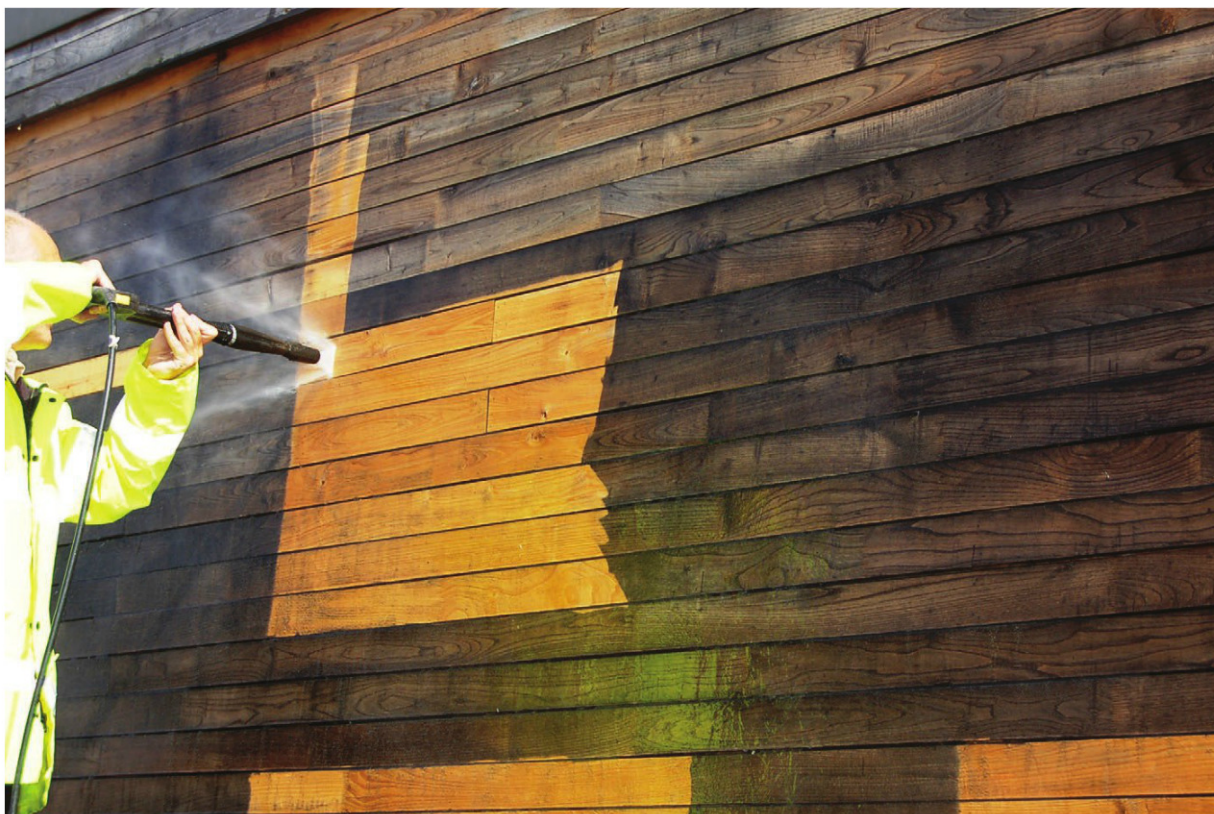
Surface cleaning of discoloured Sweet Chestnut cladding using a pressure washer

The pressure washing proved to be effective, quick and easy for removing mould and extractive staining, and meant that large tracts of cladding could be cleaned with just a single pass of the water jet.

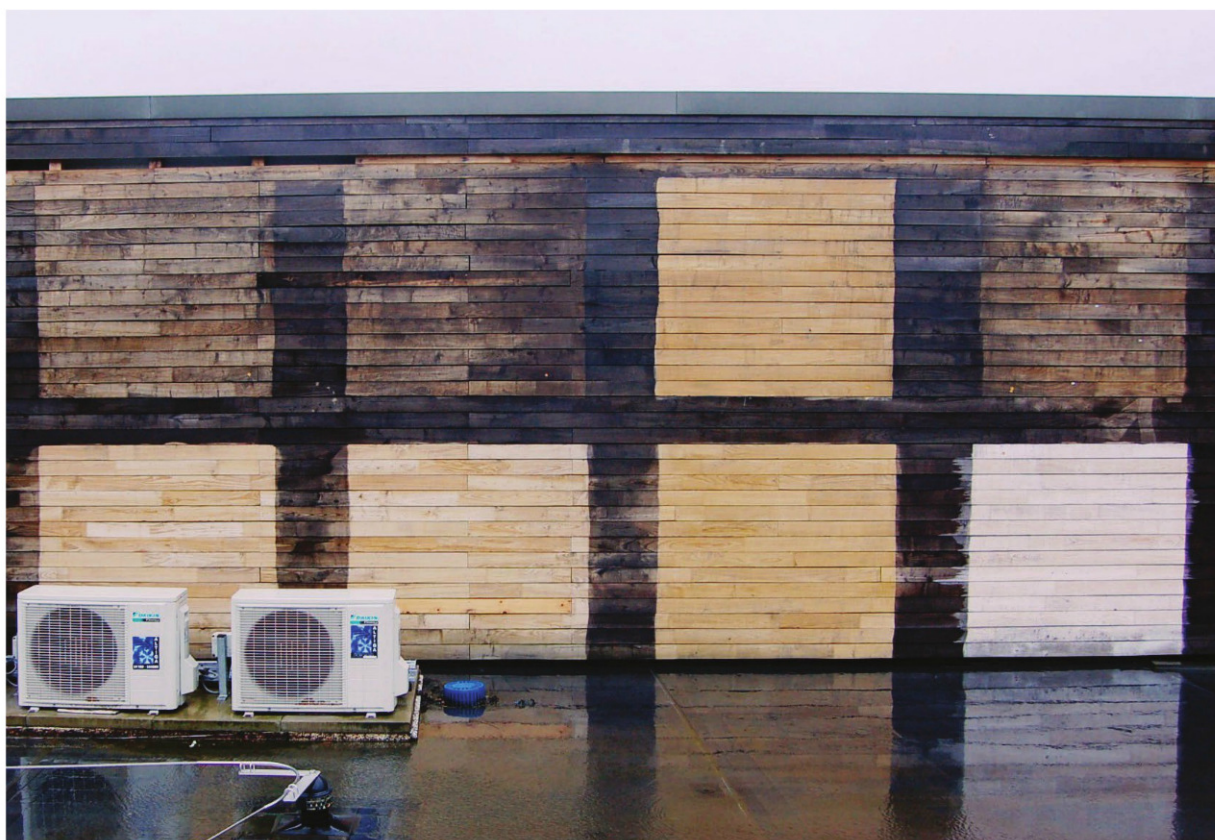
The cleaned Sweet Chestnut 14 months later, showing different levels of re-colonisation

Also, despite the cleaning, significant re-colonisation by the yeast was found after 12 months. Treatment of the surface with a resin-based, decking-protection product yielded the best results in terms of preventing the re-emergence of surface discolouration after one-year.
