Your Inspection Report

Nice Town, MN

INSPECTION DATE:
Friday, December 20, 2013

RE: Report No. 1140, v.4

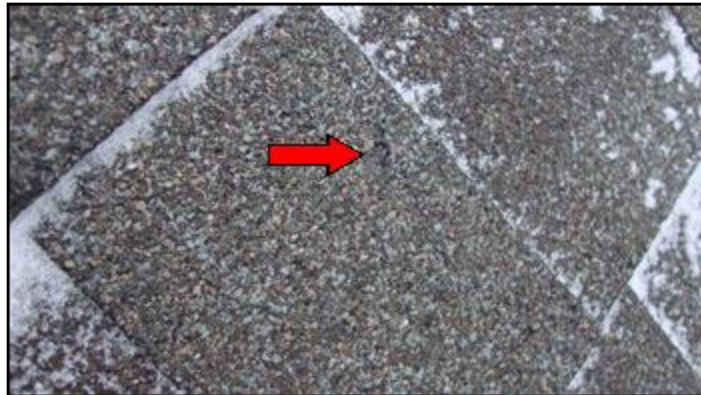
Granule loss

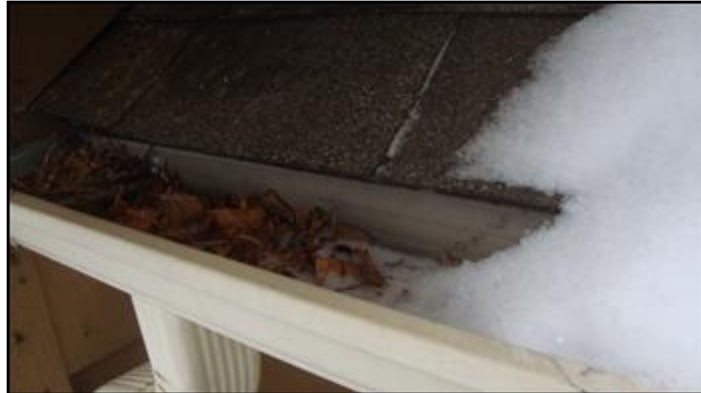
Clogged

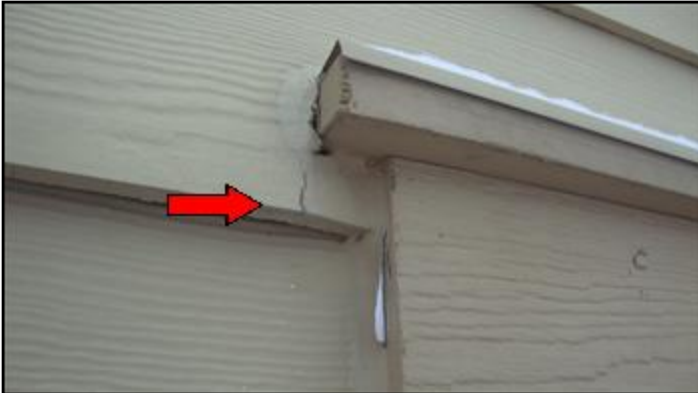
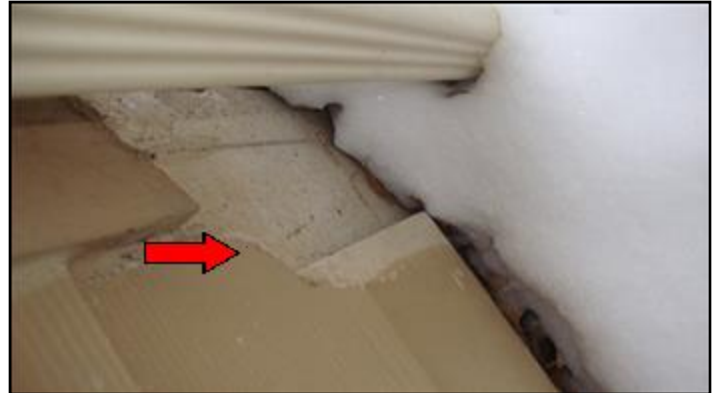
17. Condition: • [Missing paint or caulking](#)

Implication(s): Cosmetic defects | Chance of water damage to contents, finishes and/or structure

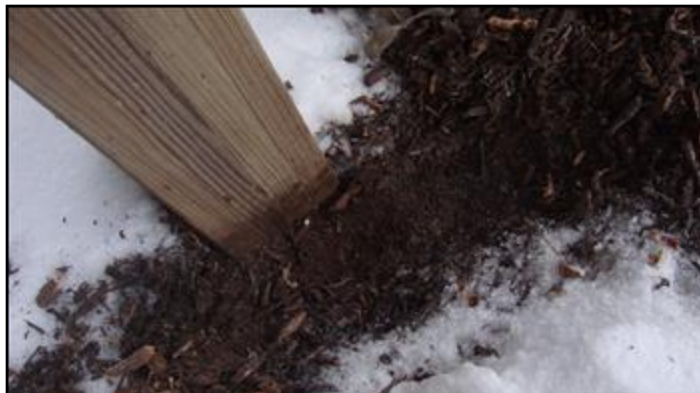
Wood/soil contact

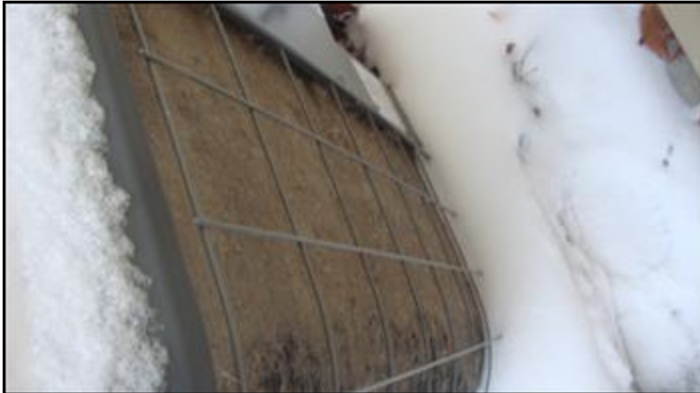
Dirty

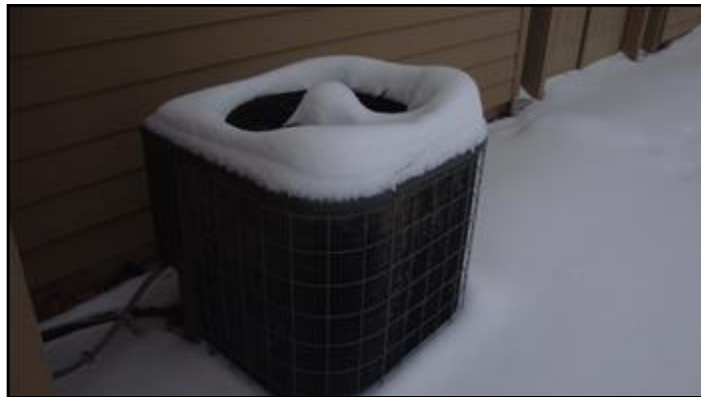
Dirty

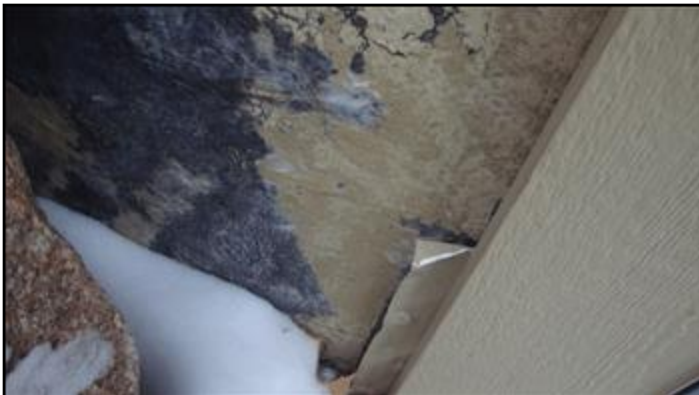
Not protected at top

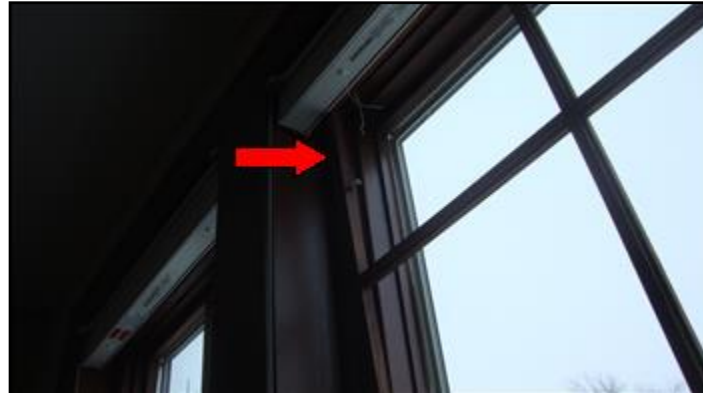
62. Condition: • Interior grills or dividers loose.

Task: Repair
