PROPERTY CONDITION ASSESSMENT REPORT

Sample Report
Minneapolis, MN

Wednesday, October 21, 2015

RE: Report No. 1480, v.2
Sample Report
Minneapolis, MN

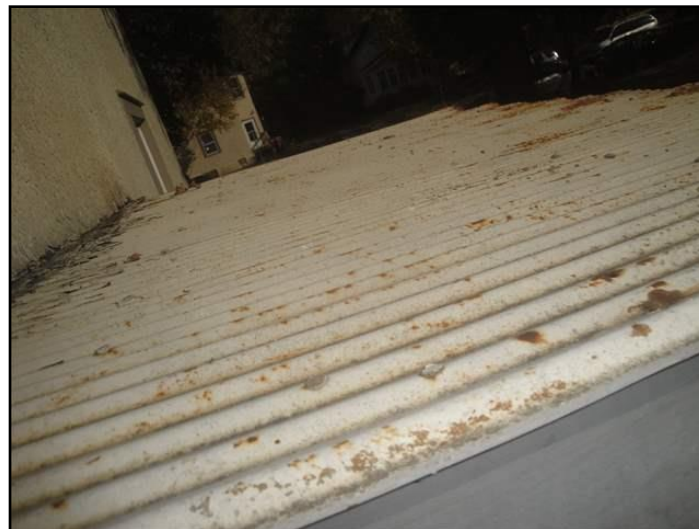
Condition: • [Rust](#)

1. *Rust*

Task: Repair

Time: Less than 2 years

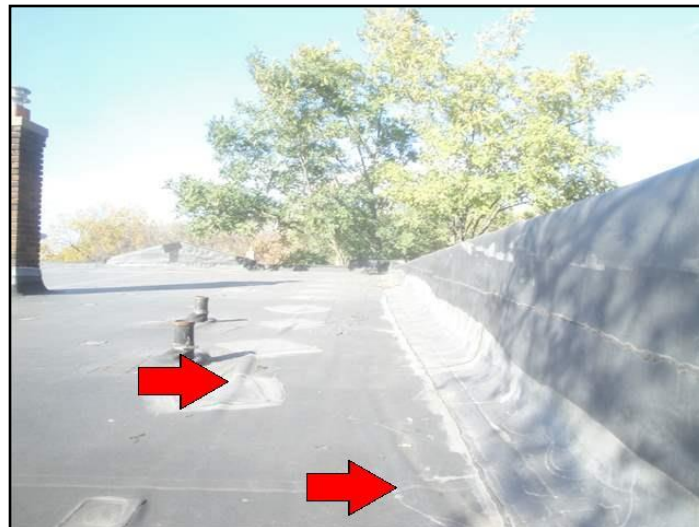
7. Condition: • [Wrinkles, ridges, fishmouths](#)

3. *Wrinkles, ridges, fishmouths*

Task: Repair

Time: Regular maintenance

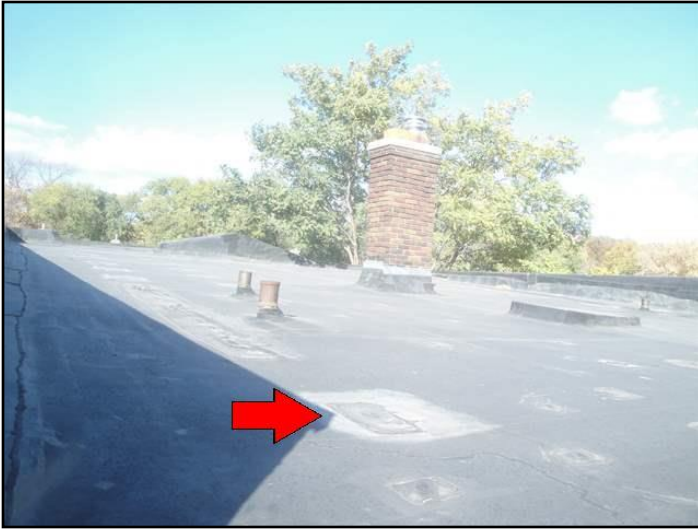
8. Condition: • [Patched](#)

4. Patched

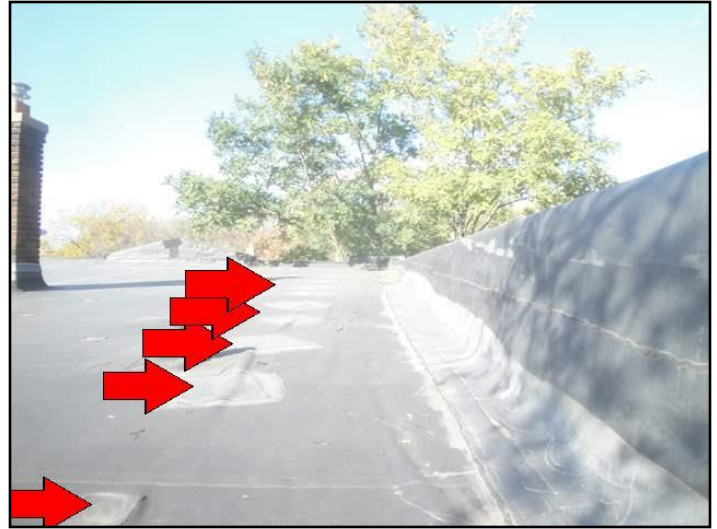
5. Patched

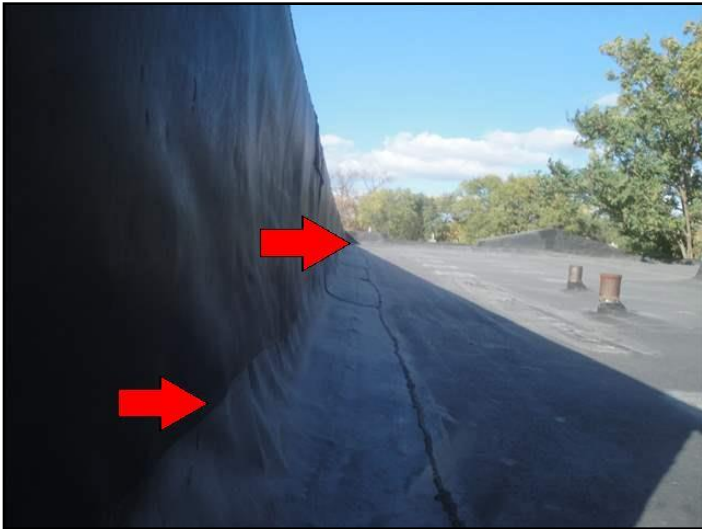
Roof is aging with minor tenting observed. Recommend annual service to prolong life of roof .

7. Taut, tenting

Task: Repair

Time: Annually

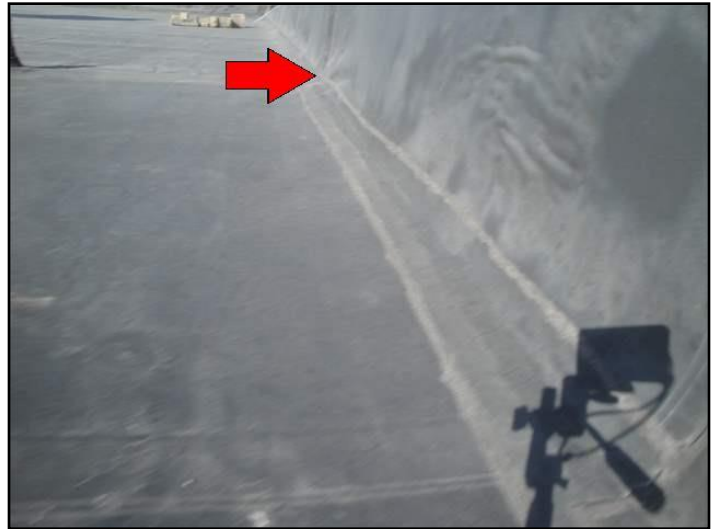
8. Taut, tenting

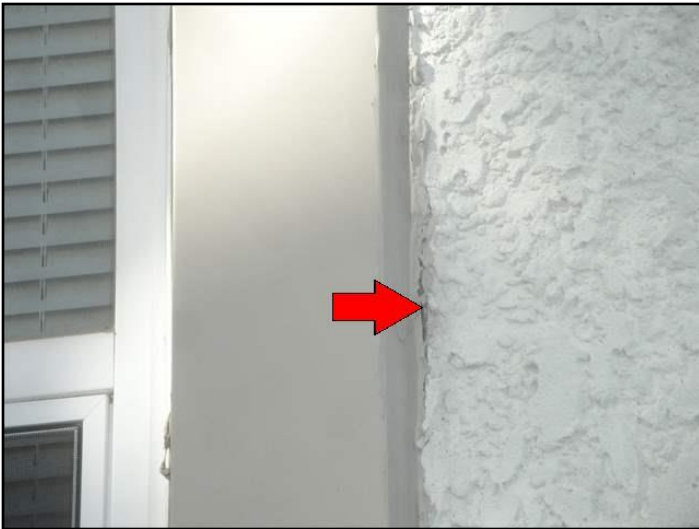
30. Caulking missing or ineffective

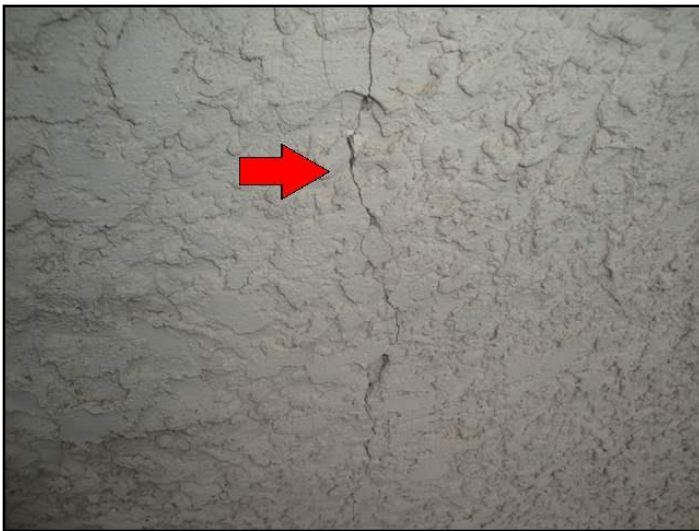
A small number of minor cracks were observed in various areas of the buildings. There is a potential for moisture penetration. Seal cracks and voids.

32. Cracked

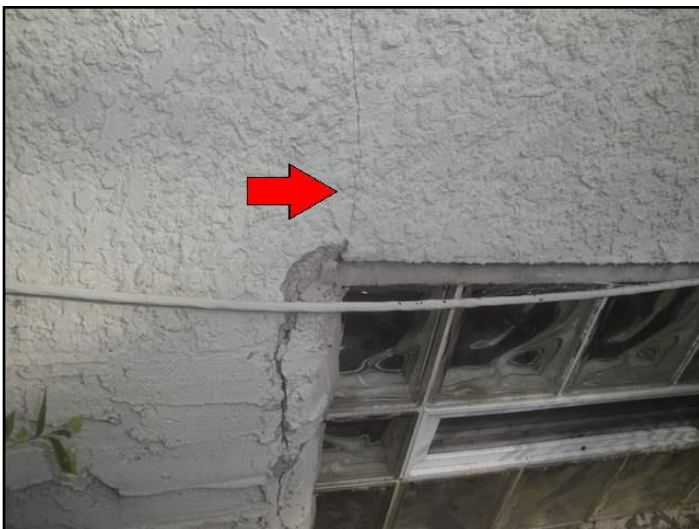
34. Cracked

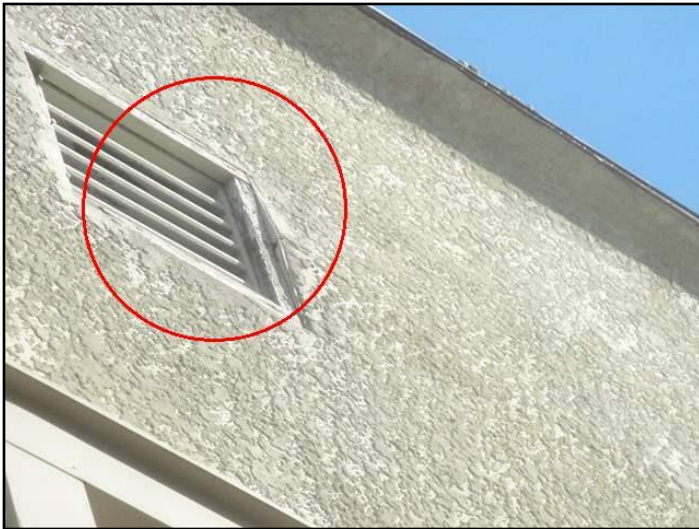
Condition: • [Bulging](#)

36. *Bulging*

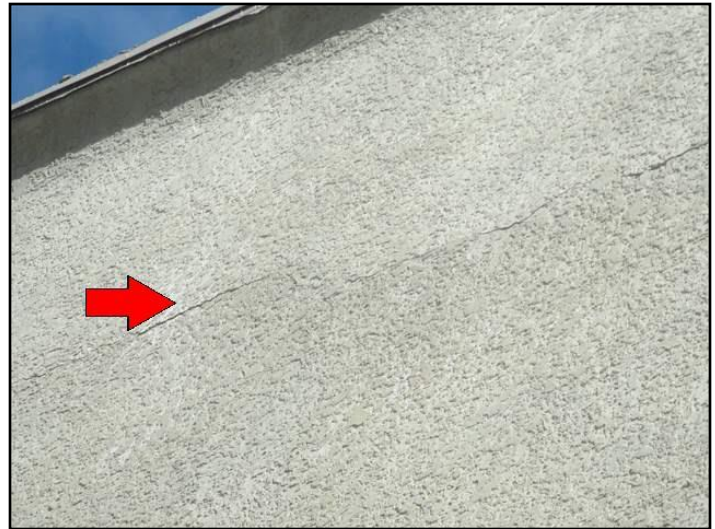
37. *Bulging*

19. Condition: • [Bulging](#)

Implication(s): Material deterioration | Chance of water damage to contents, finishes and/or structure | Cosmetic defects

Task: Repair

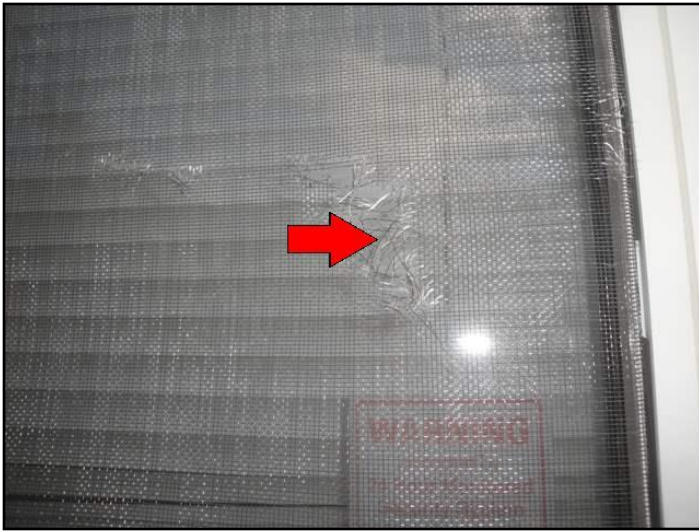
40. Torn or holes

23. Condition: • [Torn or holes](#)

Tear, holes and general damage observed at various screens.

Task: Repair

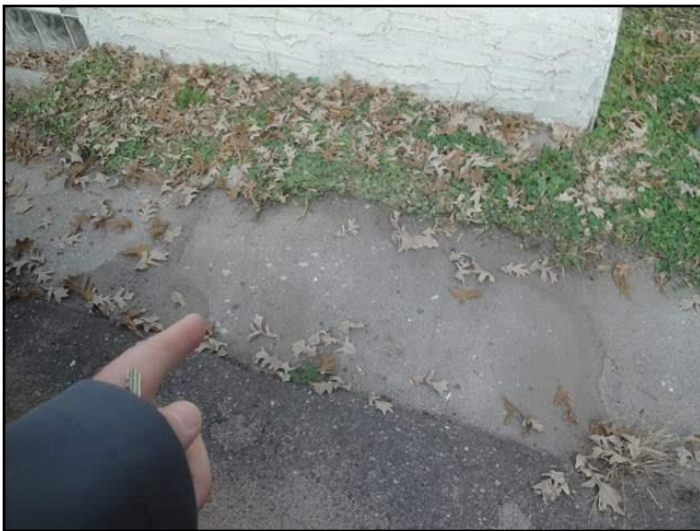
42. Improper slope

24. Condition: • [Improper slope](#)

Settled areas and areas of flat grade observed near foundations. Window sills were at or below grade. Evidence of significant moisture intrusion on interior basement walls.

Implication(s): Chance of water damage to contents, finishes and/or structure

Task: Improve

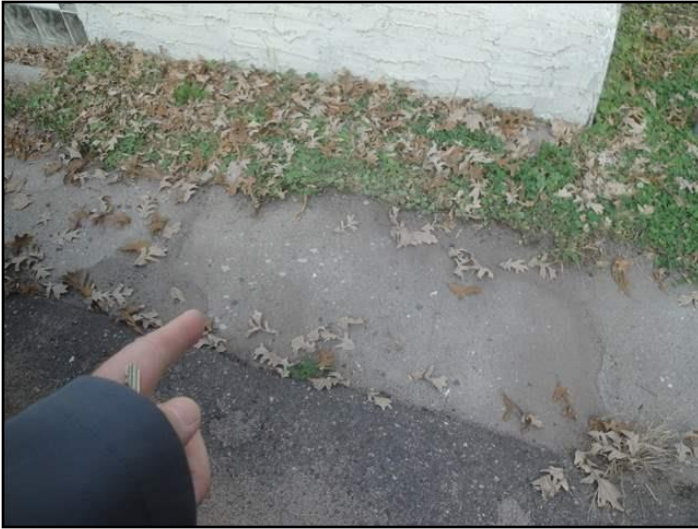
49. Improper slope or drainage

27. Condition: • [Improper slope or drainage](#)

Implication(s): Chance of water damage to contents, finishes and/or structure

Task: Repair

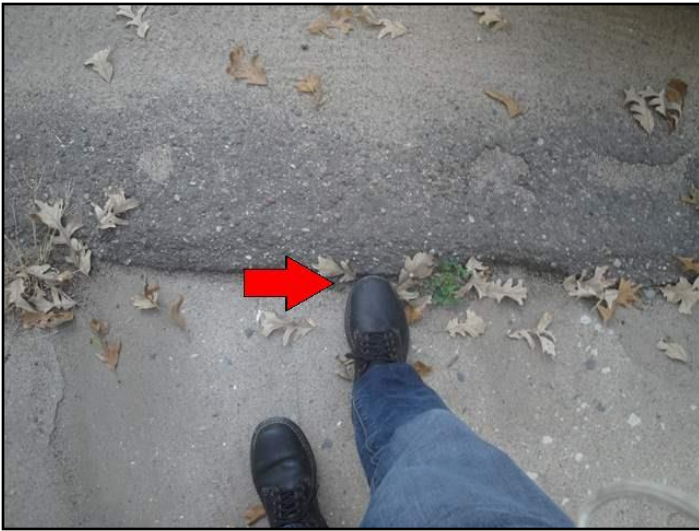
51. Uneven (trip hazard)

28. Condition: • [Uneven \(trip hazard\)](#)

Task: Repair

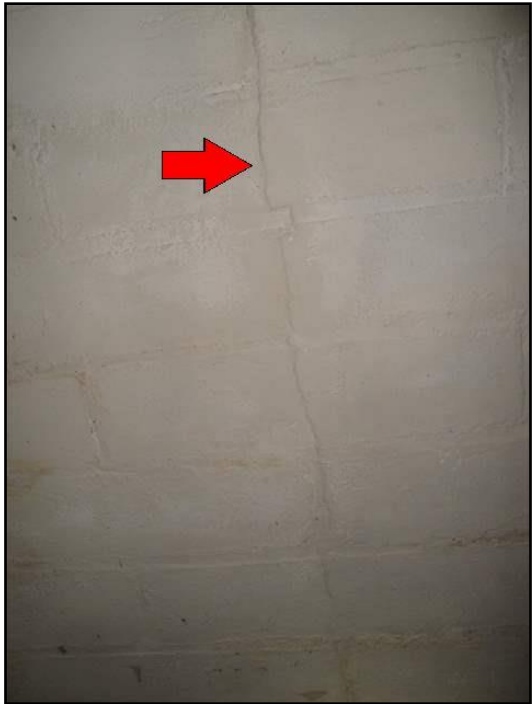
55. Cracked

31. Condition: • [Cracked](#)

Minor to moderate cracks were observed. Poor grading and water damage are contributing factors. The cracks are not an immediate structural concern however grading improvements and mortar repair or crack sealing are recommended to prevent further damage and moisture intrusion.

Implication(s): Chance of water damage to contents, finishes and/or structure | Weakened structure

Task: Repair

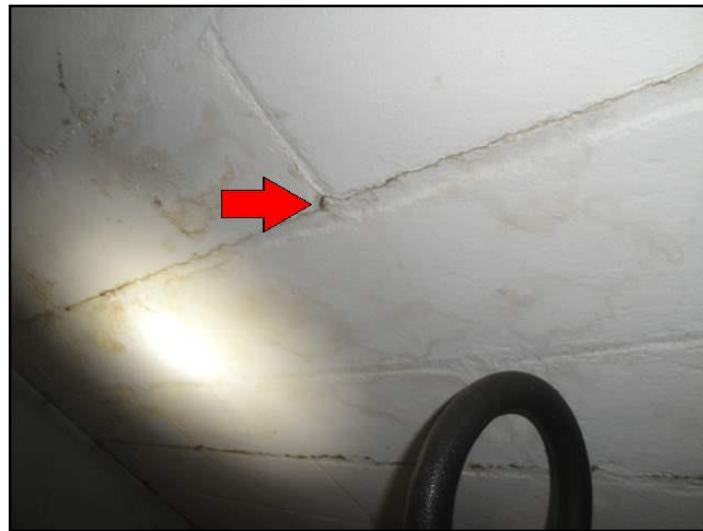
62. Cracked horizontally

32. Condition: • [Cracked horizontally](#)

A horizontal crack was observed on the east wall. Poor grading and water damage are contributing factors. The crack is not an immediate structural concern however grading improvements and mortar repair or crack sealing are recommended to prevent further damage and moisture intrusion. The wall was checked with a level and no lateral movement was observed.

Task: Repair

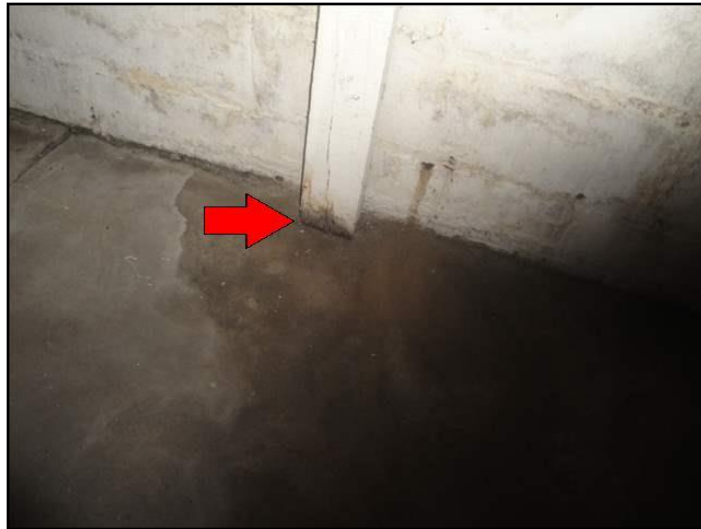
64. Rot

34. Condition: • [Rot](#)

Minor rot was observed at the column near the stairs.

Task: Monitor

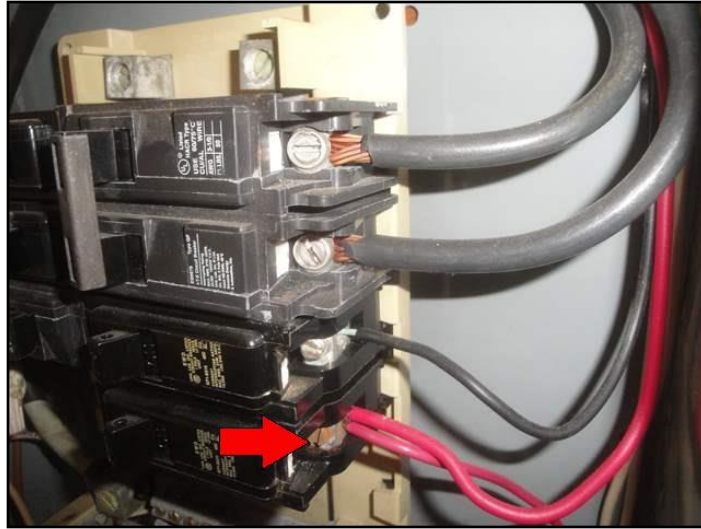
67. Double taps

36. Condition: • [Double taps](#)

Implication(s): Fire hazard

Task: Repair

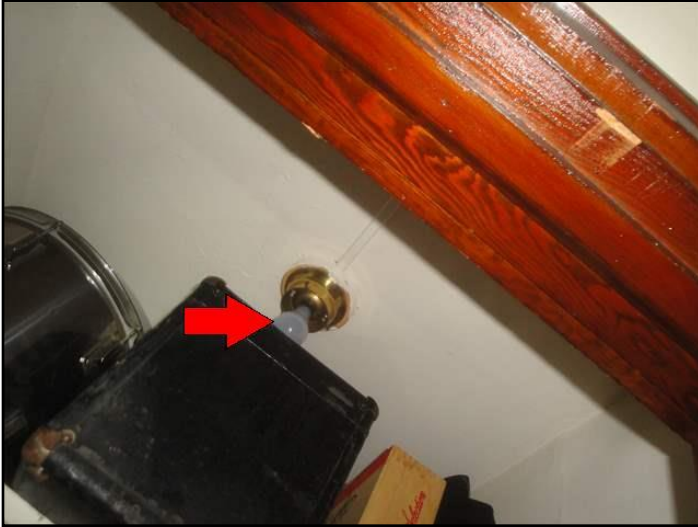
69. Improper closet lighting

38. Condition: • [Improper closet lighting](#)

Implication(s): Fire hazard

Provide a globe or replace the fixture to reduce the risk of fire when items in the closet have the potential to come into contact with or have little clearance from hot exposed bulb.

Task: Repair or replace

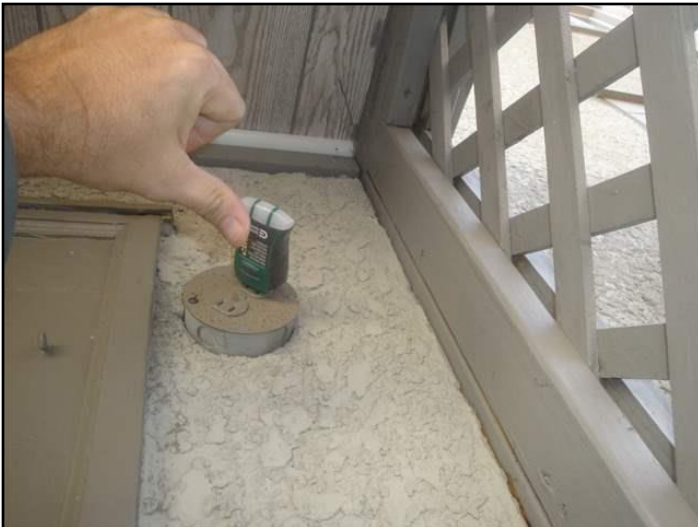
39. Condition: • [Inoperative](#)

71. Inoperative

Task: Repair

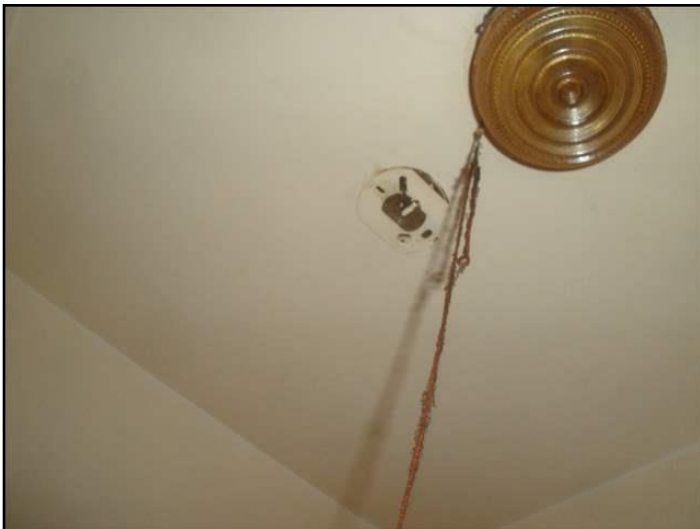
45. Condition: • Missing

Implication(s): Fire hazard

73. Missing

Task: Provide

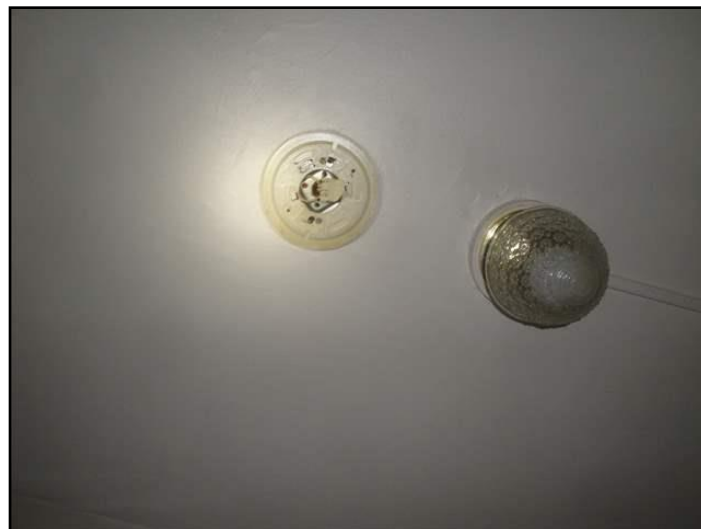
75. Missing

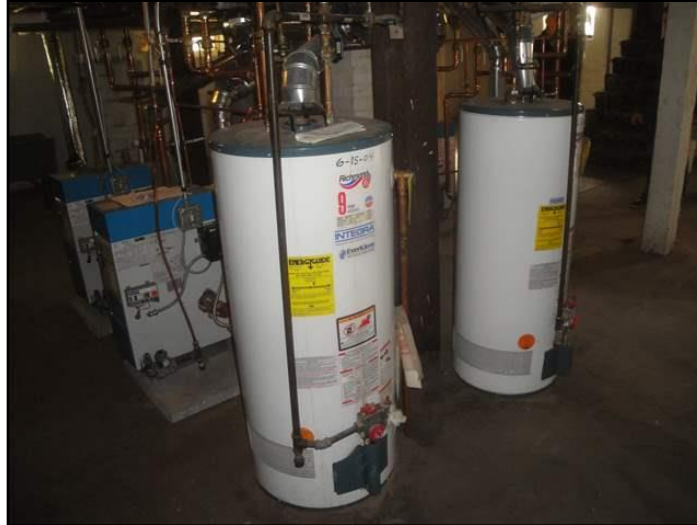
76.

General: • boiler and water heater installations:

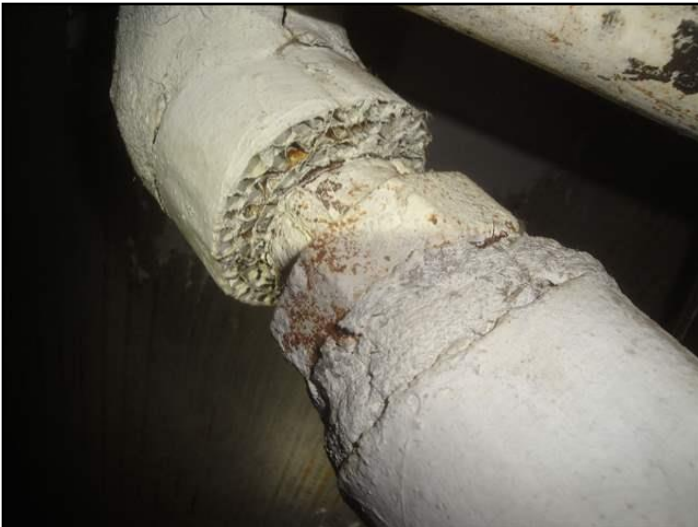
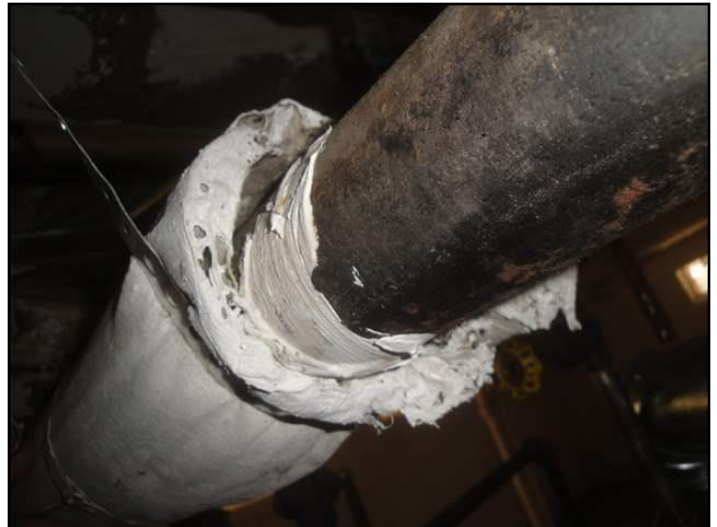
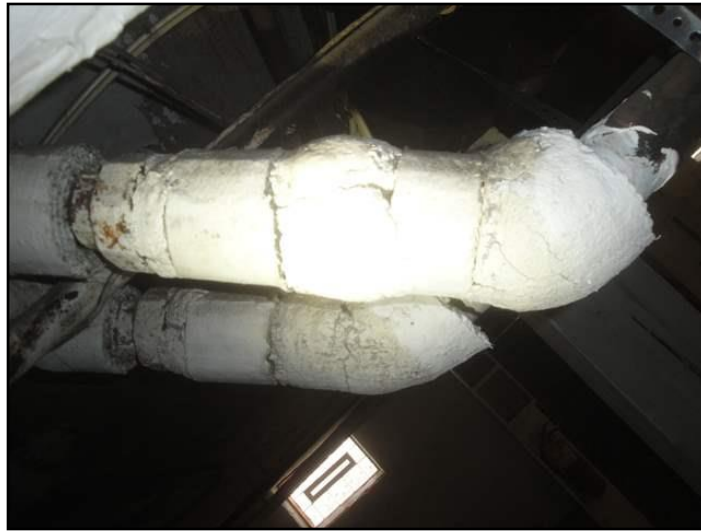
49. Condition: • Potential asbestos. Recommend further assessment by an environmental professional.

Task: Further evaluation

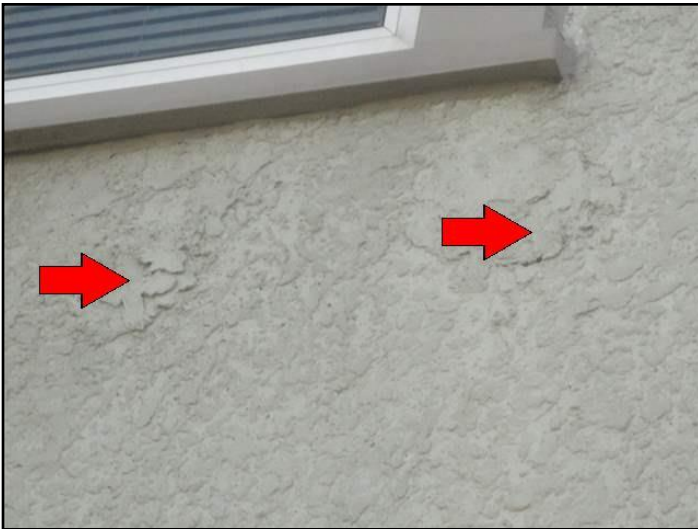
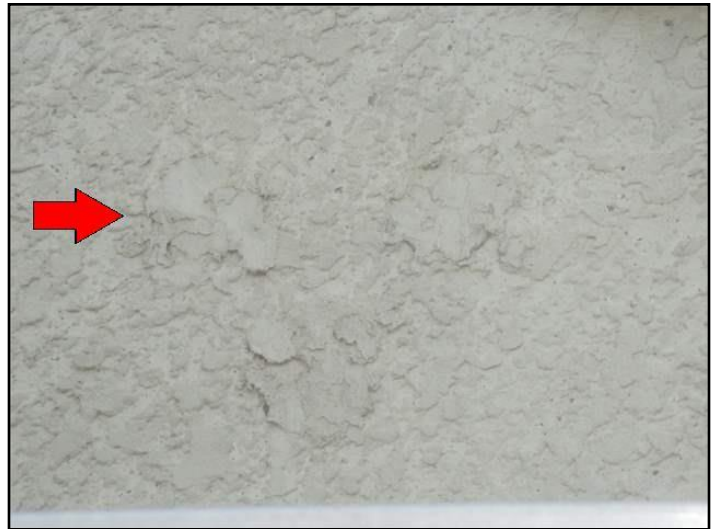
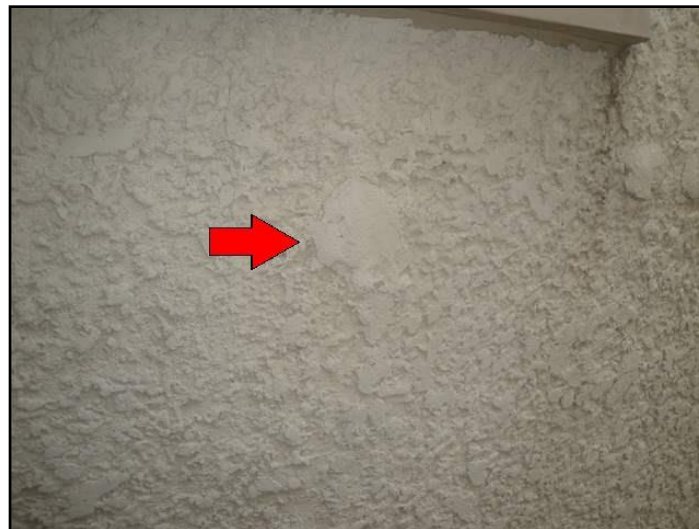
- Likely upgraded - Patched stucco was observed.

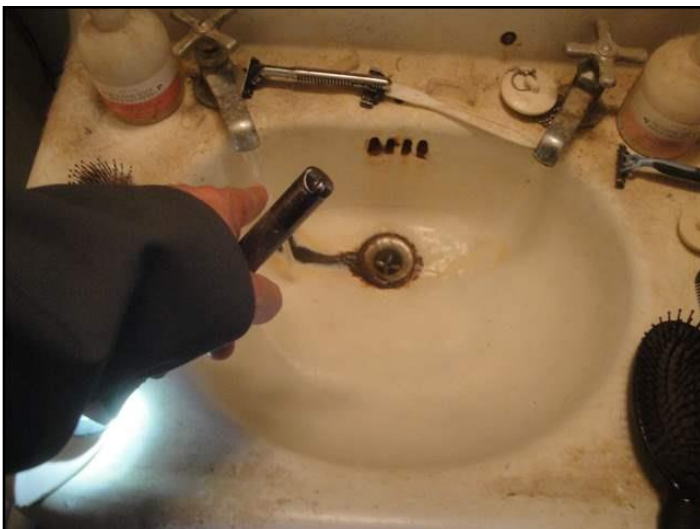
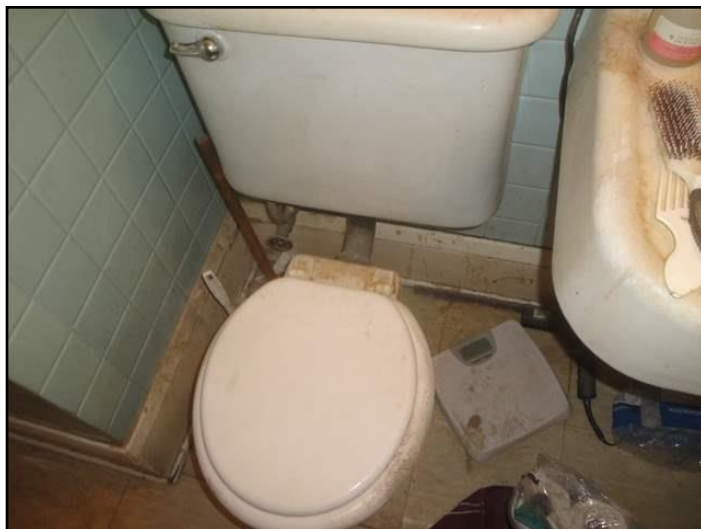
54. • Older fixtures were present throughout the apartments.

Task: Budget replacement

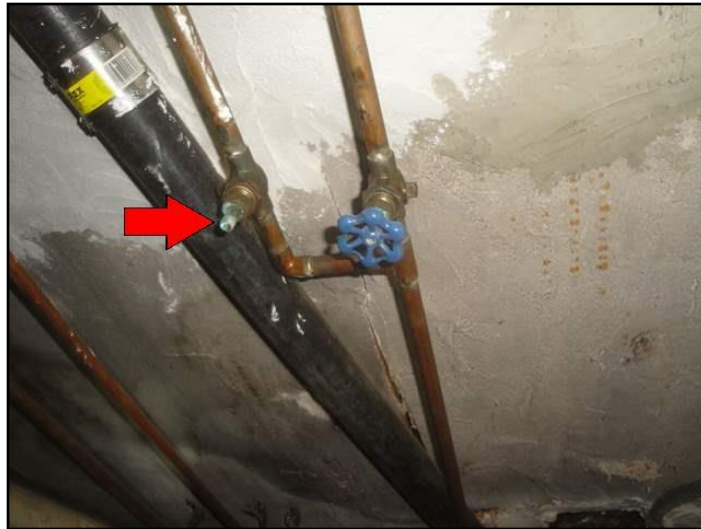
55. **Condition:** • [Damaged handle](#)

Missing.

88. Damaged handle

Task: Repair

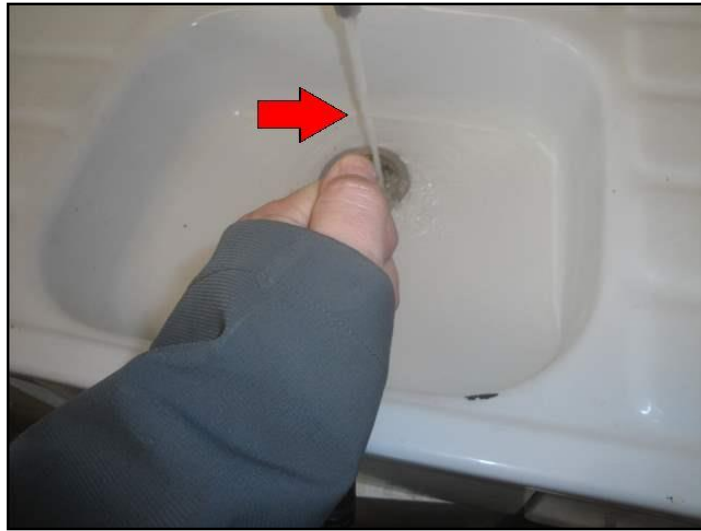
56. Condition: • [Poor pressure or flow](#)

Below average at some fixtures. Old, rusting galvanized supply feeds are suspect.

rusting of galvanized pipe can greatly reduce water pressure and will eventually cause leaks as rust creates holes in the pipe walls

89. Poor pressure or flow

Task: Monitor

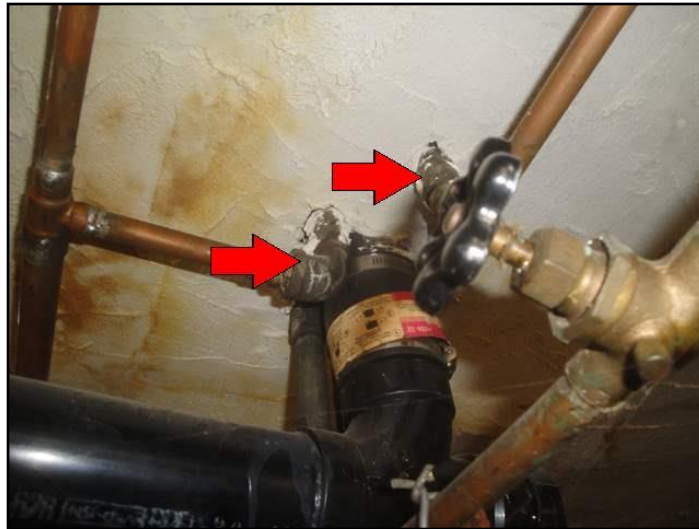
57. Condition: • [Galvanized steel](#)

rusting of galvanized pipe can greatly reduce water pressure and will eventually cause leaks as rust creates holes in the pipe walls

problems are likely to occur soonest on pipes carrying hot water, horizontal pipes and at threaded (thinner) sections

90. Galvanized steel

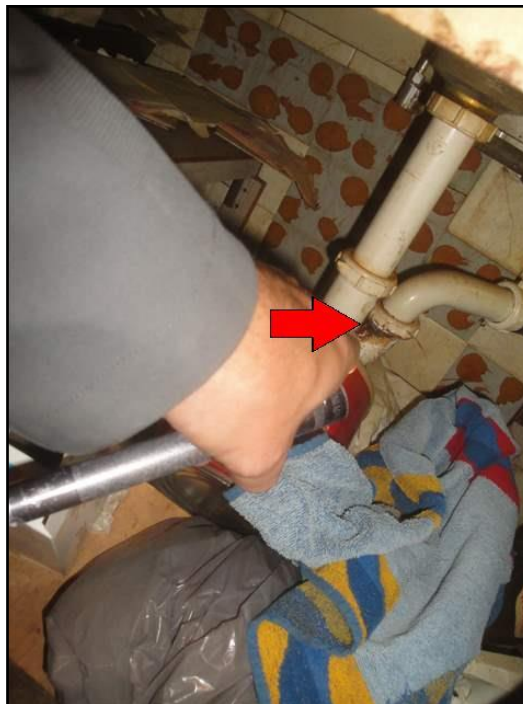
58. Condition: • [Leak](#)

91. Leak

Task: Repair

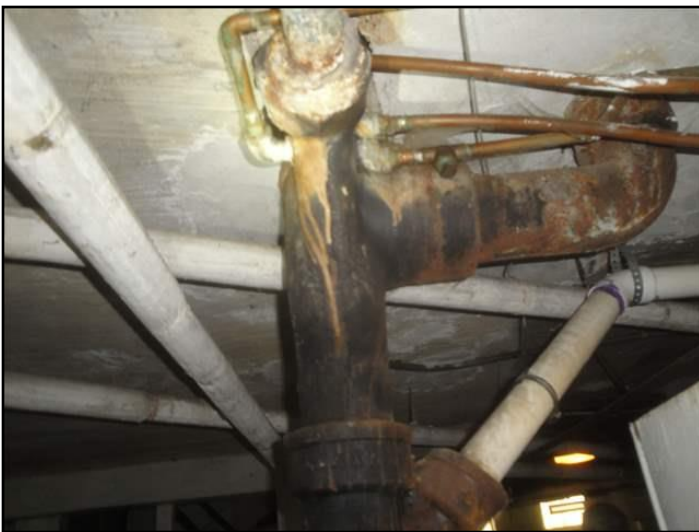
59. Condition: • [Rust](#)

92. Rust

Task: Monitor

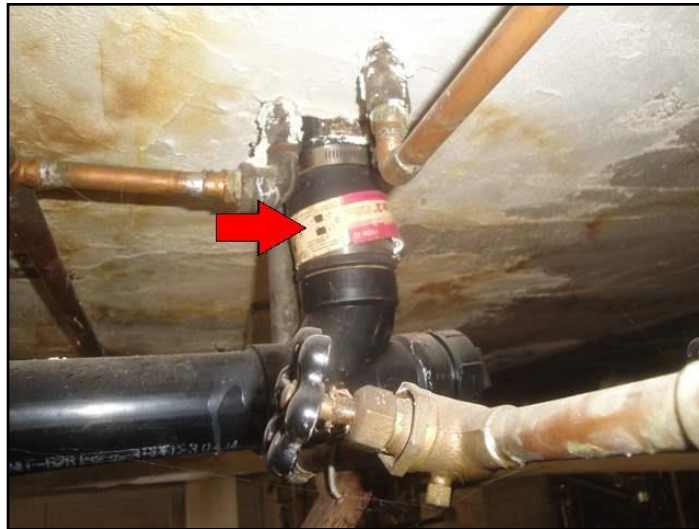
60. Condition: • [Nonstandard materials and patches](#)

Missing stainless steel sleeve at rubber union connections.

Implication(s): Sewage entering the building | Chance of water damage to contents, finishes and/or structure

94. *Nonstandard materials and patches*

Task: Replace

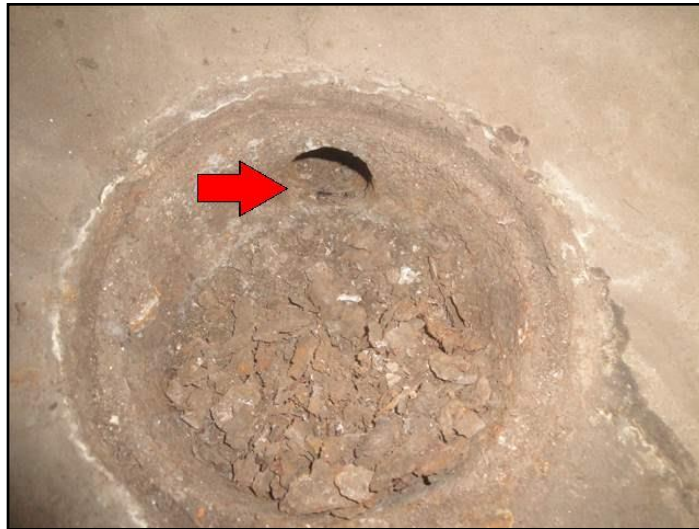
95.

61. Condition: • Missing cleanout plug. There is a potential for sewer gas to enter the building.

Task: Repair

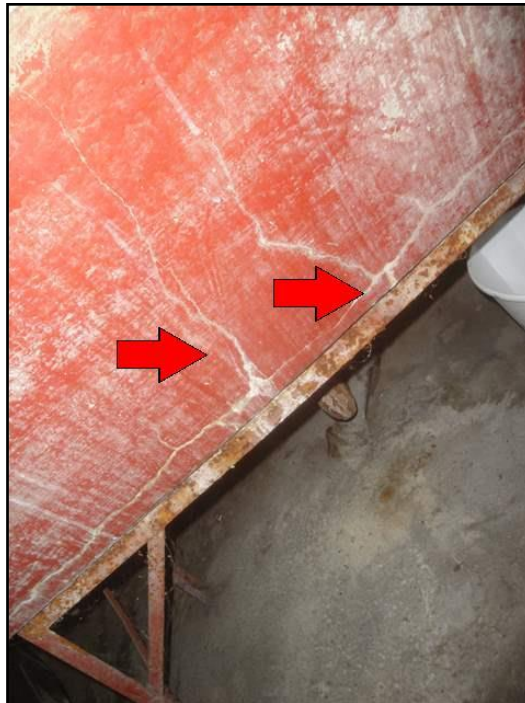
96.

63. Condition: • Cracked

Location: 962

Task: Budget replacement

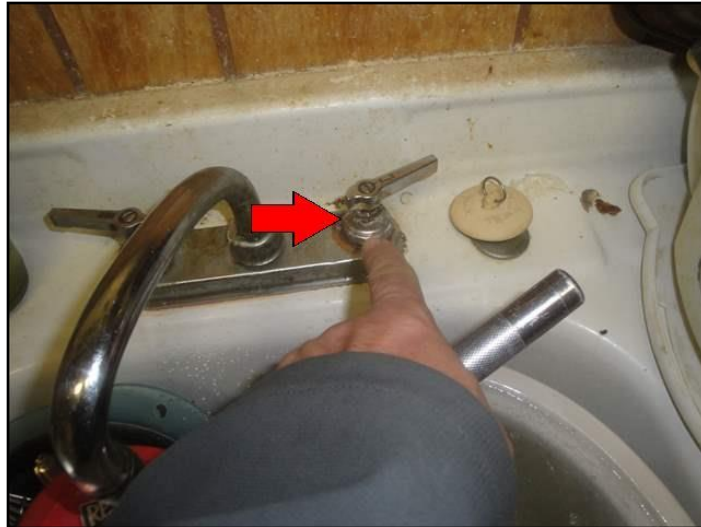
65. Condition: • [Drip, leak](#)

Implication(s): Chance of water damage to contents, finishes and/or structure

98. Drip, leak

Task: Repair

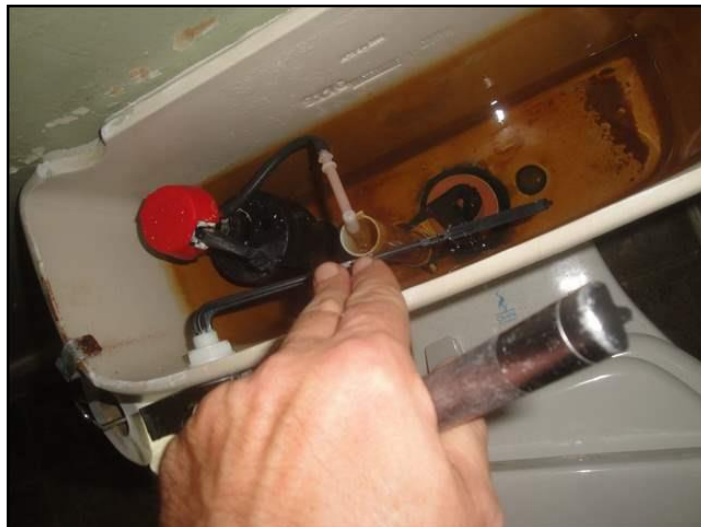
66. Condition: • [Cross connection](#)

99. Cross connection

Task: Improve

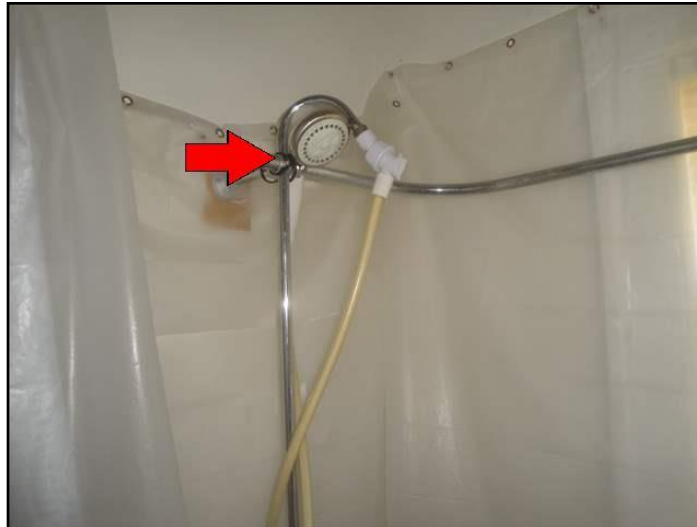
67. Condition: • [Cross connections](#)

100. *Cross connections*

Task: Improve

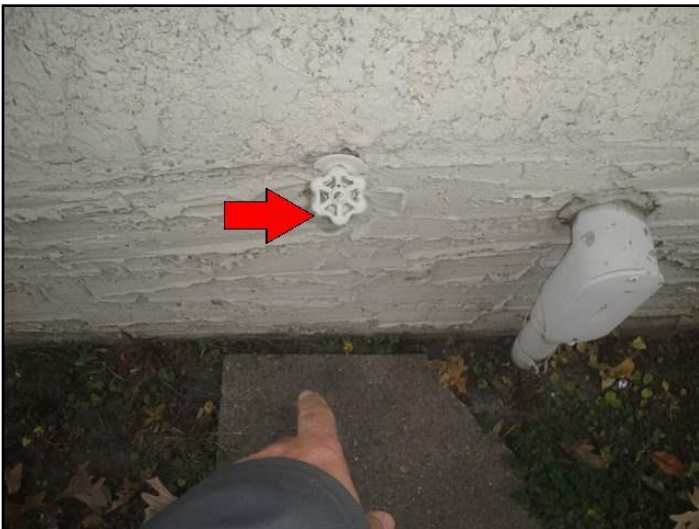
69. Condition: • [Backflow prevention missing](#)

101. Backflow prevention missing

102. Backflow prevention missing

Task: Provide

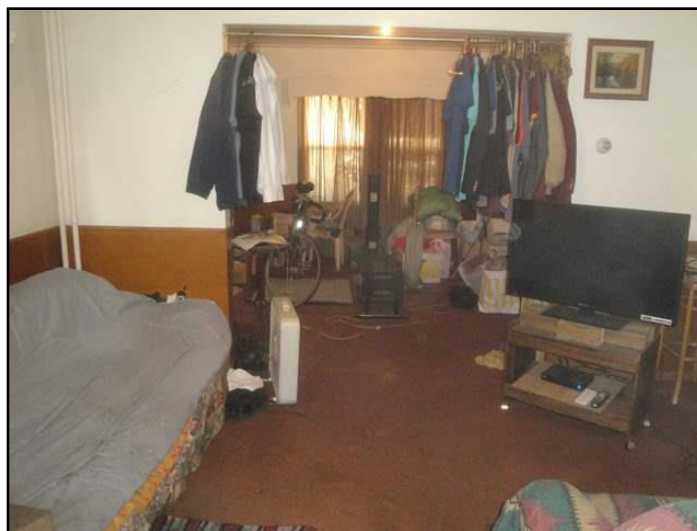
104.

73. • Apartment interiors were generally in fair to poor condition. Extensive improvements are recommended to stabilize the units and improve marketability.

Task: Improve

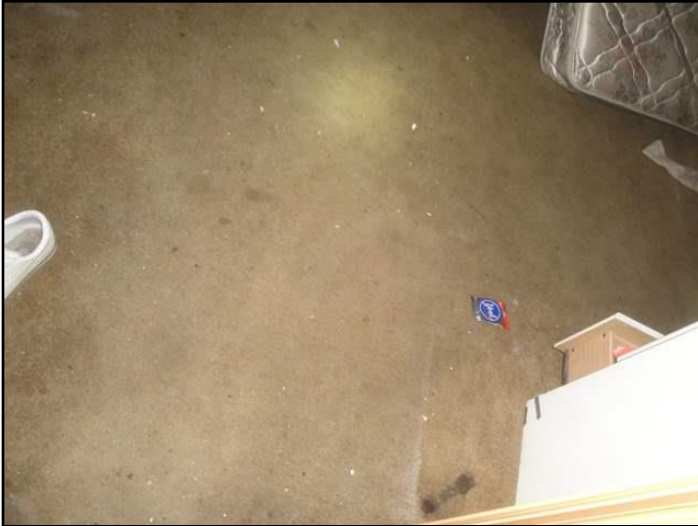
74. **Condition:** • Worn

The floors were generally in poor condition with damaged, stained and worn surfaces, stained carpet and cracked grout observed. The floors were in fair to good condition in unit 3 @ both 960 & 962.

105. Worn

Task: Repair or replace

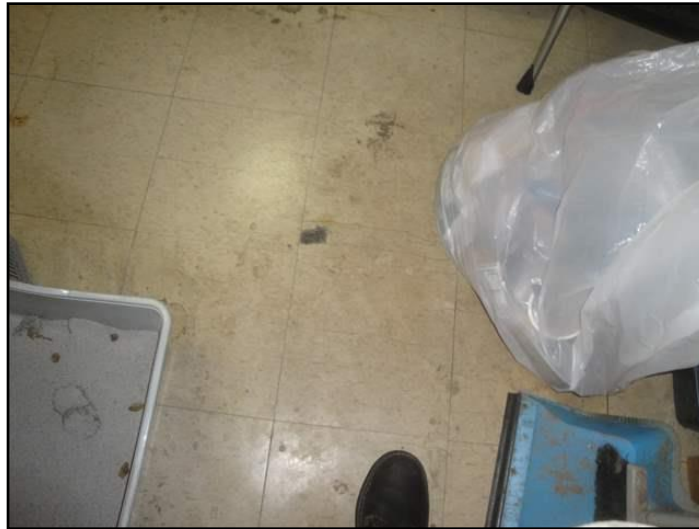
106. Worn

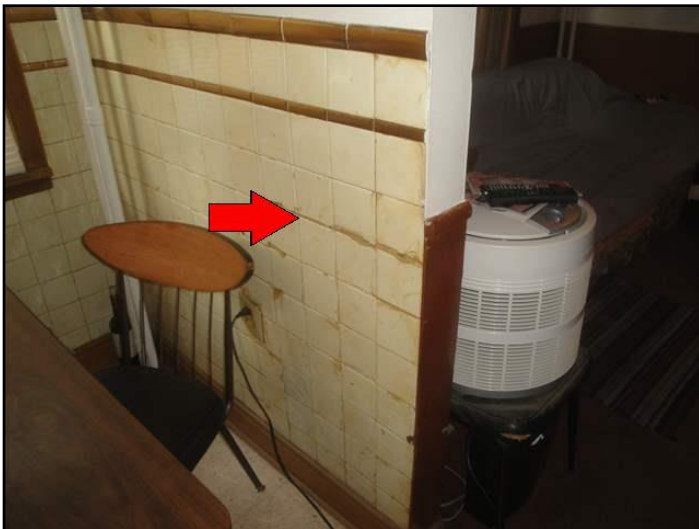
Damaged wall tiles

108. Damaged

Task: Repair

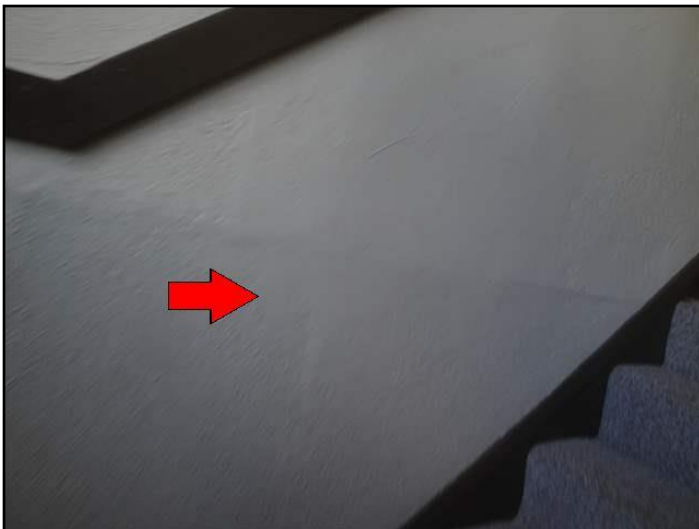
Patches, minor damage and previous repairs observed.

111. Typical flaws

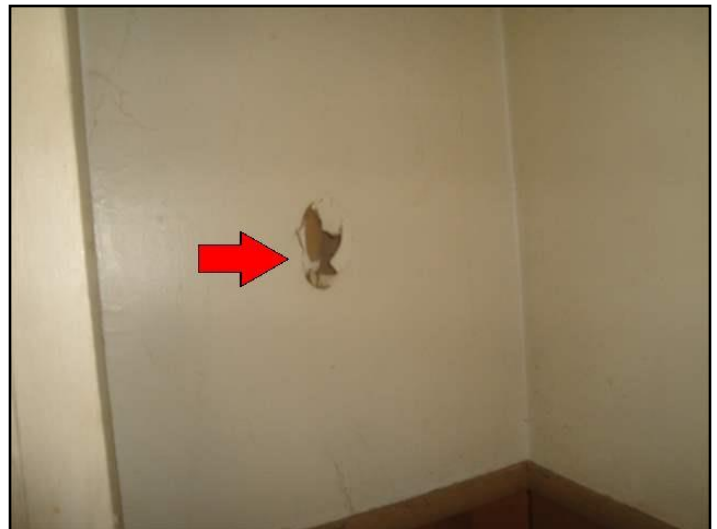
112. Typical flaws

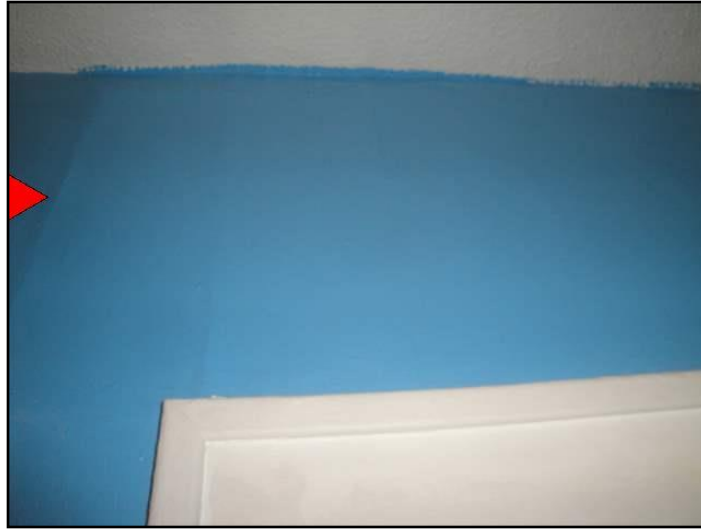
113. Typical flaws

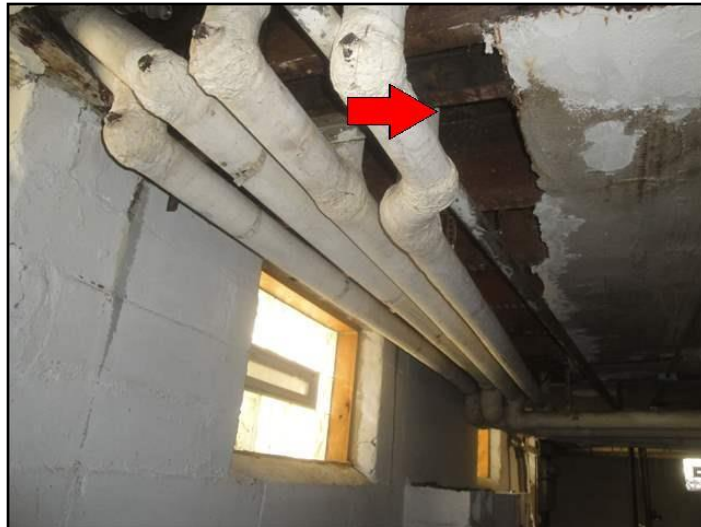
114.

77. Condition: • Missing fire protection

Task: Repair

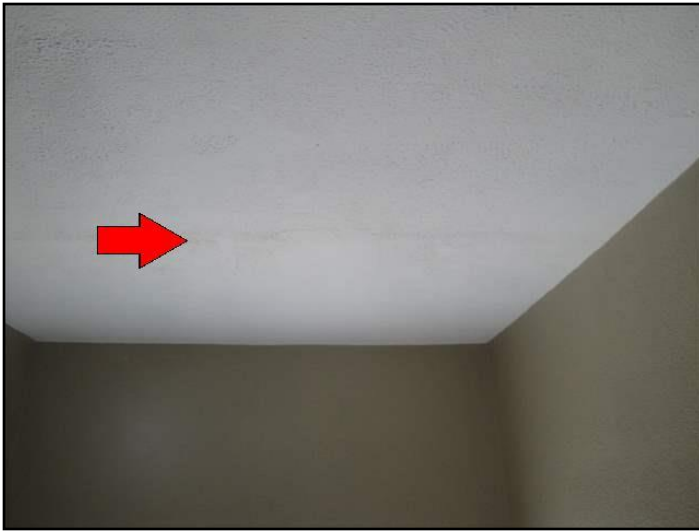
Typical minor cracks or previous repairs.

115. Typical flaws

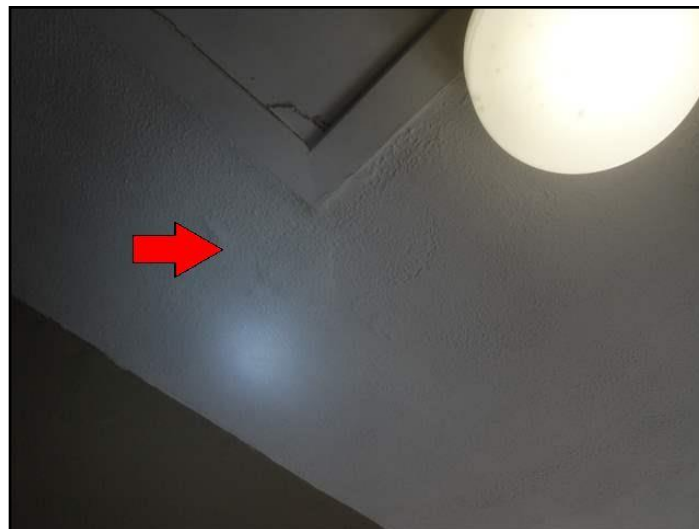
117. Typical flaws

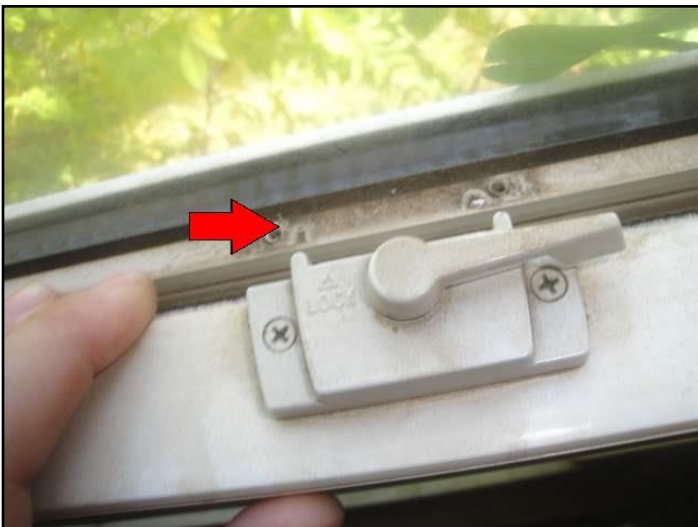
81. Condition: • [Broken](#)

119. Broken

Task: Repair

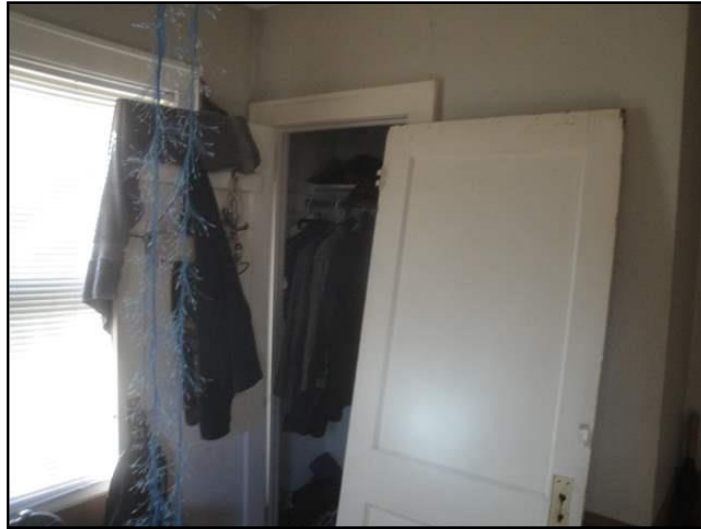
121.

82. Condition: • Loose

Task: Repair

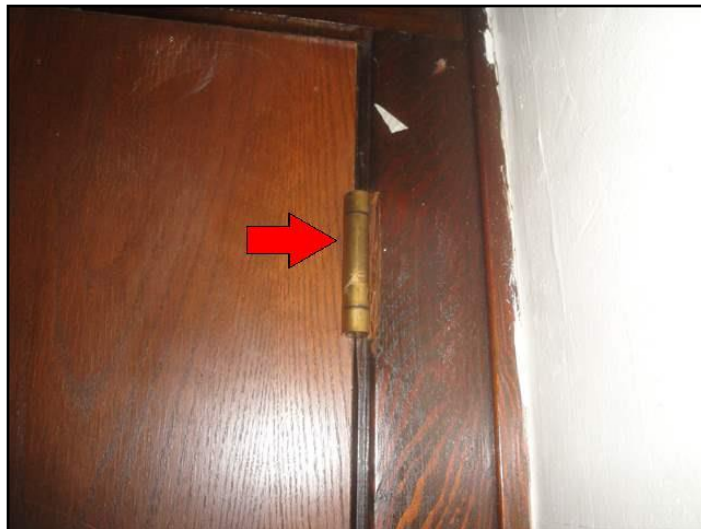
Entry door hinge loose.

122. Loose

Task: Repair
