PROPERTY CONDITION ASSESSMENT REPORT

Sample Report
Minneapolis, MN

Wednesday, October 21, 2015

RE: Report No. 1480, v.2
Sample Report
Minneapolis, MN

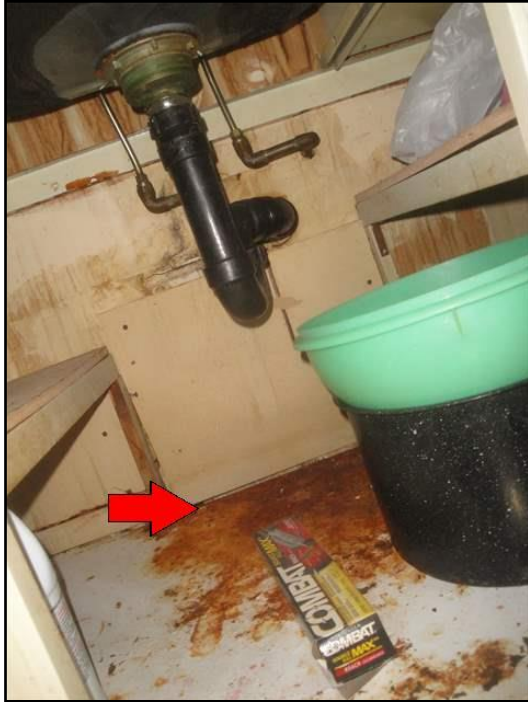
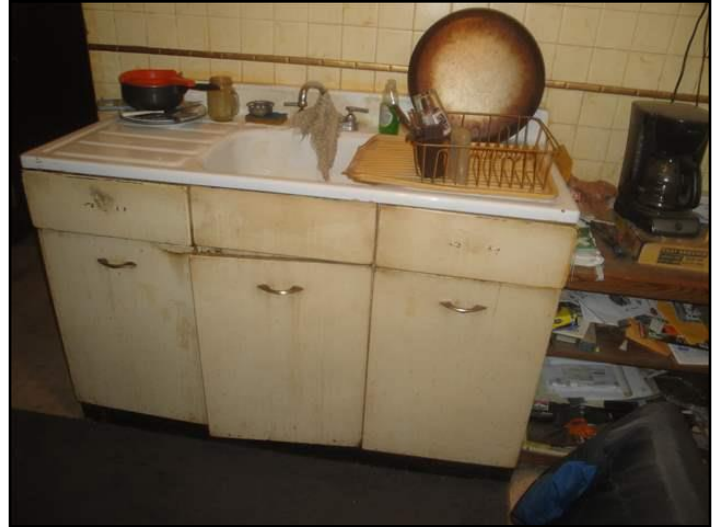
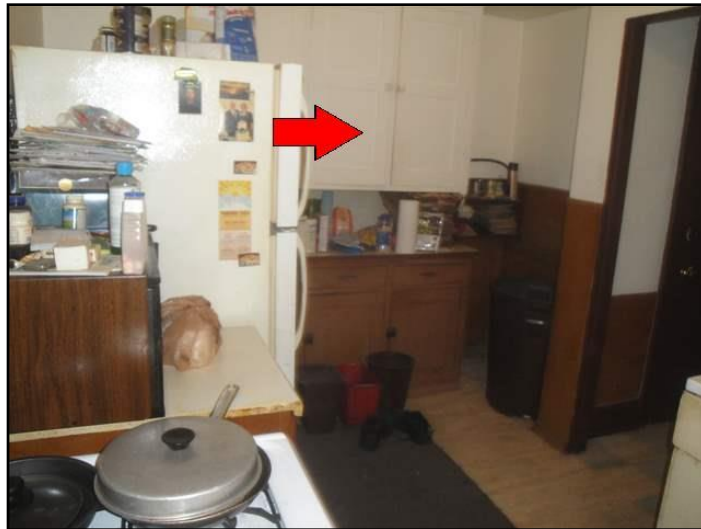
84. Condition: • Older and worn

Task: Budget replacement

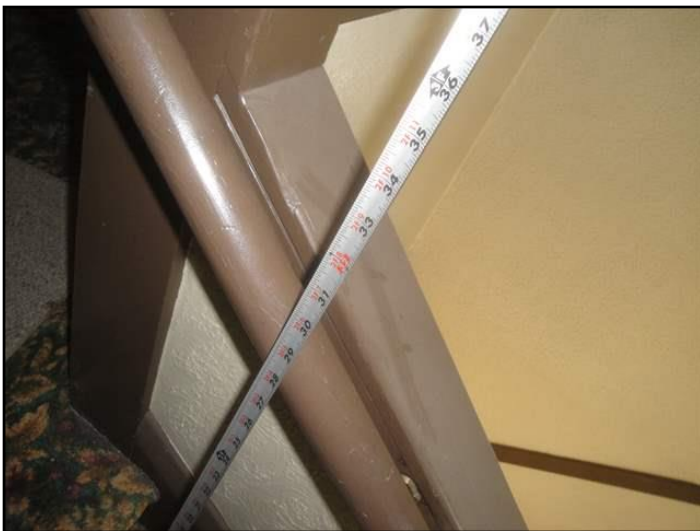
91. Condition: • [Too low](#)

127. Too low

Task: Improve

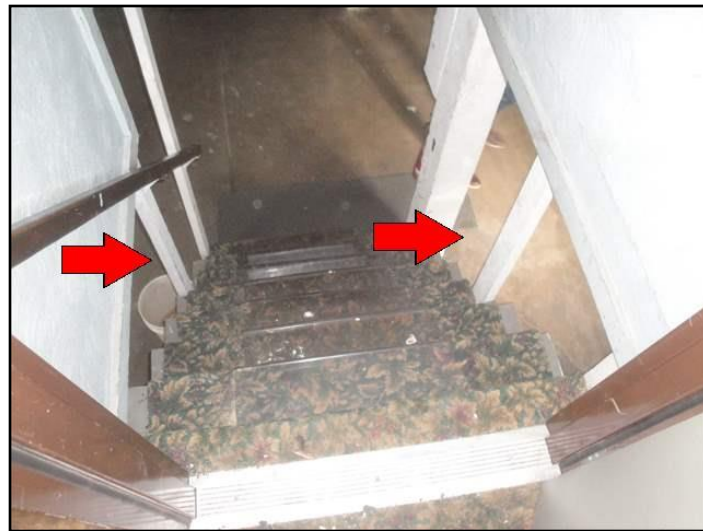
92. Condition: • [Missing](#)
Implication(s): Fall hazard
Location: Basements
Task: Provide
Time: Less than 1 year

129. Missing

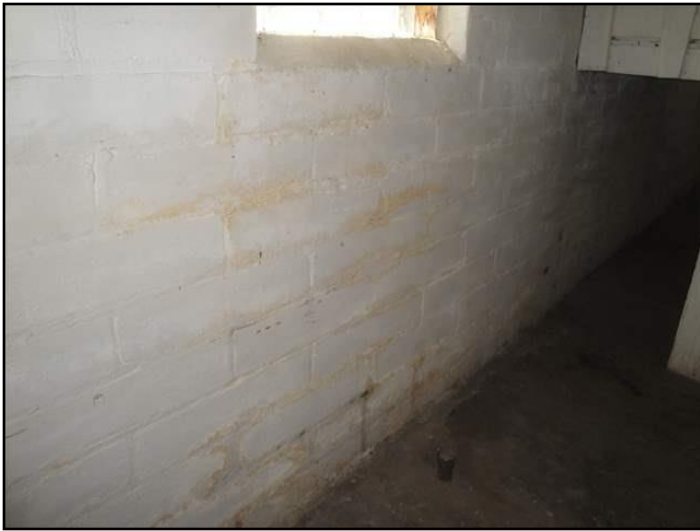
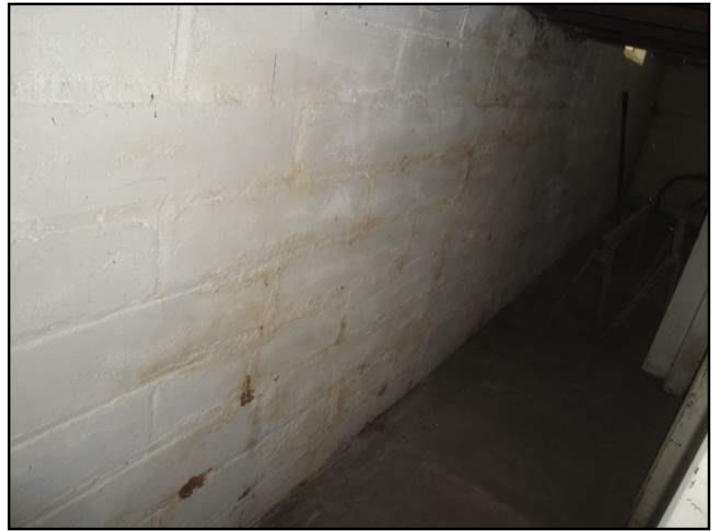
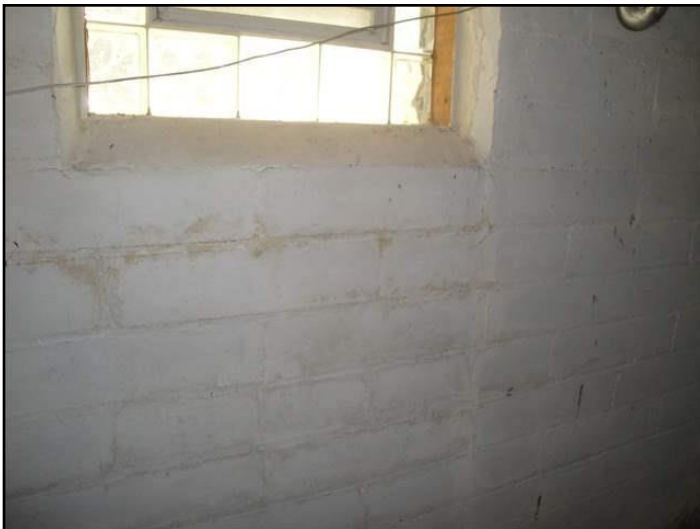
93. Condition: • [Efflorescence](#)

130. Efflorescence

Grading improvements and mortar repair or crack sealing are recommended to prevent further damage and moisture intrusion.

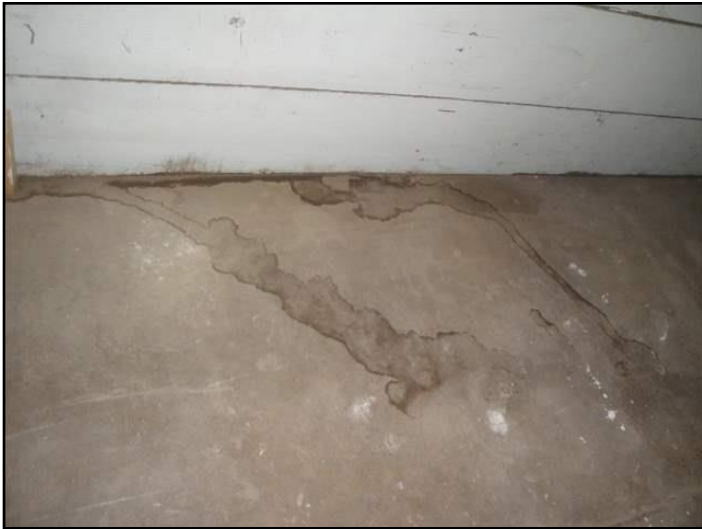
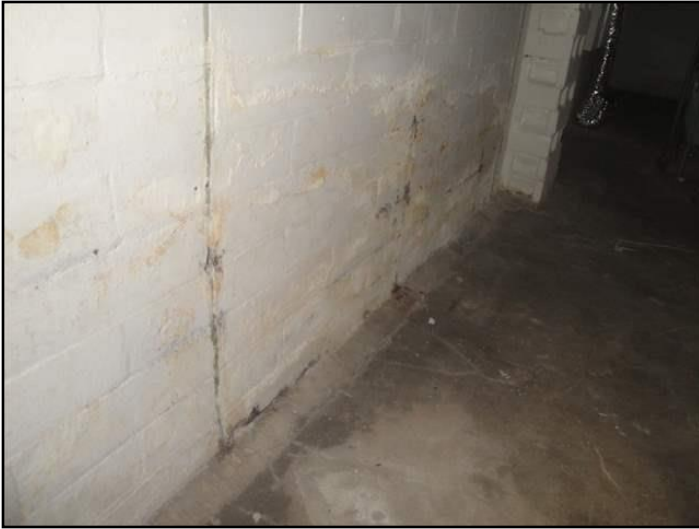
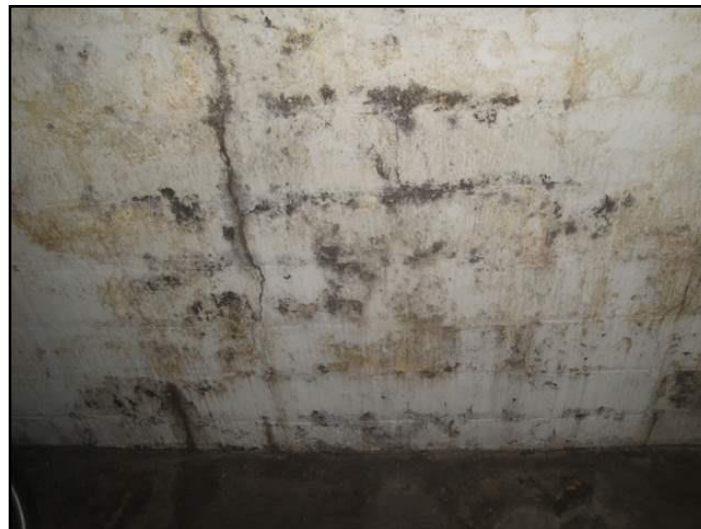
94. Condition: • [Stains](#)

134. Stains

Grading improvements and mortar repair or crack sealing are recommended to prevent further damage and moisture intrusion.

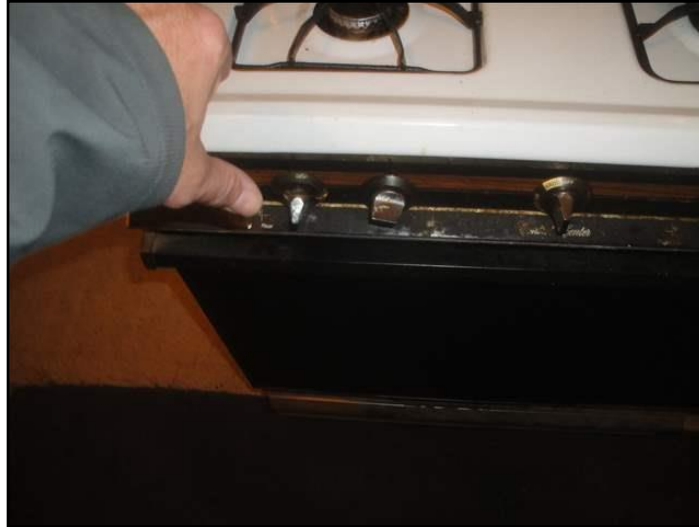
96. Condition: • Knobs broken

139. *Knobs broken*

Task: Repair
